INVESTIGATION OF THE POTENTIAL FOR CAUSTIC STRESS CORROSION CRACKING OF A537 CARBON STEEL NUCLEAR WASTE TANKS

Savannah River National Laboratory
Materials Science & Technology Directorate

Publication Date: October 2009

DOCUMENT: SRNS-STI-2009-00564 Rev.1
TITLE: Investigation of the Potential for Caustic Stress Corrosion
Cracking of A537 Carbon Steel Nuclear Waste Tanks

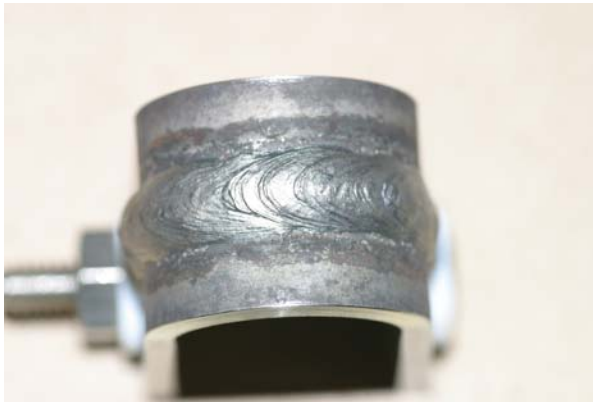
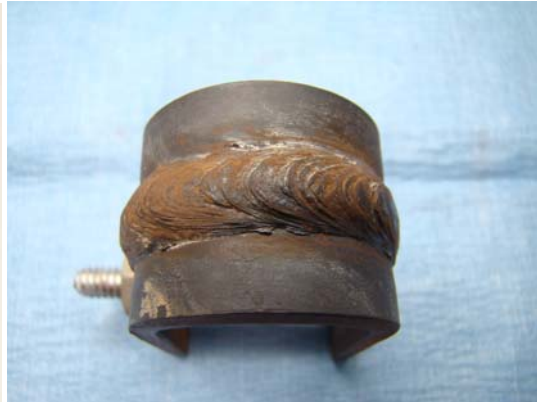
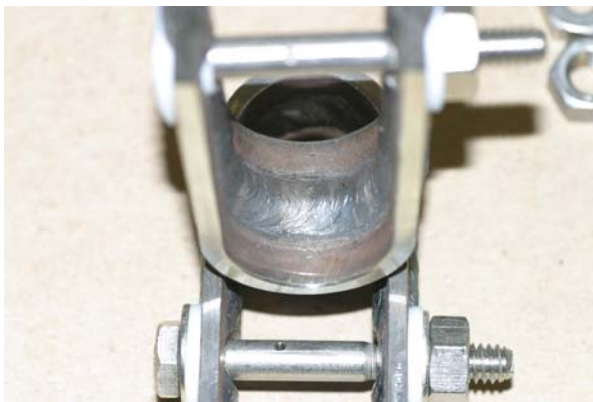
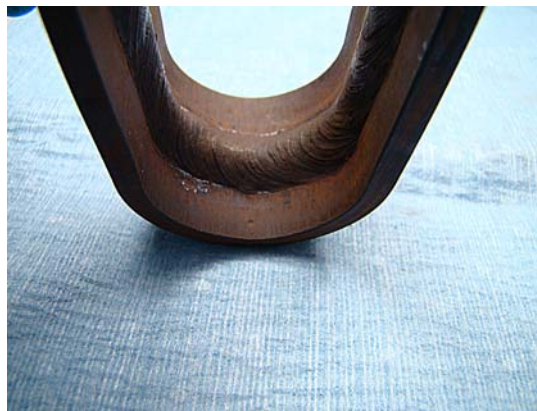
(a) Tensile side of U-bend before exposure

(b) Tensile side of U-bend after exposure

(c) Compressive side of U-bend
before exposure

(d) Compressive side of U-bend
after exposure

Figure 31 As-welded Specimen No. 247 exposed to caustic solution for 95 days.

The actual exposure time for specimens in the caustic solution was 95 days, or more precisely, 2255 hours. The test temperature was at least 125 °C. The pre- and post-exposure photographs of these specimens are placed side-by-side for comparison (Figs. 30-32). Both the outer side of the U-bend (tensile side) and the inner side (compressive) are reported. Although cracking is unlikely on the compressive stress field; the result is included in this section for completeness.

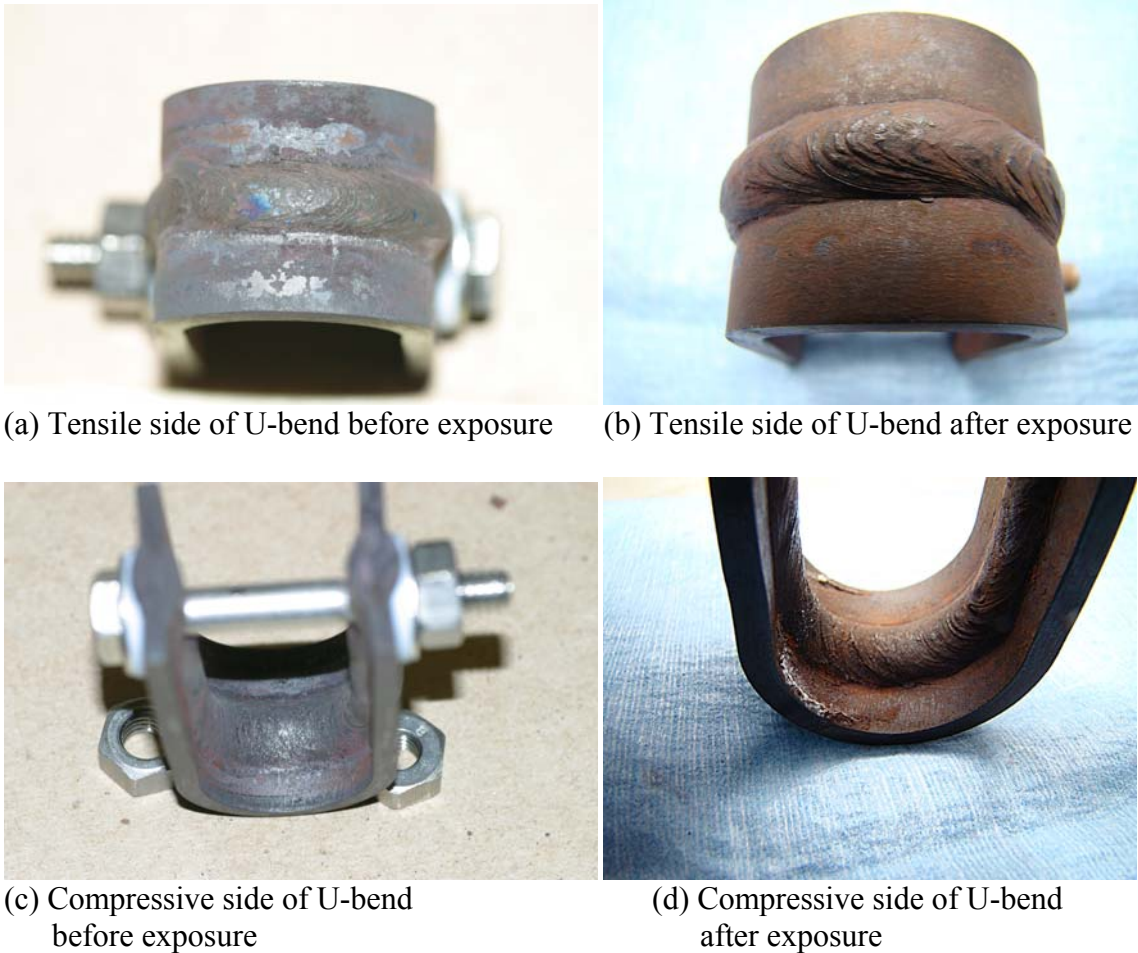
Figure 32 Heat-treated Specimen No. 243 exposed to caustic solution for 95 days.

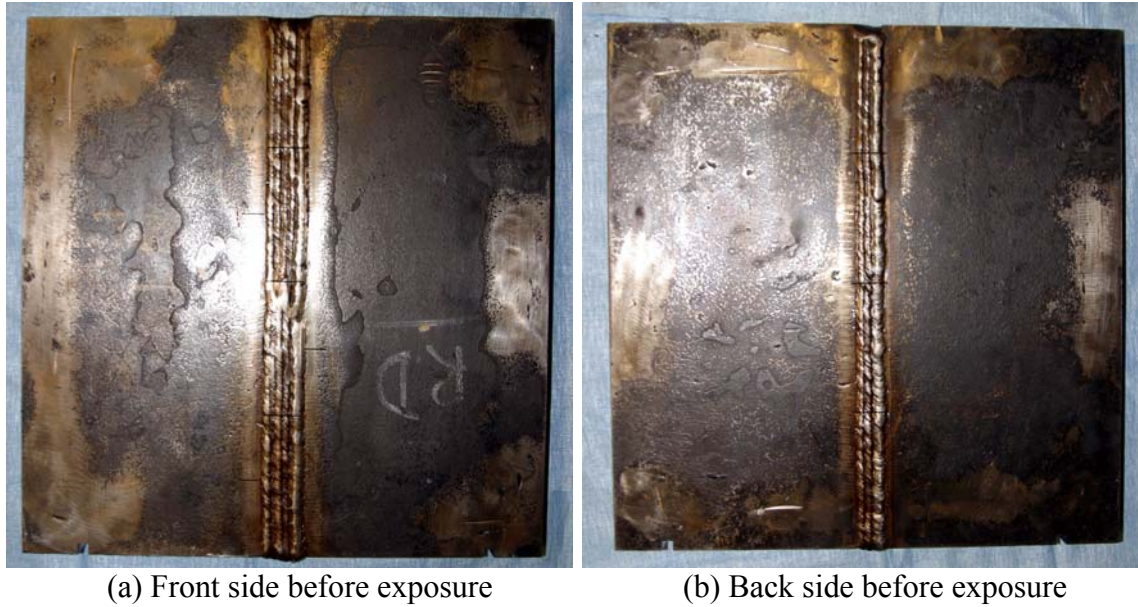
Figure 33 As-welded plate before exposure.

The large plates had been submerged in the test solution at 125 °C for 12 weeks at the end of the test. No stress corrosion cracking was found either in the as-welded plate or in the stress relieved/heat treated plate. The pre-exposure conditions of the plates are shown in Figures 33 and 34, respectively, for the as-welded and the heat-treated plates. Figures 35 and 36 are, respectively, the front and back sides of the as-welded plates after exposure for 12 weeks. The close-ups of the nine machined cracks in their post-test condition are shown in the insets. For the heat-treated plate, the post-test photographs are shown in Figures 37 (front side) and 38 (back side). Note that in Figures 35 to 38, V1, V2, and V3 are through-the-plate cracks and are across the width of the weld (vertical cracks); V4, V5, and V6 are also vertical cracks (perpendicular to the weld) but they are partly through plate ($\frac{1}{4}$ in. deep thumbnail cracks) in the HAZ; and P1, P2, and P3 are part-through plate ($\frac{1}{4}$ in. deep thumbnail cracks) cracks parallel to the weld and in the HAZ. On the back side of each plate, only three through-the-plate cracks can be seen. These machined cracks were schematically described earlier in Figure 14, and their designed dimensions were illustrated in Figures 15 to 17.

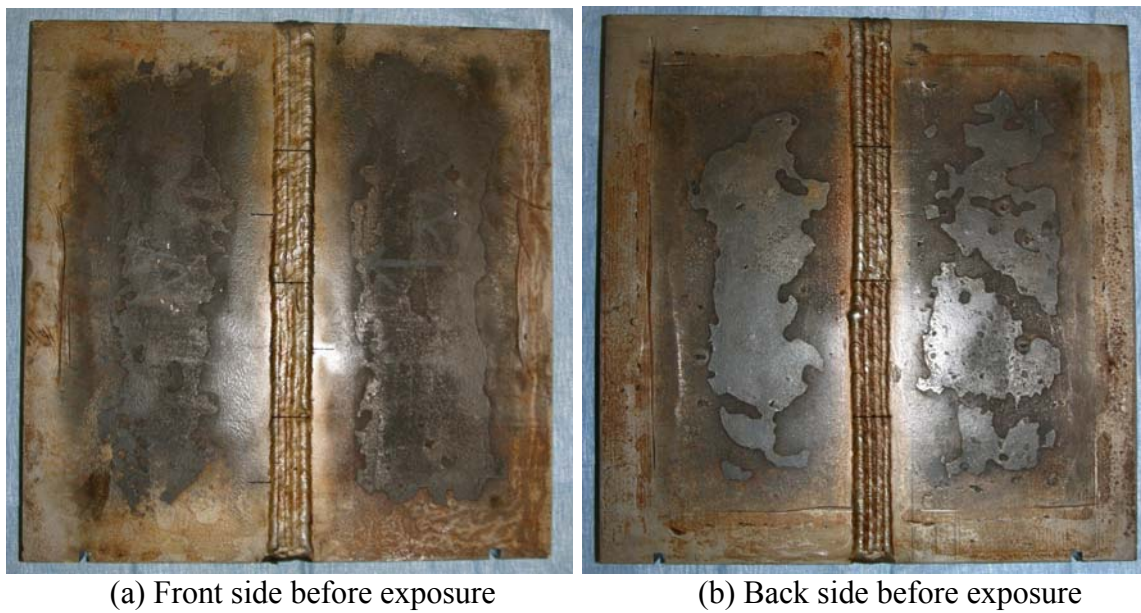
Figure 34 Heat-treated (stress-relieved) plate before exposure.

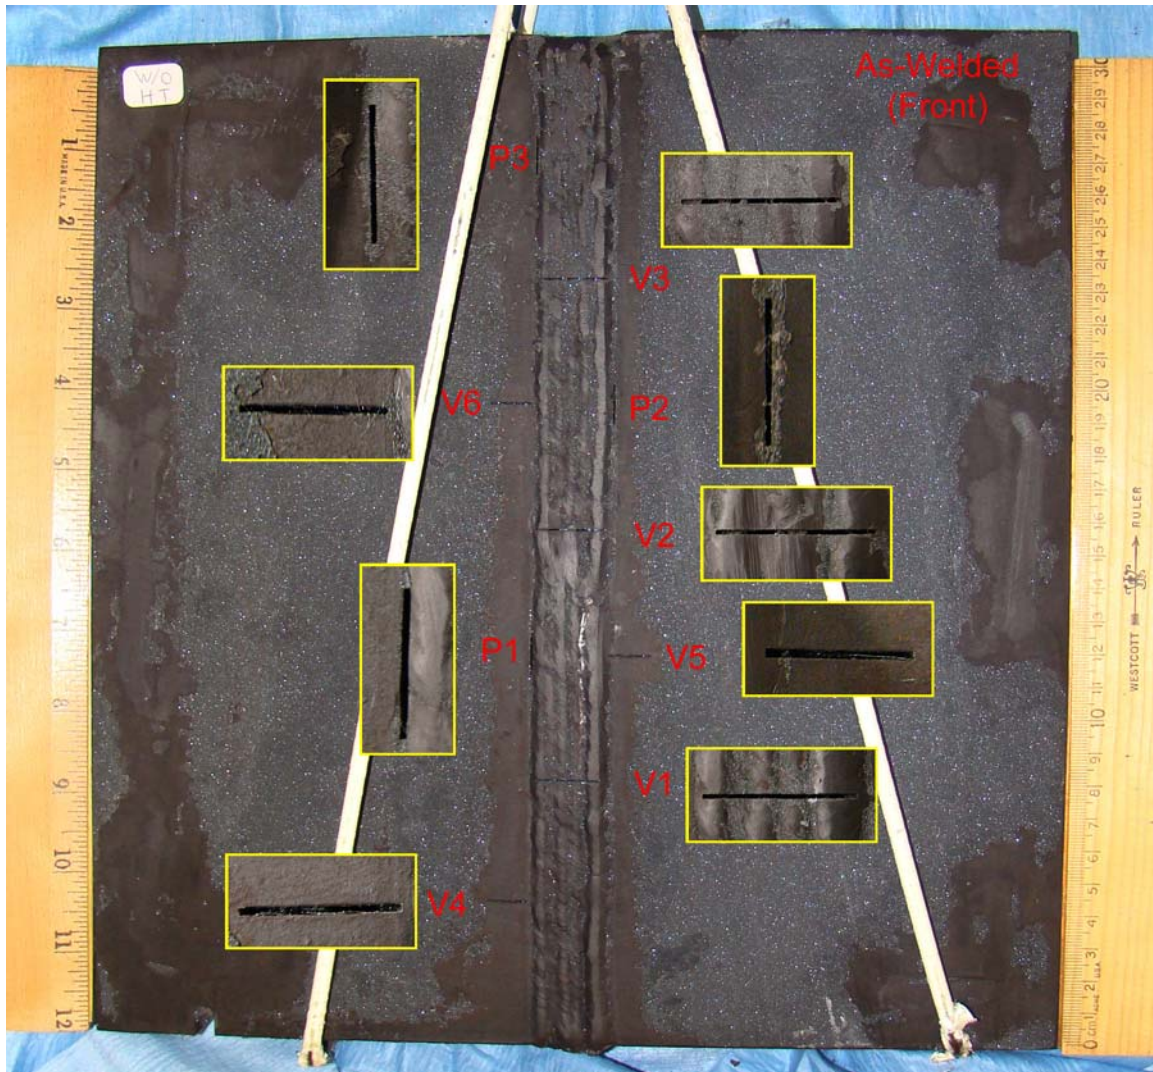
Figure 35 As-welded plate after exposure to test solution for 12 weeks (Front side, insets show close-up of the machined cracks).

The post-test large plates were visually inspected carefully for evidence of stress corrosion cracking on the specimen surfaces. The close-up photograph of each individual crack can be seen in the inset in Figures 35 to 38. In addition, nondestructive testing was conducted prior to and at the completion of exposure. Volumetric (ultrasonic shear wave) inspections were performed in search of cracking either parallel or perpendicular to the weld. NDE inspections confirmed visual findings that there was no stress corrosion cracking or increase in crack length of the machined notch. Because no cracking was found, the magnetic particle testing (MT) was not performed.

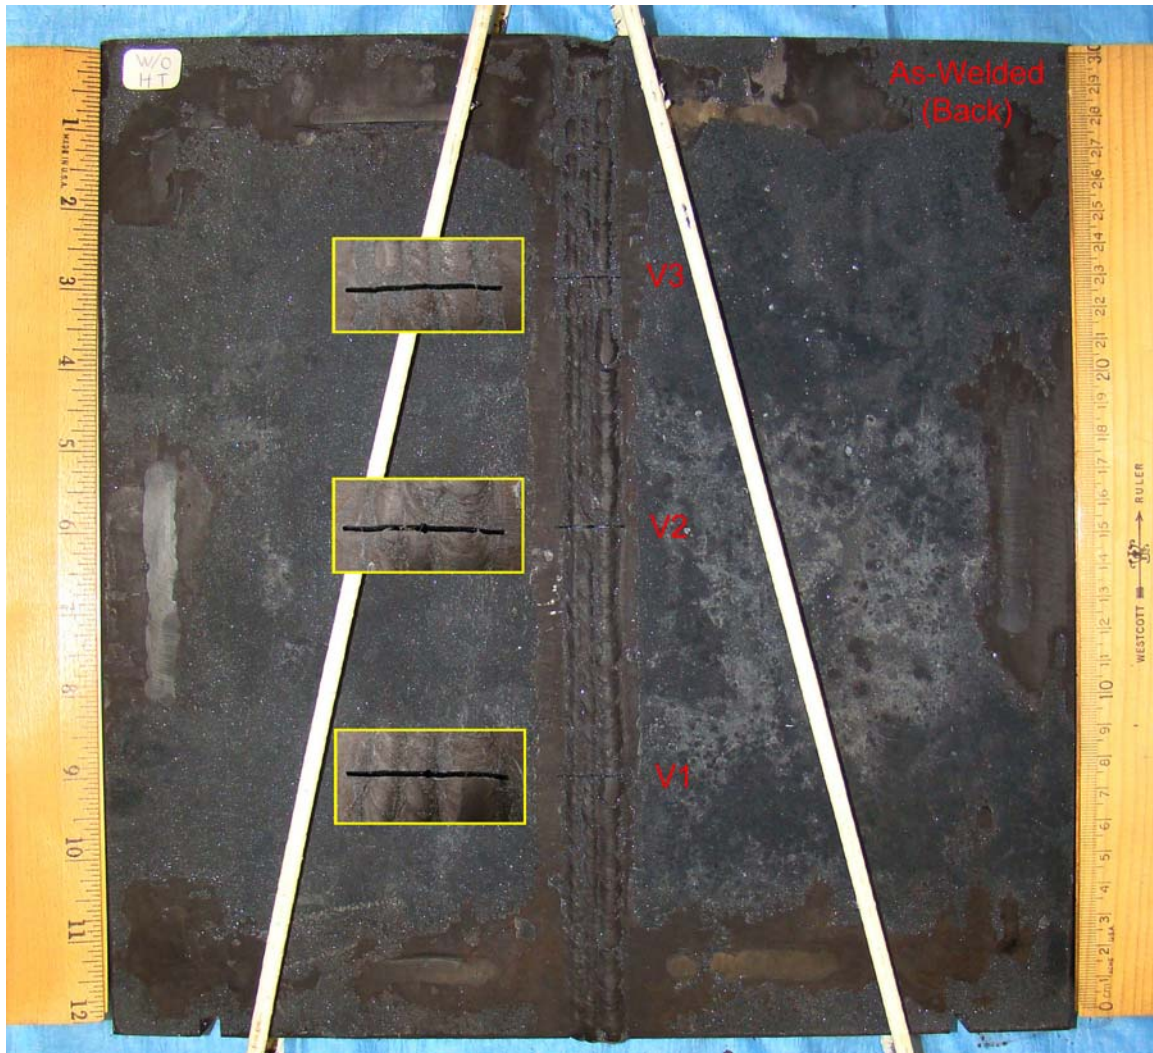
Figure 36 As-welded plate after exposure to test solution for 12 weeks (Back side, insets show close-up of the machined cracks).

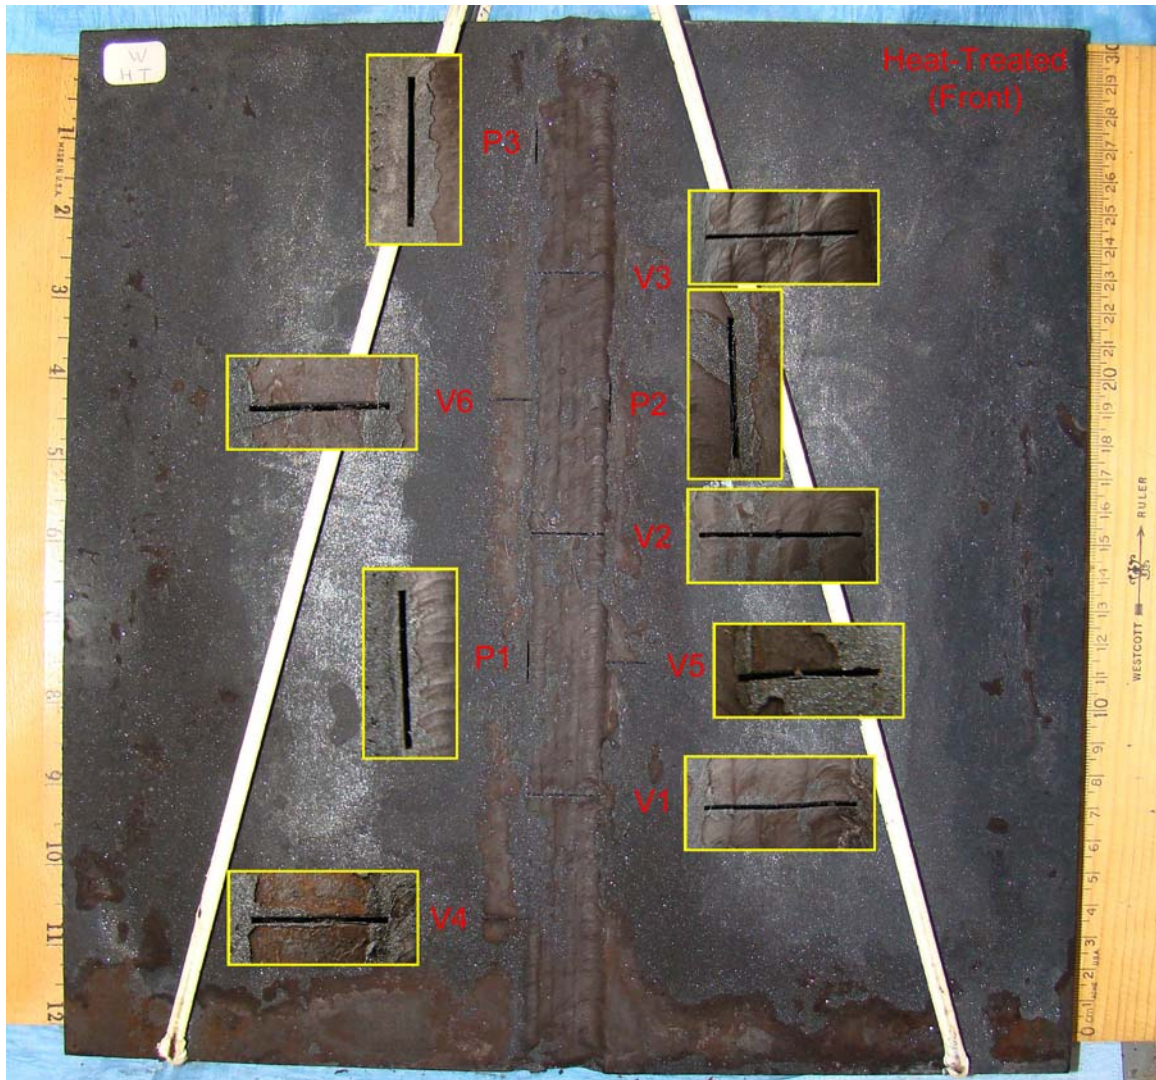
Figure 37 Heat-treated plate after exposure to test solution for 12 weeks (Front side, insets show close-up of the machined cracks).

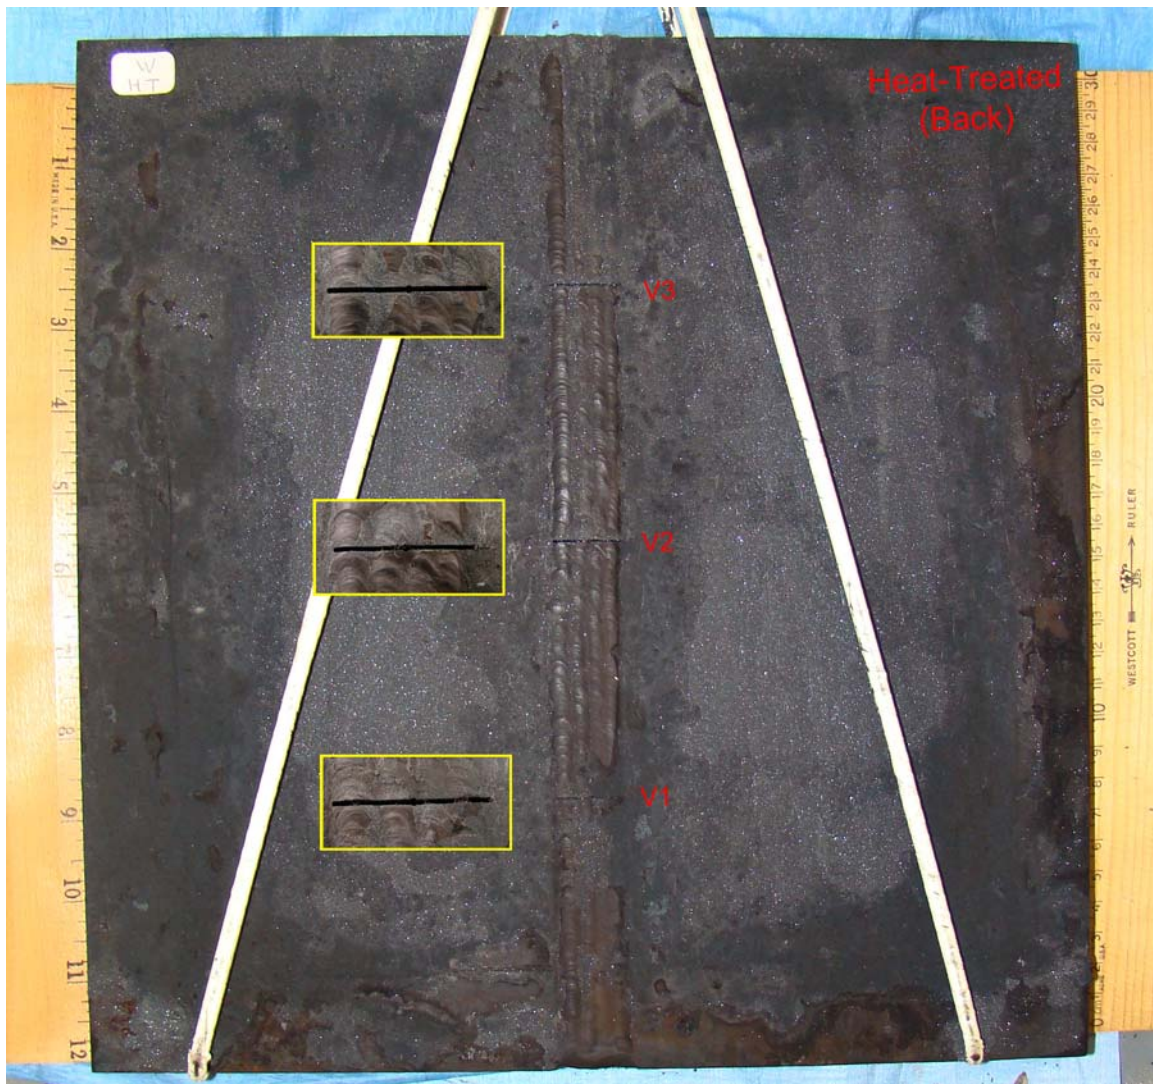
Figure 38 Heat-treated plate after exposure to test solution for 12 weeks (Back side, insets show close-up of the machined cracks).

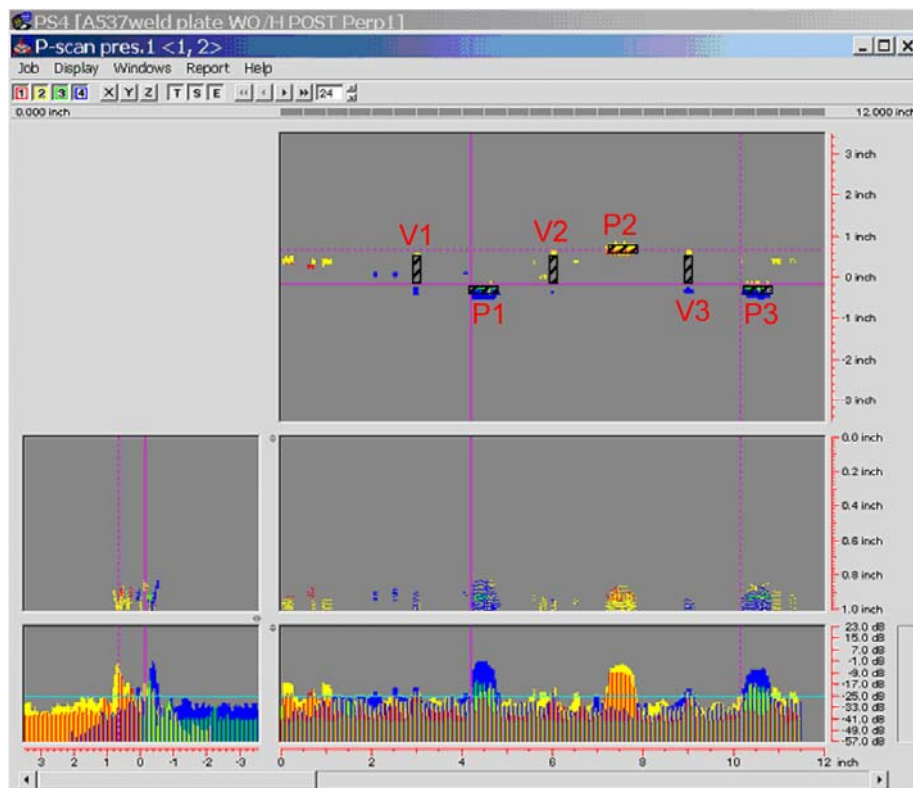
Figure 39 P-scan for stress corrosion cracking parallel to the weld for the as-welded plate.

It should be noted that the P-scan applied directly over the uneven surface of the weld beads is impractical and therefore was not performed. Should stress corrosion cracking occur in machined cracks V1, V2, and V3 (through-the-plate cracks across the weld), the indication of crack extension would have been detected by the scans in the heat-affected zone immediately next to the weld (such as in Figs 39 to 41).

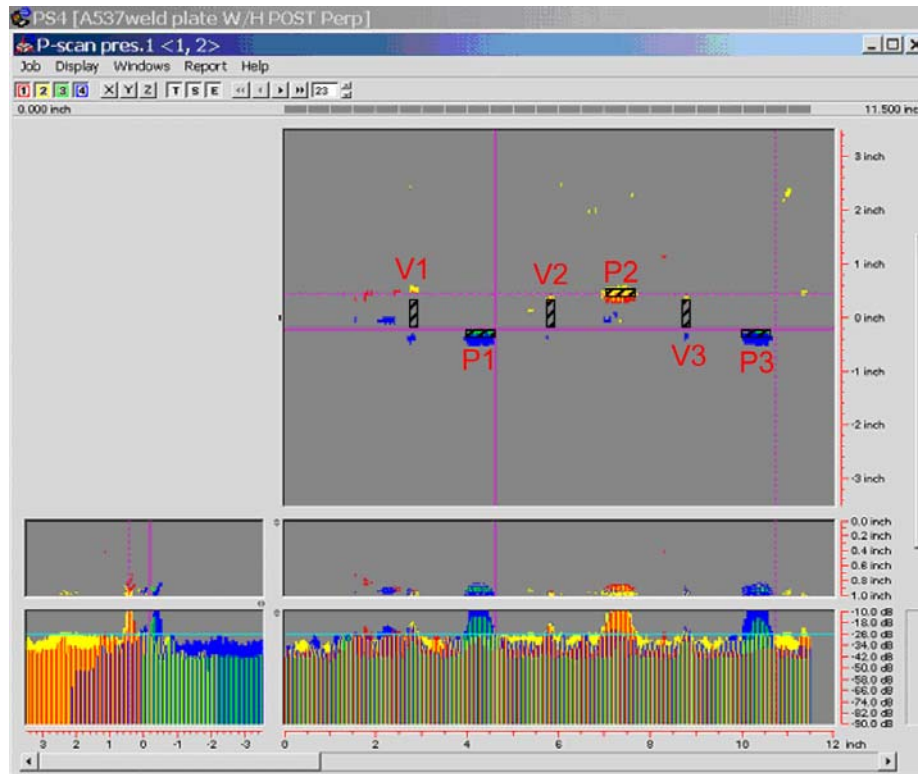
Figure 40 P-scan for stress corrosion cracking parallel to the weld for the heat-treated and stress relieved plate.

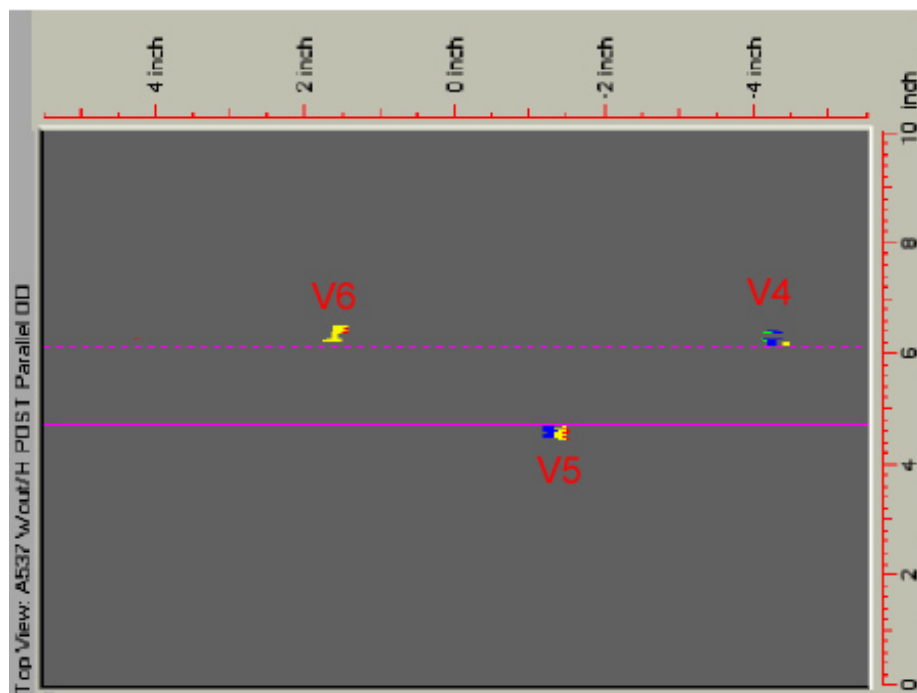
Figure 41 P-scan for stress corrosion cracking perpendicular to the weld for the as-welded plate.

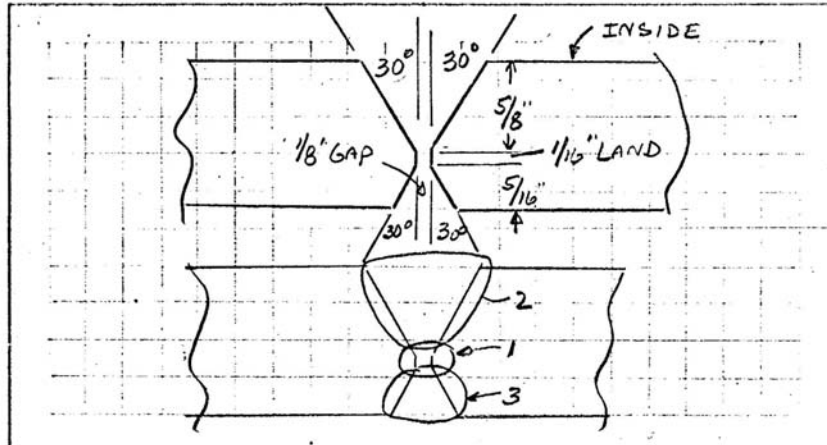
LOCATION	O.S. KNUCKLE BUTT WELD	PRIMARY
WHERE MADE	FIELD Δ SHOP	
MATERIAL	ASTM A-516 GR 70	
PROCESS	MIG DROP THRU	MANUAL COATED ROD
TECHNIQUE	DOUBLE 1G & 4G Δ 3G	
RADIOGRAPH	YES	HEAT TREAT YES
PROCEDURE QUAL. NO.	#8C	WELDER QUAL. NO.

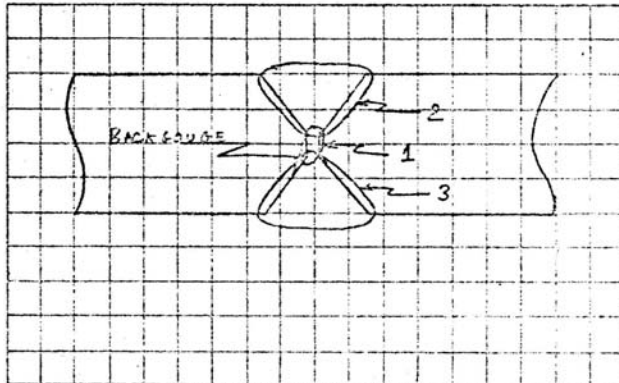
The welding technique, such as joint geometry, sequence of operations and/or welding processes, etc., shall be substantially as shown on the following sketches.

1ST PASS METAL INERT GAS
 2ND PASS COATED ROD
 BACKGOUGE
 3RD PASS COATED ROD
