DETERMINING DEGRADATION OF FIBERBOARD IN THE 9975 SHIPPING PACKAGE BY MEASURING AXIAL GAP

E. R. Hackney¹, W.L. Dougherty², K.A. Dunn², T.M. Stefek²

¹Savannah River Site
PO Box 616, Aiken, South Carolina 29808 USA

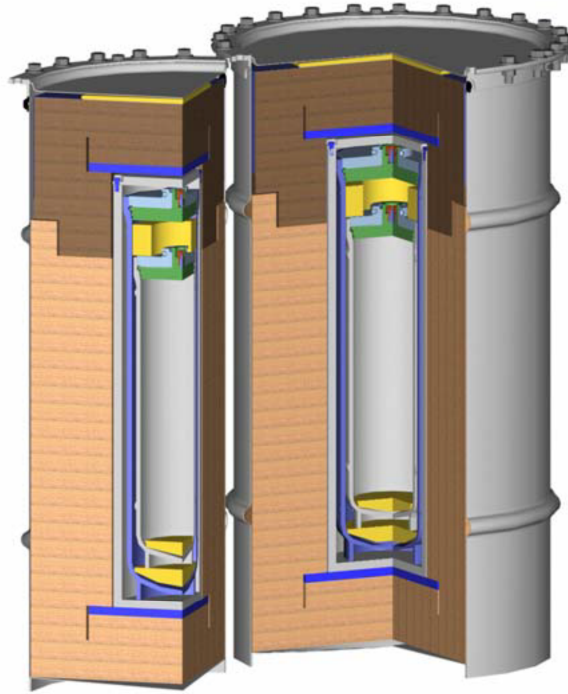
Figure 1. Cutaway of 9975 Shipping Package

The fiberboard used in the 9975 shipping packages provides impact resistance, thermal insulation and criticality control. As shown in Figure 1, the fiberboard surrounds the nested containment vessels and is separated into a lower assembly, which generally stays in the drum, and a removable upper assembly. The fiberboard assemblies can be either cane fiberboard insulation or softwood fiberboard insulation per ASTM C208-95, grade IV wall sheathing which are laminated together with an Elmer's® Professional Carpenters wood glue.

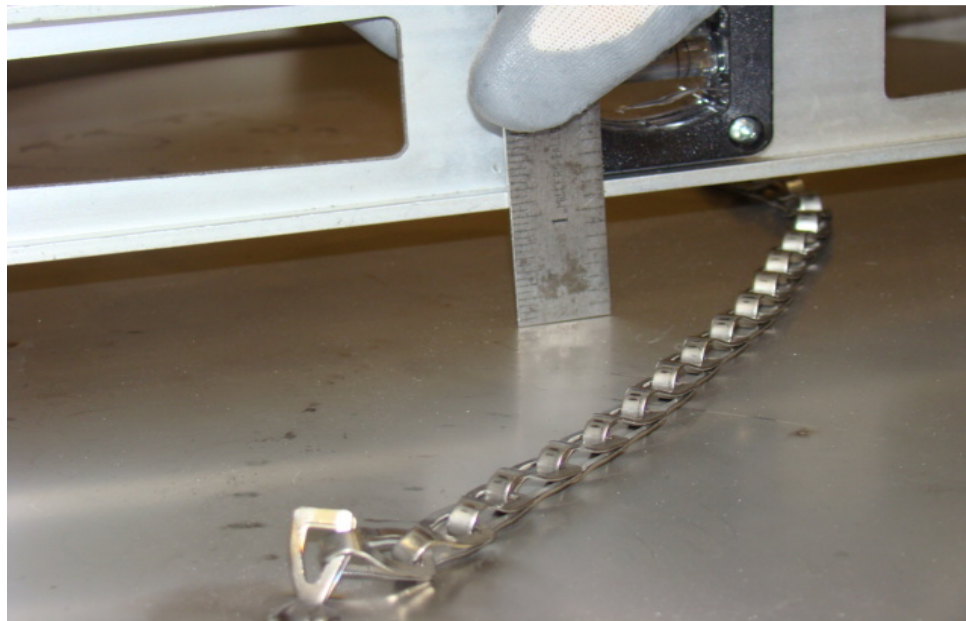
Figure 2a. Measuring the Axial Gap

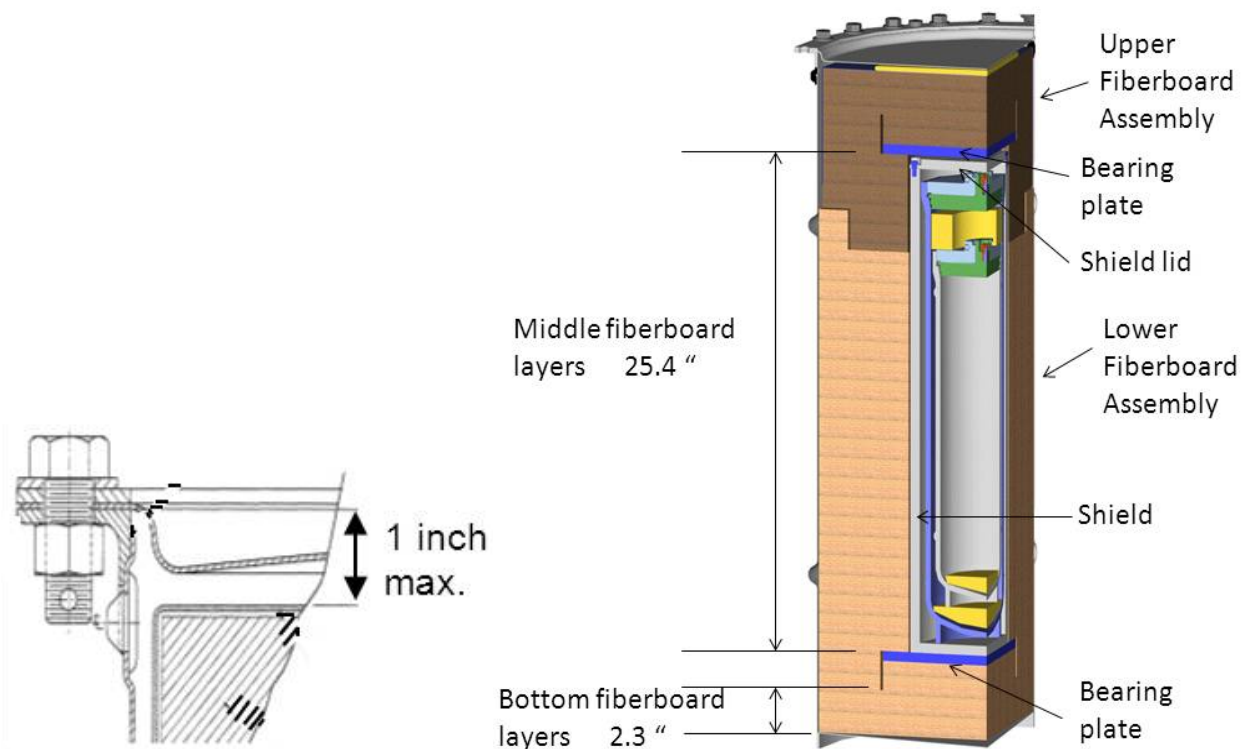
Figure 2b. Sketch of axial gap in the 9975 package (from Reference 2)

- The lower fiberboard layers will compact under the load of package internal components.
- Regions of the fiberboard assembly that lose moisture will shrink.
- The axial gap at the top of the package (between the drum flange and upper fiberboard assembly, Figure 2b) will increase.

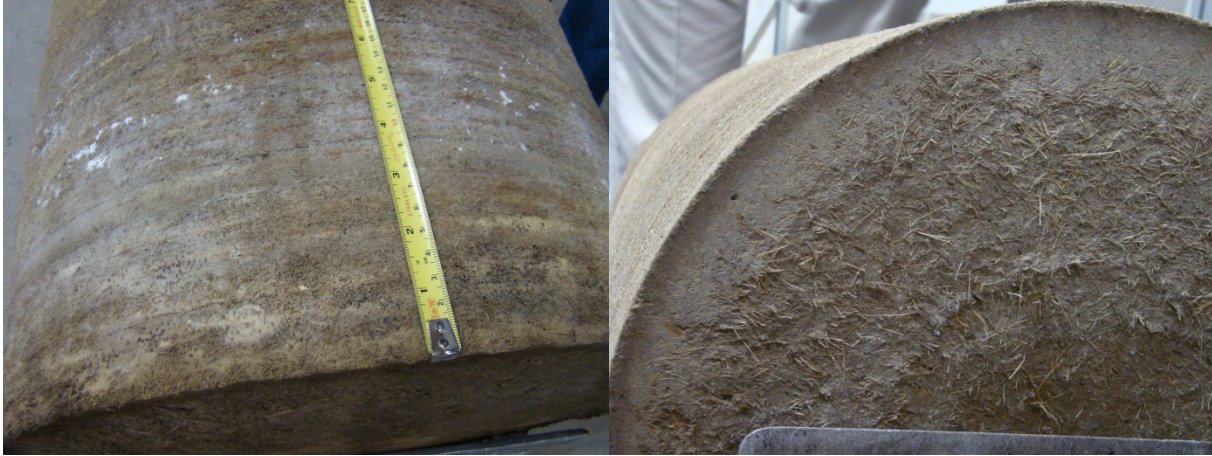
Figure 4. 9975-01818 With Excess Moisture resulting in compression and mildew

Figure 5. 9975-02287 fiberboard with only slight increase in moisture

- 9975-01818 and 9975-01819 both had high moisture levels (100%WME, above saturation) in the bottom fiberboard layers. In both cases, the drum bottom was stepped, and the fiberboard had fully conformed to the drum bottom. These drums had a much higher moisture level than expected in fiberboard probably due to improper storage of the drums prior to use.
- 9975-02130 had a moisture content of 23 – 24 %WME on the fiberboard bottom surface. The drum bottom was stepped, and the fiberboard had conformed to the outer step, but not the interior region.
- Packages 9975-01903 and 9975-02287 both had a moisture content of ~18 %WME in the bottom layers. Both packages had rounded drum bottoms, and in both cases, the fiberboard had conformed to the drum bottom over approximately 2 inches.

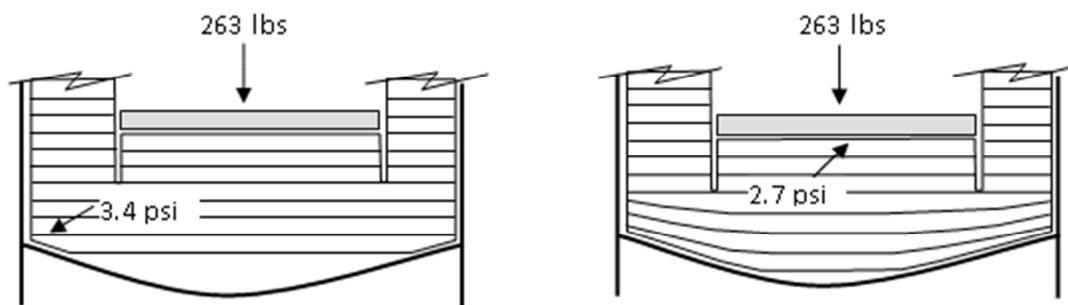
Figure 6. Varying degree of contact between the lower fiberboard assembly and drum bottom. As the contact area increases, the peak fiberboard stress will decrease to that immediately under the bearing plate. NOTE: Degree of curvature exaggerated for visual effect.

The bottom of the 9975 outer drum is dished (or stepped) and the fiberboard overpack is fabricated with a flat bottom. Typically, a ring of compressed fiberboard will form around the outer edge of the bottom surface approximately 1½ - 2 inches wide. As the bottom layer(s) compress further (due to package handling or reduced fiberboard strength), this ring will widen until the entire fiberboard bottom surface is in contact with the drum bottom. This has been observed in packages with elevated moisture content, and is illustrated in Figure 6. With the limited contact area, the peak stress in the bottom fiberboard layers is typically no greater than 3.4 psi. As the compressed region widens, the peak stress decreases to 2.7 psi, which is the stress immediately under the bearing plate.

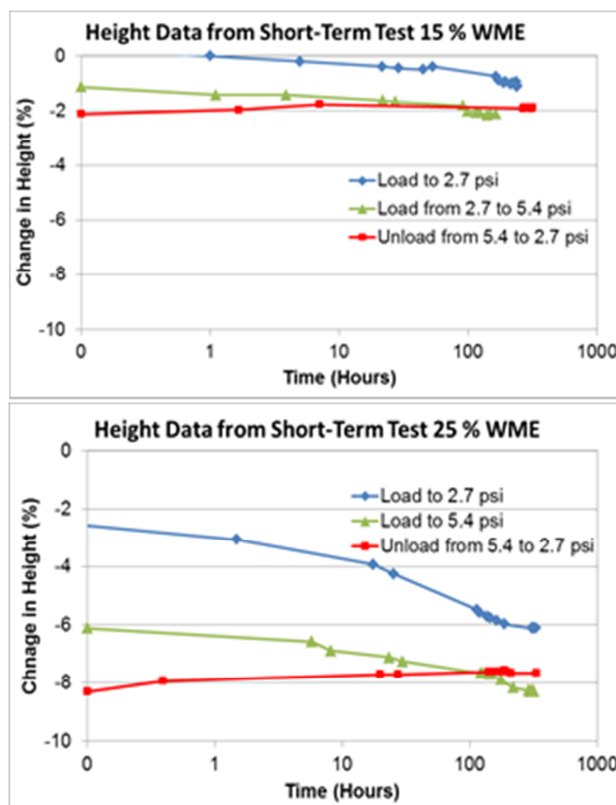
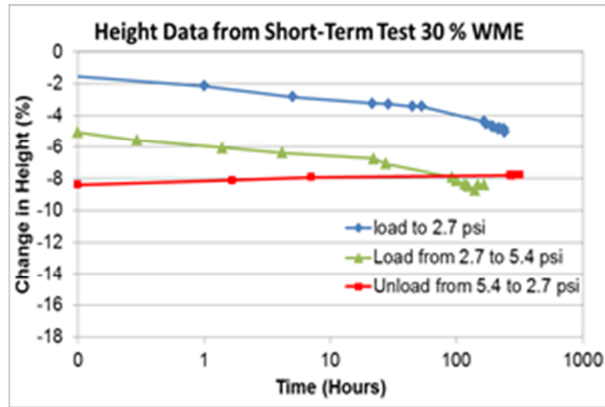
Figure 7. Change in sample height during short-term testing

The results of the short term tests generally confirm that the higher the moisture content, the greater the compaction level.

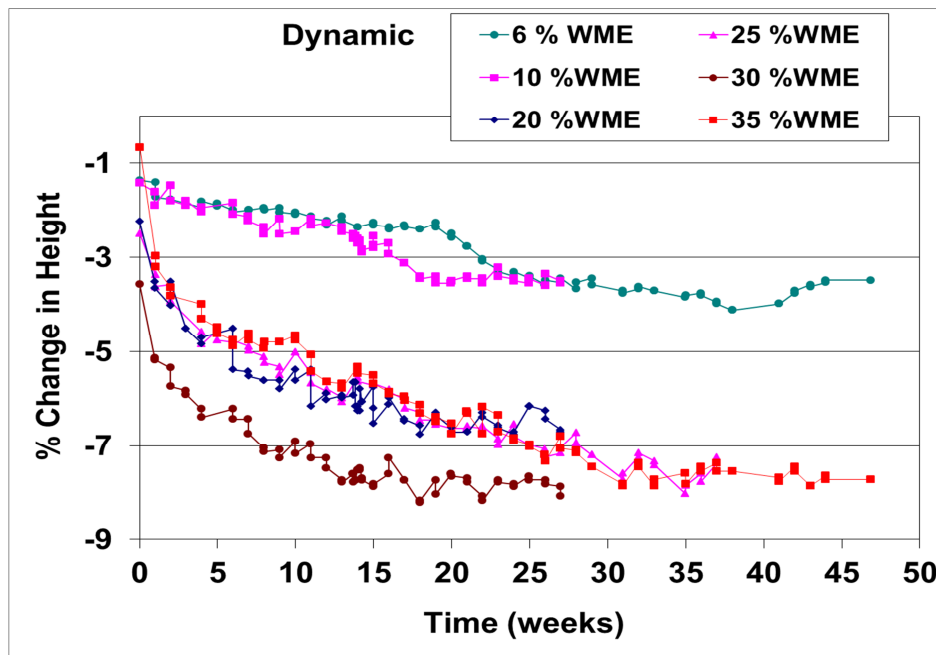
Figure 8. Relative change in height (strain) under load for dynamic test samples.

The dynamic testing which resulted in samples being subjected to up to 47 weeks of cyclic loading showed generally the rate of compression of the samples while between dynamic cycles is less than the rate of compression of the control (static) samples. Here again the higher moisture level leads to a greater compression. There is variation in the dynamic testing results most likely due to the physical properties of the fiberboard itself and the fact that the samples were taken from different regions within the same package.

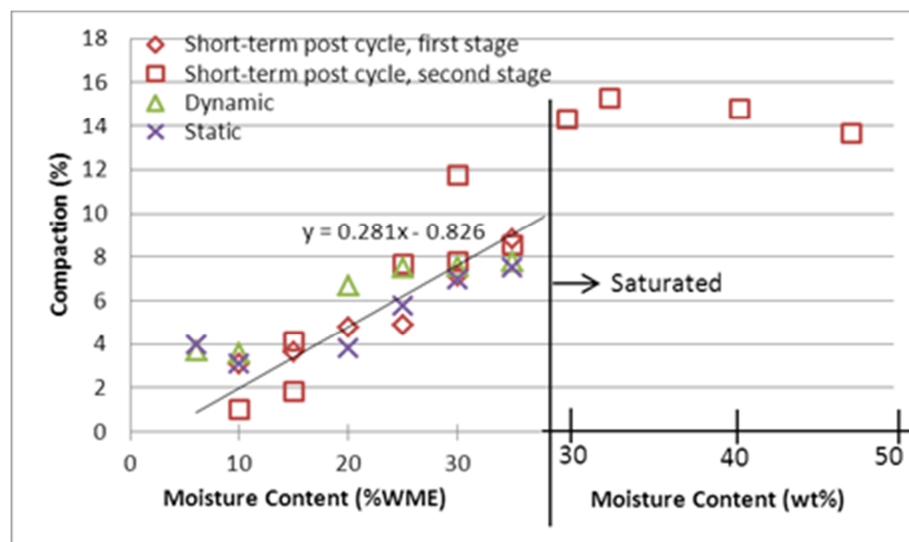
Figure 9. Final compaction data from short-term and dynamic compaction tests. The trendline is a linear fit to all data below the saturation point (~38 %WME) and a stress of 2.7 psi.

Figure 9 shows the final compaction data from the short term and dynamic compaction tests combined into a single chart. There is little difference in compaction between the short-term, dynamic and static samples. The trendline shows the behavior with all of the samples tested at 2.7 psi averaged together. The behavior is linear up to the saturation point, and appears to have little variation with moisture levels above saturation.

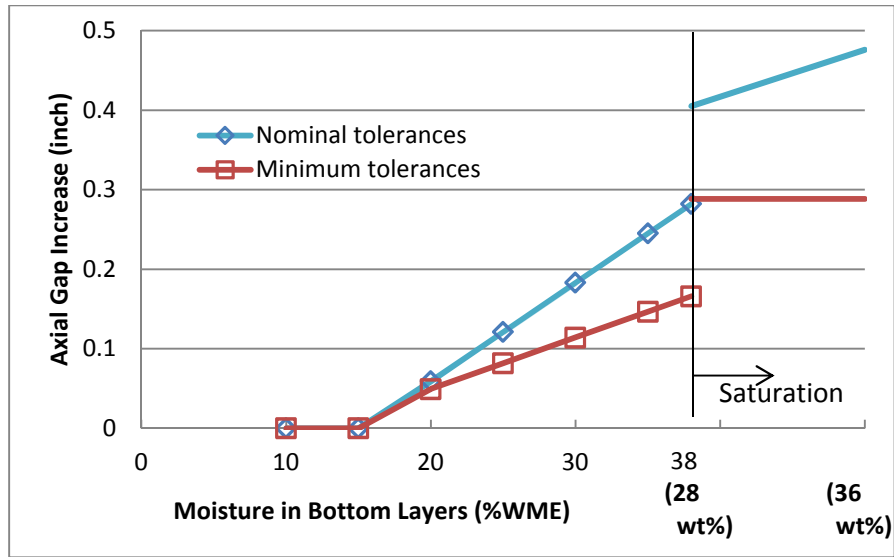
Figure 10. Predicted axial gap increase as a function of moisture level in the bottom fiberboard layers.

The scenario described above for moisture in the bottom fiberboard layers increasing from 10 to 30 %WME can be repeated for different final moisture levels. Table 2 summarizes the results for scenarios in which an initial 10 %WME moisture level increases to a range of values, up to saturation of the bottom layers (38 %WME). Figure 10 presents these results graphically

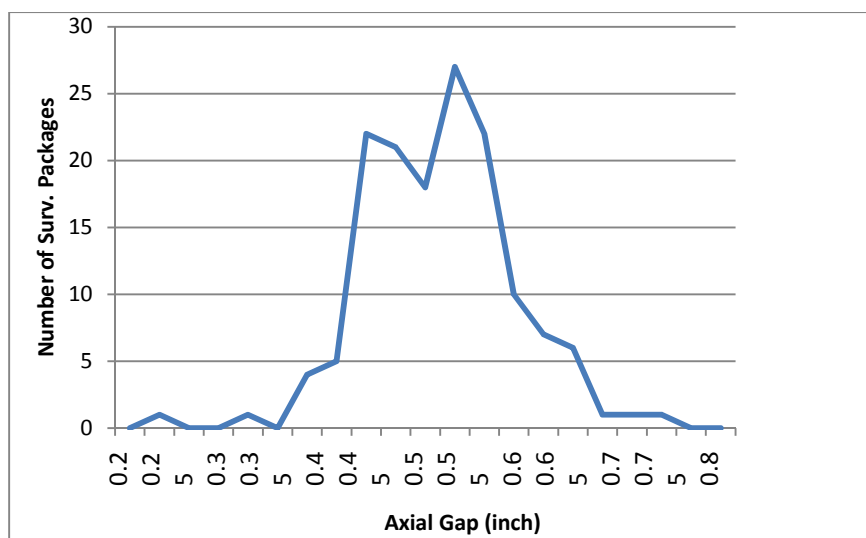
Figure 11. Summary of axial gap measurements from field surveillance activities. The number of packages having an axial gap within each interval is shown. Total number of packages is 147.

The reasonableness of this assumption is seen by comparing the average measured axial gap (0.75 inch) to the nominal value (0.8 inch). Of these 147 packages, 40 packages, or 27%, had an axial gap of 0.817 inch or greater. Similarly, 12% of the packages would fail the axial gap criterion in the event that minimum tolerances limit the axial gap increase to 0.114 inch. Similar percentages of packages to fail the axial gap criterion for a range of moisture content are shown in Figure 12. For nominal packages in which the bottom fiberboard layers exceed saturation, the likelihood of failing the axial gap criterion is very high (>92%).

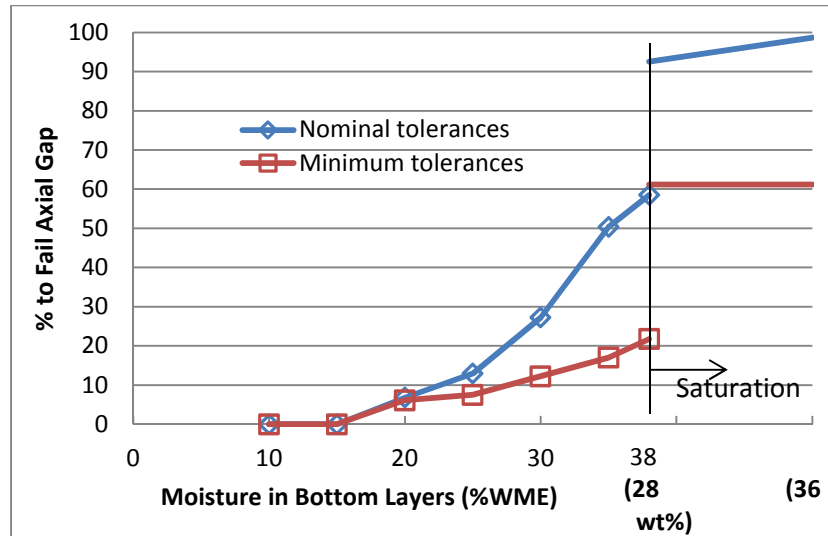
Figure 12. Estimated percentage of packages to fail the axial gap criterion as a function of moisture content in the bottom fiberboard layers.
