Evaluating the Chemical Resistance of Saltstone Disposal Unit (SDU) Concrete and Polymeric Coatings – 18494

John Seaman **, Fanny Coutelot **, Jarad Cochran **, Steven Simner *

ABSTRACT

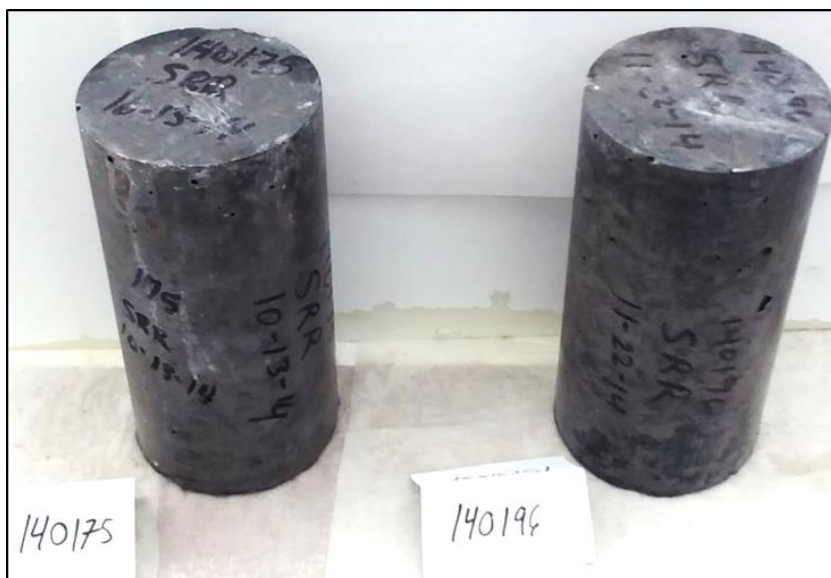
Fig. 3. 10 cm dia. by 20 cm high cast SDU 6 concrete cylinders used in chemical exposure testing.

It is not known if SDU concrete without the addition of a polymeric barrier exhibits sufficient resistance to salt solution ingress and/or chemical reactivity, and thus chemical exposure of uncoated SDU concrete samples was considered in this study. The samples evaluated were cast into 10 cm (diameter) by 20 cm (length) cylindrical molds from the mixer trucks in the field during SDU 6 construction (2014 – 2015 timeframe). Samples were transferred to a curing room (maintained between 21 – 25 °C and greater than 95% relative humidity) for long-term storage. Examples of the SDU 6 concrete cylinders prior to testing are provided in Fig. 3.

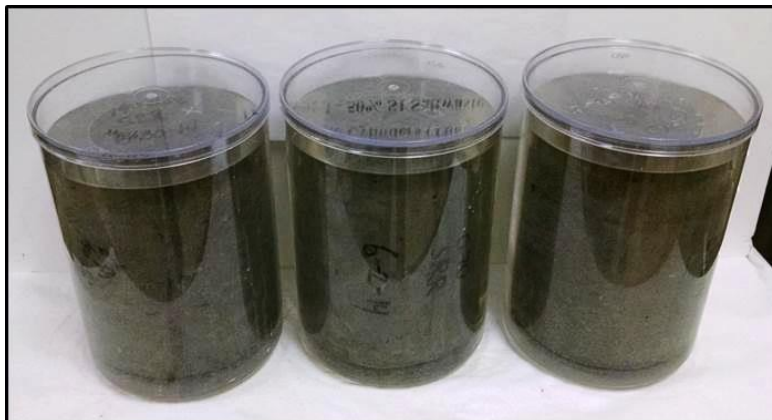
Fig. 4. SDU 6 concrete cylinders fully immersed in salt solution during exposure testing.

Note: Uncoated SDU 6 concrete samples were completely immersed in the relevant salt solution during exposure testing (Fig. 4). Coated samples were immersed to cover one holiday while leaving the other holiday exposed to the atmosphere above the salt solution (Fig. 5); the purpose of this is to assess the interaction of evaporative species that may condense on the coating and at the coating-substrate interface within the engineered holiday.

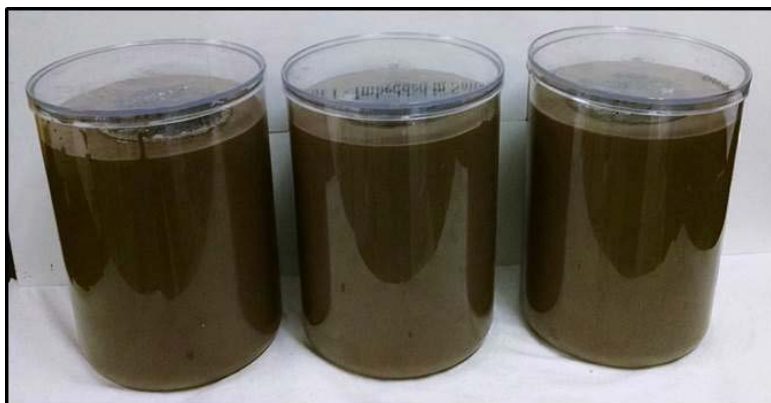
Fig. 6. Uncoated SDU 6 concrete cylinders fully immersed in fresh saltstone during exposure testing.

- iii. Saltstone was processed with the 100% S1 salt solution using the standard 45/45/10 mass % blast furnace slag (BFS), fly ash (FA), and cement dry powder mix and a water-to-dry powder ratio of 0.6. Immediately after mixing and prior to gelation the saltstone mixture was poured around the coated and uncoated samples as depicted in Figs. 6 and 7, respectively. The purpose of this test configuration is associated with the fact that the majority of the interior walls and floors of the SDUs will be in direct contact with cured saltstone rather than residual salt solution or bleed water held up in the SDUs. For this scenario it is the salt solution contained within the saltstone pores

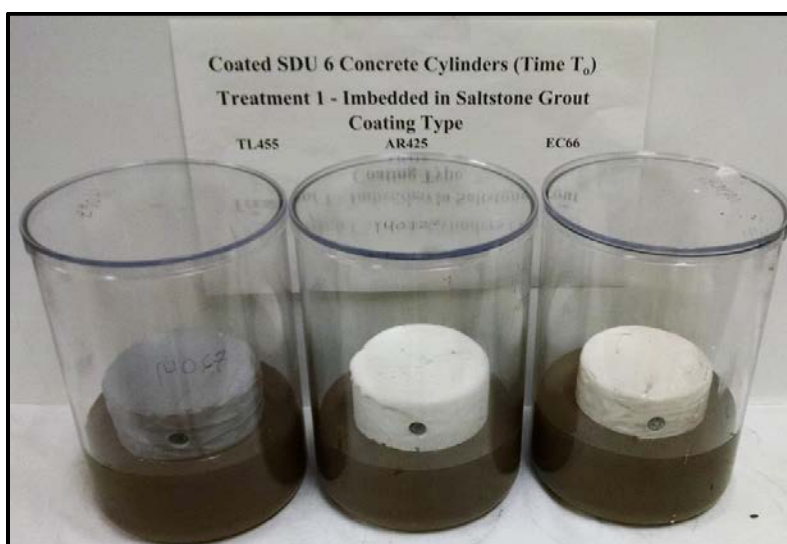
Fig. 7. Coated SDU 6 concrete cylinders partially immersed in fresh saltstone (lower holiday immersed; upper holiday open to atmosphere above grout).

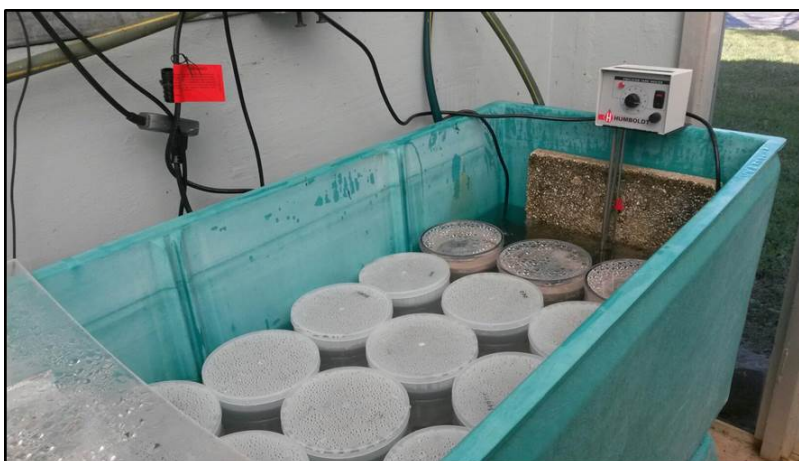
Fig. 8. Heating bath setup used for maintaining samples at 68 °C (± 2 °C).

In addition to chemical exposure, the walls and floors in the SDUs will be subjected to above ambient temperatures due to the exothermic nature of saltstone hydration reactions. Reference 2 has previously prescribed that materials considered for coating the SDU interior be capable of resisting chemical attack at 68 °C for a period of 1,000 hours. As such, exposure tests were conducted in contact with the aforementioned salt solutions, or saltstone, at 68 °C, for 1,000 hours. Exposure temperatures were maintained to ± 2 °C using the circulating heater baths depicted in Fig. 8.

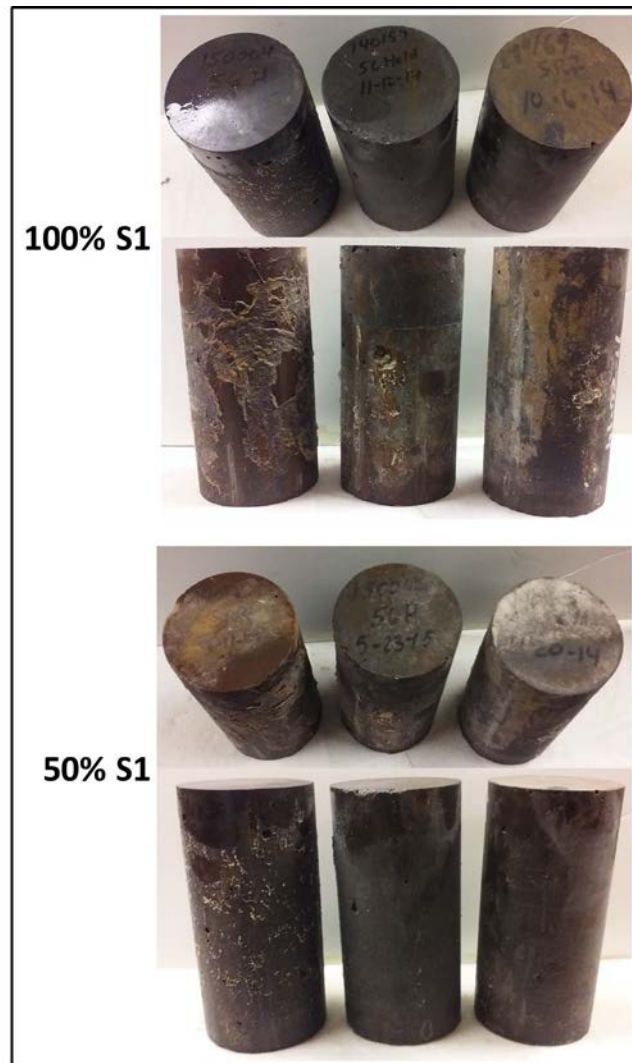
Fig. 14 represents the uncoated SDU 6 cylinders after full duration (90-day) exposure to the 100% and 50% S1 solutions (the samples embedded in saltstone were no different in comparison to those observed after elevated temperature exposure). Some discoloration (again potentially associated with iron oxidation) and salt buildup was noted on both the 50% and 100% S1 treatments. It is important to note that one cylinder exposed to each of the 50% or 100% S1 solutions indicated a surficial material the origin of which was not immediately obvious; however, it appears that this may be the result of residue from the saturated wrapping paper in which these two cylinders were stored in prior to testing.

Fig. 14. Uncoated SDU 6 concrete cylinders after elevated (68 °C) and ambient temperature exposure to the indicated treatments for 90 days.

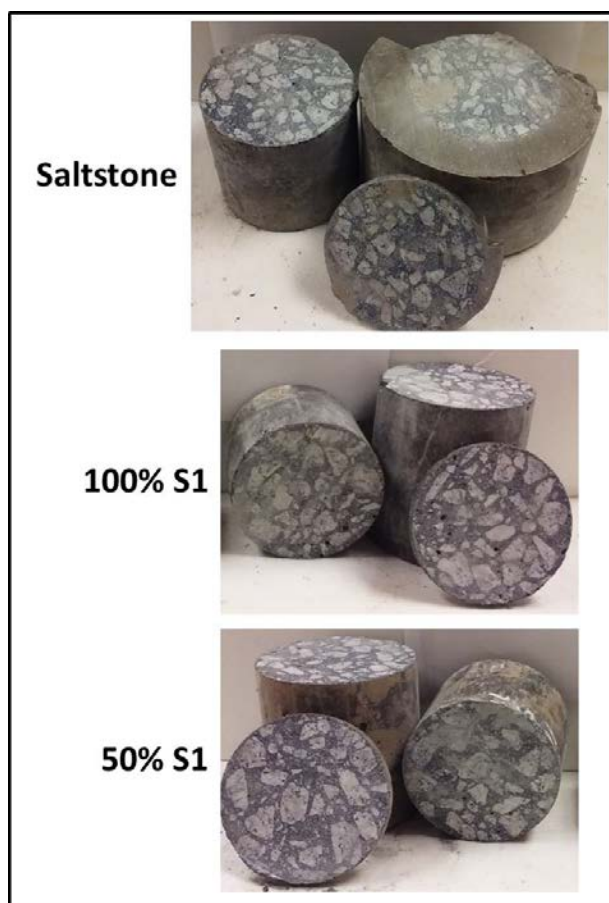
One remaining cylinder from the 50% S1 treatment, one remaining cylinder from the 100% S1 treatment, and one of the three samples embedded in saltstone were sectioned using a masonry saw to investigate the presence of visual indications of chemical attack/physical deterioration. Fig. 15 shows the cross-sectional image of the sectioned samples representing the three main treatments, with Fig. 16 providing a close-up view of the SDU concrete cylinder surface. No obvious changes in structure were observed for the three samples.

**Fig. 15.** Sectioned SDU 6 concrete after 90-day exposure in the indicated treatments.
