Achieving Leak Tightness in New Savannah River Site Saltstone Disposal Units – 17454

Charles Keilers, Savannah River Remediation, LLC

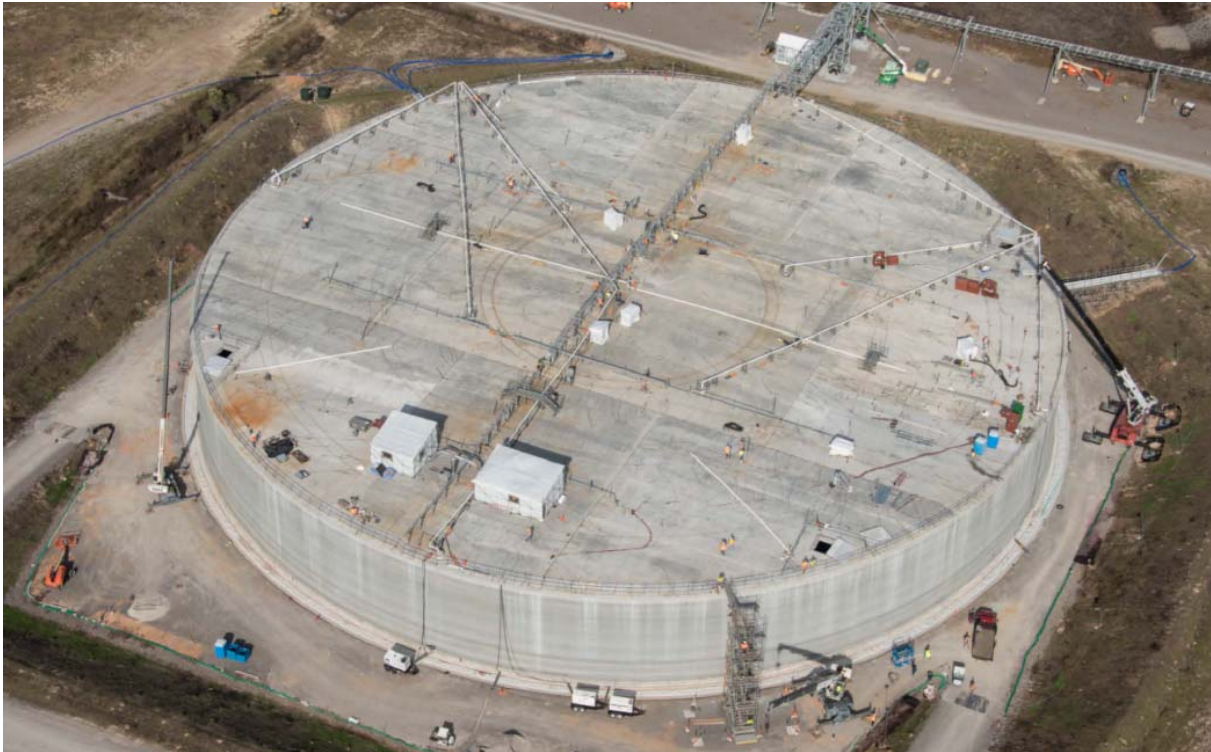
Fig. 3. SDU-6 near completion.

In December 2013, construction began on SDU-6, shown in Figures 2 and 3. SDU-6 is the first in a series of larger disposal units to be constructed on site. Its internal diameter and height are 114 m (375 ft) and 13.1 m (43 ft), respectively. It uses a pre-stressed concrete water tank design, similar to the earlier SDUs but an order of magnitude larger in volume. At 121 ML (32 Mgal), it is one of the largest cylindrical wire-wrapped tanks in the country.

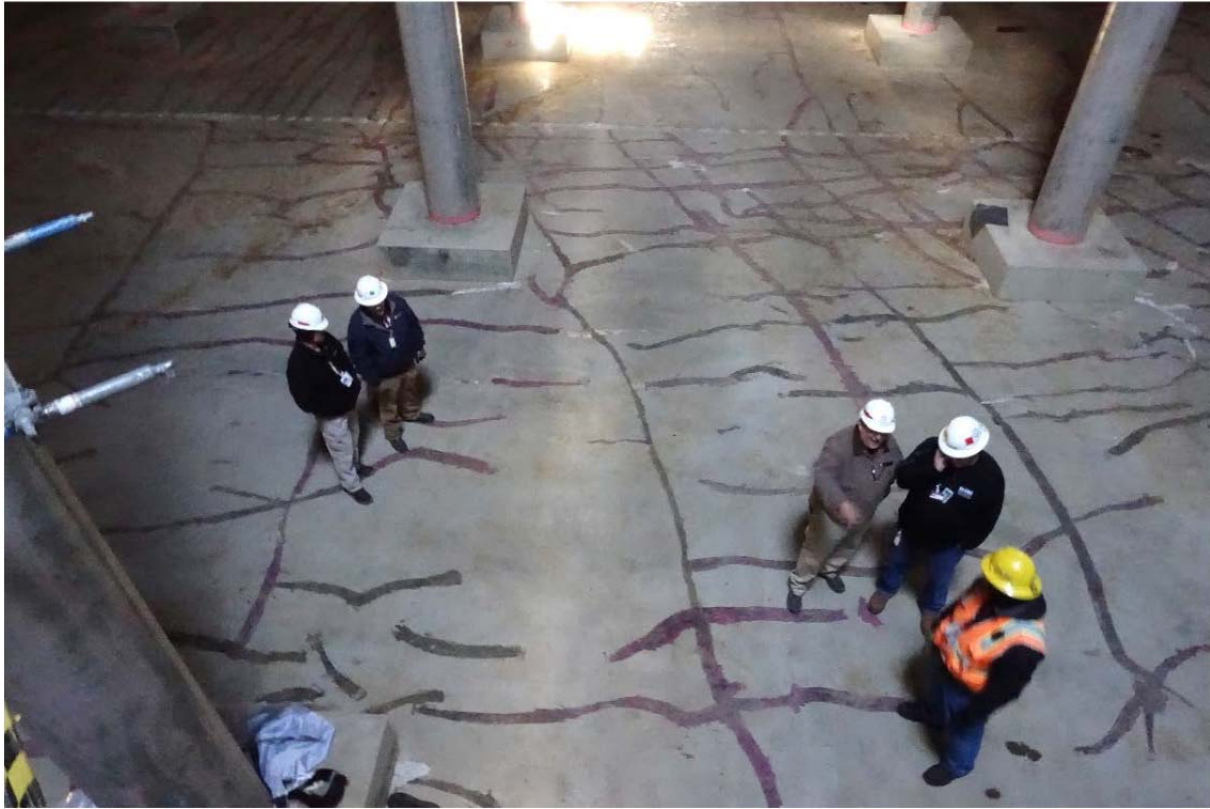
- The SDU-6 base slab has extensive tight visible cracks with widths of 0.07 to 0.5 mm (3 to 20 mils). Visible surface cracks were repaired with a flowable, gravity-fed epoxy, as shown in Figure 5. Early on, several cracks were ground down, and the cracking disappeared within 6 to 10 mm depth. However, concrete core samples taken in January 2016 in areas susceptible to shrinkage found cracks extending through the slab thickness [7].

Fig. 5. Slab cracking, highlighted in purple from the dye used in the 2015 hydrostatic test adhering to epoxy that was gravity-fed into cracks (photograph from [7]).
