Annual Radioactive Waste Tank Inspection Program – 2017

July 2018

**Savannah River Remediation
Savannah River Site
Aiken, SC 29808**

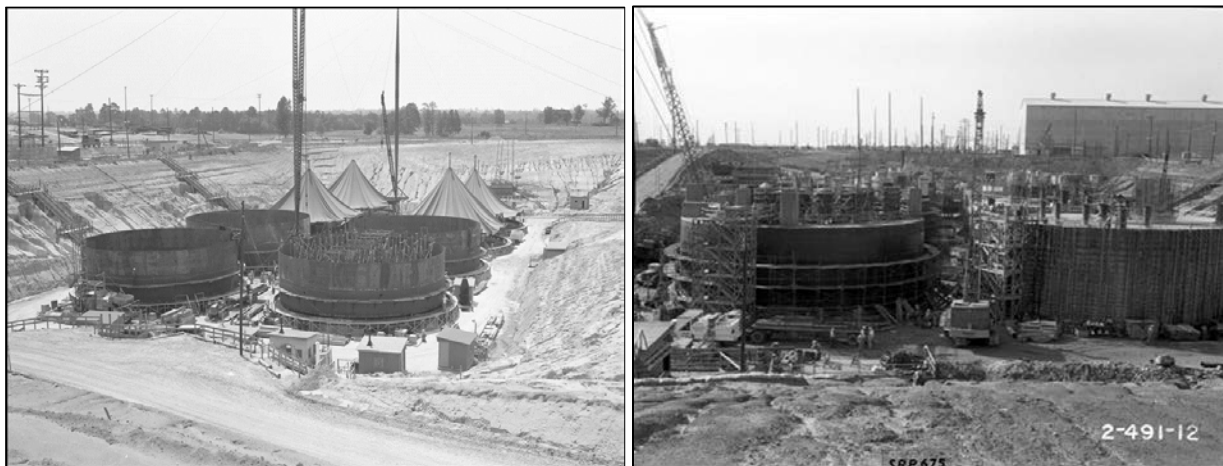
Figure 3.1-1: Construction of the Type I Tanks in FTF

There are eight Type I tanks in FTF (Tanks 1 through 8) and four Type I tanks in HTF (Tanks 9 through 12); all were constructed in the early 1950s as part of the original site construction activities. Tanks 5 and 6 in FTF were operationally closed in 2013 and Tank 12 in HTF was operationally closed in 2016. Figure 3.1-1 shows the Type I tanks during construction.

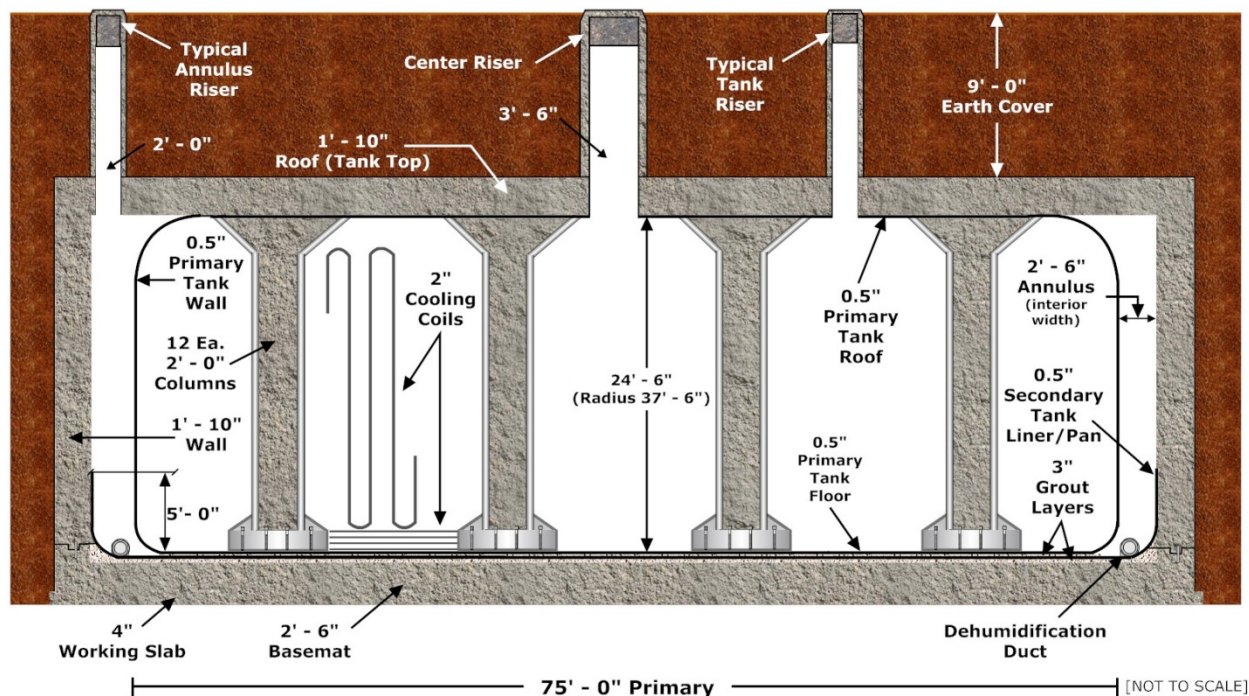
Figure 3.1-2: Typical Type I Tank Cross-Section

A typical Type I tank cross-section is shown in Figure 3.1-2. [SRS-REG-2007-00002]

The Type I primary tank is constructed of 0.5-inch thick carbon steel. The tank wall is joined to the roof and floor with non-stress-relieved welded knuckle plates also made of carbon steel. It should be noted that none of the Type I tanks were post-weld heat treated to relieve stresses following construction. The secondary liner is made of 0.5-inch thick carbon steel. The top edge of the secondary liner has a riglet – an L-shaped carbon steel stiffener lip that is wrapped in lead and extends 6 inches perpendicularly inward from the liner edge with another 4-inch long section extending perpendicularly down from that edge. [W145367] The primary tank roof is supported by twelve 2-foot diameter columns.

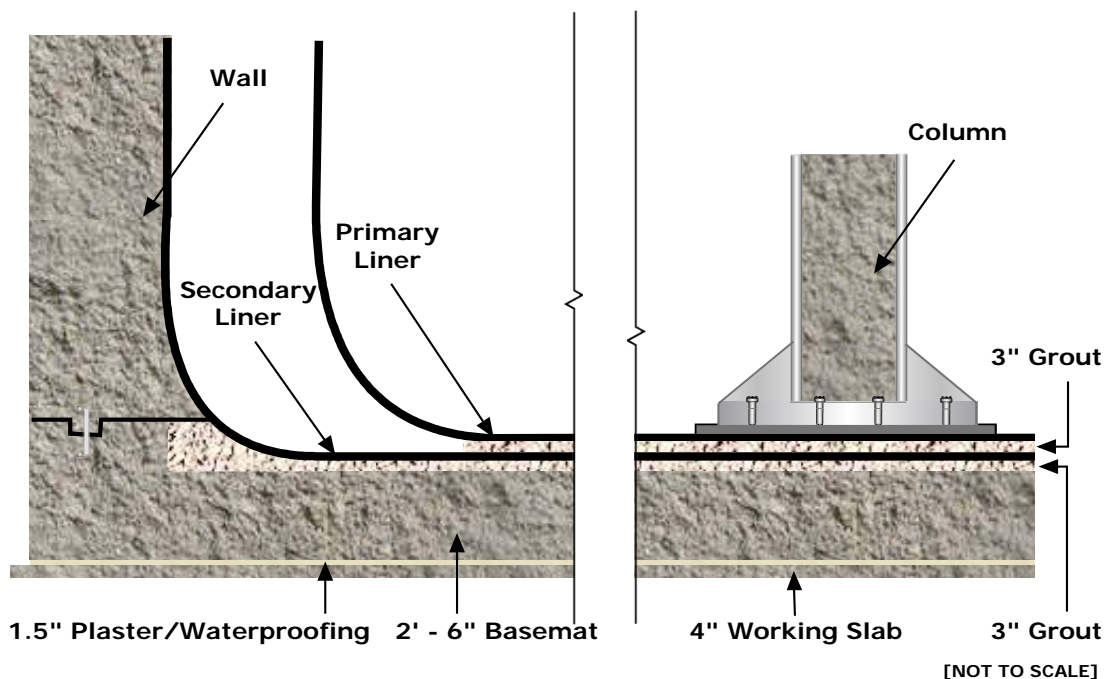
Figure 3.1-3: Typical Type I Tank Floor Configuration

The primary tank rests on a 3-inch thick layer of grout inside the secondary liner and the secondary liner sits on a 3-inch thick grout layer on top of the concrete basemat (Figure 3.1-3).

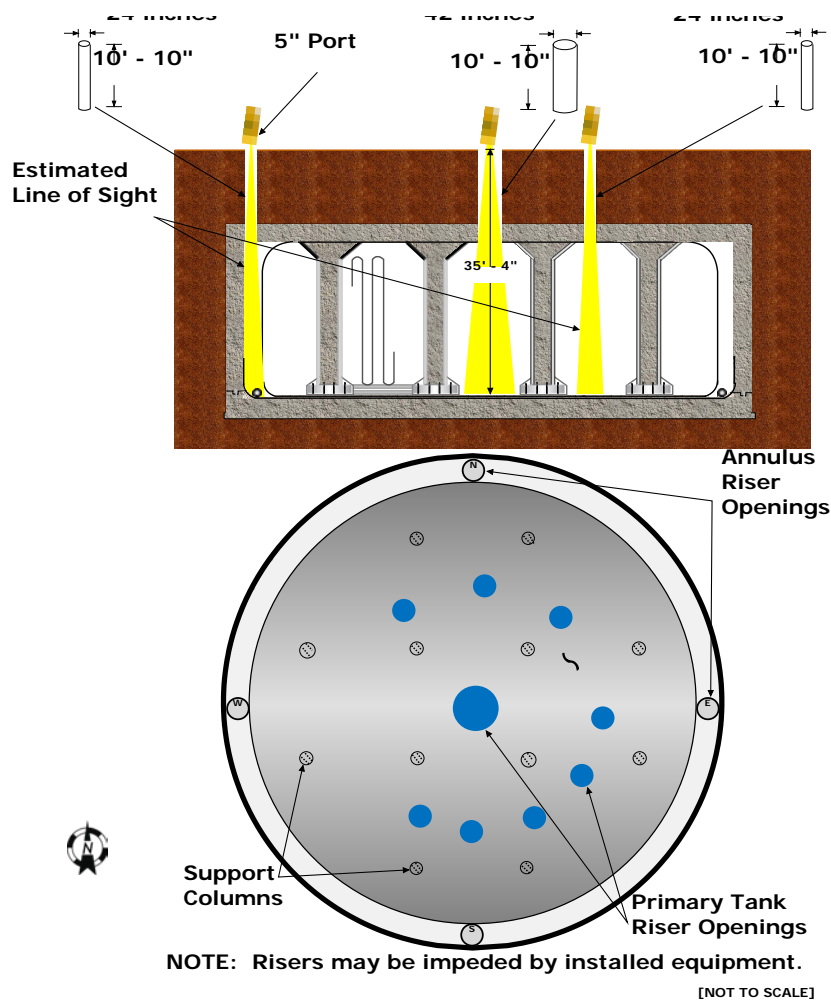
Figure 3.1-4: Typical Type I Tank Access Area

Access to the primary tank interior is limited to nine locations, and to the annular space at four locations, through riser pipes that extend through the concrete vault roof and up through the approximately 9 feet of soil. Each of the 13 riser pipes is capped at the top with a concrete shield plug. Each plug is typically provided with two 5-inch diameter ports equipped with removable plugs (unless equipment has been installed to support waste removal or tank closure activities). The center plug port may provide access through three 4- to 8-inch diameter ports. Some of

these ports provide access for inspections. Figure 3.1-4 shows a typically layout of the Type I tank riser locations.

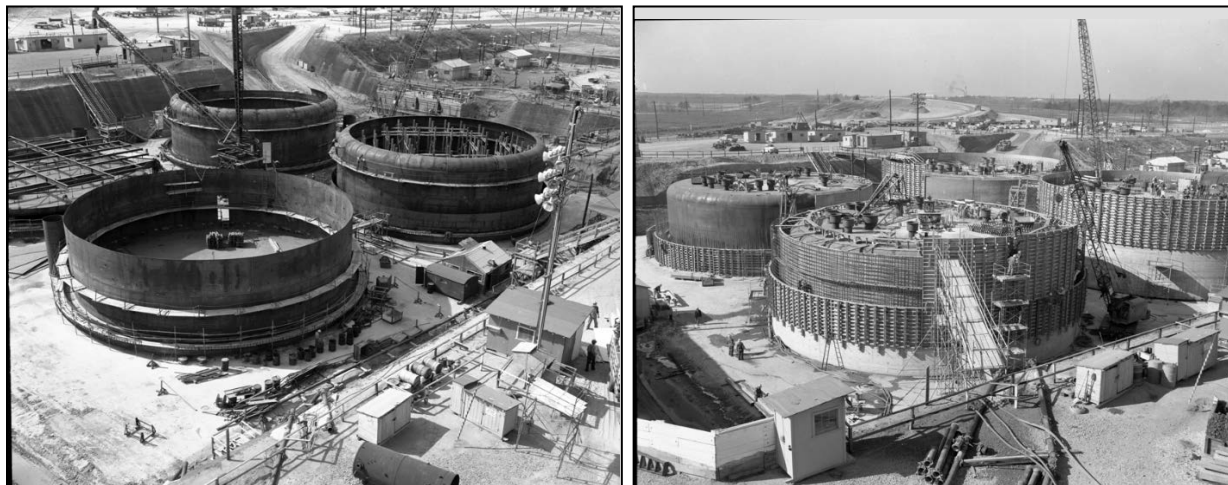
Figure 3.2-1: Construction of the Type II Tanks in HTF

The second generation of waste tanks, the Type II tanks, completed construction in 1956 soon after the Type I tanks were placed into service. They are similar in design concept to the Type I tanks, but with some notable differences. There were only four Type II tanks constructed, Tanks 13 through 16, and were built as a four-pack in the HTF. There are no Type II tanks in the FTF. Tank 16 was operationally closed in 2015. Figure 3.2-1 shows the Type II tanks during construction.

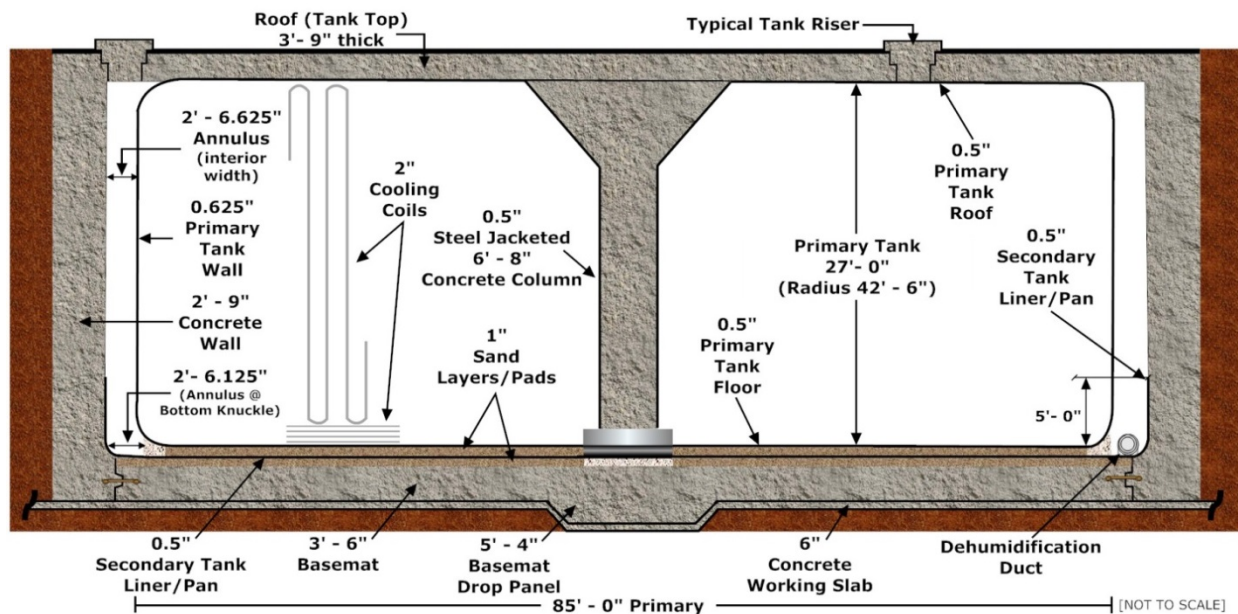
Figure 3.2-2: Typical Type II Tank Cross-Section

The Type II primary tanks have an 85-foot inside diameter and are 27 feet high with a nominal operating capacity of 1,070,000 gallons. The primary tank sits inside a 5-foot high, approximately 90-foot, 1.25-inch inside diameter secondary liner. The primary tank and secondary liner (also known as the annular pan) are enclosed within a 95-foot, 8.5-inch outside diameter concrete vault that creates an approximately 2-foot, 6.625-inch wide annular space. Unlike the Type I tanks, these tanks were built so that the roof of the concrete vault was at grade level; this concrete roof is 3 feet, 9 inches thick. A typical Type II tank cross-section is shown in Figure 3.2-2.

The primary tank is made of 0.625-inch thick carbon steel. The tank wall is joined to the primary tank roof and floor with non-stress relieved welded knuckle plates also made of carbon steel. The top knuckle is 0.5625 inches thick, the bottom knuckle is 0.875 inches thick, and the associated top and bottom plates are 0.5 inches thick; all are made of carbon steel. It should be noted that none of the Type II tanks were post-weld heat treated to relieve stresses following construction. The secondary liner is made of 0.5-inch thick carbon steel. [W162688] The top edge of the secondary liner has a riglet – an L-shaped carbon steel stiffener lip that is wrapped in lead and extends 6 inches perpendicularly inward from the liner edge with another 4-inch long section extending perpendicularly down from that edge. The primary tank was constructed above a 1-inch thick sand pad placed on top of the secondary liner. An additional 1-inch thick sand pad is between the secondary liner and the basemat. Unlike the Type I tanks, the Type II tanks do not have a series of roof support columns. Instead, these tanks have a single, large roof support in the center of the tank.

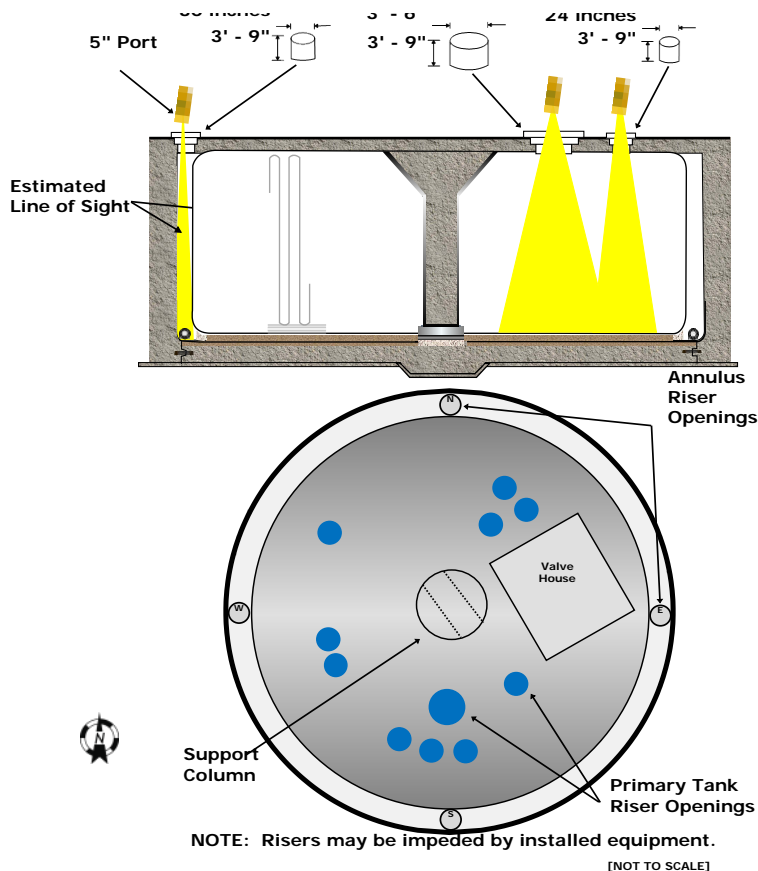
Figure 3.2-3: Typical Type II Tank Access Area

Riser configuration at time of construction.

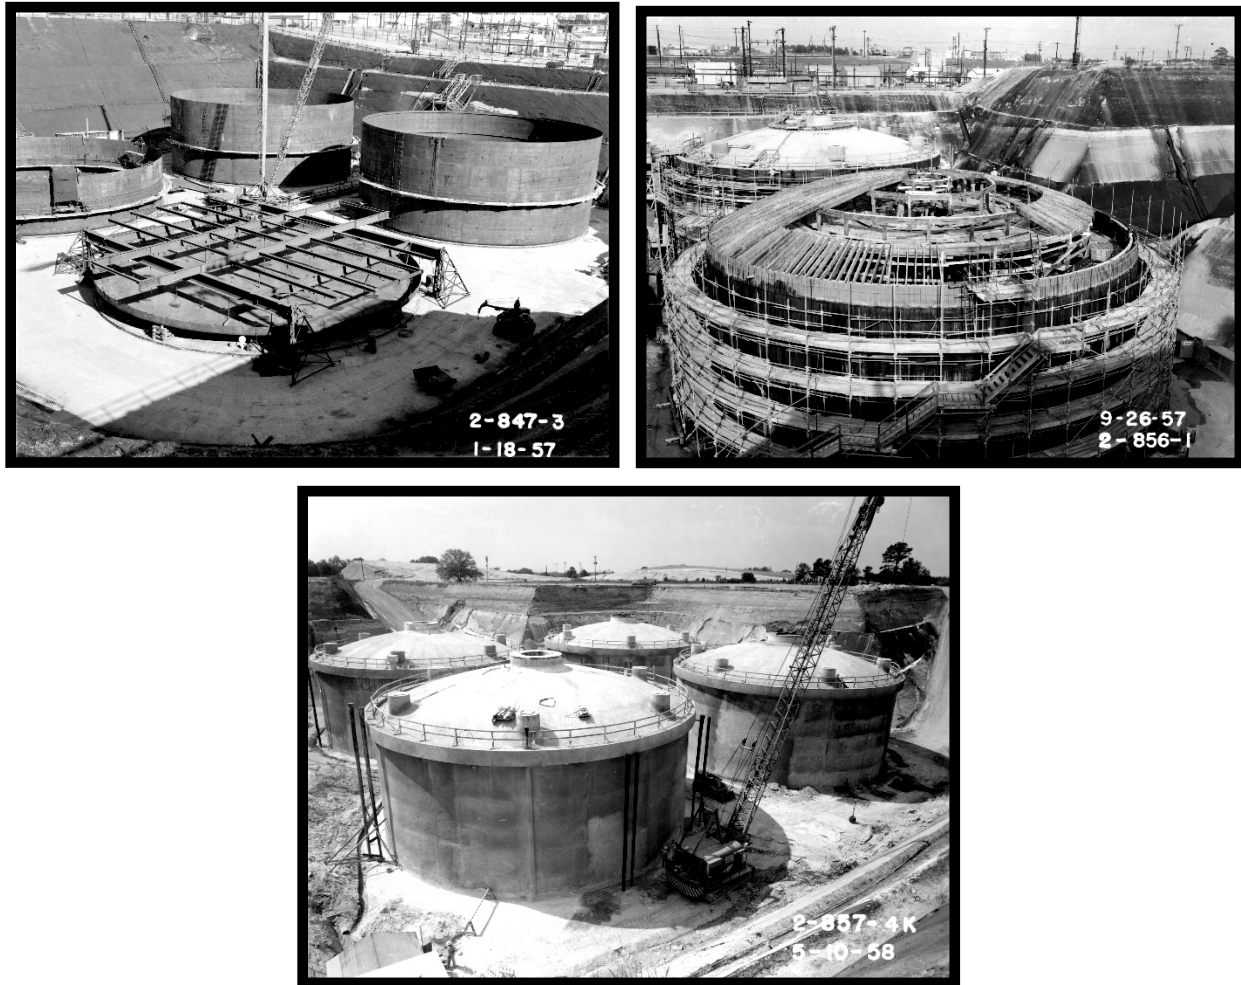
Figure 3.3-1: Construction of Type IV Tanks

Type IV tanks have a single carbon steel liner with a hemispherical, reinforced concrete roof. These tanks are 85 feet in diameter and approximately 34 feet high at the side wall with a nominal operating capacity of 1,300,000 gallons. The liner wall and floor are made of 0.375-inch thick carbon steel with 0.4375-inch thick knuckle plates. The liner wall is reinforced internally by three circumferential 4- by 4-inch, L-shaped, carbon steel stiffener bands. This liner is anchored externally to the enclosing concrete vault wall. The liner floor is essentially flat with no sump, significant low points, or slope.

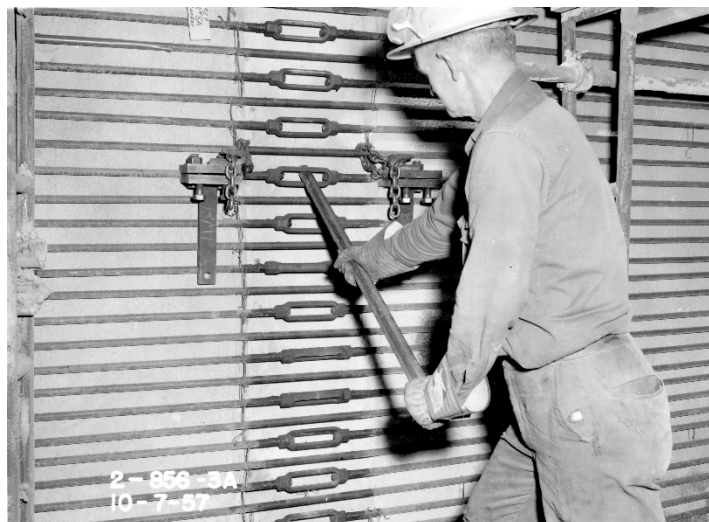
Figure 3.3-2: Steel Bands and Turnbuckles on the Type IV Tank Walls

remained in place and were covered with the concrete. Figure 3.3-2 shows these bands and associated turnbuckles prior to the formation of the concrete wall.

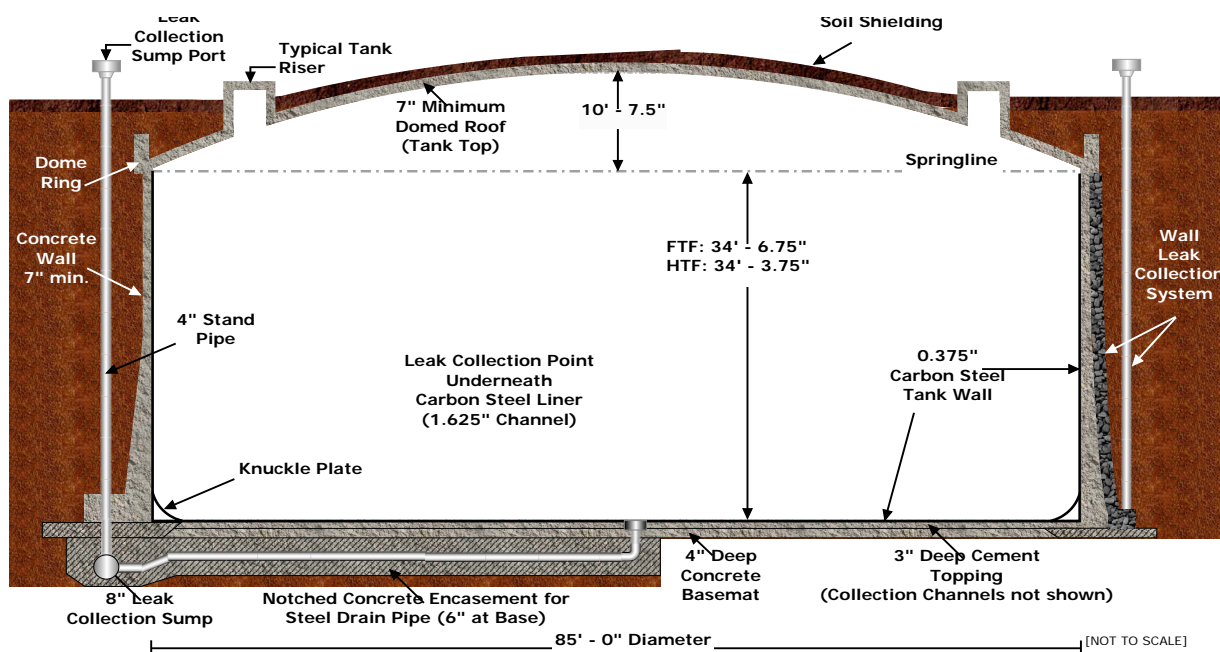
Figure 3.3-3: Typical Type IV Tank Cross-Section

There is no secondary containment (secondary liner) or an annulus in the Type IV tanks. Instead, drainage channels were formed in a 3-inch thick concrete topping layer above the basemat and drain to a collection point, which empties to a collection chamber (sump) below the waste tank footing at the edge of the waste tank wall. A riser pipe to the surface enables a leak detection probe to be placed in the chamber and for sampling of any liquid that was to accumulate. A typical Type IV tank cross-section is shown in Figure 3.3-3.

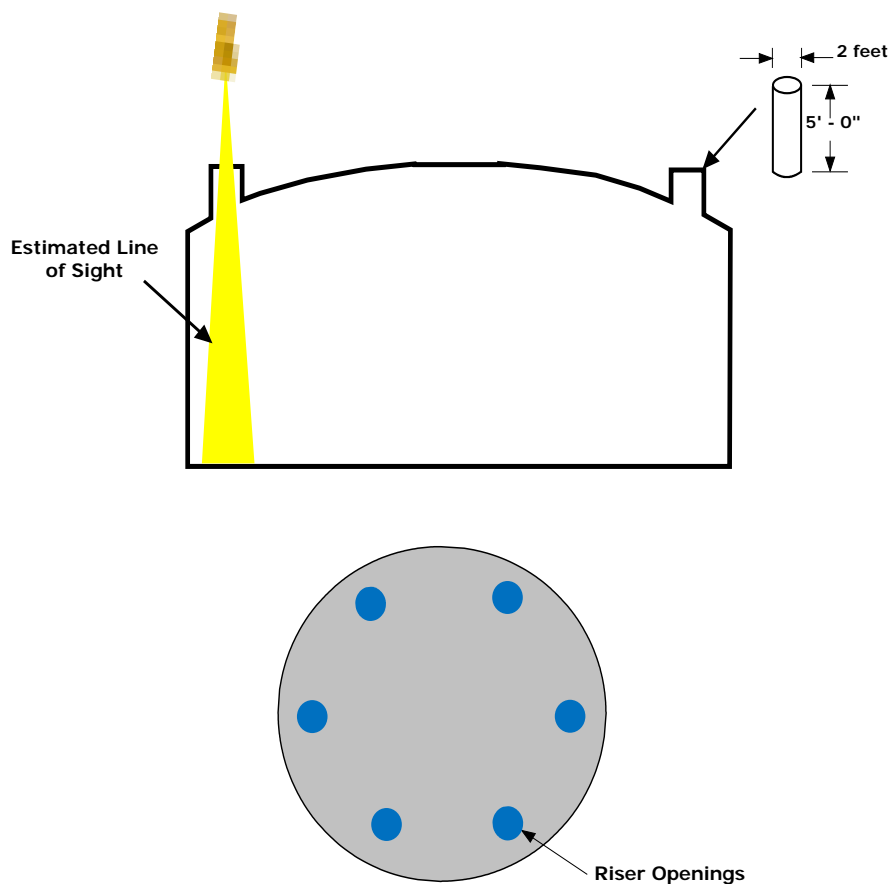
Figure 3.3-4: Typical Type IV Tank Access Locations

Access to the interior of the HTF Type IV tanks is provided at six locations through perimeter riser pipes that are 2-foot in diameter and 5 feet long. The Type IV tanks in FTF had a center roof riser while those in HTF do not. Each riser opening is capped at the top with a concrete plug. Some of these risers provide access for inspection. There is no access to inspect the outside of the carbon steel liner as it is in direct contact with the surrounding concrete wall. Further, the outside of the concrete wall is covered in soil for shielding purposes. Figure 3.3-4 shows the typical access locations for a HTF Type IV tank.

NOTE: Risers may be impeded by installed equipment.

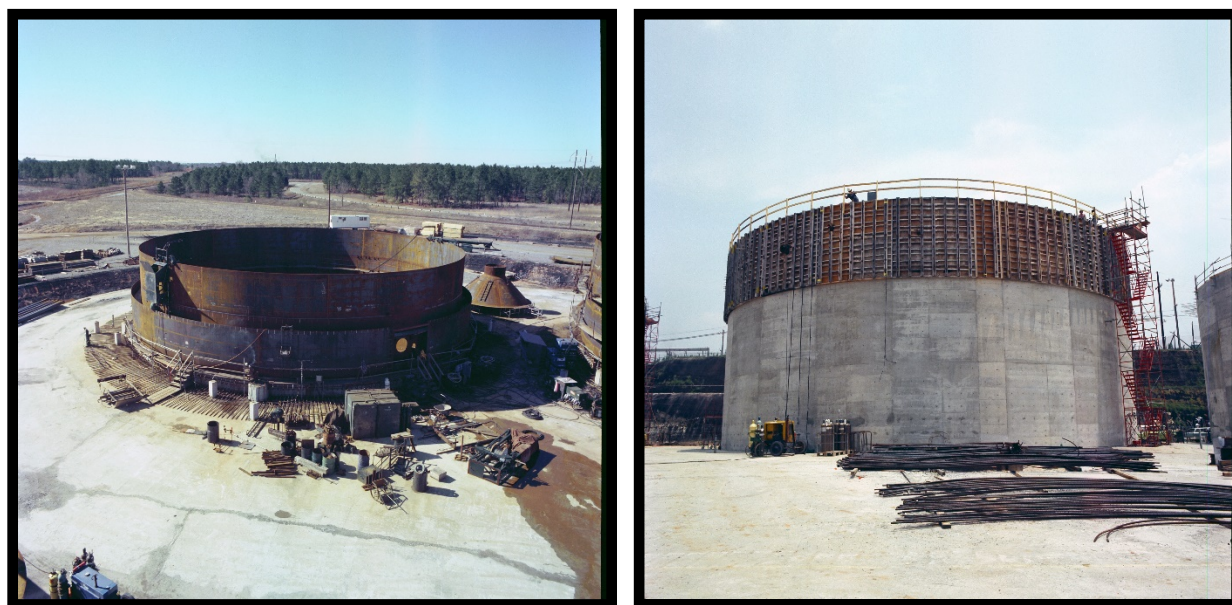
Figure 3.4-1: Typical Construction of Type III/IIIA Tanks

The Type III/IIIA primary tank is 85 feet in diameter and 33 feet high with a nominal operating capacity of 1,300,000 gallons. Type III/IIIA tanks have both a center and outer annulus. The center annulus is formed between the primary tank wall and the roof support column. The primary tank is made of concentric carbon steel cylinders joined to circular top and bottom plates by curved knuckle plates. The top plate of the primary tank is 0.5 inches thick, the middle plate is 0.625 inches thick and the bottom plate is 0.875 inches thick; the top knuckle is 0.5 inches thick and the bottom knuckle is 0.875 inches thick. After construction, the Type III/IIIA primary liners were fully stress-relieved by heating to help prevent the nitrate-induced, stress corrosion cracking seen in both the Type I and Type II tanks. The Type III/IIIA secondary liner is 0.375-inch thick carbon steel and is the full height of the primary liner with a 90-foot, 1.75-inch outside diameter forming a 2-foot, 6-inch wide annular space between the primary tank and secondary liner. [W702700]
