**ANNULUS CLOSURE
TECHNOLOGY DEVELOPMENT
INSPECTION / SALT DEPOSIT CLEANING
MAGNETIC WALL CRAWLER**

June 2008

Robotics, Remote & Specialty Equipment Section
Engineered Equipment and Systems Directorate
Savannah River National Laboratory
Aiken, SC 29808

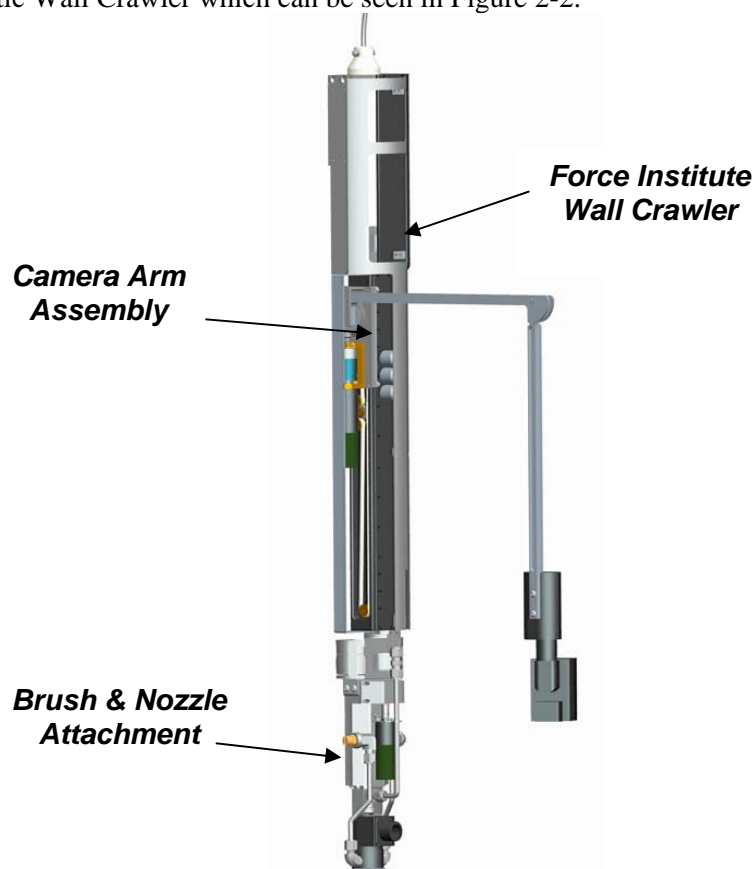
The Force Institute crawler includes two sets of magnetic wheels, one at each end of the crawler. The wheels are very strong magnets that hold the crawler to a magnetic metal wall. Each magnetic wheel has a holding force of approximately fifty pounds. The wheels can be controlled independently to steer the crawler. The crawler travels in a direction perpendicular to its length. The crawler also comes with a movable carriage that is located between the wheels that is typically used to position UT probes. The crawler is operated by a computerized controller. In order to achieve the additional objectives of this task, a camera arm system and a brush & nozzle attachment were designed, built and added to a Force Institute Magnetic Wall Crawler which can be seen in Figure 2-2.

Figure 2-2 Annulus Inspection / Cleaning Wall Crawler

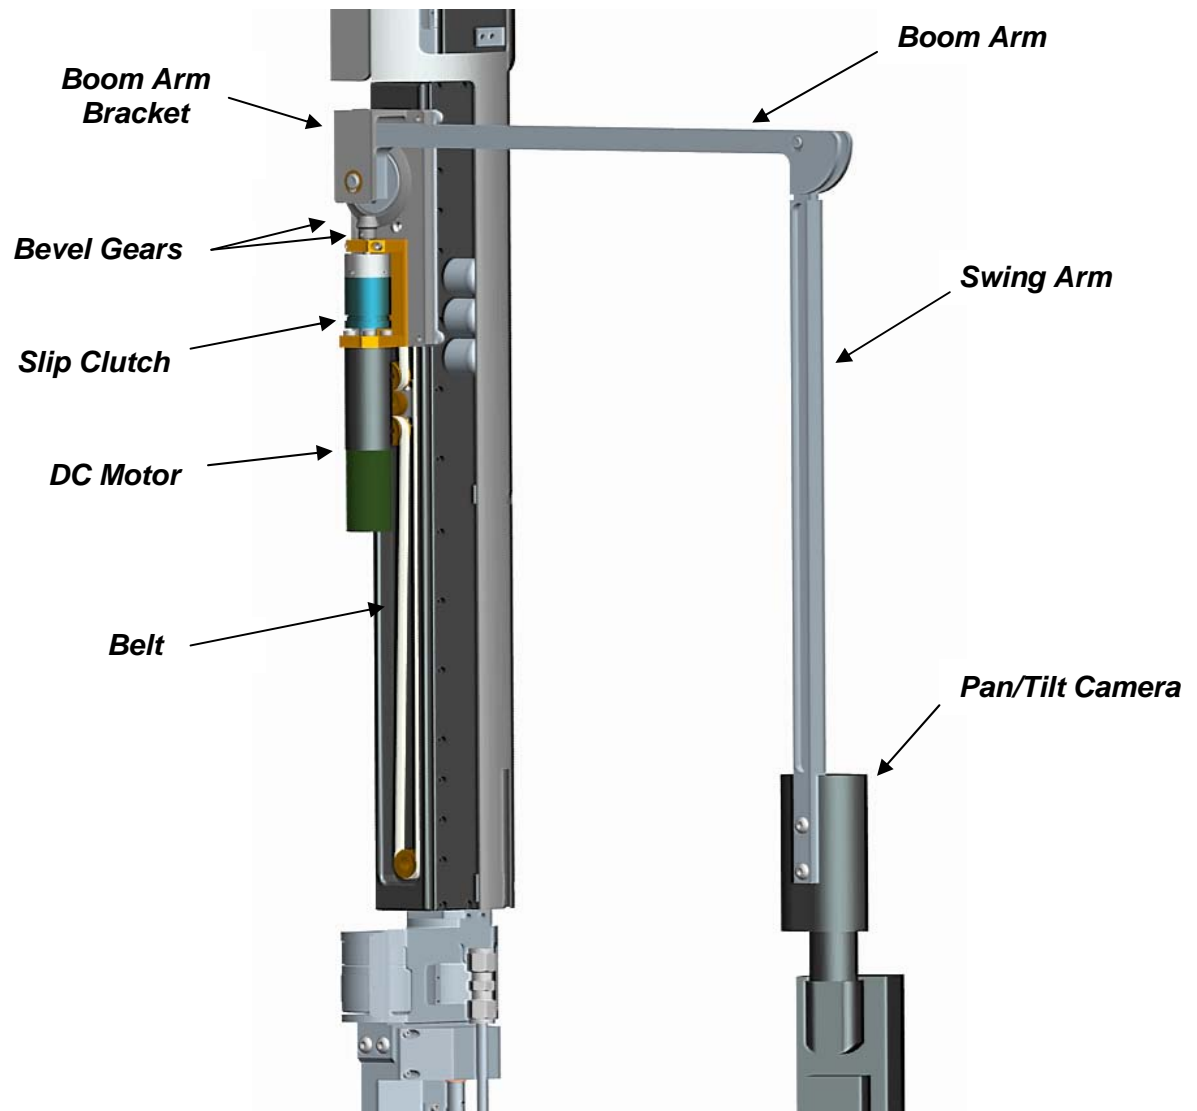
Duct inspection was achieved by replacing the UT scanning equipment on the Force Institute crawler with a pan/tilt/zoom camera on an arm. The arm allows the camera to get the necessary distance away from the annulus wall so that it can enter the duct opening. A DC motor with a high gear ratio is used with a bevel gear arrangement to lift the arm. A slip-clutch positioned between the motor and one of the bevel gears protects the motor when driven at the extremes of the arm's range. To lower the camera into the duct opening the belt mechanism built into the wall crawler for UT scanning is used. This allows the entire camera arm assembly to be lowered approximately nine inches. A small nozzle placed on the camera (not shown in Fig 2-3) provides the ability for the crawler to aim & direct a small stream of water approximately four feet in any direction to aid cleaning efforts.

Figure 2-3 Camera Arm Assembly

Boom Arm Operation: The crawler can be driven circumferentially with the boom arm extended. The boom arm can be remotely deployed and stowed. The crawler must be in a vertical position to stow the camera boom arm which can be a delicate process. The camera boom arm must be stowed properly to remove the crawler from the annulus through a riser. Additional camera views might be helpful while extracting the crawler from the annulus.

The crawler was able to position the camera over the duct opening. The camera boom arm operated properly and was able to reach inside both the smaller diameter and the larger diameter duct and perform a visual examination. The picture was very high quality and the camera can see down the duct until the radius turns.

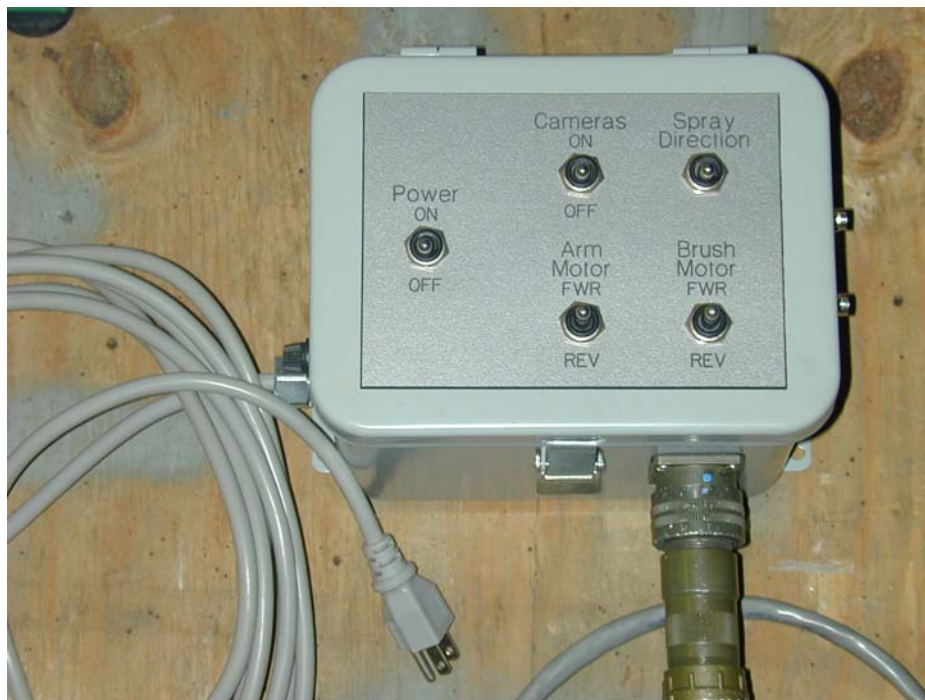
The new control box provides the ability to raise and lower the camera arm by rotating it 90°, turn the brush motor on and off and select the nozzle for spraying the salt nodules. The electrical design uses a simple set of toggle switches to provide either 12 or 24 VDC to the onboard robotics tools. All functions are labeled on the panel of the electronics enclosure, which is designed to be splash proof. The external power supply requirement is a standard 120 VAC plug. Additional 100ft cable extensions (with 1/4 turn quick release bayonet connectors) allow the user(s) to increase the distance up to a few hundred feet as required for remote deployment.

Figure 2-6 External Control Box

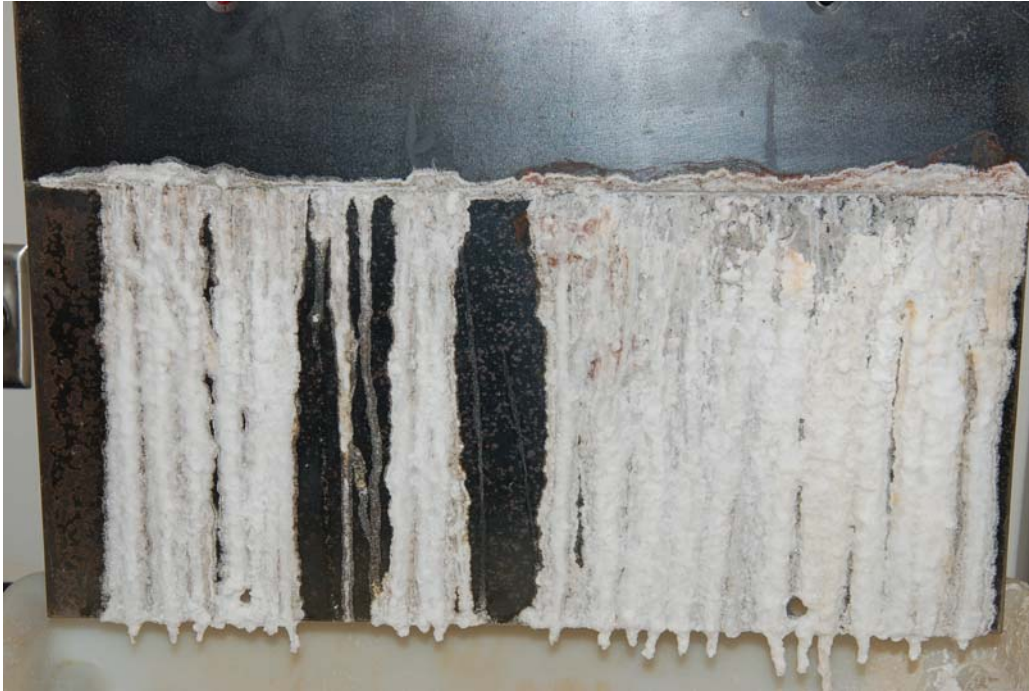
The salt deposits were produced using carbon steel plates mounted in two different positions. The least massive deposits were produced by mounting the steel plates vertically and allowing the salt solution to weep through a horizontal seam on the upper portion of the plate. The plate was heated by hot air blowers to accelerate evaporation. Deposition by this process was slow since liquid drained off the plate before all of the water had evaporated. The second position for the carbon steel plate was a slightly inclined position (10-15 degrees) and the supernate was added slowly near the top of the plate. The steel sheet was heated by large heating pads mounted on the reverse of the plate with a controlling thermocouple mounted between the pad and the steel plate. The heated pad was maintained at 90° C while the air flow in the chemical hood carried the evaporated water away from the deposits. This approach deposited much larger quantities of solids.

The salt deposits produced on the vertical plates were probably mostly sodium carbonate with some aluminum hydroxide. The aluminum hydroxide would be generated by the reaction between carbon dioxide in the air and sodium aluminate in the liquid as shown below.

Figure 2-7 Typical Salt Deposit Produced on a Vertical Plate

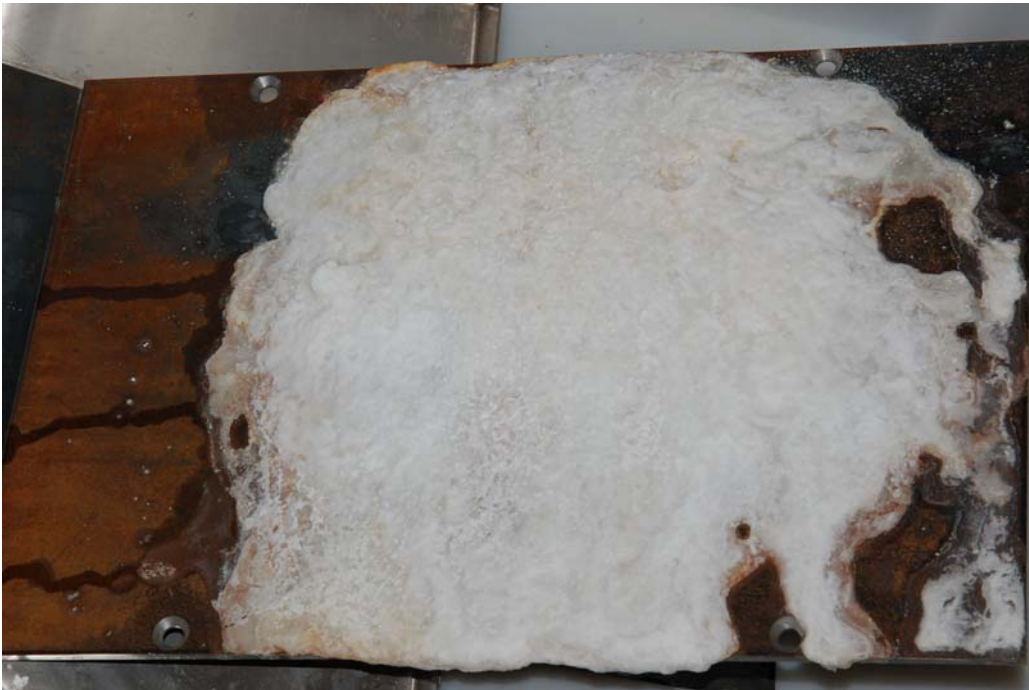
The more massive deposits are more likely to contain not only sodium carbonate and aluminum hydroxide but also more of the other salts due to the greater degree of evaporation achieved with the low angle plate position. The other salts include sodium nitrate, sodium nitrite and possibly sodium aluminate. Sodium hydroxide is another salt that may be present although less likely.

Figure 2-8 Typical Salt Deposit Produced on an Inclined Plate
