## **Hydrogen Embrittlement of Metals: A Primer for the Failure Analyst**

M. R. Louthan, Jr.  
Materials Science and Technology  
Savannah River National Laboratory  
Aiken, South Carolina 29808

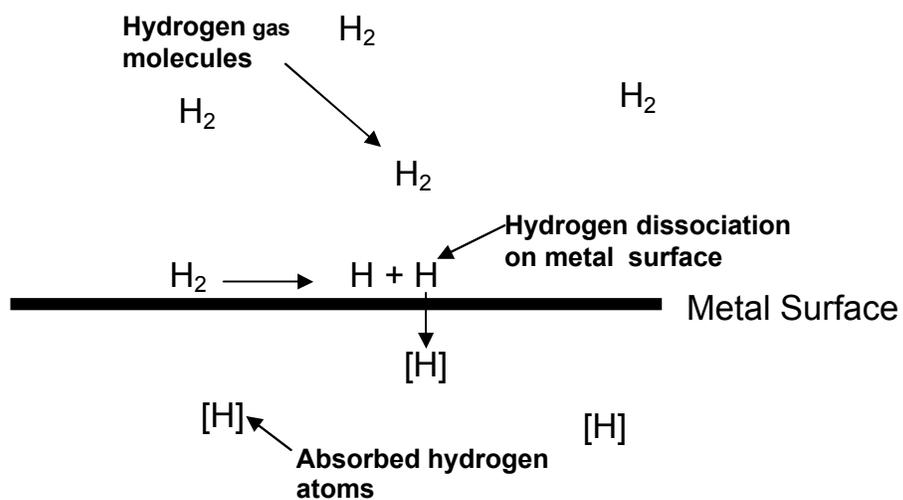
Figure1. Hydrogen Absorption in Metals Exposed to a Gaseous Hydrogen Environment

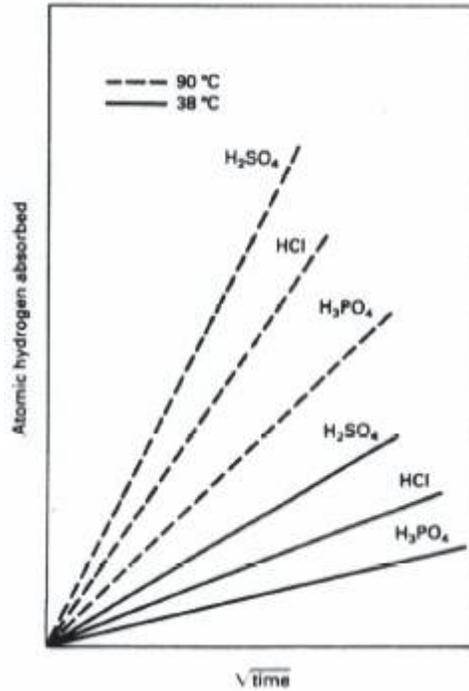
Figure 2. Time and Temperature Effects on Hydrogen Absorption in Metals Exposed to Various Acids. After Figure 6, page 330 of Reference 1.

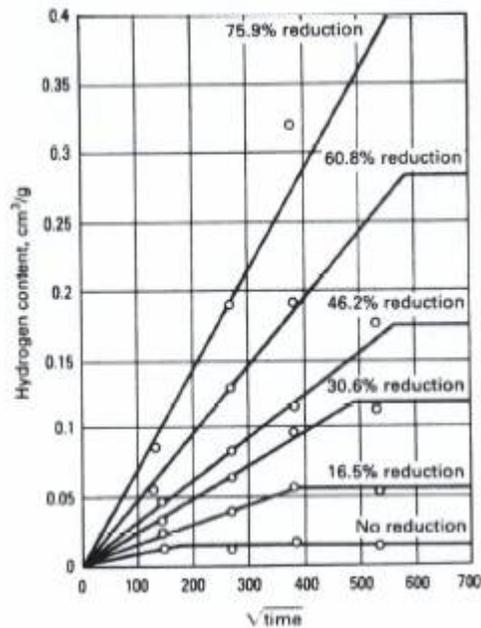
Figure 3. The Effect of Cold Work on Hydrogen Absorption in Carbon Steel Exposed to 1N Sulfuric Acid. A hydrogen content of 0.1 cm<sup>3</sup>/g is approximately 8 ppm by weight. After Figure 2, page 329 of Reference 1.

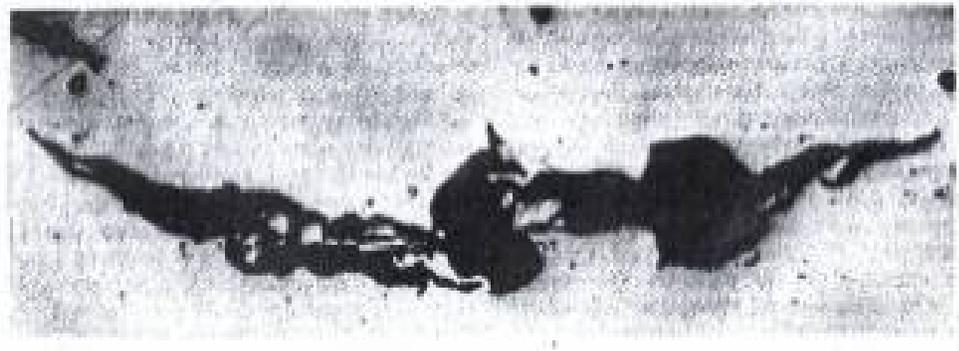
Figure 4. Initiation of a Hydrogen Induced Blister in 1020 Steel. One inch on the photograph equals 0.0025 inches on the actual part. After Figure 3, page 247 of Reference 2

The development of a hydrogen gas pressure at an internal surface not only leads to plastic deformation but may also alter the deformation and fracture characteristics of the metal. The metal at the tips of blisters, such as those shown in Figures 4 and 5, is highly stressed because of the notches that the blister produces. The stress state at a sharp notch becomes triaxial (increasing triaxiality with increasing blister tip sharpness), dilating the blister tip lattice and creating extraordinary sites for hydrogen accumulation. The ductility of the metal typically decreases as the hydrogen content increases, Figure 6. The magnitude of the hydrogen induced decrease in ductility typically increases as the strength of the alloy increases (note the strength levels of the steel on the curves shown in Figure 6) thus very little plastic deformation occurs in high strength alloys and a crack, rather than a blister, develops when the hydrogen gas precipitates at internal interfaces.

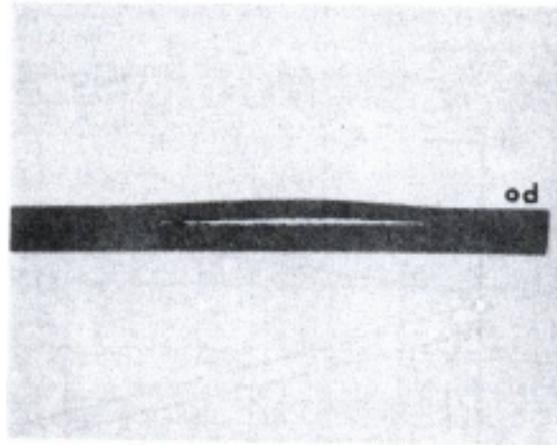
Figure 5. Hydrogen Blister in a  $\frac{3}{4}$  inch Thick Steel Plate. The plate was in a tank used to store HF and the side of the plate that was outside the tank is marked od. After Figure 10a, page 332 of Reference 1

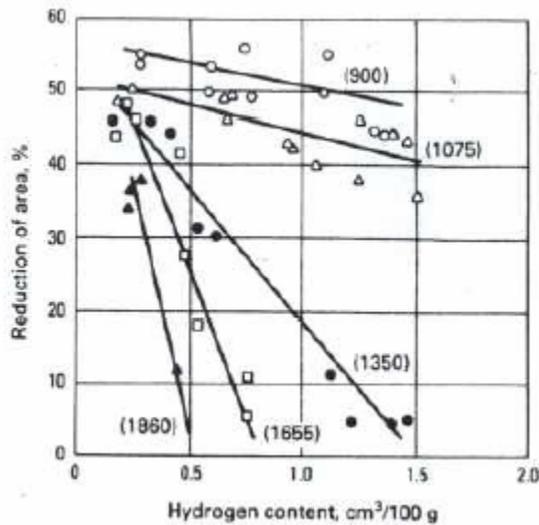
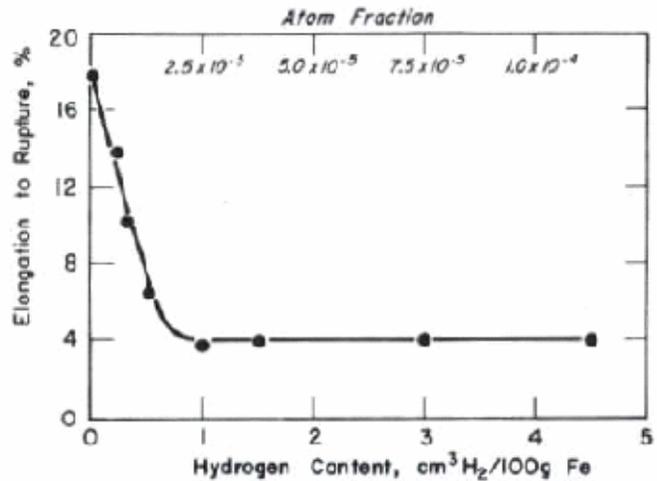
a) Quenched and Tempered Steels  
Strength Levels in MPa Marked

b) Zone Refined Iron

Figure 6. Effect of Hydrogen Content on Ductility of Steels and Zone Refined Iron. After Figure 4, page 330 of Reference 1 and Figure 4, page 57 of Reference 3

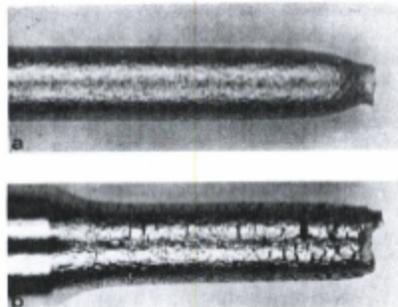
Figure 7. Surface Cracks on Tensile Specimen Strained in the Presence of High Pressure Hydrogen. Type 304L stainless steel tested in 10,000 psi hydrogen at room temperature. The ¼ inch diameter sample was not exposed to hydrogen prior to initiation of the tensile test. After Figure 5, page 293 of Reference 4.

hydrogen at the surface of many metals and alloys causes surface defects to extend in a macroscopically brittle fashion, Figure 7. The void tips cannot blunt in the presence of hydrogen and the lack of blunting causes the tips to remain sharp and extend into the metal. This extension, in ferritic and martensitic steel, generally occurs along prior austenite grain boundaries giving an intergranular appearance to the fracture surface. The hydrogen pressure drops as the crack extends because to void volume increases. Because a high hydrogen pressure is necessary for crack extension, crack growth ceases when the crack reaches a certain size. Fisheyes are produced when this localized hydrogen damage process takes place during a tensile test.

Hydrogen in a service environment may also adversely alter the properties of metals and alloys. Tensile, creep and fatigue tests have shown that hydrogen in the test environment will decrease the tensile ductility, increase fatigue crack growth rates and accelerate creep. Decades ago, there was a tendency to divide hydrogen embrittlement into two categories: internal hydrogen embrittlement and environmental hydrogen embrittlement. However, because of hydrogen-dislocation interactions, dislocation transport of hydrogen and hydrogen enhanced dislocation emission it is difficult to separate the two categories. Environmental hydrogen embrittlement is important to the failure analyst because hydrogen in the test/service environment will increase the susceptibility of metals and alloys to hydrogen damage. In fact, many metals and alloys that contain no hydrogen will show surface cracks and reduced ductility when tested in hydrogen gas. The surface cracks generally propagate from surface defects such as machine marks and the tendency for such cracking can be reduced by polishing the surface of the test material. The surface cracks on a

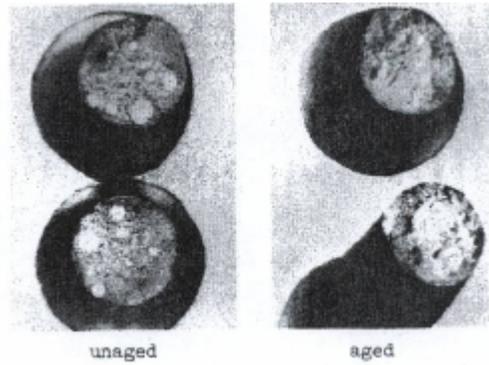
Figure 8. Fracture Surface Appearance Giving Rise to the Term Fish-eye. Tensile specimens were 4140 steel. The aged samples were heated to 260 C for one hour to remove the hydrogen. After Figure 8, page 60 of Reference 5.

The intergranular fracture process produces a semi-flat surface that is shiny relative to a fracture surface produced by the microvoid coalescence process that takes place during tensile overload. Thus when a tensile specimen that contains excess hydrogen precipitated at a void or inclusion is fractured, a macroscopic view of the fracture surface may show a shiny, almost circular “eye” (the intergranular fracture region) contained in a darker matrix (the ductile fracture region), Figure 8. Additionally, the topography of the void or inclusion where hydrogen originally accumulated may provide a pupil for the eye. The fisheye does not generally form until the metal is placed in tension because the hydrogen induced crack growth requires void tip stresses approaching the yield strength of the material. Therefore, components may pass a non-destructive inspection and develop fisheyes after they are placed in service. The fisheye will generally be oriented perpendicular to the maximum tensile stress, thus if the fish eye is formed in a tensile specimen the eye will be perpendicular to the tensile axis.

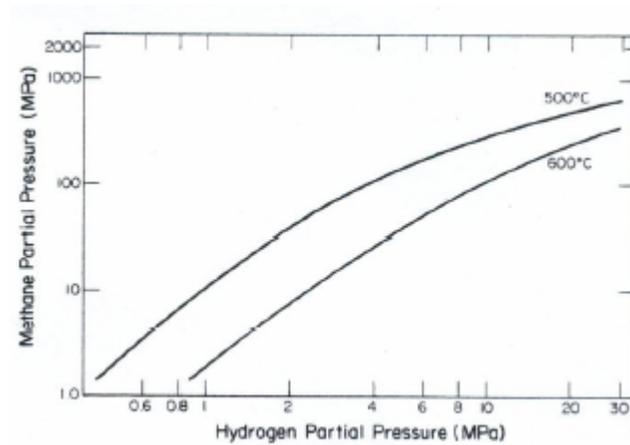
Figure 9. Equilibrium Methane Pressures in a Commercial Quenched and Tempered 2.25Cr-1Mo Steel. After Figure 4, page 1147 of Reference 6.

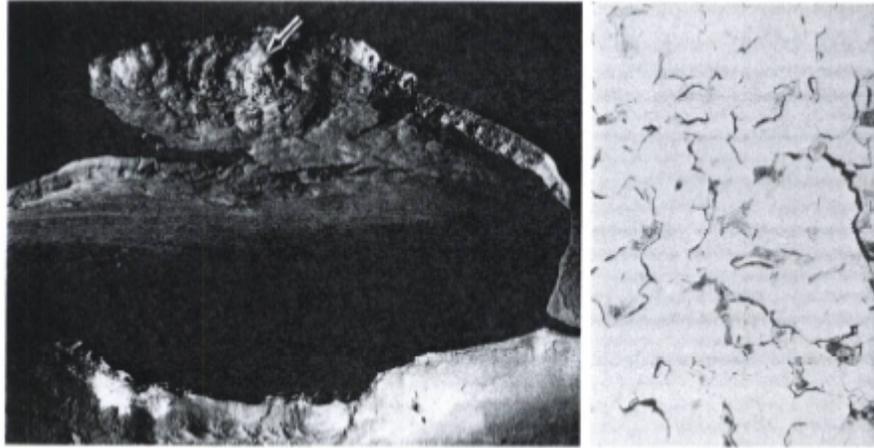
Figure 10. Intergranular Cracking and Rupture due to Hydrogen Attack. After Case History 01.01.20.03, page 39 of Reference 7

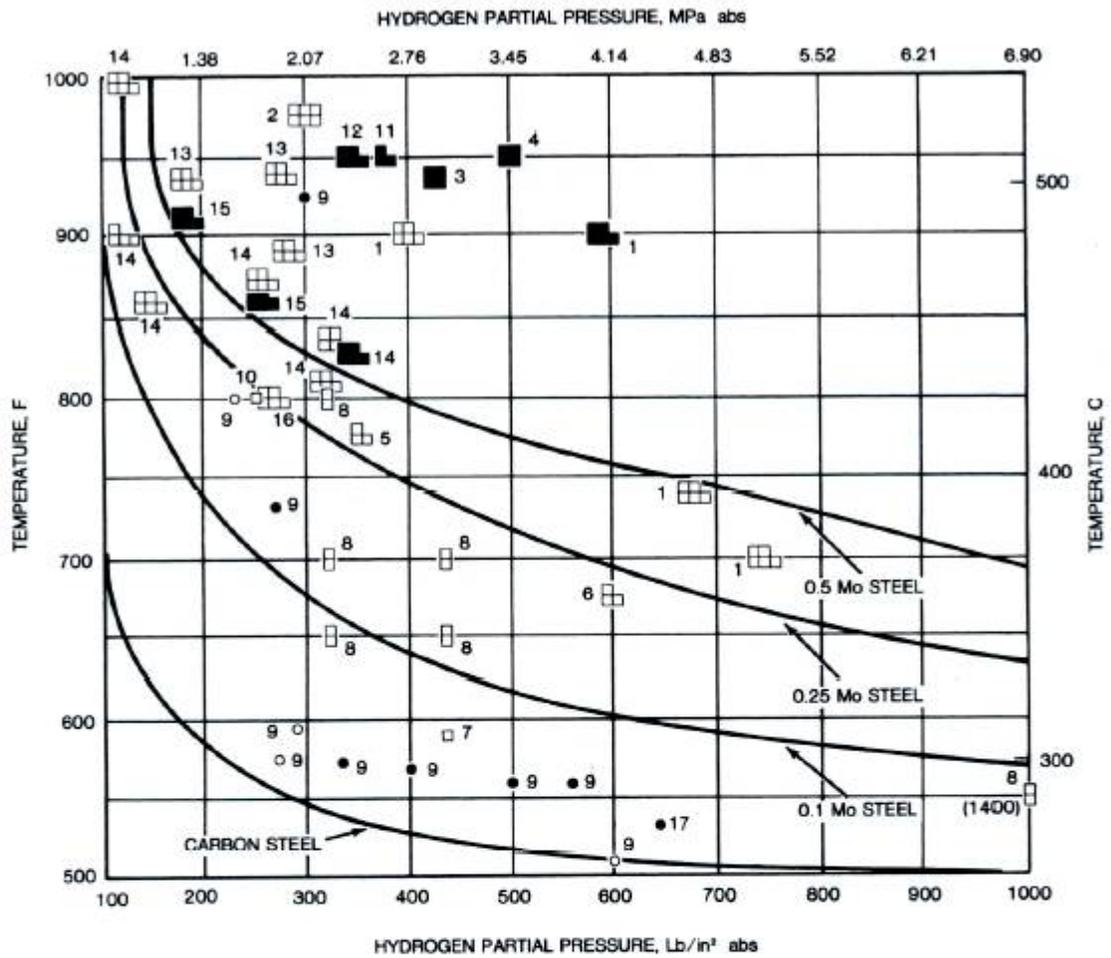
NOTES:  
 1. Mo has four times the resistance of Cr to H<sub>2</sub> attack.  
 2. Mo is equivalent to V, Ti, or Nb up to 0.1 percent.  
 3. Si, Ni, Cu, P, and S do not increase resistance.

Figure 11a. Nelson Curve Showing Operating Limits for a Carbon and Low Molybdenum Steels. After Figure 2, page 391 in Reference 8

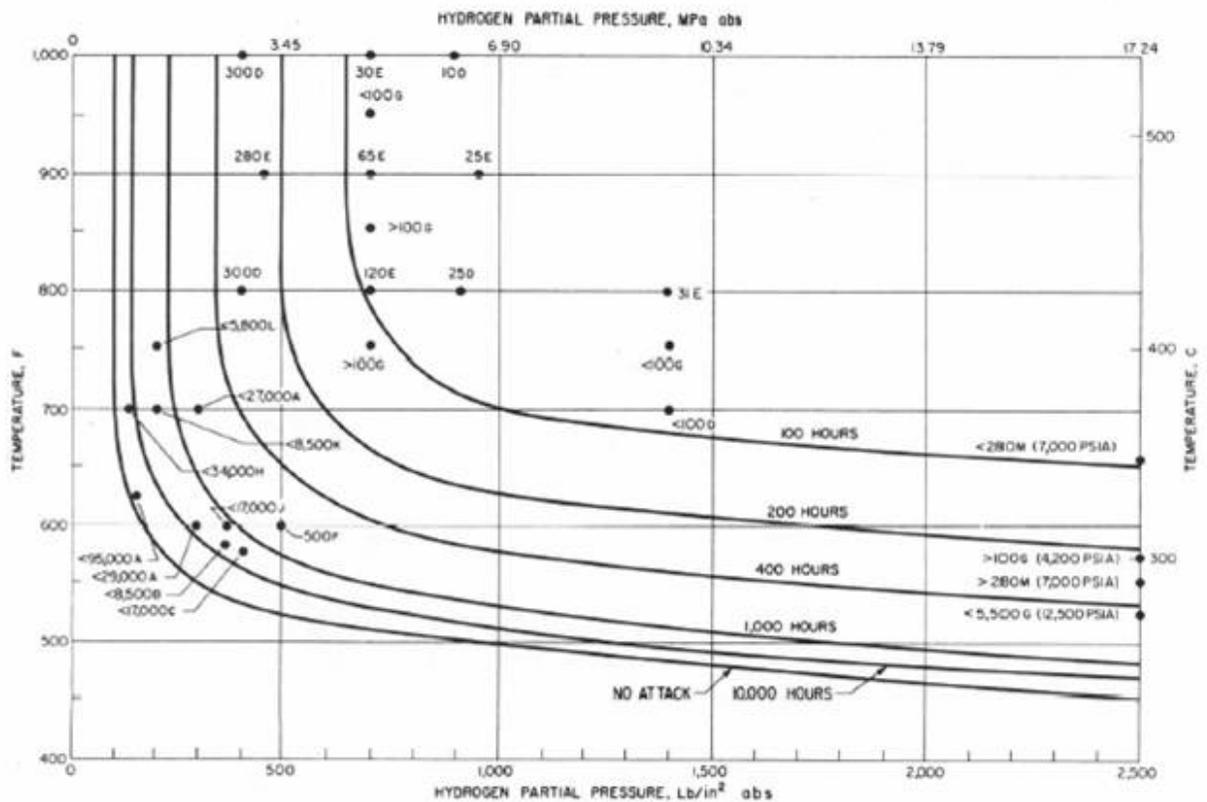
Figure 11b. Importance of Time in the Positioning of Lines on a Diagram Similar to a Nelson Curve. After Figure 3, page 392 of Reference 8

in Figure 11b, and a true Nelson Curve is only developed after prolonged exposures to the hydrogenous environments. Although the Nelson curves only provide general, empirical guidelines for materials selection for application in high temperature hydrogen service, it is unlikely that anyone with experience in the petrochemical industry would willingly disregard a Nelson Curve and use steels under conditions where hydrogen attack is considered probable. Industrial operations such as welding and cold work can have deleterious effects on the resistance to hydrogen attack and alter the Nelson Curve, as can the presence of moisture in the hydrogen and/or prior exposure to a high temperature hydrogen environment.

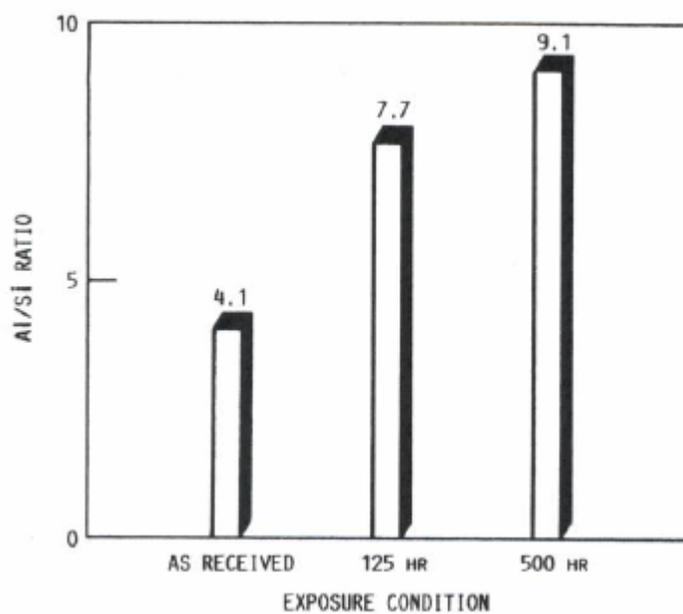
Figure 12 Al/Si Ratio at the Surface of Mullite Exposed to Hydrogen Gas at 1250 C. After Figure 3, page 355 of Reference 9

Hydrogen is a very effective reducing agent as illustrated by the experience with mullite. Therefore, whenever a material is exposed to high temperature hydrogen environments, regardless of the hydrogen pressure, some consideration should be given to the potential for hydrogen interaction with components of, or microstructural elements in, the material.

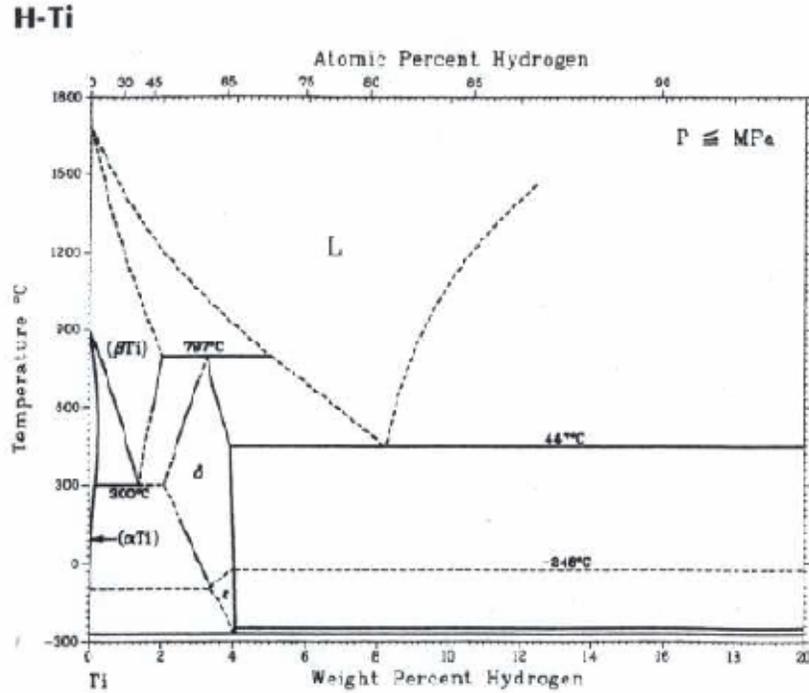
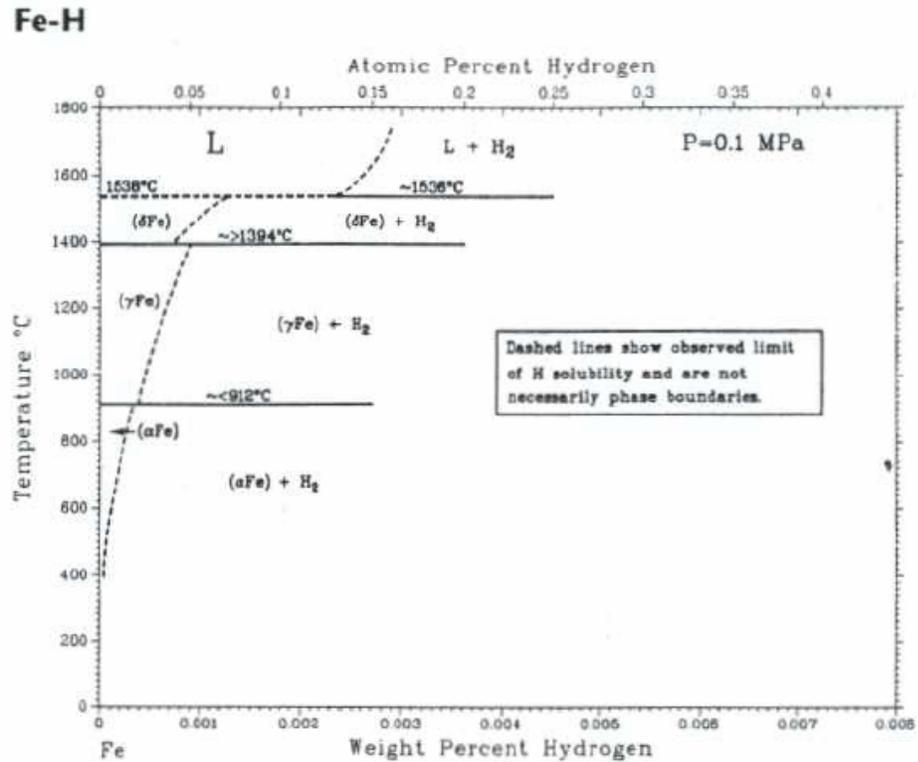
a) A Hydride Forming Metal (Titanium)

b) Non-Hydride Forming Metal (Iron)

Figure 13 Hydrogen-Metal Phase Diagrams. After the H-Ti phase diagram on page 238 and the Fe-H phase diagram on page 195 of Reference 10

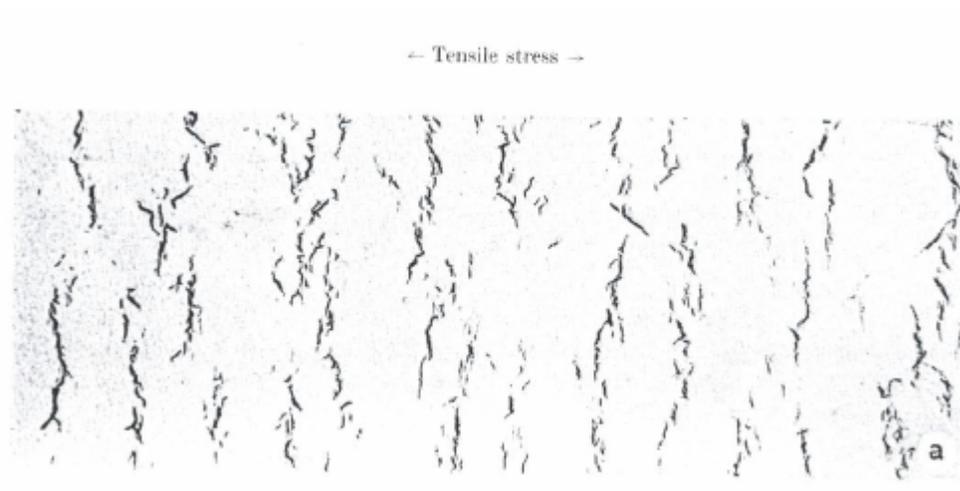
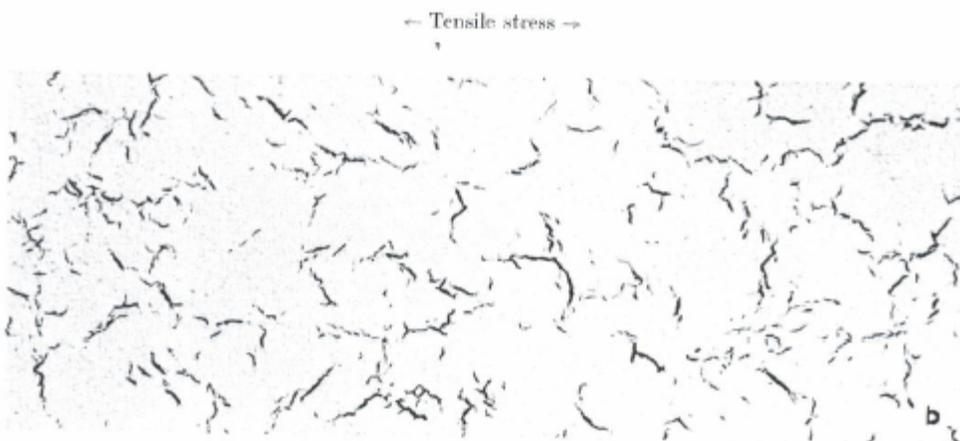
a) Hydride Precipitation in Stressed Sample

b) Hydride Precipitation in Non-stressed Sample

Figure 14. Stress Orientation of Hydrides in Zircaloy-2 Cladding. After Figure 15, page 182, of Reference 11

platelets are formed. Such columns are apparent in Figure 14 and, because of limited ductility, the hydrides and hydride-metal interfaces provide an easy path for crack propagation along the hydride column and across the material.

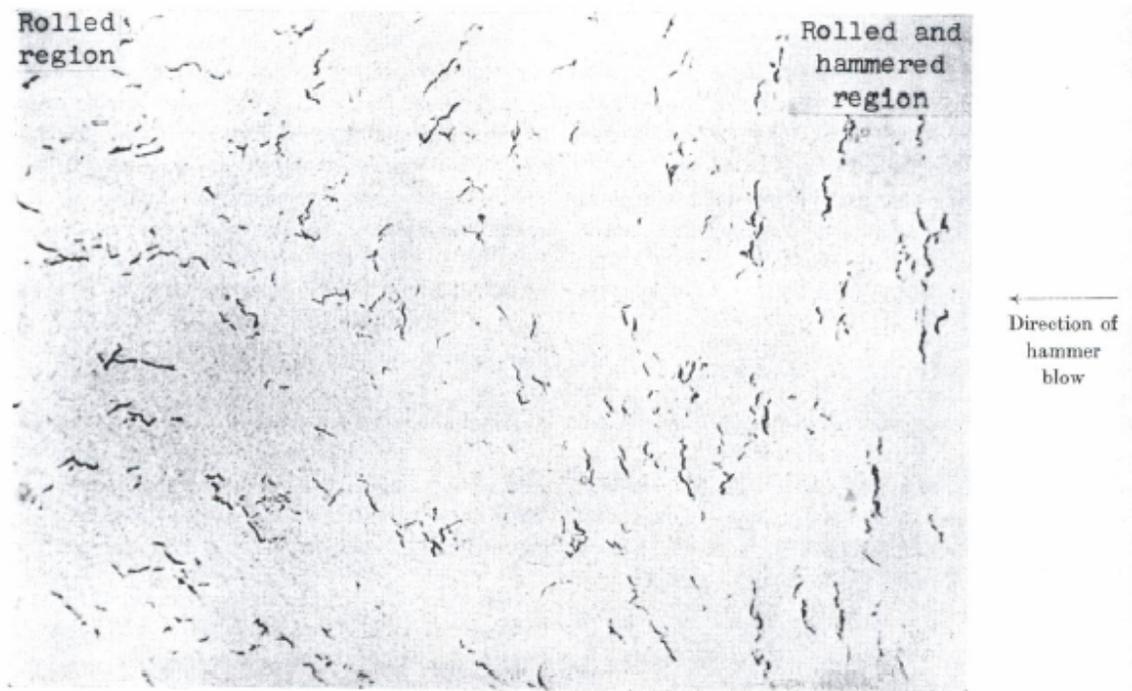
Figure 15. Strain Orientation of Hydrides in Zircaloy-2 Plate. Hydride orientation in rolled plate that was hammered on one end and then hydrided. After Figure 13, page 181 of Reference 11

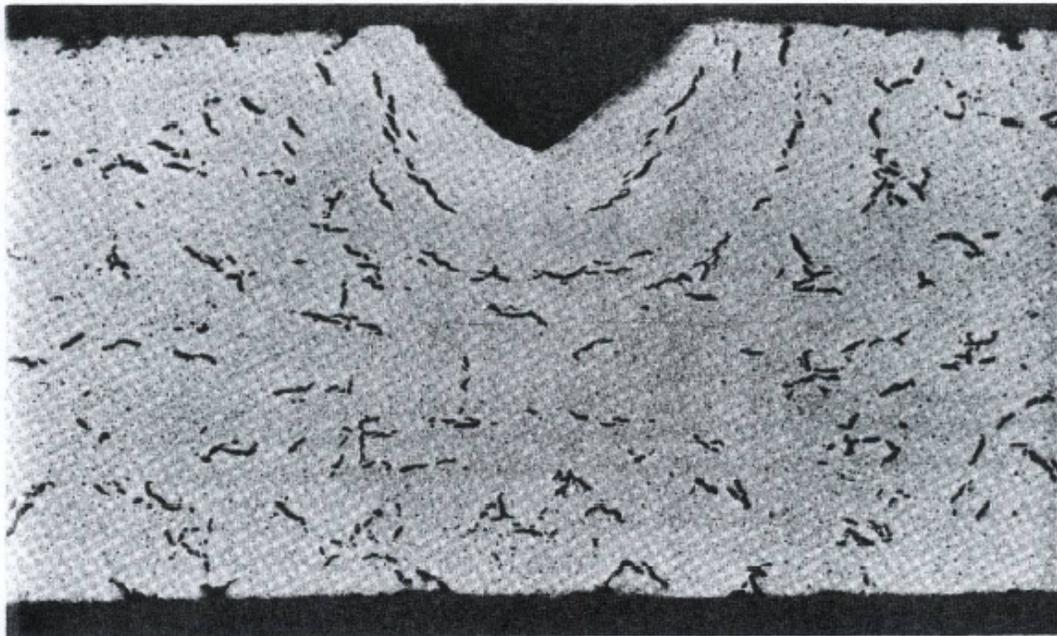
Figure 16. Hydride Reorientation at Room Temperature. The notch was placed on a 30 mil thick tensile specimen which was then sectioned and examined without ever heating the specimen above room temperature. After Figure 11, page 179 of Reference 11

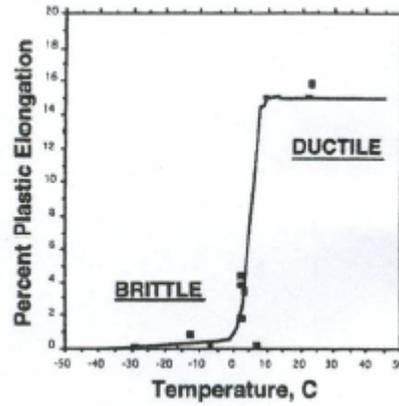
Figure 17. Ductile to Brittle Transition in Hydrogen Charged Timet 21S, a Beta Titanium Alloy. After Figure 8, page 709 of Reference 12

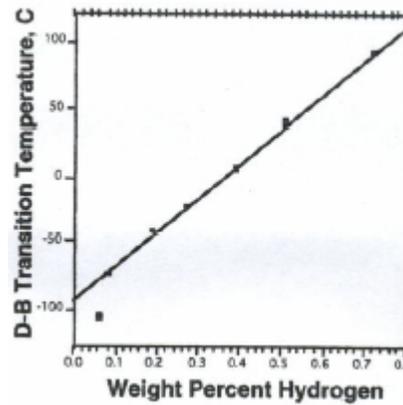
Figure 18 Influence of Hydrogen Content on the Ductile-to-Brittle Transition Temperature of Timet 21S. After Figure 9, p709, of Reference 12

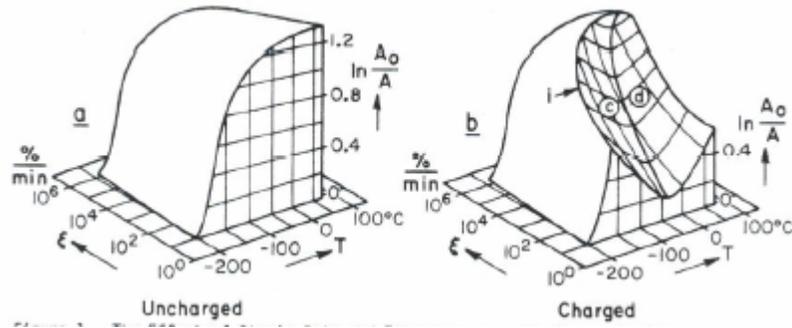
Figure 19. The Effect of Test Temperature and Strain Rate on the Susceptibility of Mild Steel to Hydrogen Embrittlement. After Figure 1, page 56 of Reference 3 (original work by Toh and Baldwin)

The strain rate dependence of body centered cubic mild steels to hydrogen embrittlement is shown in Figure 19. Similar strain rate dependencies have been found for other metals and alloys and a key point of these observations is that hydrogen embrittlement increases as the strain rate decreases. This point, when extrapolated to the extreme, suggests that the maximum susceptibility to embrittlement would be produced by static loads. This is the case to a certain extent because some alloys are susceptible to delayed failure hydrogen embrittlement. These alloys, when loaded to around 80% of their yield strength and held under load for a period of time, will fracture with essentially no macroscopic plastic strain. The susceptibility delayed failure hydrogen embrittlement is a function of the metallurgical condition of the material. The time required for delayed failure also depends on hydrogen content, stress level and the degree of stress concentration. A schematic illustration of stress-time dependence of delayed failure is shown in Figure 23 and the effect of stress concentrations in Figure 24. Figures 23 and 24 are based on studies with notched tensile specimens. More modern treatments of delayed failure processes use fracture mechanics techniques to determine the influence of applied stress intensity on crack growth rates (Figure 25). There are three critical “levels” of applied stress intensity: Stage I represents the minimum stress intensity necessary to cause hydrogen induced crack growth, Stage II represents a region where the sub-critical crack velocities are relatively independent of applied stress intensity and Stage III represents unstable crack growth and approaches the critical stress intensity necessary to fracture the material in the absence of hydrogen.

The strain rate dependence of hydrogen embrittlement in a tensile test (Figure 19) is consistent with the observations that hydrogen diffusion is a critical factor in the embrittlement process. During fatigue, the time available for hydrogen diffusion will vary with cyclic frequency and wave form. Low cyclic frequencies will provide more time for diffusion and hence more time for sub-critical crack growth during each fatigue cycle. An example of the effect of frequency on fatigue crack growth rates is shown in Figure 28. Note that decreasing the cycle frequency from 5 Hz to 0.05 Hz increased the fatigue crack growth rate by about an order of magnitude. Similarly, crack opening displacement rates have a major impact on the J-resistance curves for materials tested in hydrogen environments and/or after hydrogen charging. The fracture resistance decreases as the crack opening displacement rates are decreased.

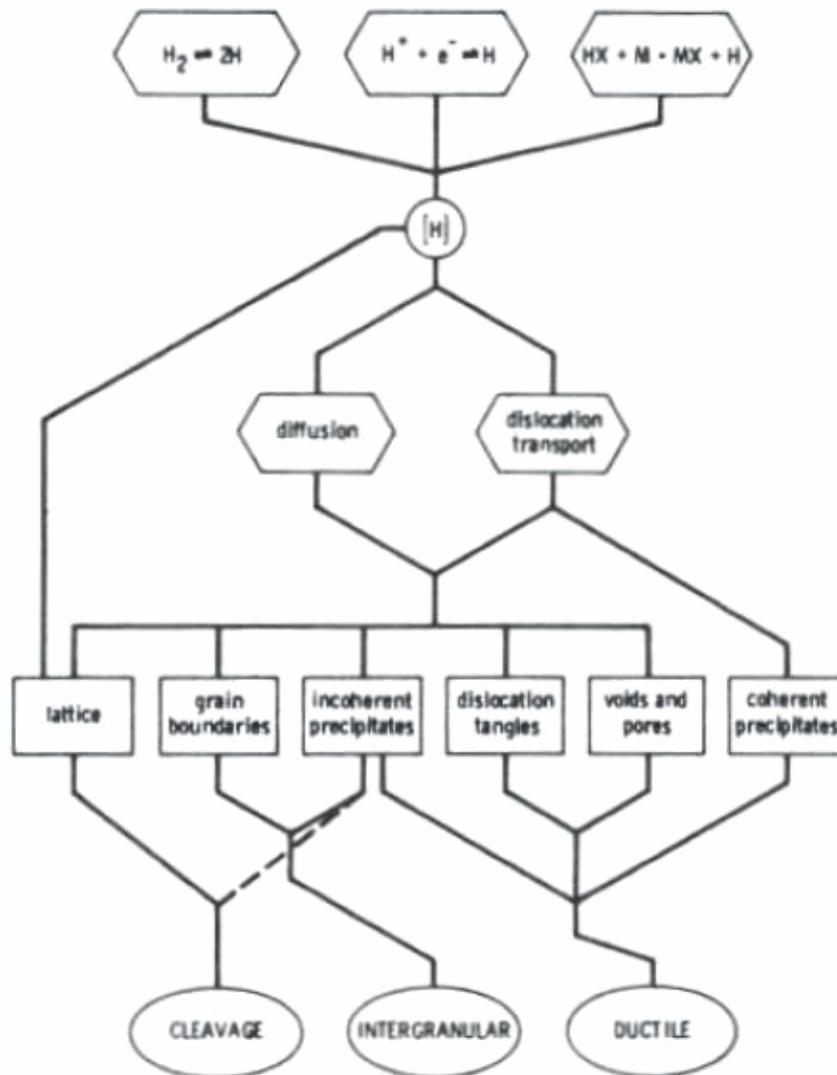
Figure 20. Schematic of Some of the Processes and Microstructural Variables Involved in Hydrogen Embrittlement. After Figure 15, page 304 of Reference 13

Some of the sources of hydrogen and microstructural variables involved in this highly simplified, six step scenario are illustrated in Figure 20. Factors that are important to the analysis and prevention of failures include the role of lattice dilation in causing hydrogen relocation, necessity for hydrogen diffusion during the hydrogen relocation process and the existence of a critical hydrogen concentration for embrittlement.

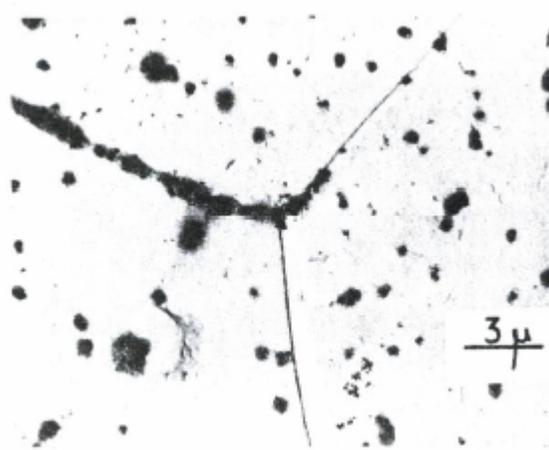
Figure 21. Autoradiograph Showing Tritium Segregation to Grain Boundaries in Iron. The dark spots are regions of high hydrogen concentration – note that one grain boundary has a higher hydrogen content than the other boundaries. After Figure 2, page 562 of Reference 14

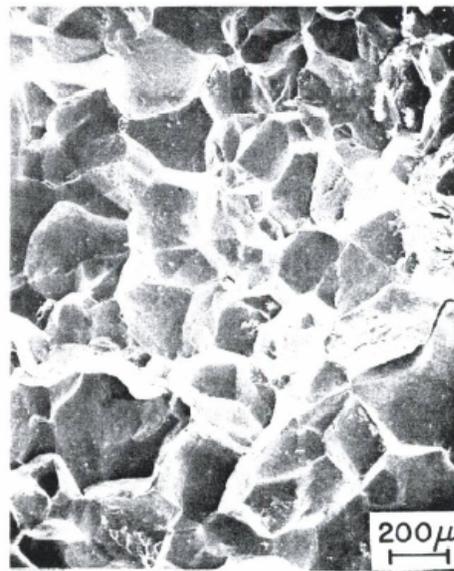
a) hydrogen embrittlement

b) temper embrittlement

Figure 22 Fractographic Features of Hydrogen Assisted Cracking and Temper Embrittlement in an HY-130 Steel. Note that the hydrogen embrittlement fracture, a), is characterized by ductile rupture while the temper embrittlement fracture, b), is characterized by intergranular rupture. After Figure 4d, page 313 and Figure 8b, page 315 of Reference 15

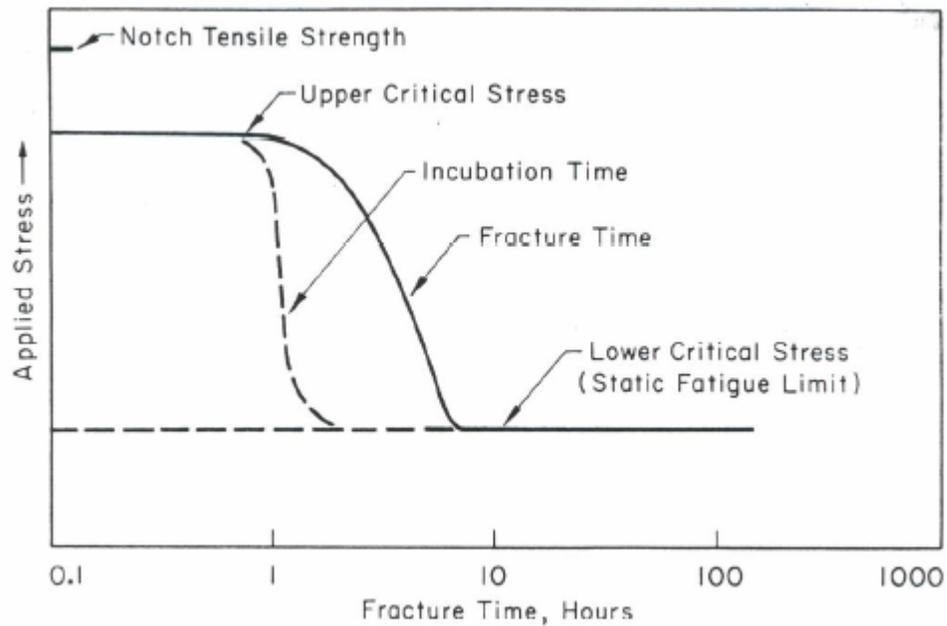
Figure 23. Schematic Illustration of the Stress/Time Dependence of Hydrogen Embrittlement. The stress levels and times required for the hydrogen embrittlement processes vary with exposure temperature, hydrogen content, metallurgical condition and effectiveness of the stress concentration. After Figure 1, page 153 of Reference 16

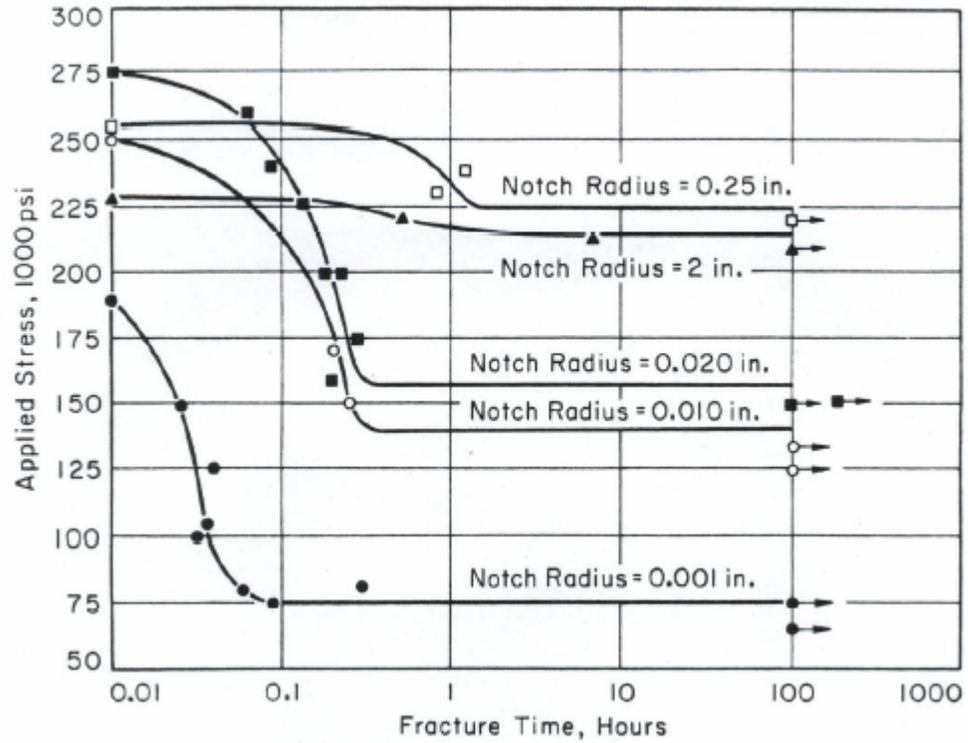
Figure 24. Effect of Notch Root Radius on Delayed Failure Processes in a High Strength Steel. After Figure 3, page 156 of Reference 16

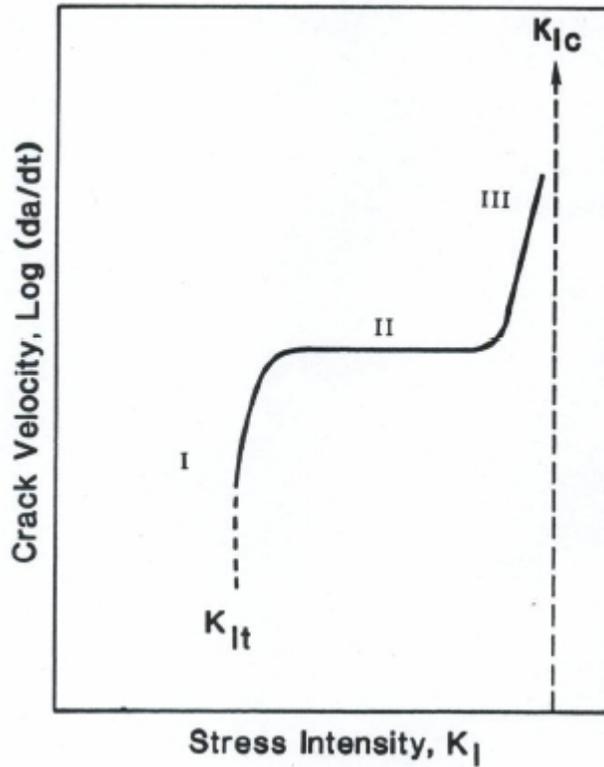
Figure 25. Effect of Applied Stress Intensity on Crack Growth in Hydrogen. After Figure 9, page 14 of Reference 17

Stage I and II cracking are significant because they characterize crack growth over a large range of stress intensities that are relevant to practical design considerations. Extrapolation of Stage I (dashed line in Figure 25) provides an estimate of the threshold stress intensity necessary to cause hydrogen induced cracking while Stage II shows the potential rates at which hydrogen induced cracks might grow. Analysis of Stage II crack velocities and hydrogen diffusivities has shown that the fastest rates of Stage II intergranular cracking are directly proportional to hydrogen diffusivity for a wide range of high strength steels, nickel alloys and aluminum alloys, Figure 26. This proportionality is consistent with the hydrogen embrittlement model that assumes a critical, localized region of very high hydrogen concentration is a precursor to hydrogen embrittlement. The size of this localized region remains the subject of debate and there is evidence that whatever the size may be (10 nm or 10 $\mu$ m) in hydrogen charged material, exposure of the material to an external hydrogen pressure reduces that size. This observation is consistent with a model for hydrogen induced crack propagation where hydrogen promotes interfacial fracture and facilitates

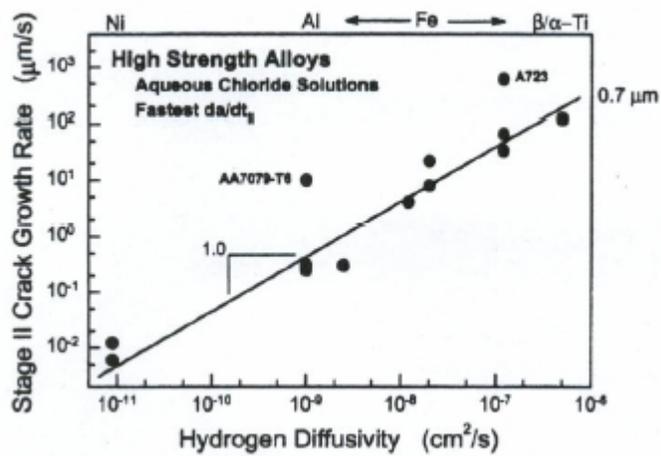
Figure 26. Dependence of Stage II Crack Growth on Hydrogen Diffusivities. After Figure 1, page 480 of Reference 18

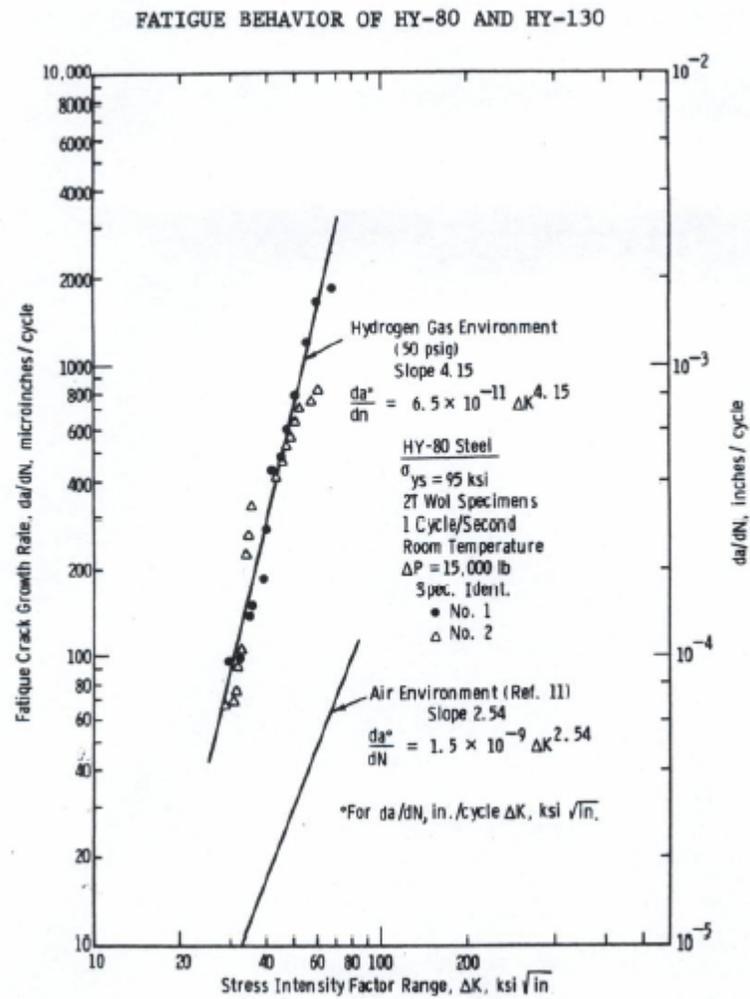
Figure 27. Hydrogen Effects on Fatigue Crack Growth in a HY-80 Steel. After Figure 5, page 157 of Reference 19

Hydrogen induced sub-critical crack growth in statically loaded materials exposed to hydrogen occurs over the same broad range of stress intensities that cause fatigue when the loads are cycled. Therefore, if a susceptible material is undergoing fatigue, the presence of hydrogen may accelerate fatigue crack growth. Such acceleration has been observed in numerous metals and alloys and example of that effect in HY-80 steel is shown in Figure 27.

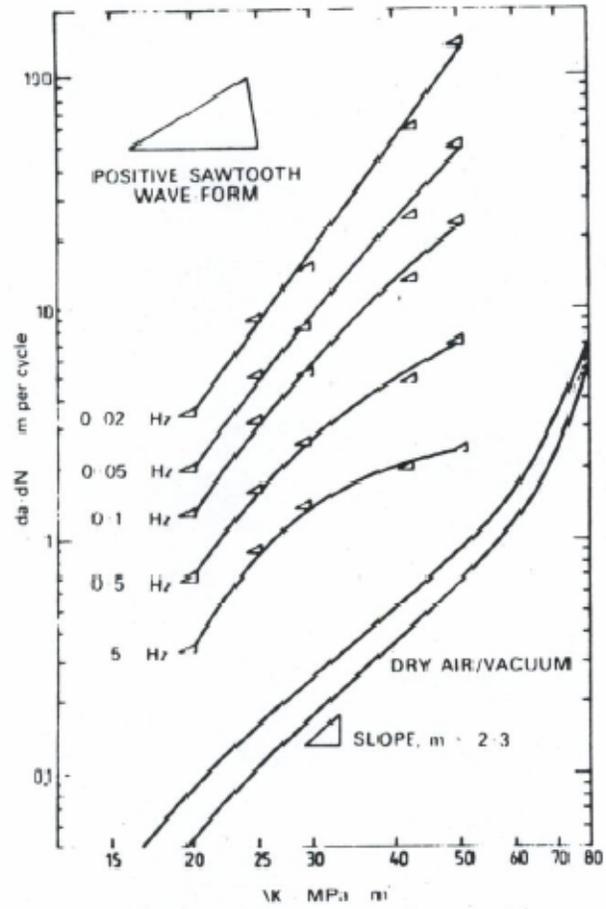
Figure 28. Effect of Cyclic Frequency on Hydrogen Enhanced Fatigue Cracking in a D6aC Steel. After Figure 1, page 376 of Reference 20

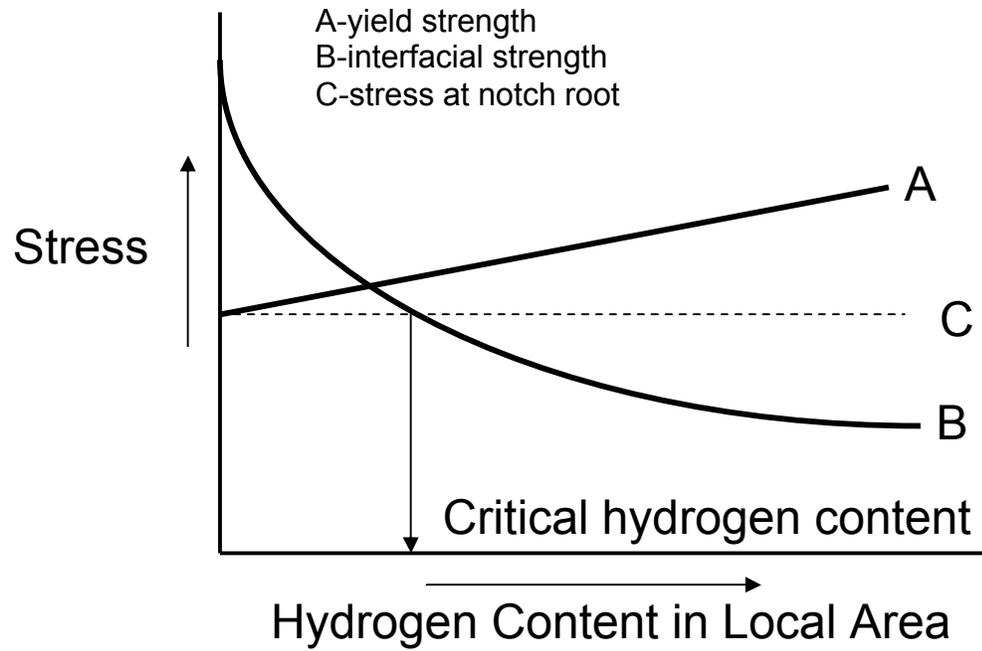
Figure 29. A Description of the Critical Hydrogen Content
