WSRC-TR-96-0394  
Revision 0

**CORROSION RESISTANCE OF INCONEL 690 TO BORAX, BORIC  
ACID, AND BORON NITRIDE AT 1100 °C (U)**

# **Corrosion Resistance of Inconel 690 to Borax, Boric Acid, and Boron Nitride at 1100° C (U)**

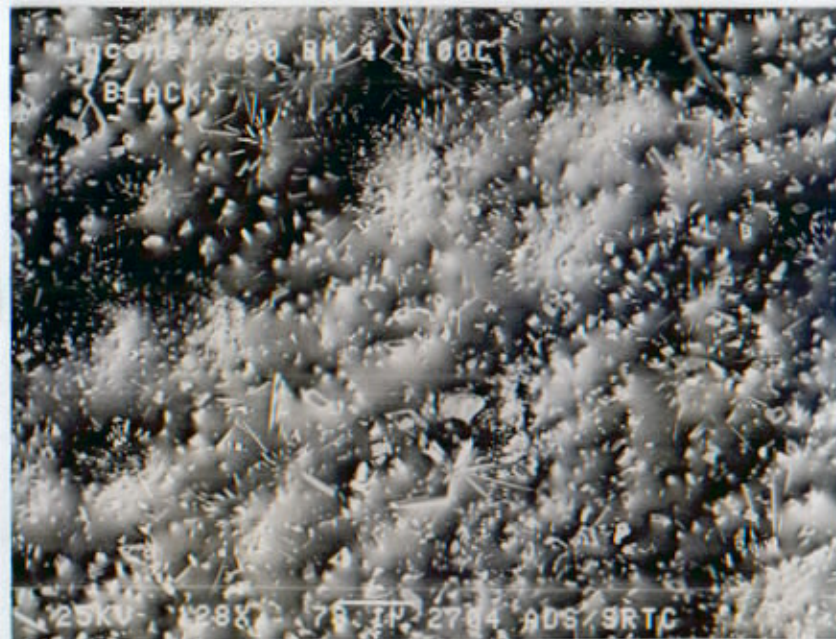
Figure 2. SEM image of chromium borate layer (same coupon as in Figure 1, boron nitride exposure). The surface was rough and various geometric shapes are shown protruding from matrix.

Visual examination of the coupon exposed to boron nitride exhibited a heavy black scale on all surfaces. This scale was identified by XRD and consisted primarily of chromium borate. Some chromium oxide was also identified. Results of the test are summarized in Table 2. Additional data can be found in Lab Notebook WSRC-NB-93-30. Portions of the chromium borate layer spalled off during cooling, exposing the tenaciously adhering grey chromium oxide scale. This oxide was more metallic in appearance than the original oxidized coupon. Scanning electron images of the two layers are shown in Figures 1, 2, and 3. The outer layer consisted of various geometric shapes, consisting mainly of Cr, Ni, Al, Ca, O, in a matrix composed of Al, Ca, and O. A small amount of Si was identified in both of these samples. Elemental analyses were performed on a SEM (the light element detector cannot detect boron). The grey layer beneath consisted primarily of Cr and O, although some aluminum was evident. Lighter colored particles randomly embedded in the matrix contained Ni, Cr, and Fe similar to that found in Inconel 690. Metallography revealed no evidence of localized attack; however, internal voids were observed to an average depth of 2 mils (Figure 4).

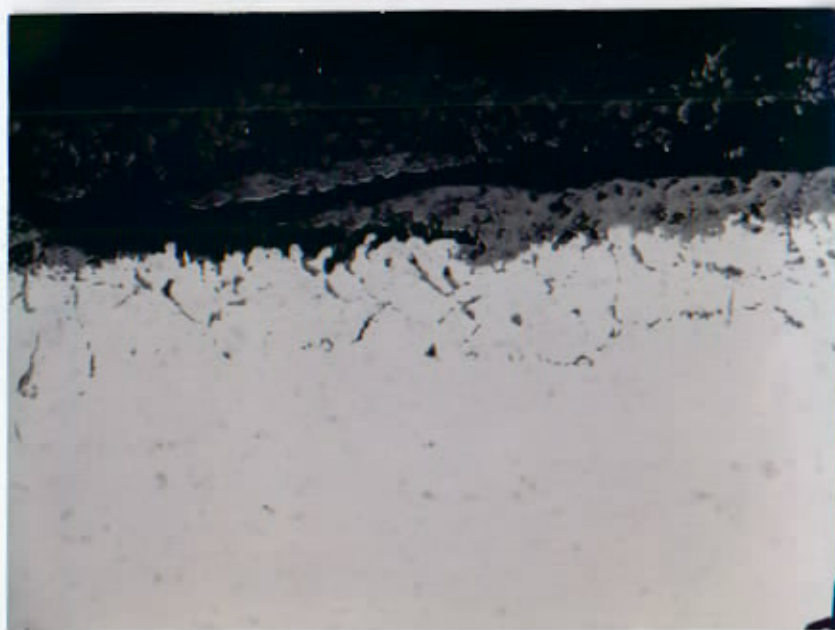
Figure 4. Microstructure of an as-polished Inconel 690 coupon showing internal void formation and some evidence of IGA (same coupon as in Figure 1, magnification 250 X).

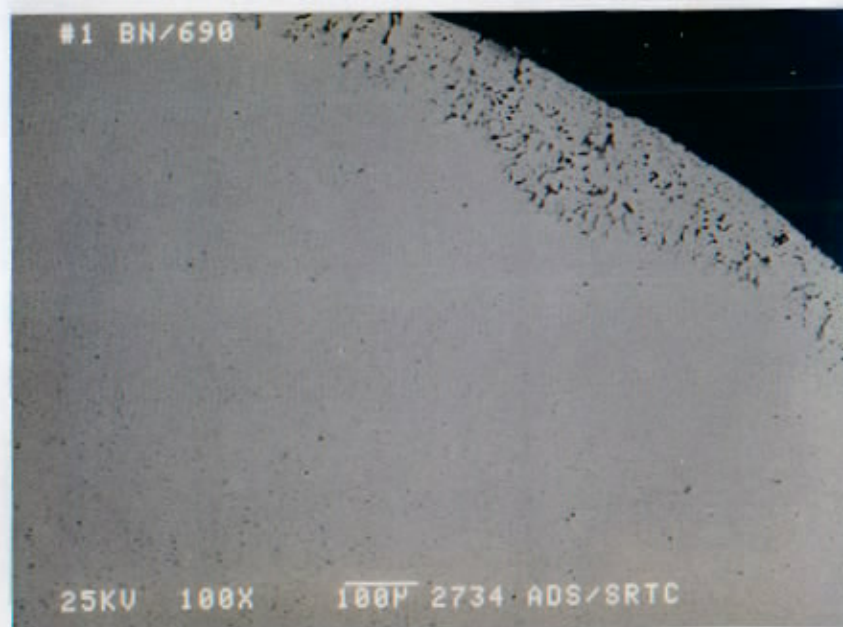
Figure 6. SEM image showing internal void formation in Inconel 690 coupon exposed in direct contact to boron nitride for 6 days. Average depth of penetration was 6 mils.

The four coupons removed from the boron nitride block contained a thick black outer scale, most likely chromium borate, and an underlying grey tenaciously adhering scale. The inner scale was identified as chromium oxide. Corrosion rates, based on weight loss, for the four coupons ranged from 50 to 90 mils per year. Metallographic and SEM analyses revealed an internal attack of the Inconel 690 to an average depth of 6 mils (Figure 6). Chromium oxide was observed in several of the voids. Results from the 690 / boron nitride corrosion rate test are presented in Table 3.
