**Degradation and Failure Characteristics of
NPP Containment Protective Coating Systems
Interim Report No. 2**

SRTC Coating System No. 2

(Phenoline[®] 305 epoxy-phenolic topcoat, Starglaze[®] 2011S surfacer, concrete substrate)

M. E. Dupont, N. C. Iyer, P. S. Lam, R. L. Sindelar,
T. E. Skidmore, F. R. Utsch, and P. E. Zapp
Savannah River Technology Center
Westinghouse Savannah River Company
Aiken, SC 29808

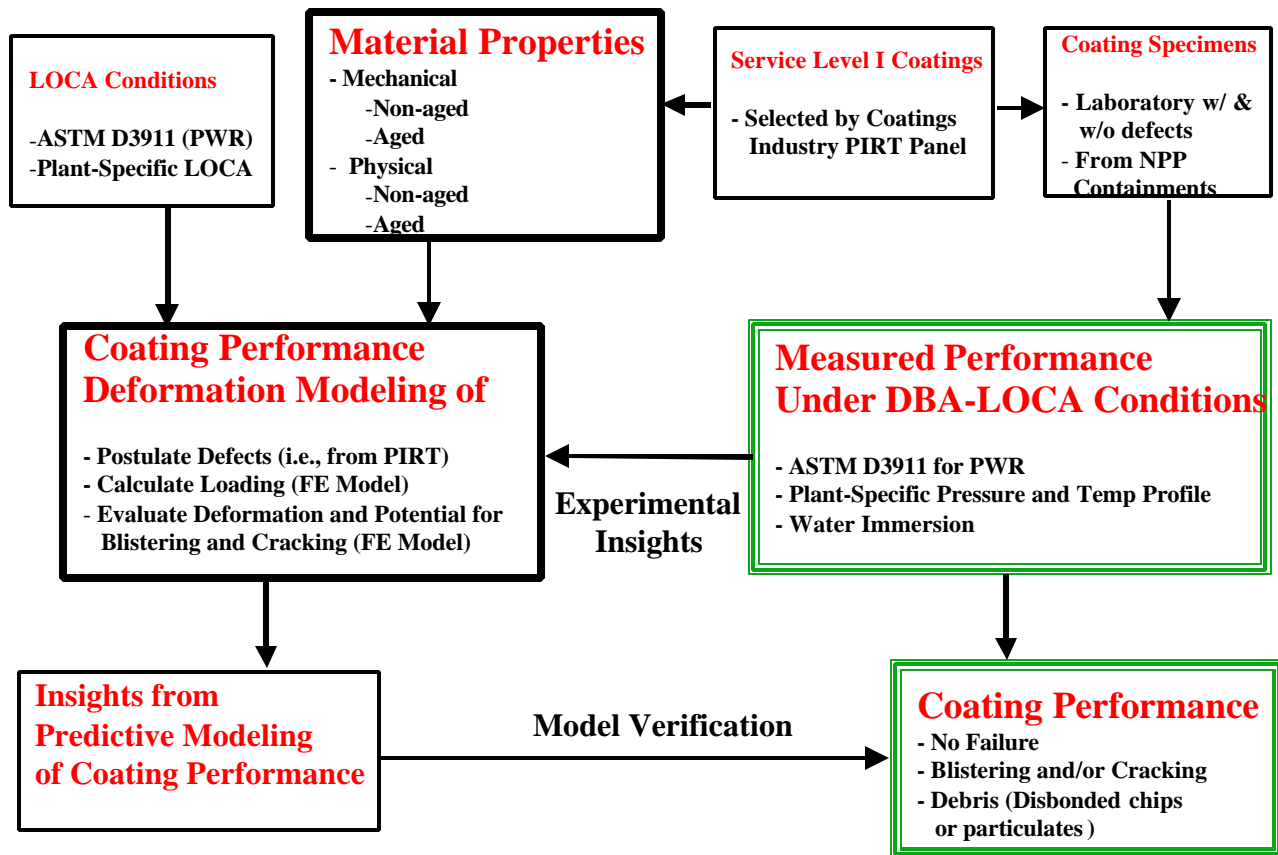
Figure 2-1. Task Logic Diagram for SRTC Project

Materials' properties are required input to analytical models of coating deformation and failure (see Figure 2-1). The input parameters used for coating System 2 are contained in Table 2-3. The table also includes several property parameters, not used directly as inputs to modeling, that provide a quantitative measure of the effects of aging and DBA exposure conditions on the potential for coating failure. One such parameter being measured in the research program is the adhesion strength. It is a simple measurement with sensitivity to detect differences in specimens tested at various conditions of temperature, wetness, and irradiation exposure. A reduction in the adhesion strength indicates an increase in potential for failure. The properties have been categorized as either "properties for loading" or "properties for mechanical response." The properties for loading are those used to calculate the stress distribution in the coating system; the properties for mechanical response are those used to calculate deformation of the coating system. The steps in analytical modeling are outlined in section 2.2.

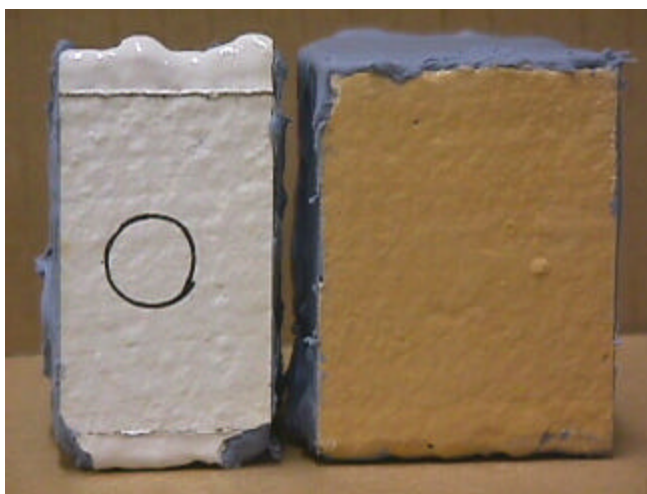
Figure 2-4. Laboratory Specimens Topcoated with Phenoline[®] 305 before (left) and after (right) exposure to 10^9 rad per ASTM D4082-95.

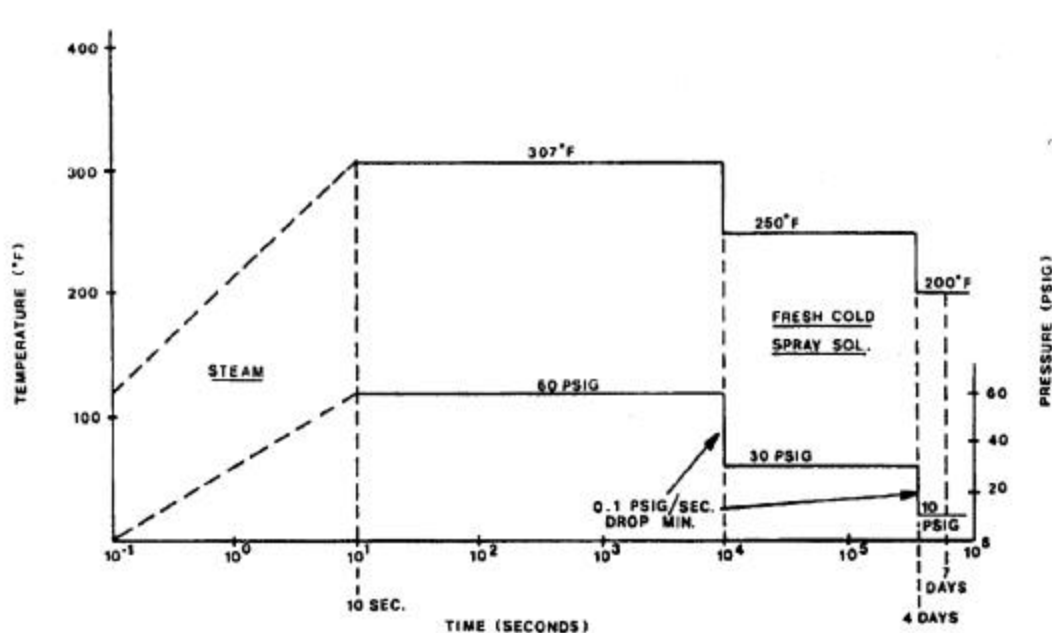
Figure 2-5. DBA Profile for PWR per ASTM D3911-95

There are two DBA profiles investigated in this study: the pressurized water DBA profile specified in ASTM standard D3911-95 [2.6], termed the “full DBA profile” in this report, and a plant-specific rapid pressure/temperature pulse test. Figure 2-5 below shows the ASTM profile, which is run for a total exposure period of approximately one week.

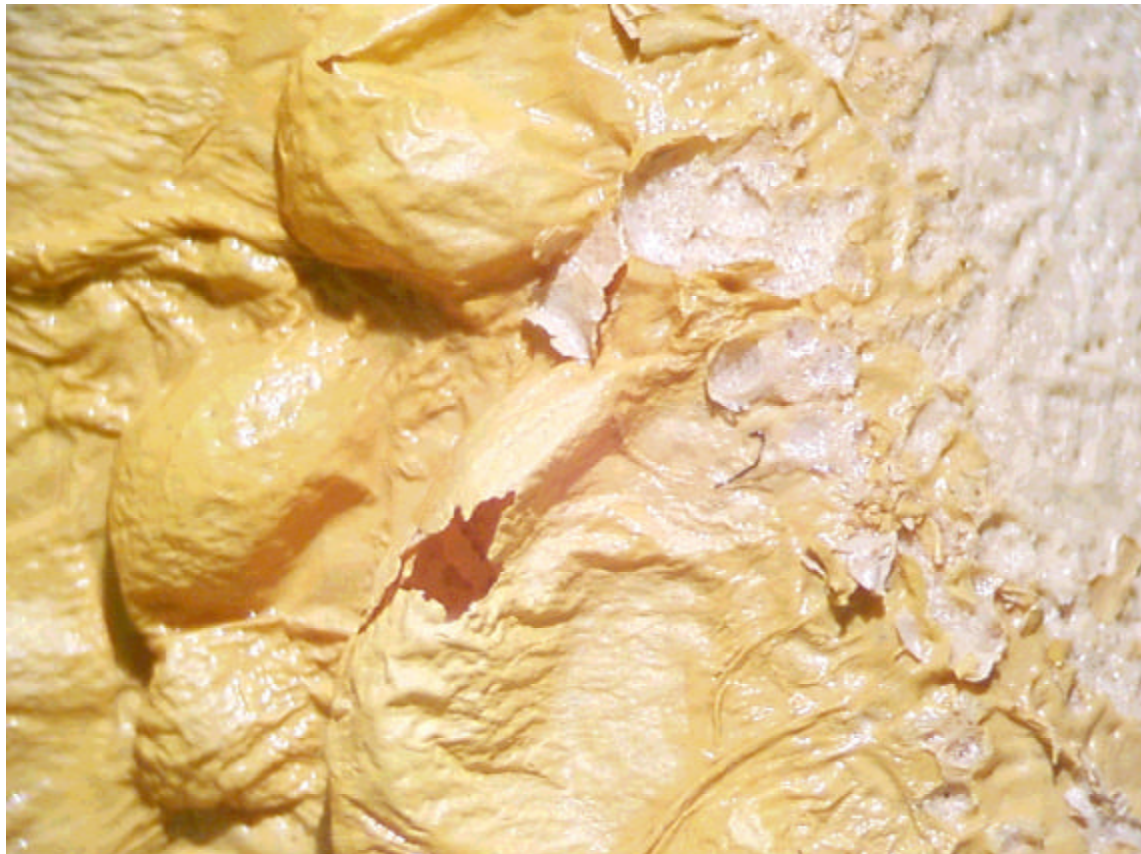
Figure 2-6. Blister Formation in Near-Surface Region of Phenoline[®] 305 Following Irradiation to 10⁹ Rad and a 200° F Water Soak.

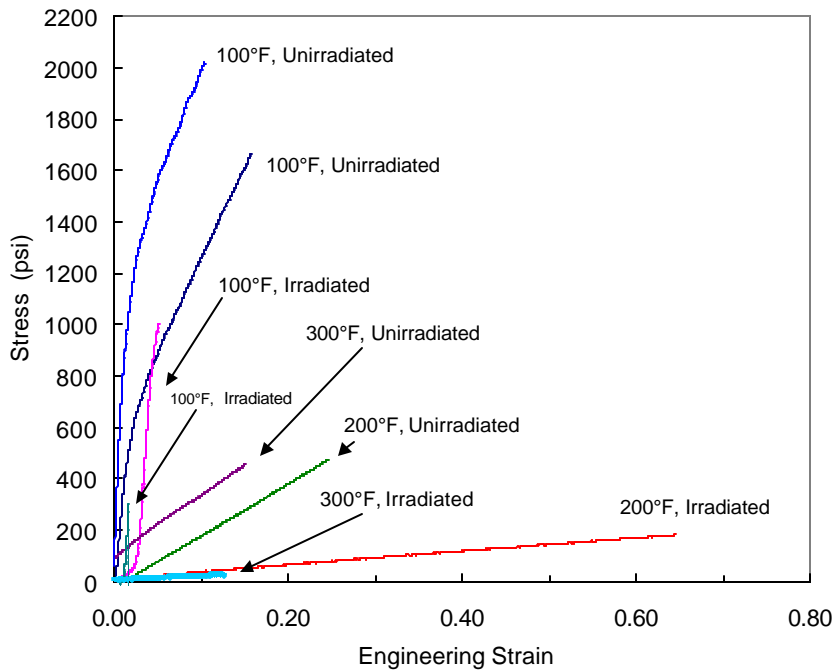
Figure 3-1. Free-film tensile test results for Phenoline[®] 305 in the dry condition.

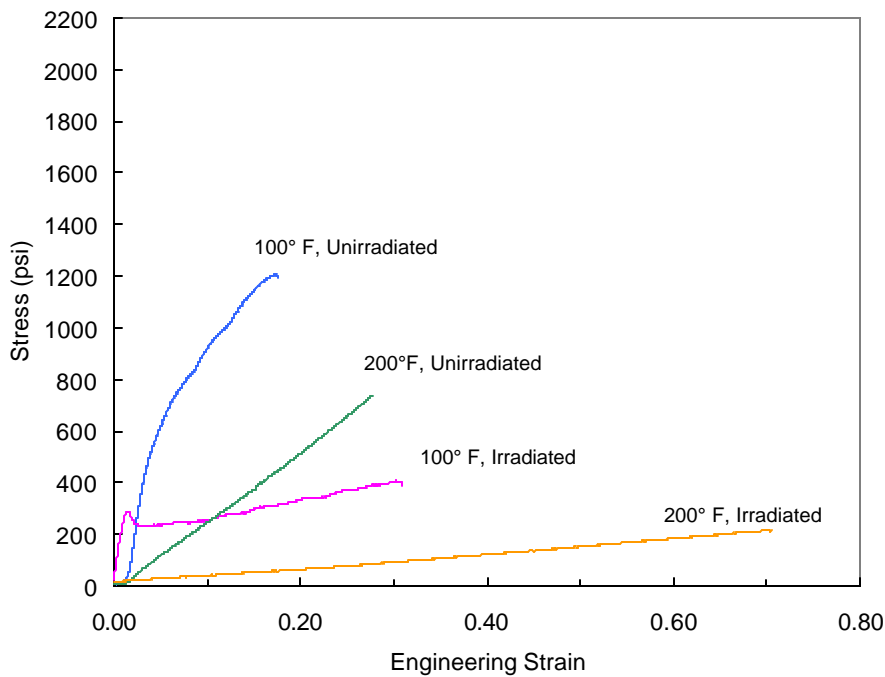
Figure 3-2. Free-film tensile test results for Phenoline[®] 305 in the wet condition.

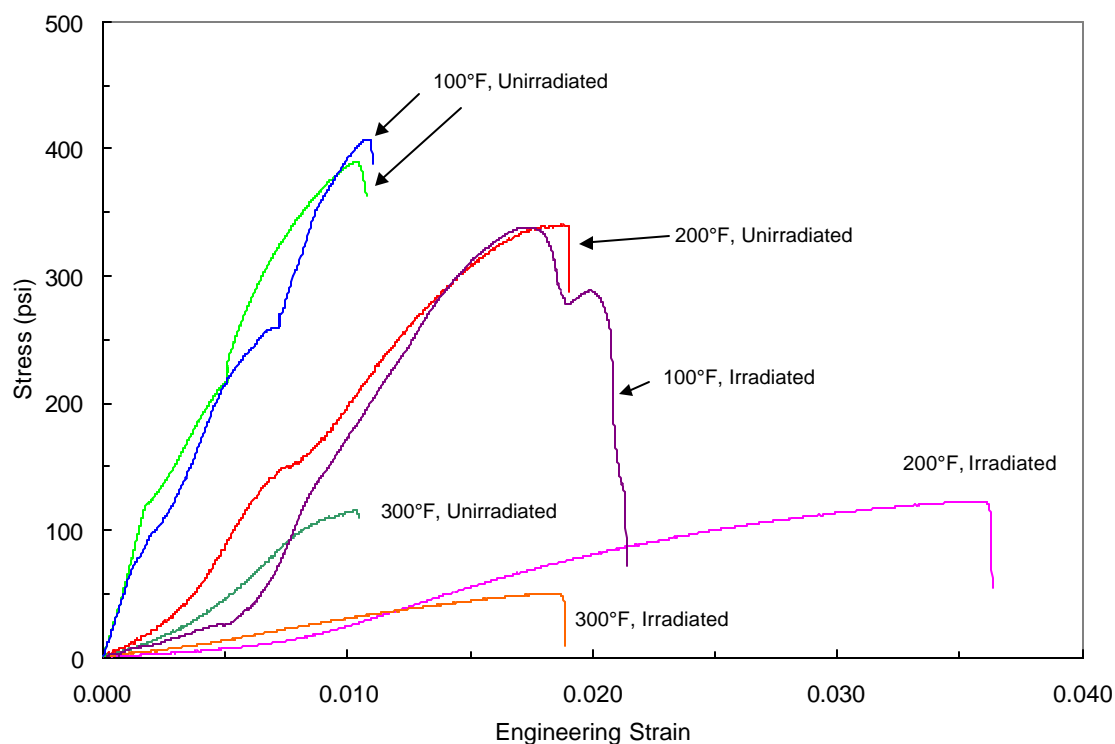
Figure 3-3. Free-film tensile test results for Starglaze[®] 2011S in the dry condition.

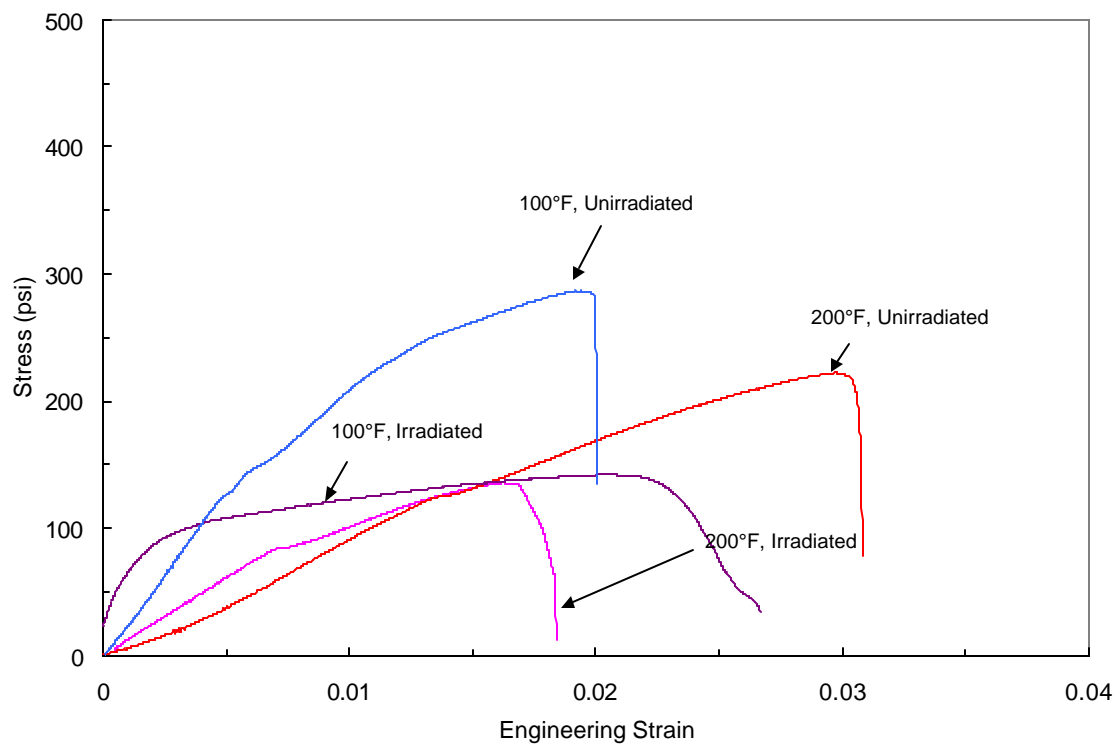
Figure 3-4. Free-film tensile test results for Starglaze[®] 2011S in the wet condition.

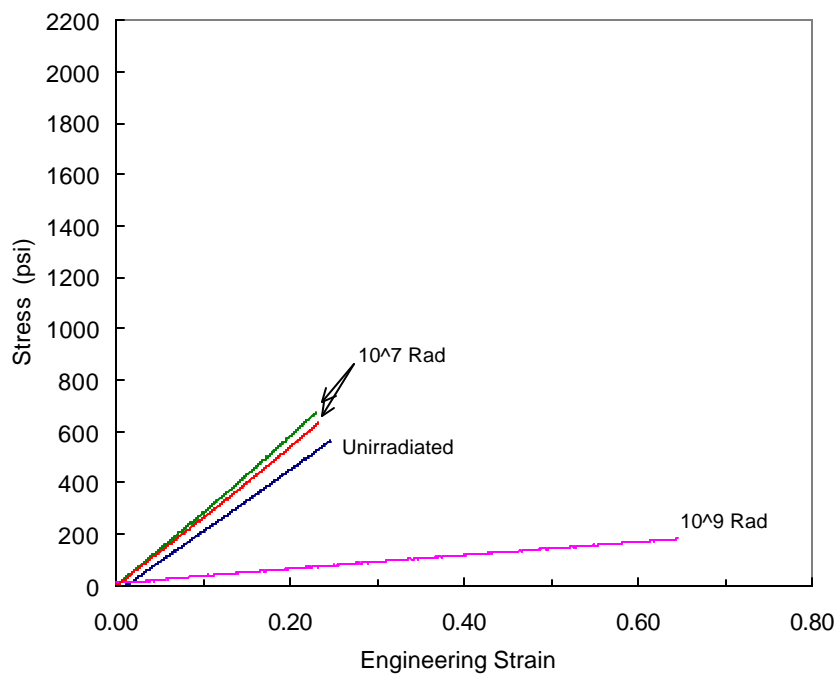
**Figure 3-5. Tensile test data for Phenoline[®] 305 at 200°F obtained in the dry condition.****Table 3-8. Adhesion Pull Test Results for System 2**

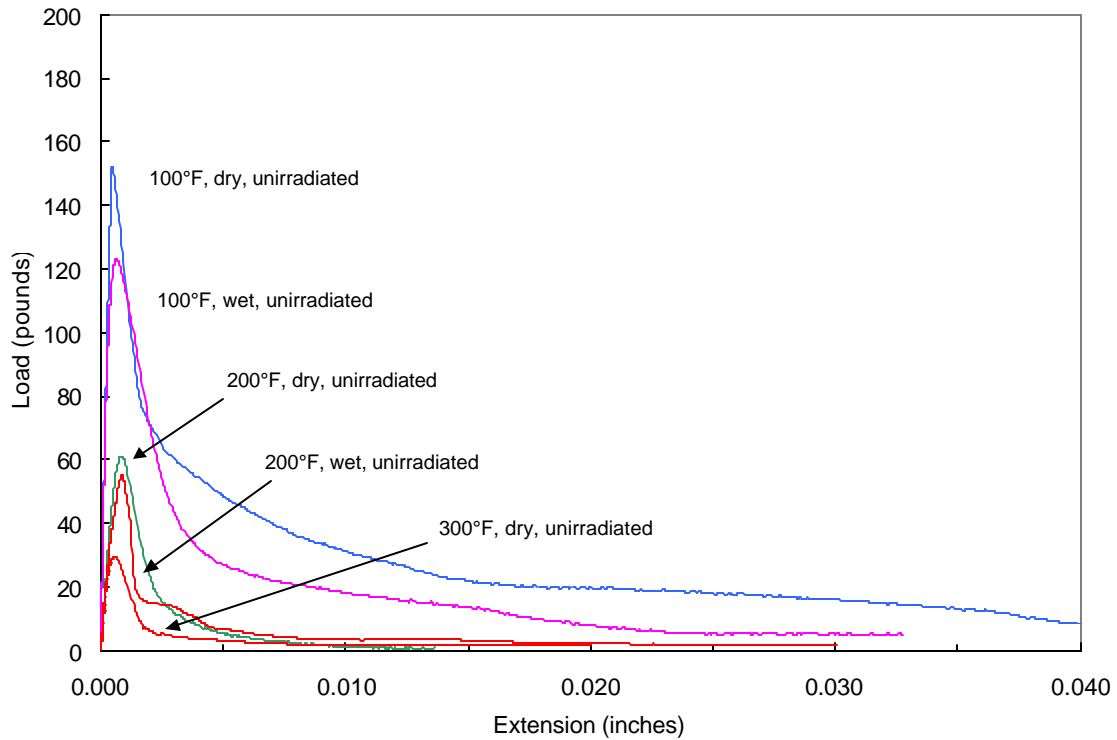
Figure 3-6. Adhesion pull test results for System 2

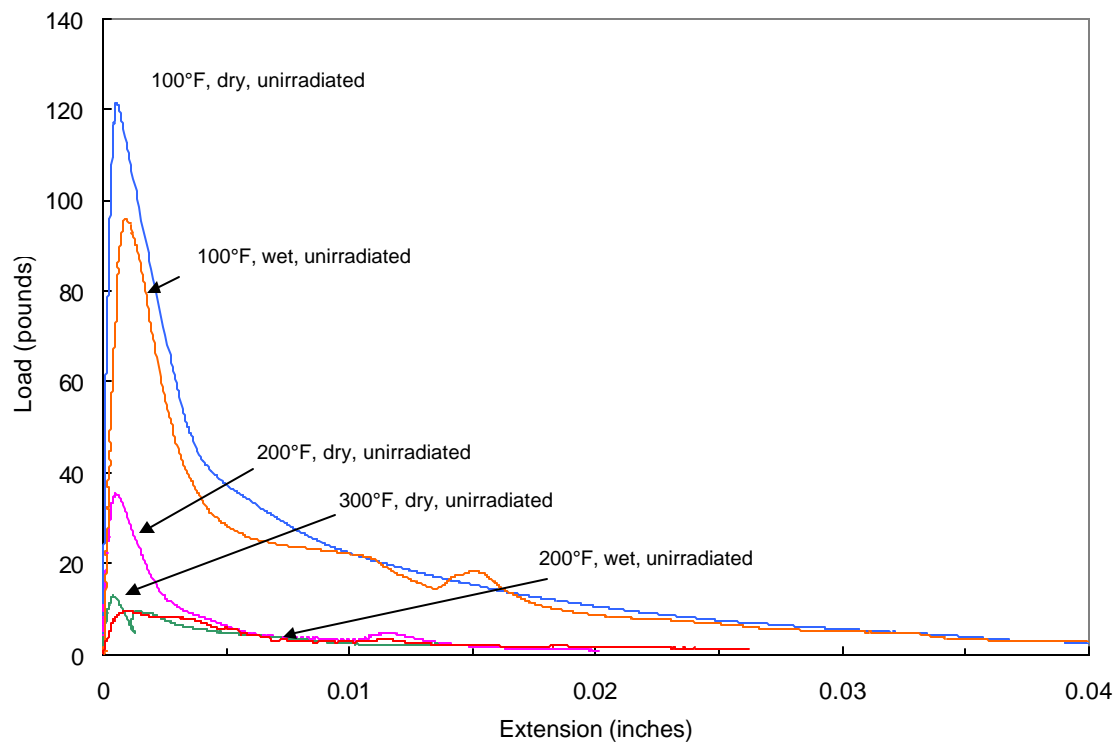
Figure 3-7. Adhesion G-value test results for non-irradiated System 2.

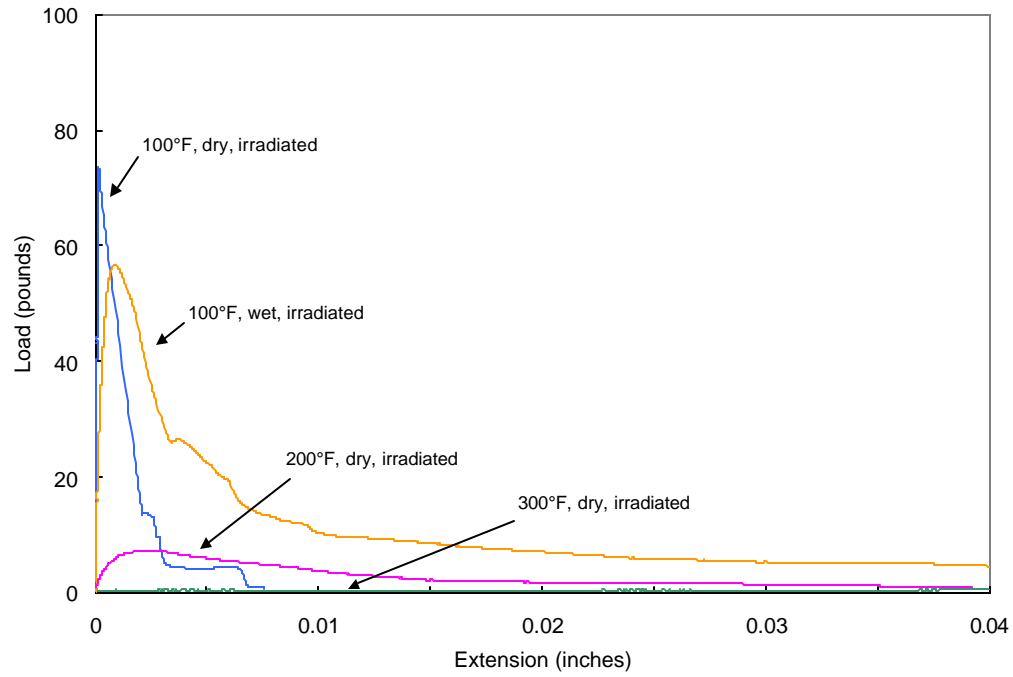
Figure 3-8. Adhesion G-value test results for irradiated System 2.

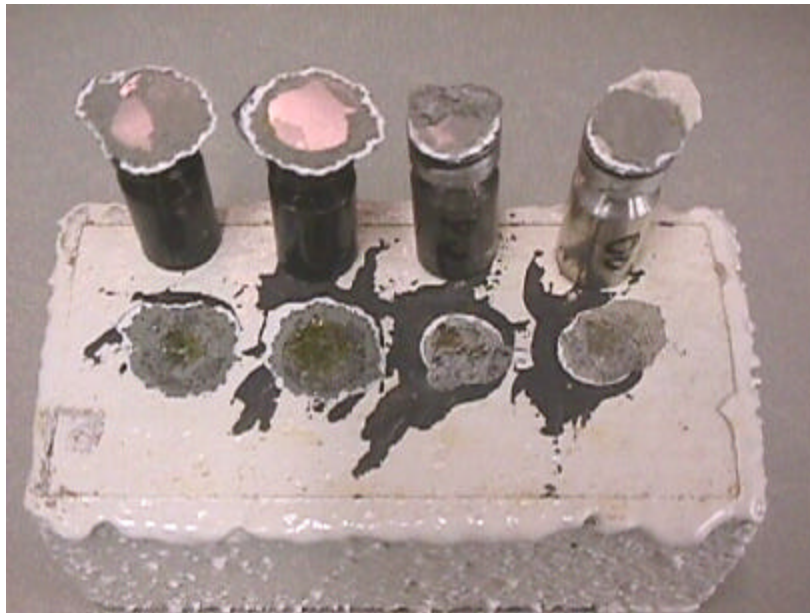
Figure 3-9. Non-irradiated System 2 specimen block and pullers from the G-value tests. The two left pullers were tested at 100°F, and the two on the right at 200°F. Broken glass discs (type 1 defect) reflect light on pullers. Second from right puller has concrete fragment from beneath level of the type 1 defect.

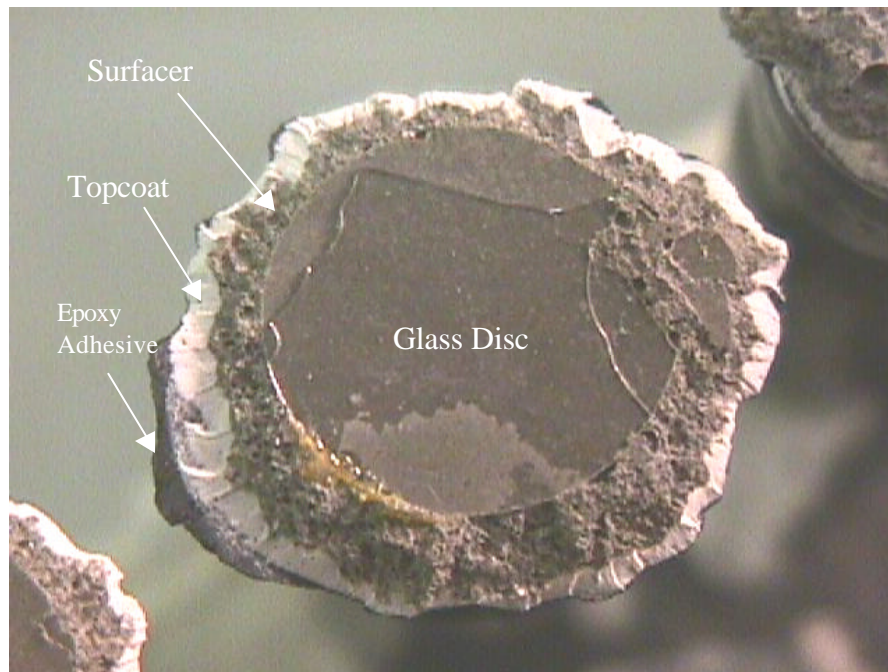
Figure 3-10. Photograph of puller from a 100°F non-irradiated, wet condition G-value test.

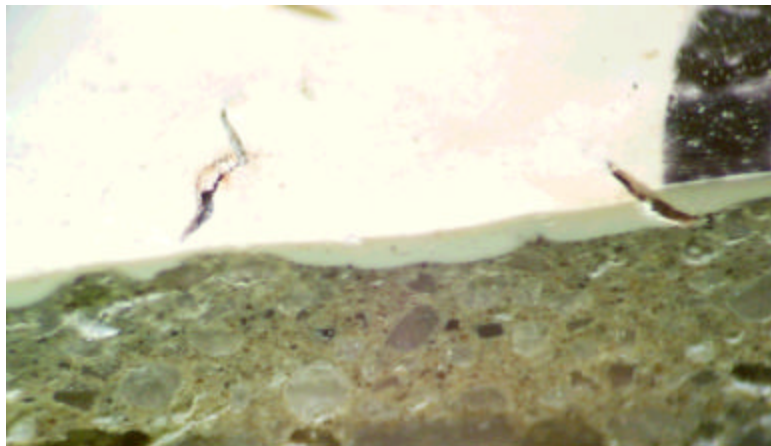
Figure 3-13. Oblique view of cross-section of non-aged System 2 specimen illustrating minor cracking which occurred during DBA-LOCA testing. The cracks appear in the topcoat only, and extend to the underlying surfacer. Magnification is approximately 15X.

As discussed in Section 3.3, cracking was observed in the topcoat, with the cracks through the topcoat thickness to the surfacer (see Figures 3-13 and 3-39). This would be expected if local stress intensifiers (e.g., thin spots and/or micro-cracks at the topcoat/surfacer interface) were present in the topcoat. Minor cracks in the topcoat were observed from both the full DBA and "plant-specific" DBA exposures.

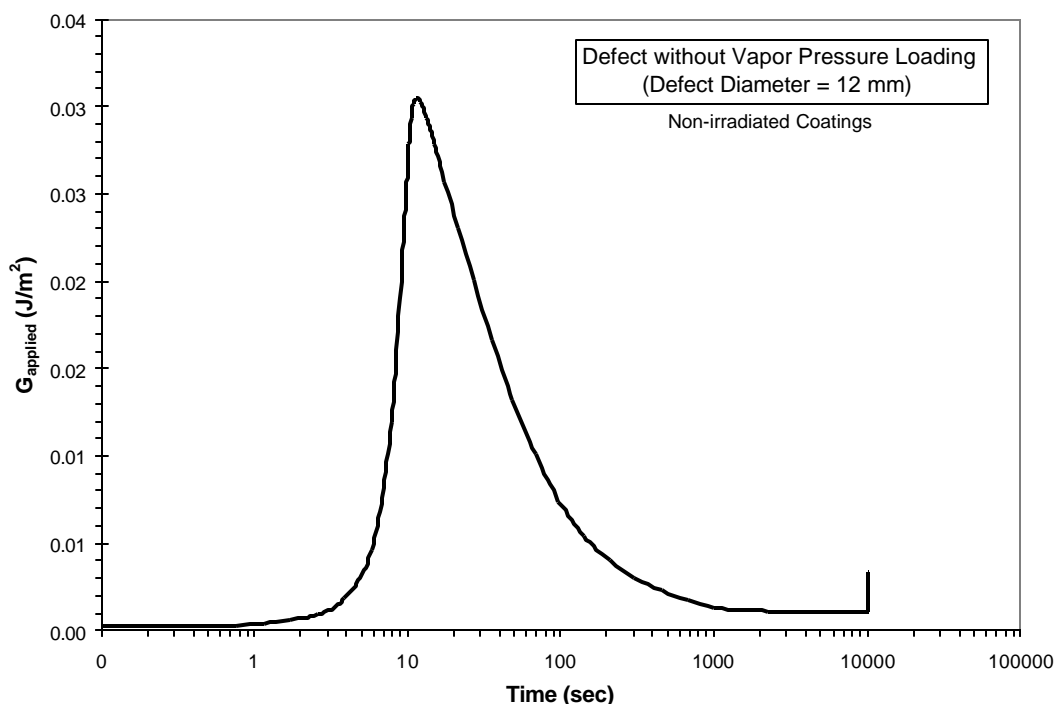
Figure 3-14. Applied G-Values at the Edge of a dry Defect (Diameter 12 mm) during DBA Test (Logarithmic Time Scale).

A Type 1 defect with diameter 12 mm was placed between the surfacer and the concrete substrate. The J-integral option in the finite element code (ABAQUS) was used to evaluate the applied G-values for this defect with and without vapor pressure due to trapped water in the defect. When there is no vapor pressure present inside the defect, the applied G-value is mainly due to the thermal expansion mismatch. The maximum applied G-value (0.03 J/m²) occurs about a second after the initial heating is complete (10 seconds and at 307 °F), as shown in Figure 3-14. It can be seen that the peak value of the applied G-value is insignificant compared to the material G-values in Table 3-9, and thus no delamination would occur. It can be concluded that this defect will not grow under the condition in which there is no trapped water in the defect.

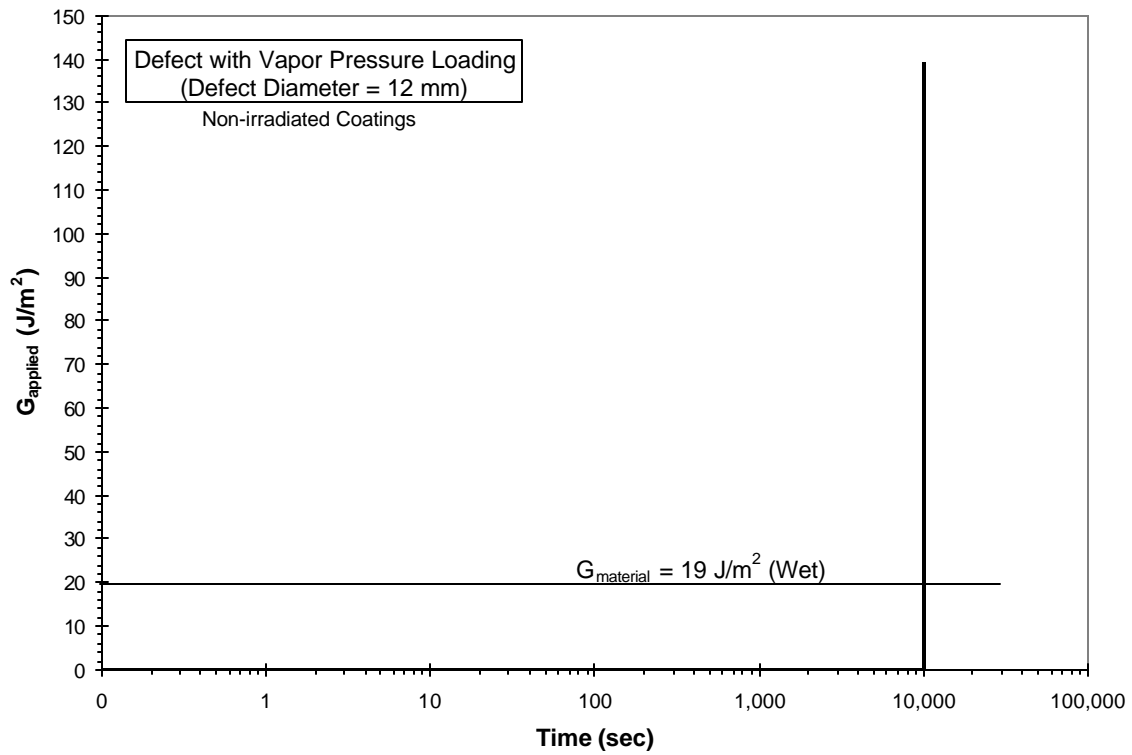
Figure 3-15. Applied G-Values at the Edge of a Vapor Pressurized Defect (Diameter 12 mm) during DBA Test (Logarithmic Time Scale).

The DBA test results (Figures 3-27 and 3-28) are consistent with the prediction, if it is assumed that water becomes trapped within the defect, either from the release from concrete or because water permeates the coating during the hold at 307°F and then is trapped during the rapid cool-down to 250°F .

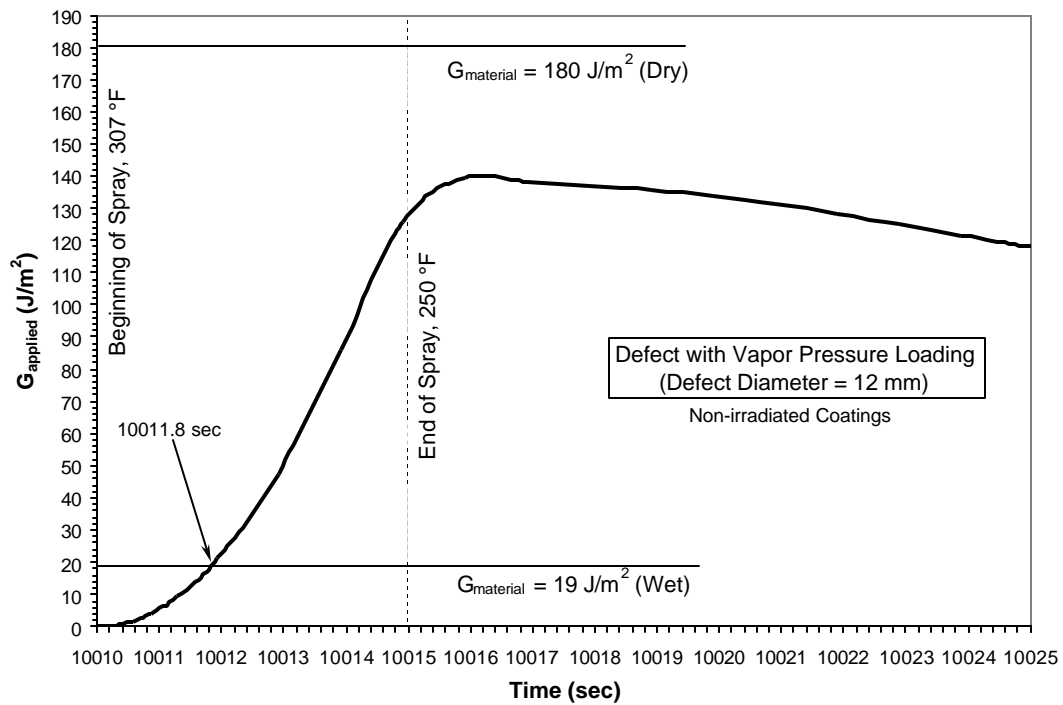
Figure 3-16. Applied G-Values at the Edge of a Vapor Pressurized Defect (Diameter 12 mm) during Cooling Phase in DBA Test (Linear Time Scale).

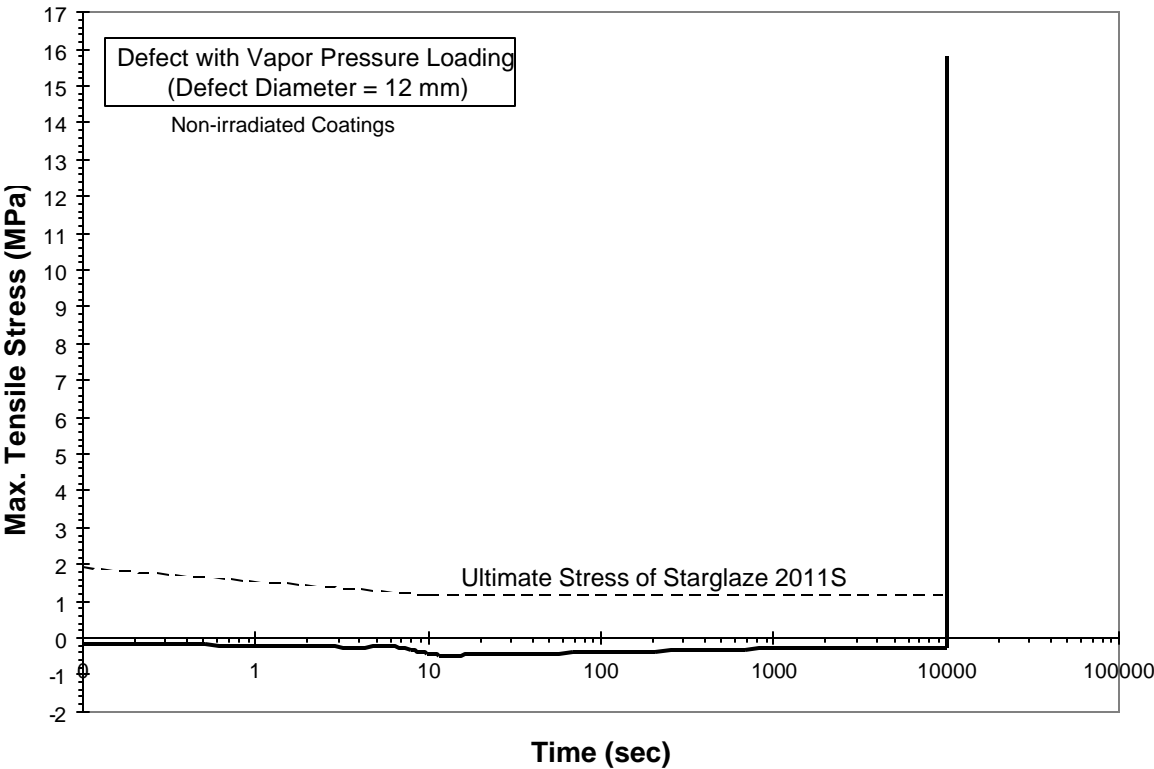
Figure 3-17. Failure of Mode 1 Defects based on Peak Tensile Stress Criterion (Entire Time History with Logarithmic Time Scale).

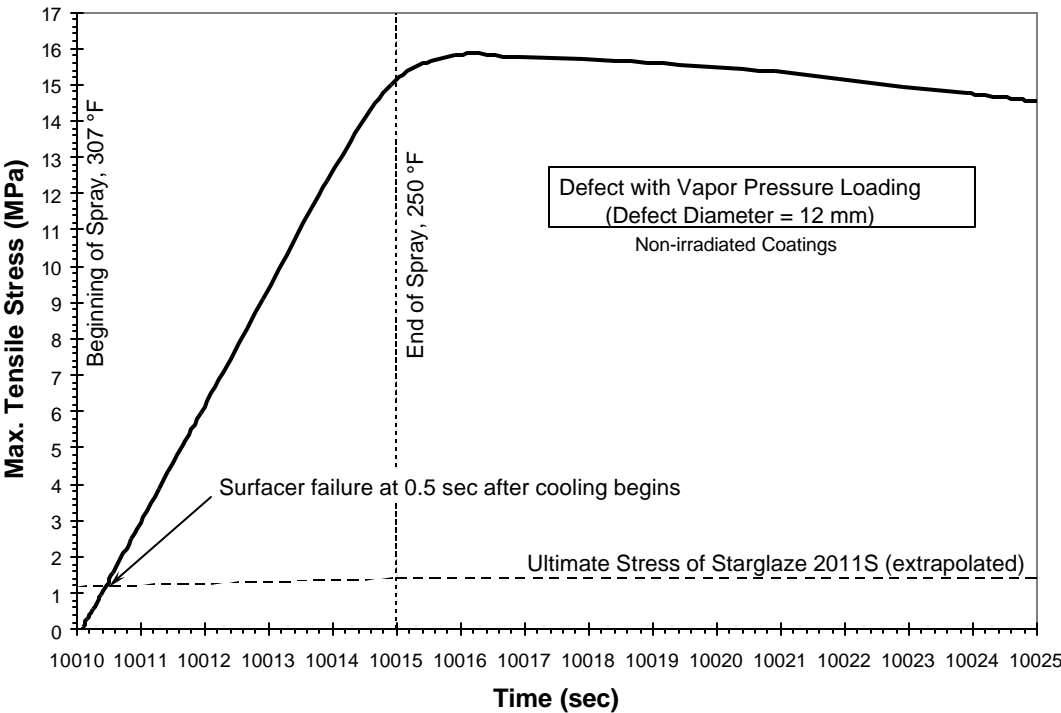
Figure 3-18. Failure of Mode 1 Defects based on Peak Tensile Stress Criterion

(Cool-down Phase with Linear Time Scale).

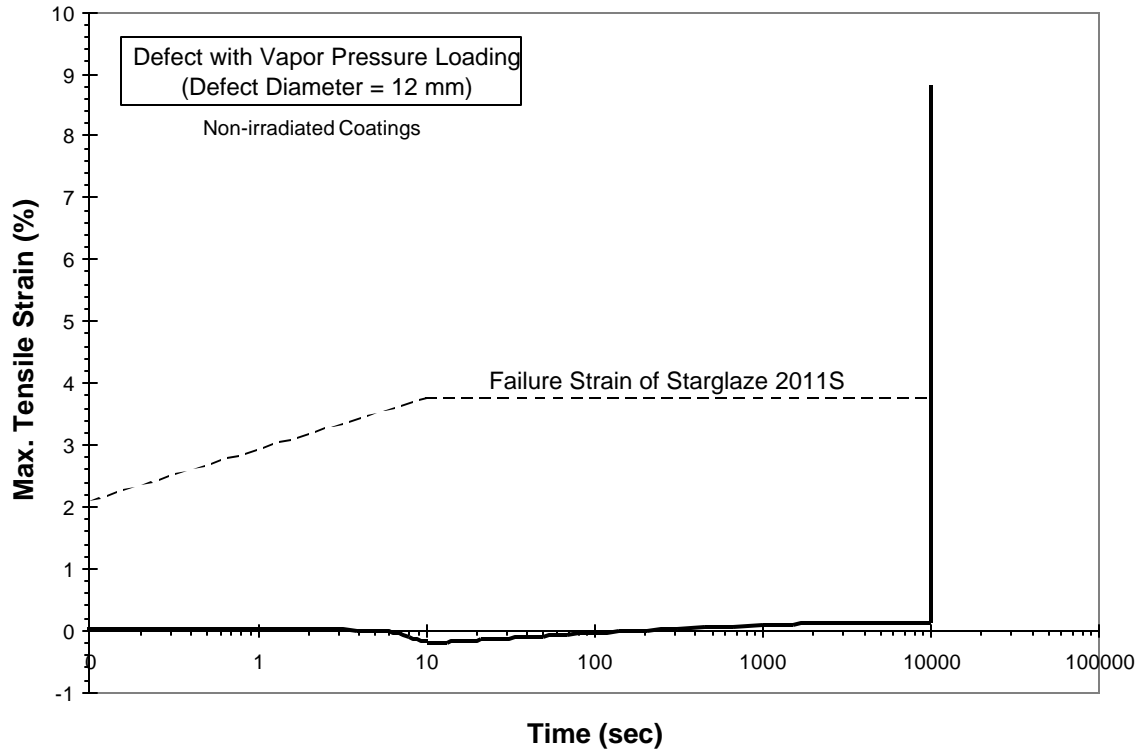
Figure 3-19. Failure of Mode 1 Defects based on Failure Strain Criterion
(Entire Time History with Logarithmic Time Scale).

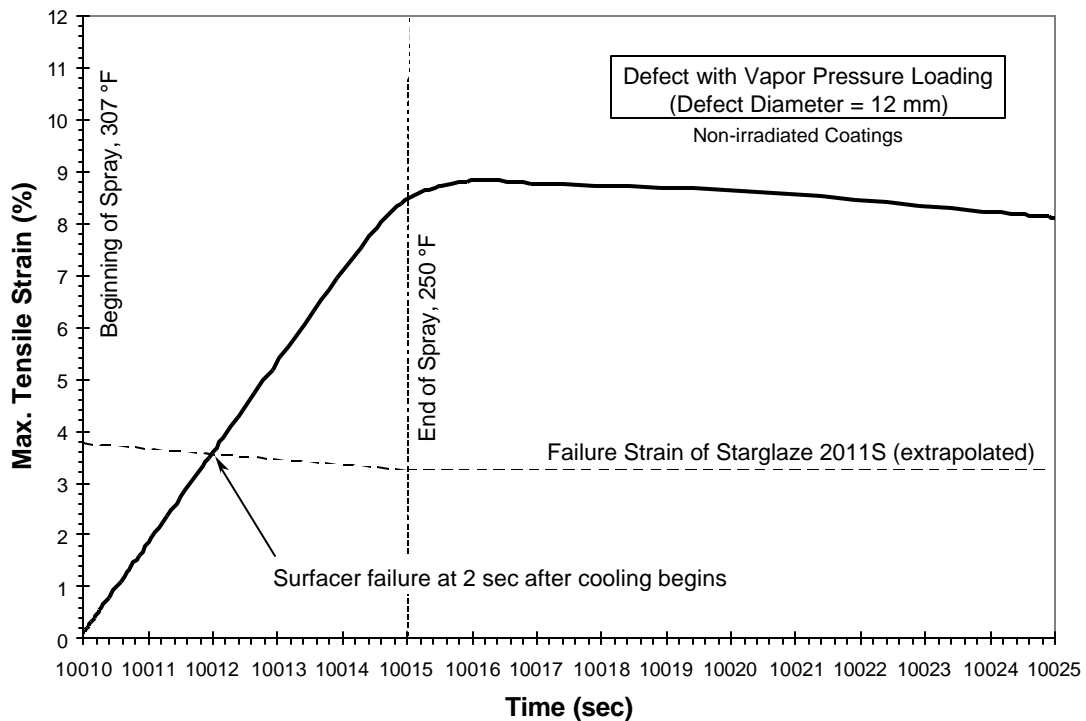
Figure 3-20. Failure of Mode 1 Defects based on Failure Strain Criterion

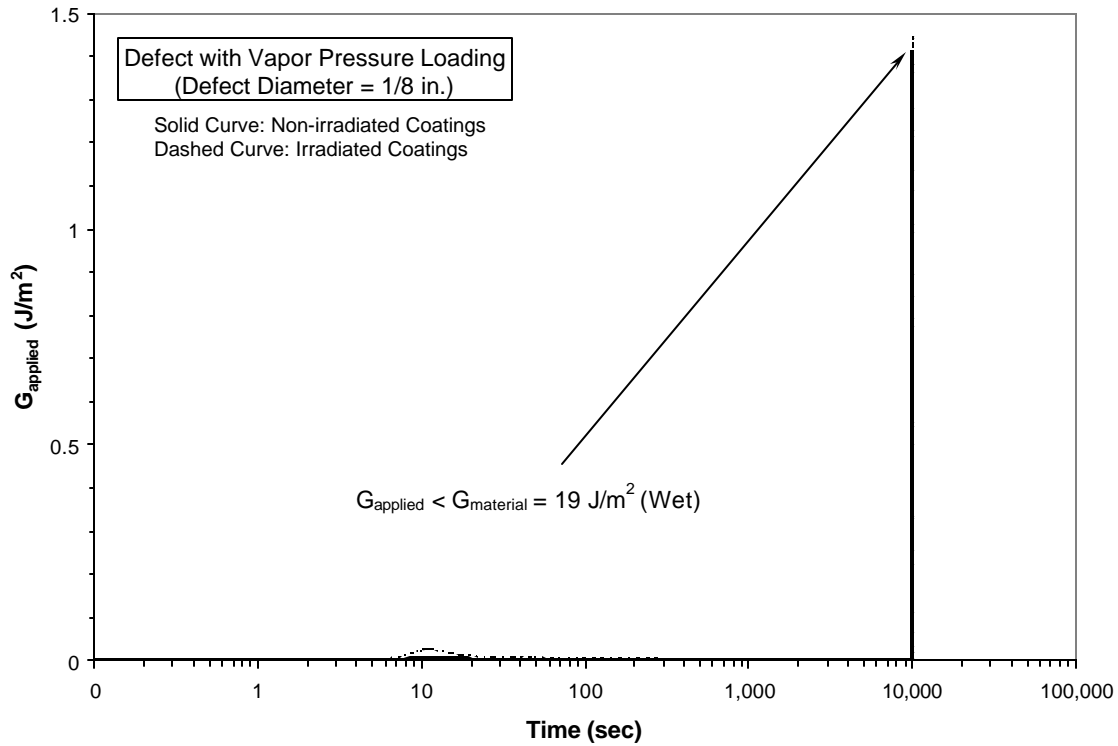
Figure 3-21. Applied G-Values at the Edge of a Vapor Pressurized Defect (Diameter 1/8 in.) during DBA Test (Logarithmic Time Scale).

The same analysis was performed with a smaller defect (diameter 1/8 in.) which is subject to water vapor pressure loading. Figures 3-21 to 3-26 show that this defect remains stable during DBA testing, regardless which failure criterion is applied (material G value, ultimate stress, or failure strain criterion).

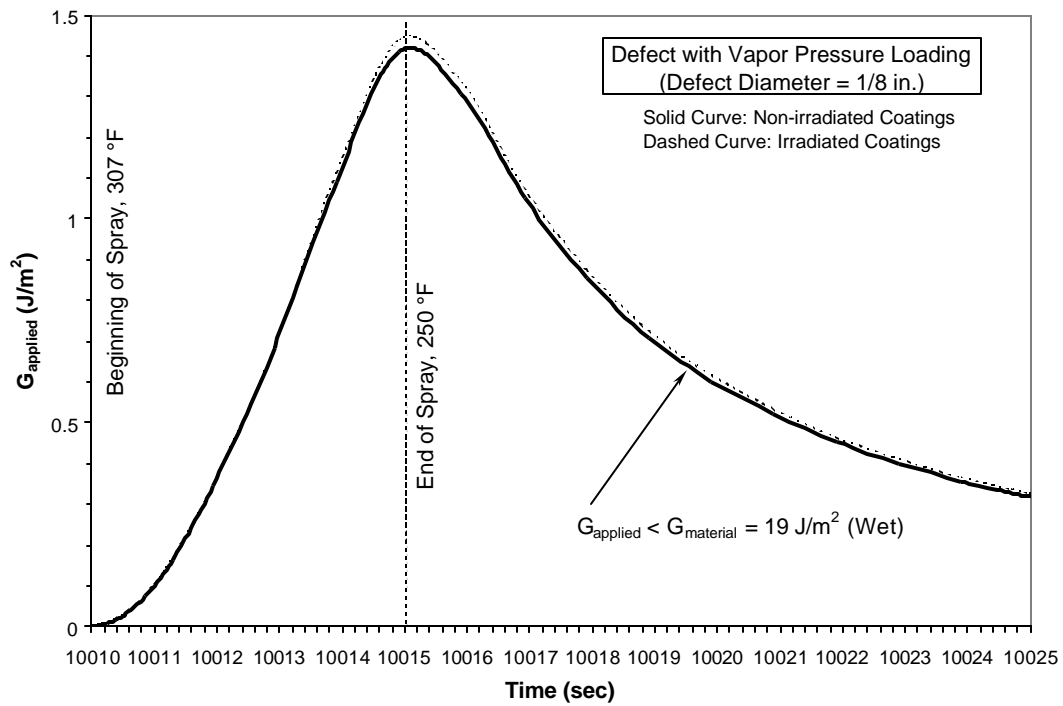
Figure 3-22. Applied G-Values at the Edge of a Vapor Pressurized Defect (Diameter 1/8 in.) during Cool-down Phase in DBA Test (Linear Time Scale).

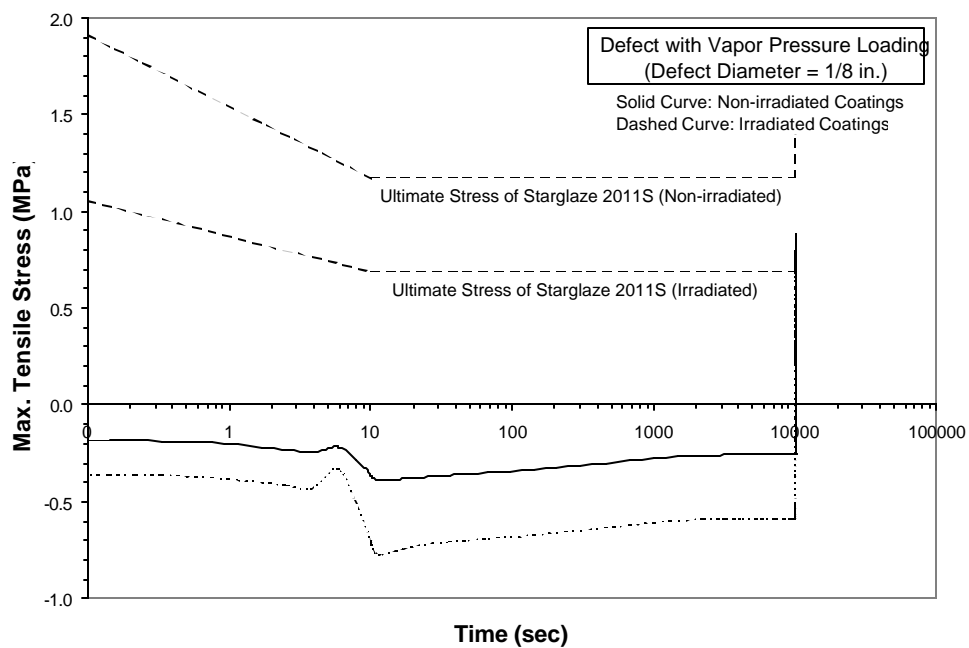
Figure 3-23. Failure of a Vapor Pressurized Mode 1 Defects (Diameter 1/8 in.) based on Peak Tensile Stress Criterion (Entire Time History with Logarithmic Time Scale).

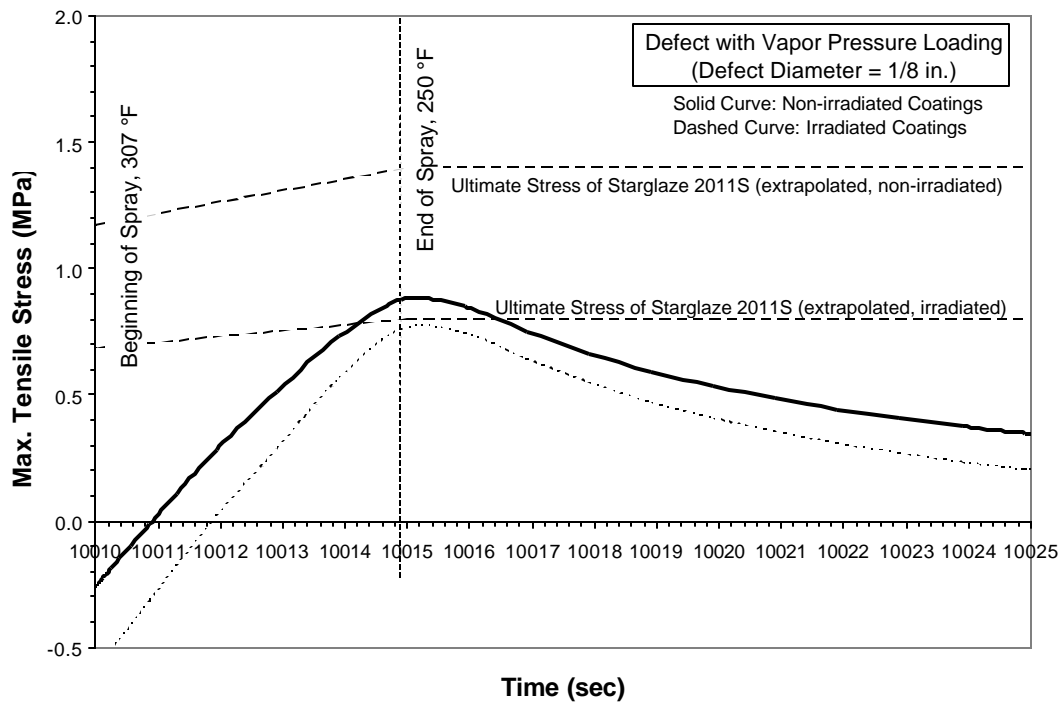
Figure 3-24. Failure of a Vapor Pressurized Mode 1 Defects (Diameter 1/8 in.) based on Peak Tensile Stress Criterion
(Cool-down Phase with Linear Time Scale).

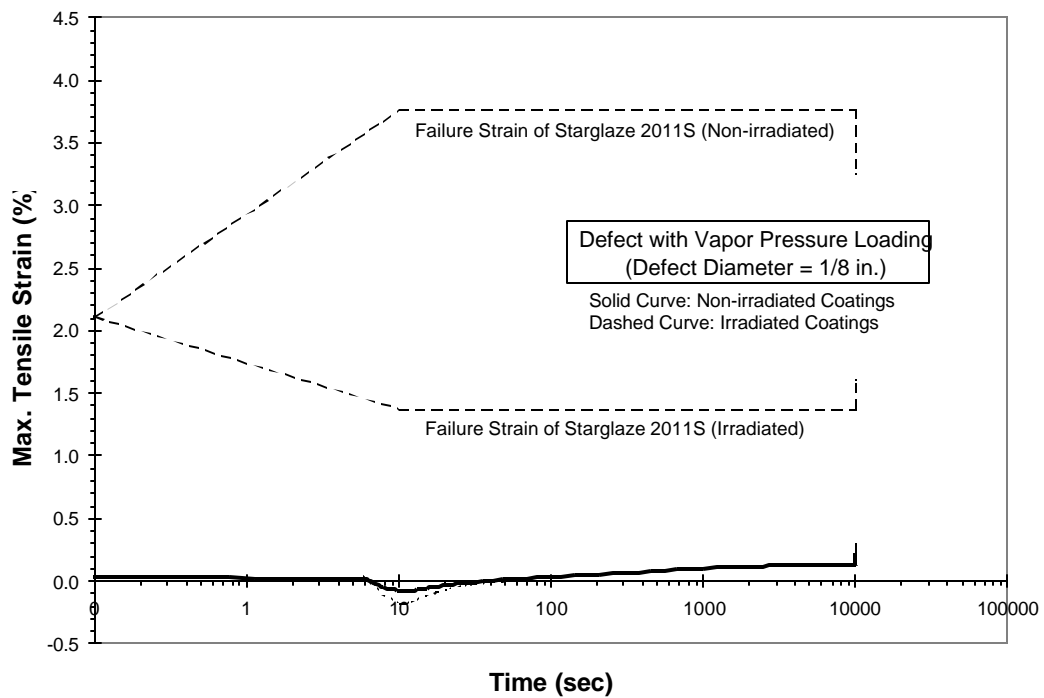
Figure 3-25. Failure of a Vapor Pressurized Mode 1 Defects (Diameter 1/8 in.) based on Failure Strain Criterion
(Entire Time History with Logarithmic Time Scale).

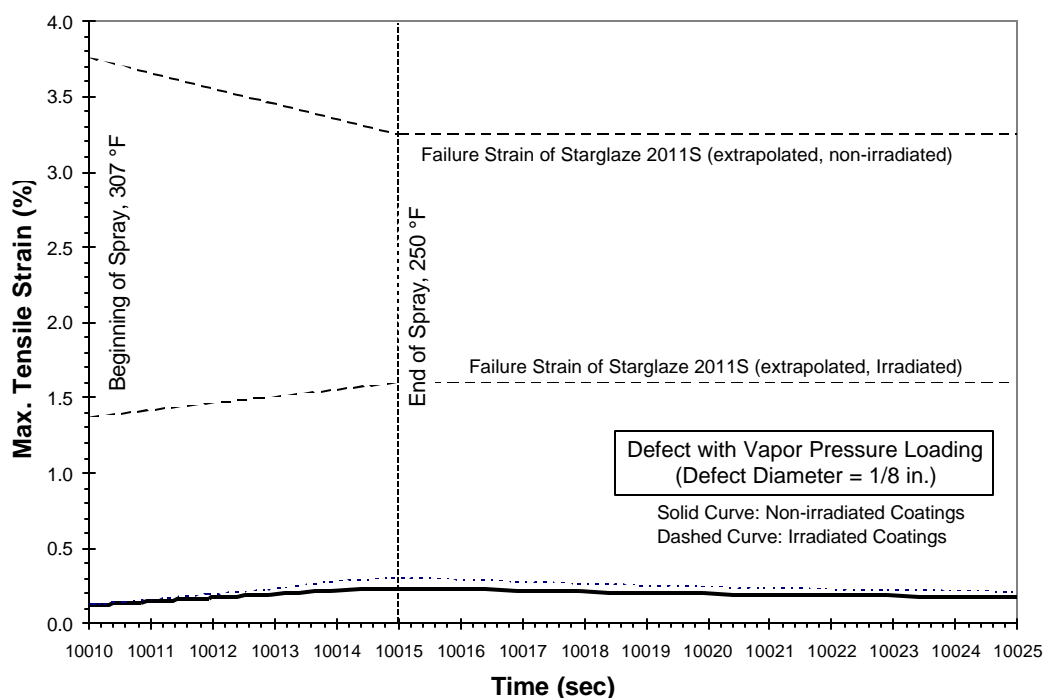
Figure 3-26. Failure of a Vapor Pressurized Mode 1 Defects (Diameter 1/8 in.) based on Failure Strain Criterion (Cool-down Phase with Linear Time Scale).

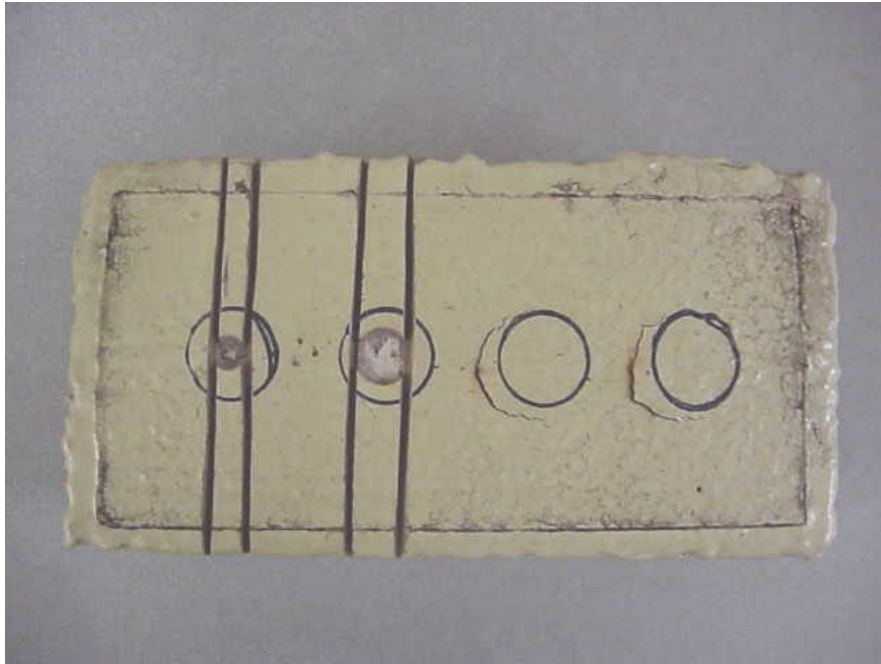
Figure 3-27. System 2 specimen, non-aged, following DBA testing. Note the circumferential cracks in the coating adjacent to the two Type 1 defects on the right. No evidence of coating peel-back was observed in the Type 2 defects on the left.

As a result, the cracking failure due to the peak stress criterion appears to occur first. The Type 1 specimen was predicted to fail by cracking in the defect edge when moisture is present. This is consistent with the laboratory observations shown in Figures 3-27 and 3-28.
