**Degradation and Failure Characteristics of
NPP Containment Protective Coating Systems
Interim Report No. 2**

SRTC Coating System No. 2

(Phenoline[®] 305 epoxy-phenolic topcoat, Starglaze[®] 2011S surfacer, concrete substrate)

M. E. Dupont, N. C. Iyer, P. S. Lam, R. L. Sindelar,
T. E. Skidmore, F. R. Utsch, and P. E. Zapp
Savannah River Technology Center
Westinghouse Savannah River Company
Aiken, SC 29808

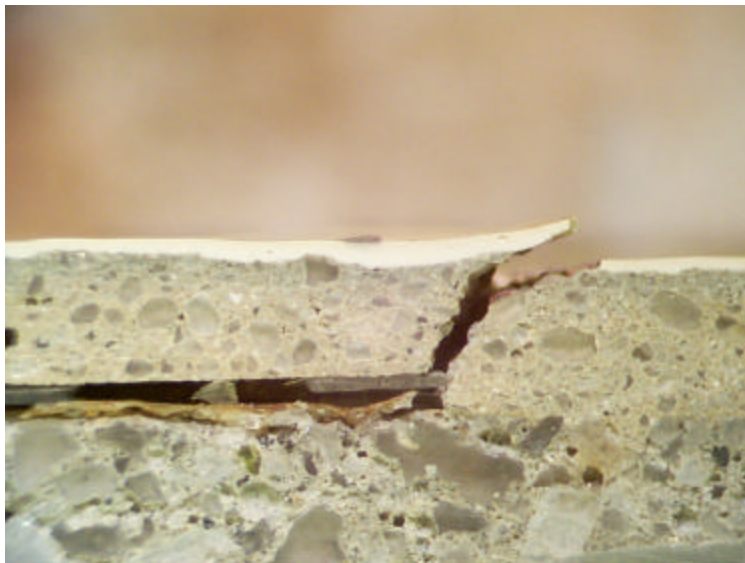
Figure 3-28. Cross-section of circumferential crack in System 2 specimen (Fig. 3-26) illustrating the location of coating failure at the edge of the glass disk used to create the Type 1 defect.

As a result, the cracking failure due to the peak stress criterion appears to occur first. The Type 1 specimen was predicted to fail by cracking in the defect edge when moisture is present. This is consistent with the laboratory observations shown in Figures 3-27 and 3-28.

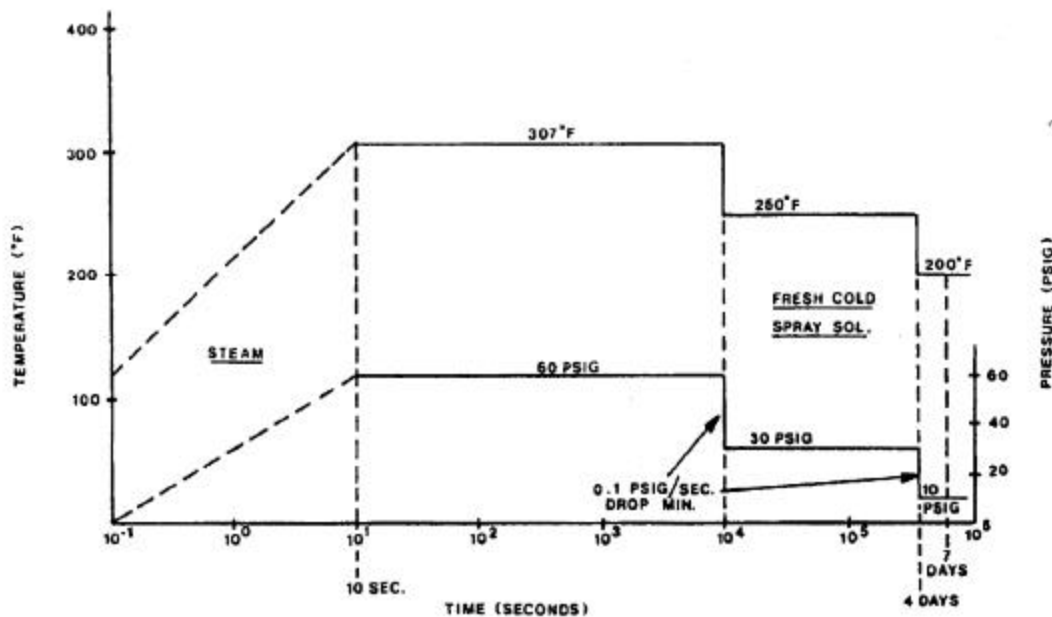
Figure 3-29. Typical Pressurized Water Reactor Design Basis Accident (DBA) Testing Parameters (from ASTM D3911-95). (Note: The ASTM figure contains an error: 30 psig should be 15 psig, which is equivalent to 30 psia).

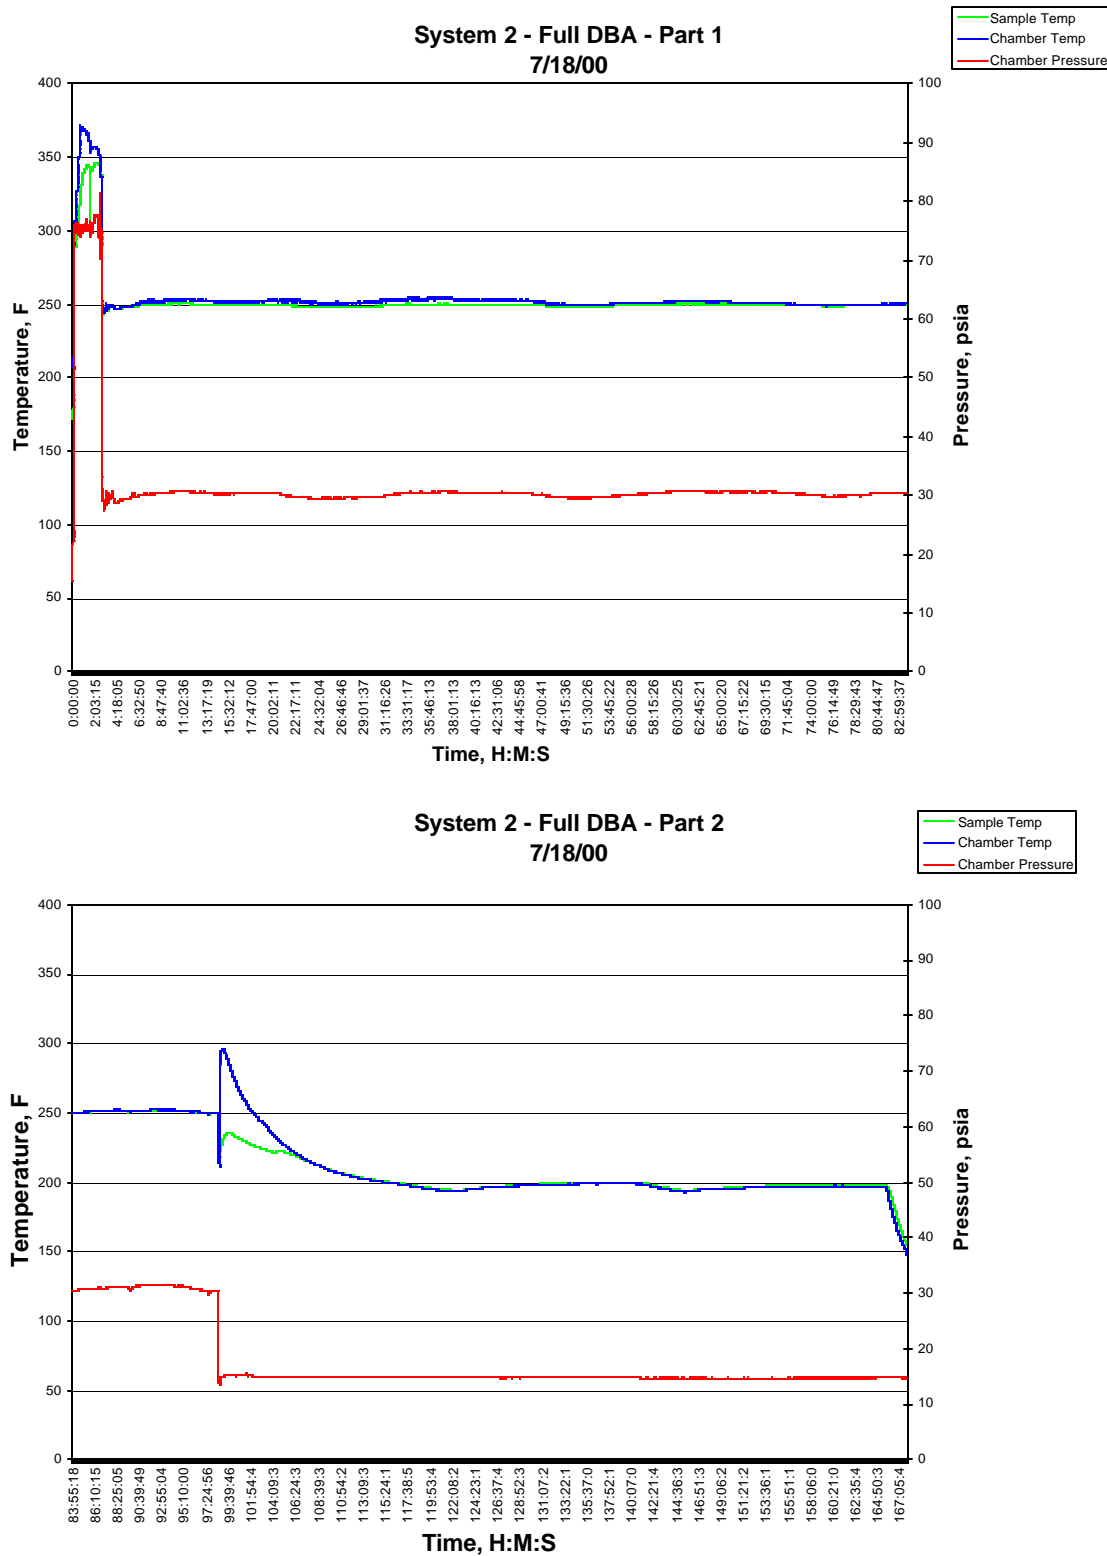
Figure 3-30. Typical Temperature-pressure Profile from SRTC System 2 D3911 DBA-LOCA Test.

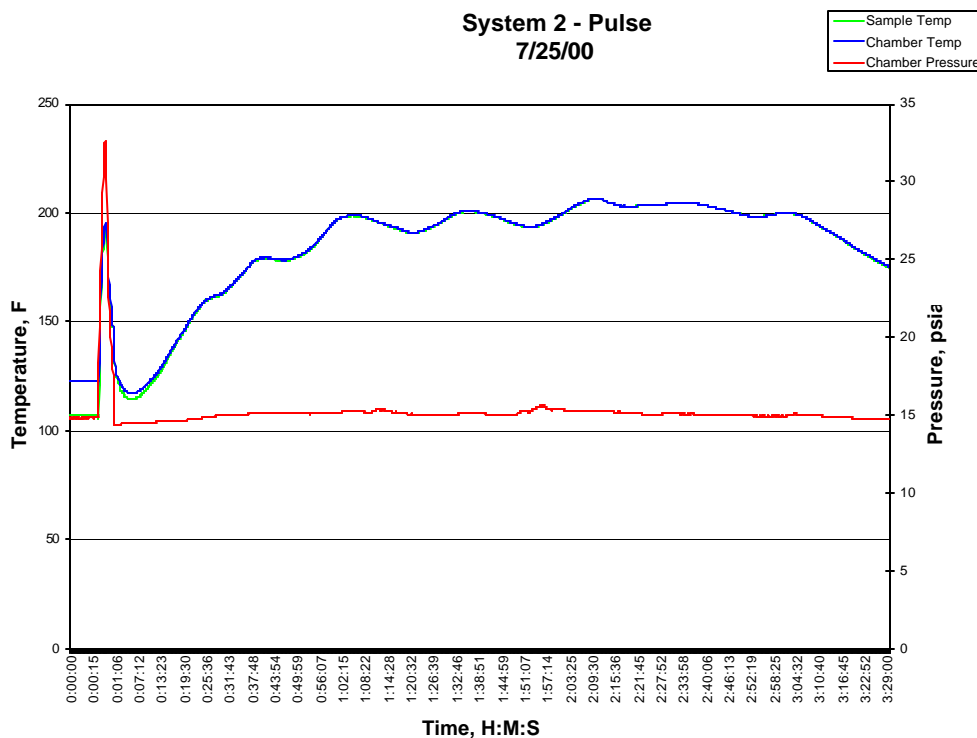
Figure 3-31. Temperature-Pressure Curves from Plant-specific LOCA Test

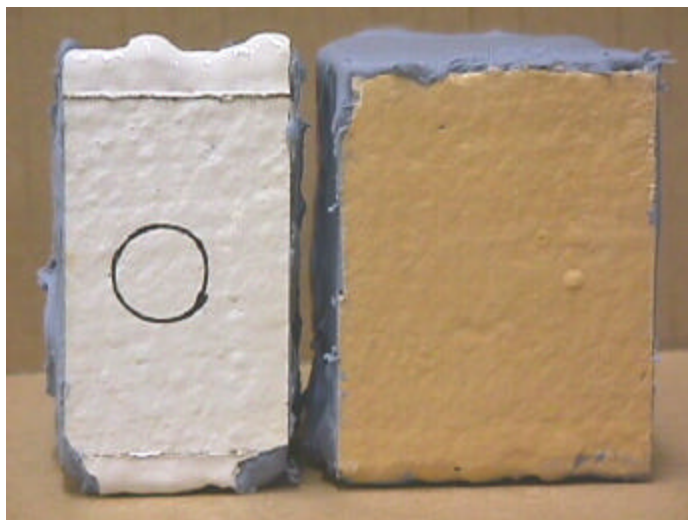
Figure 3-32. System 2 specimens before (left) and after (right) irradiation to 10^9 rad

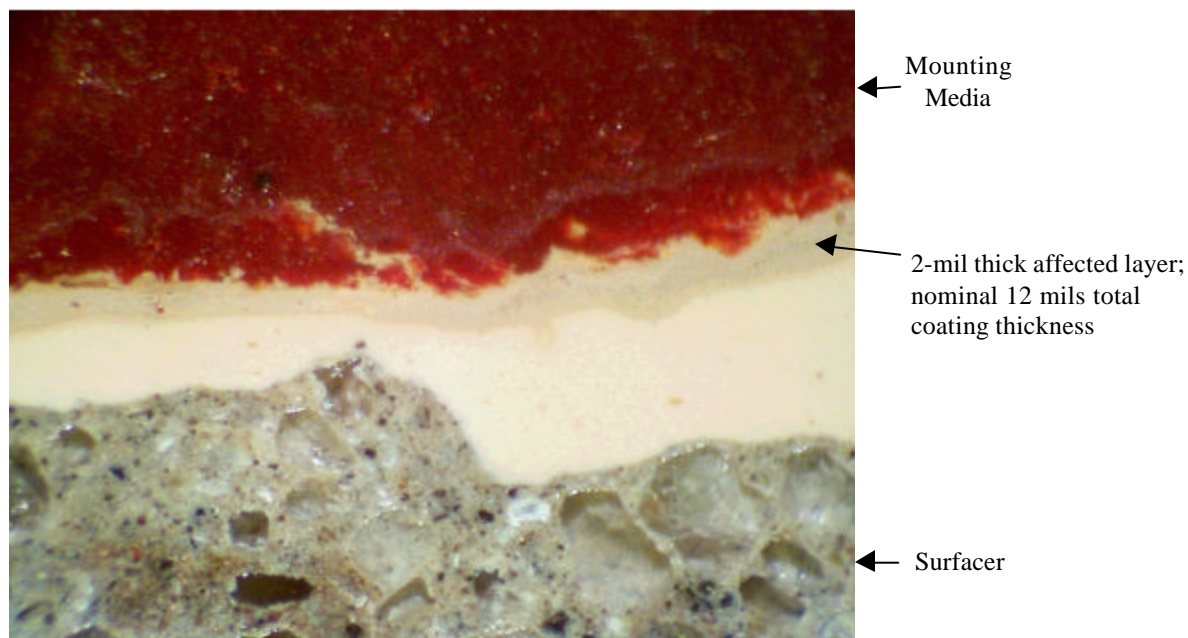
Figure 3-33. Cross-section of System 2 coating, irradiated to 10^9 rad, original magnification 30X.

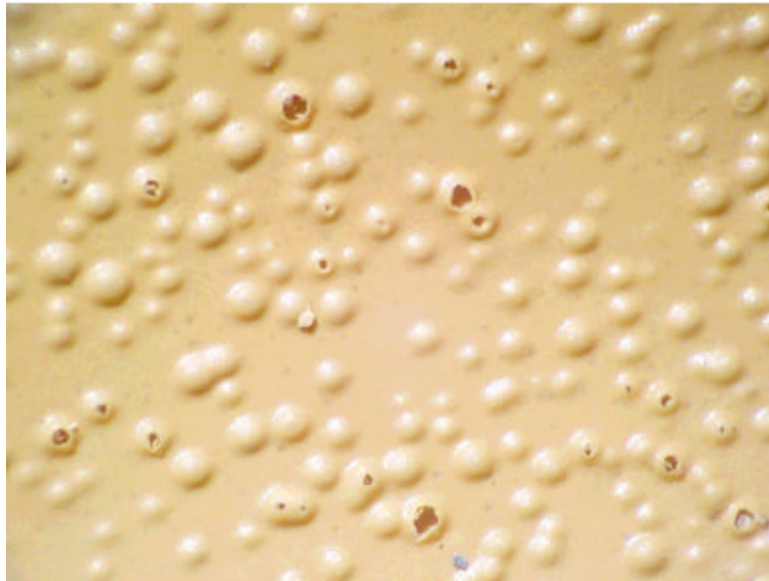
Figure 3-34 Micrograph of blistering formed on Phenoline[®] 305 free-film specimen following irradiation and heating to 200°F, dry; original magnification approximately 20x.

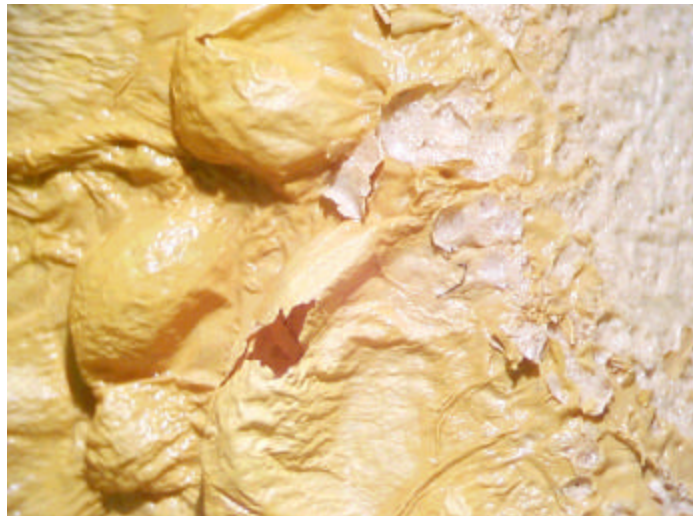
Figure 3-35 Sloughing of surface of irradiated specimen following water soak at 200°F, original magnification 7X. Blister thickness is of the order of 1-2 mils. Note: The remaining coating is visible in the upper-right of the image.

Aged System 2 specimens exhibited blistering after having been exposed to elevated temperature in air or in water (Figures 3-34 and 3-56). Similar blistering was observed during the testing of SRTC System 5 coatings. Numerous small blisters appeared in free-film specimens when they were heated in air to 200°F during tensile testing (Figure 3-34). The blisters were approximately 1mm in diameter and remained intact. Much larger blisters appeared when coated concrete specimens were heated to 200°F in tap water (Figure 3-35). The blisters which were formed are quite thin compared to the nominal 12 mil coating thickness, and are quite fragile when dry. The thickness of the coating layer forming the blister is only about 0.001 inch (1 mil). The thickness of the blisters indicates they are formed in the darkened, ostensibly oxygen affected, outer layer of the irradiated coating.

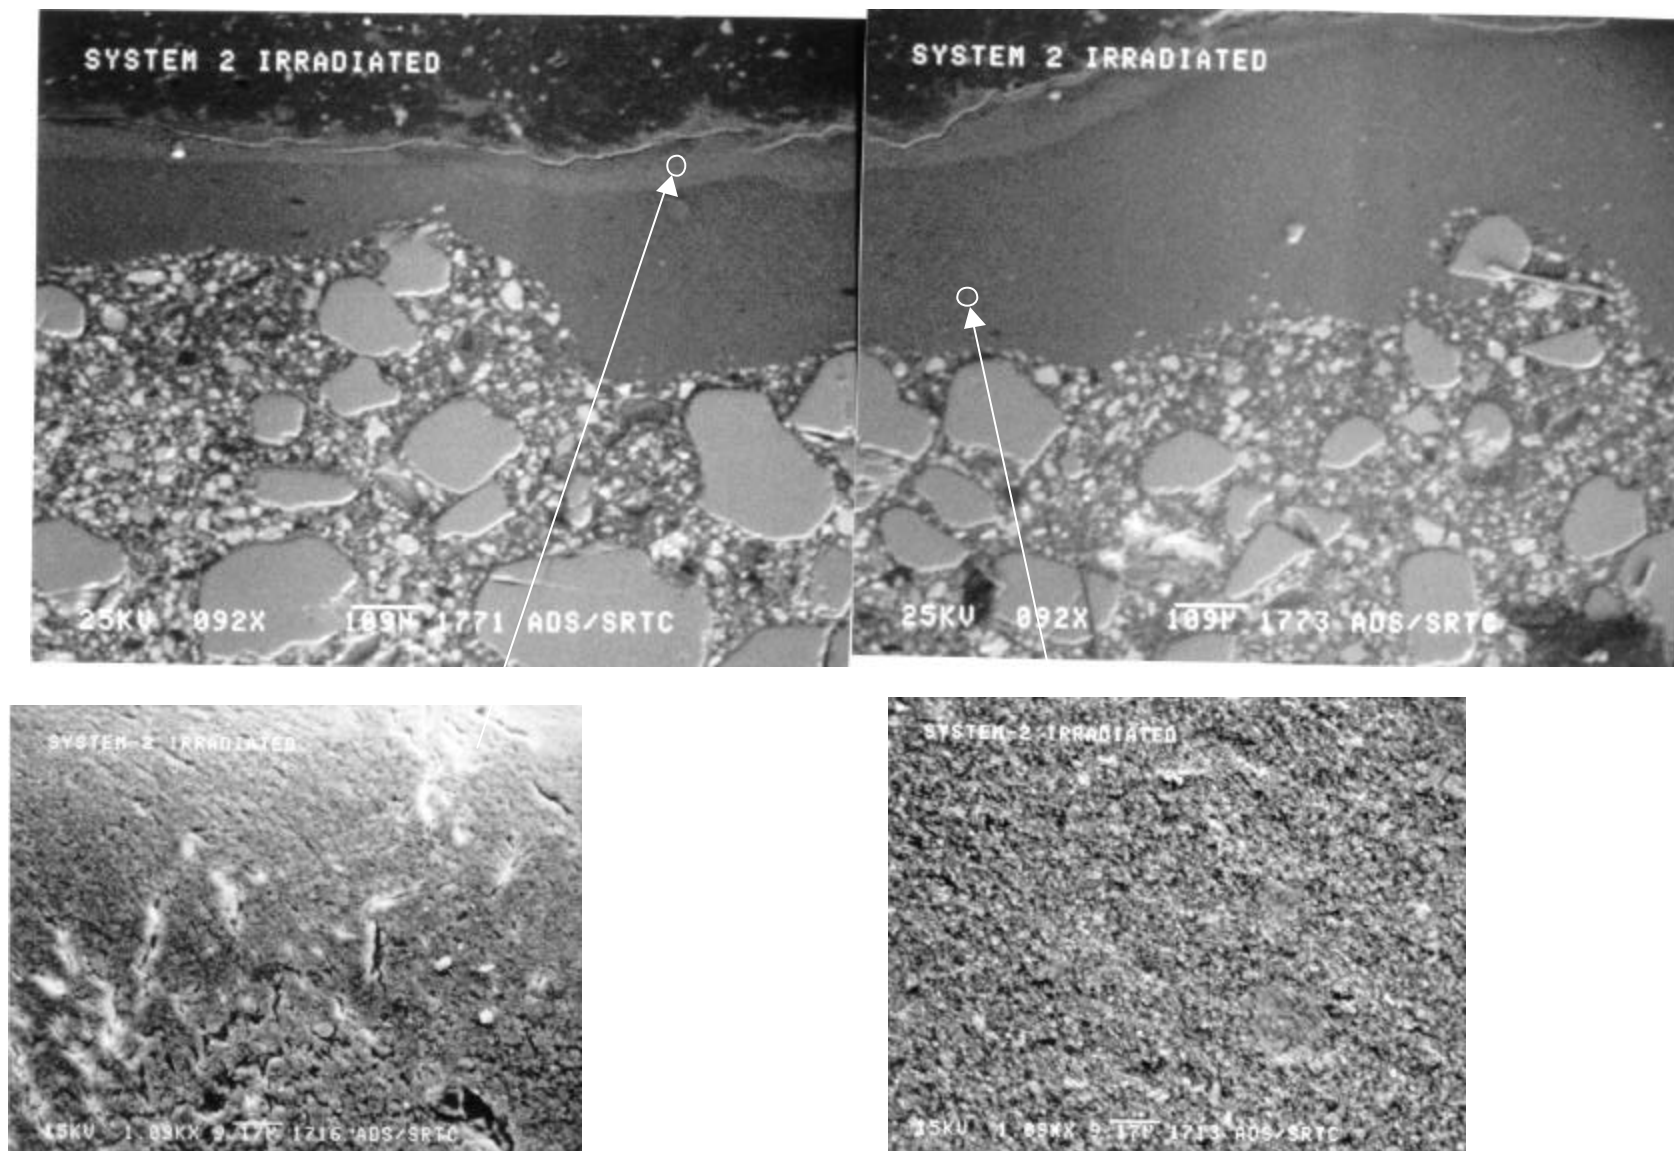
Figure 3-36. SEM micrographs illustrating the appearance of the outermost layer (left) and the bulk Phenoline[®] 305 coating (right) of irradiated System 2. This is the same specimen shown in Figure 3-33.

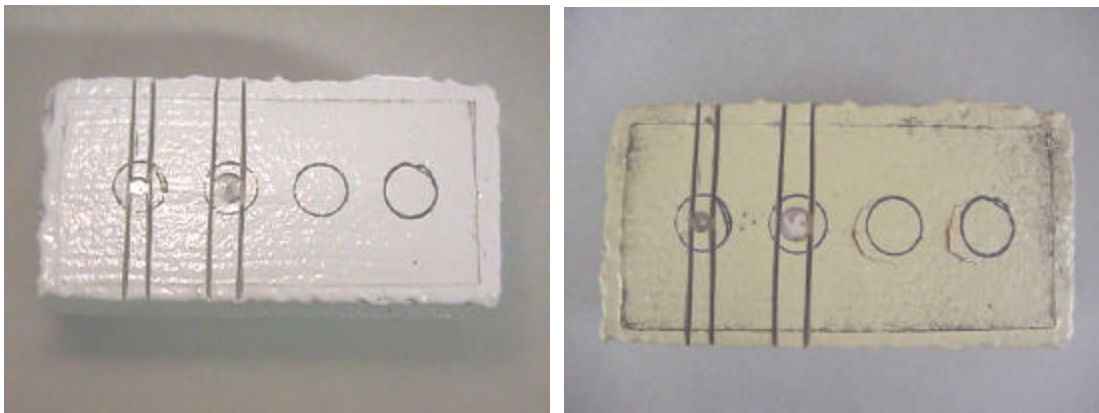
Figure 3-37. Overall views of nonaged System 2 specimens before (left) and after DBA testing. Note coating color change and circumferential cracks adjacent to Type 1 defects which are present following testing.

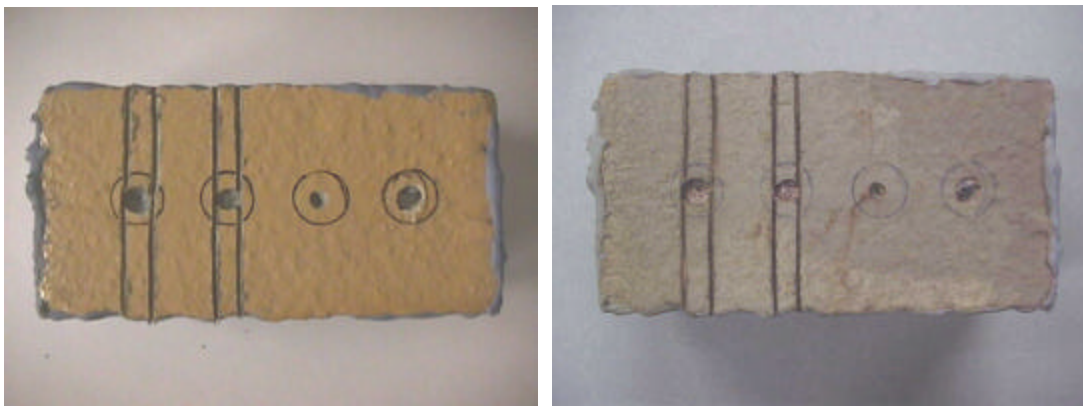
Figure 3-38. Overall views of irradiation-aged System 2 specimens before (left) and after DBA testing.

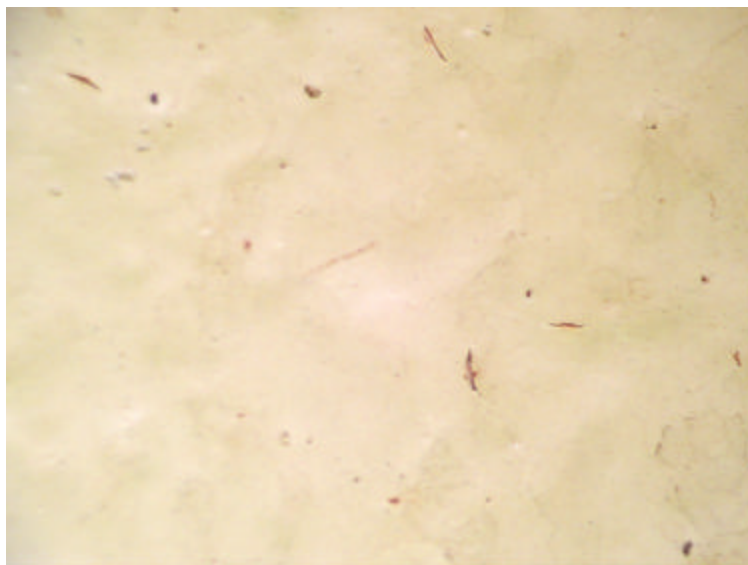
Figure 3-39. Detail of the surface of the non-aged specimen after DBA testing. Note the presence of minor cracks in the coating, as discussed in Section 3.2.2. Original magnification 7X. A cross-section view of these cracks is shown in Figure 3-12.

As discussed in Section 3.3, cracking was observed in the topcoat, with the cracks through the topcoat thickness to the surfacer (see Figures 3-13 and 3-39). This would be expected if local stress intensifiers (e.g., thin spots and/or micro-cracks at the topcoat/surfacer interface) were present in the topcoat. Minor cracks in the topcoat were observed from both the full DBA and "plant-specific" DBA exposures.

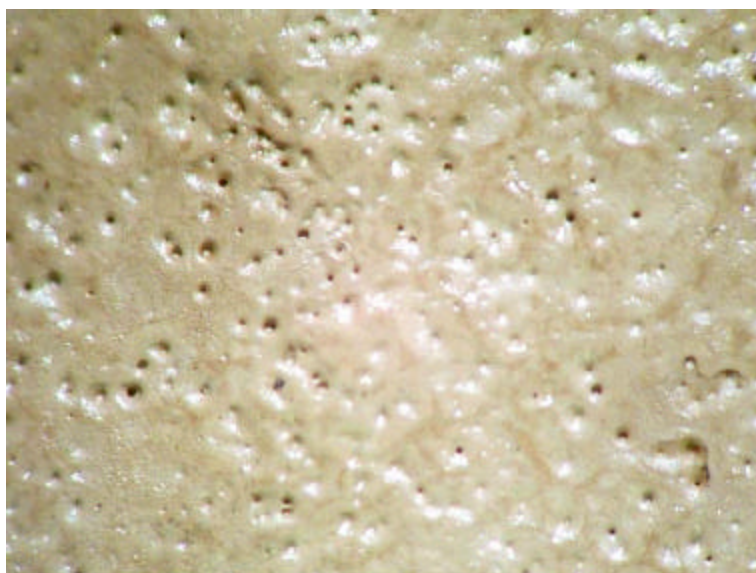
Figure 3-40. Detail of the surface of the irradiation aged specimen after DBA testing. Note the presence of pores in the coating. Original magnification 7X

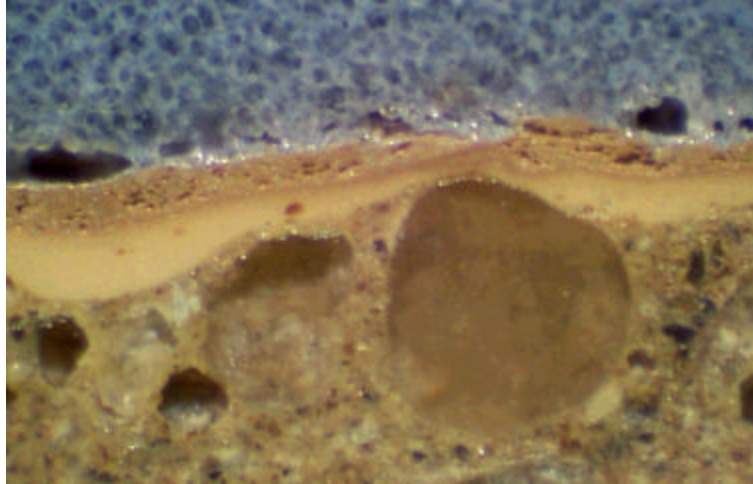
Figure 3-41. Cross-section of the surface of the irradiation aged specimen after DBA testing. Note the presence of pores in the coating. Original magnification 45X

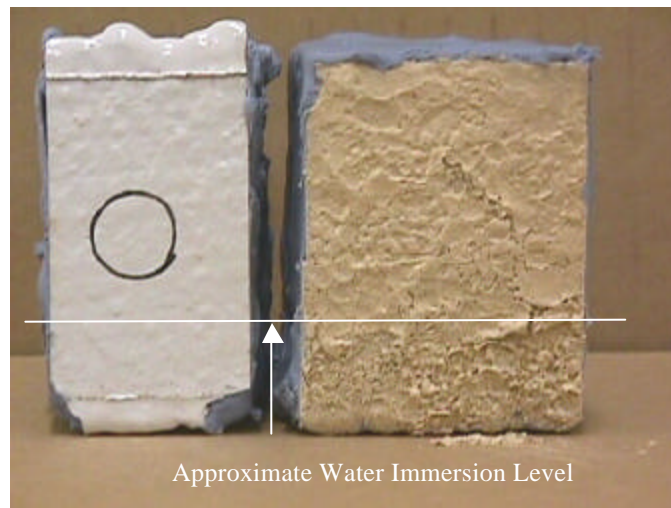
Figure 3-42. System 2 non-aged (left) and irradiation aged (right) specimens following DBA pulse-test. Note blister formation in the near-surface, oxidized layer of the irradiated specimen. Note also the presence of debris powder beneath the irradiated specimen. The bottom portions of both specimens were allowed to become immersed during the water spray portion of the pulse test.

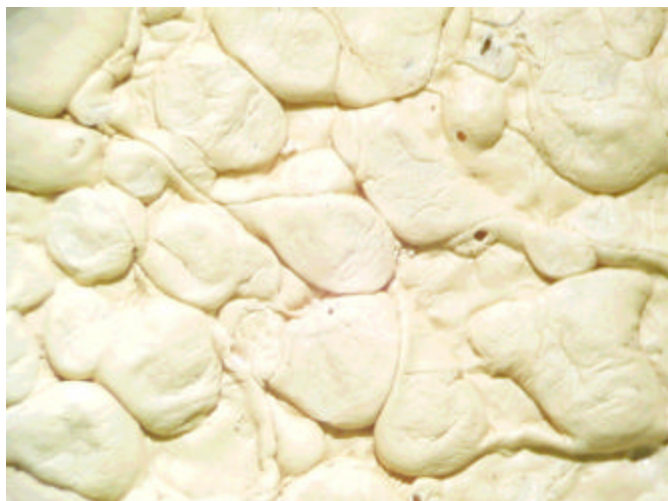
Figure 3-43. Detail of irradiation-aged specimen in Figure 3-42, taken above the water immersion level, illustrating extensive blister formation. Original magnification 7X.

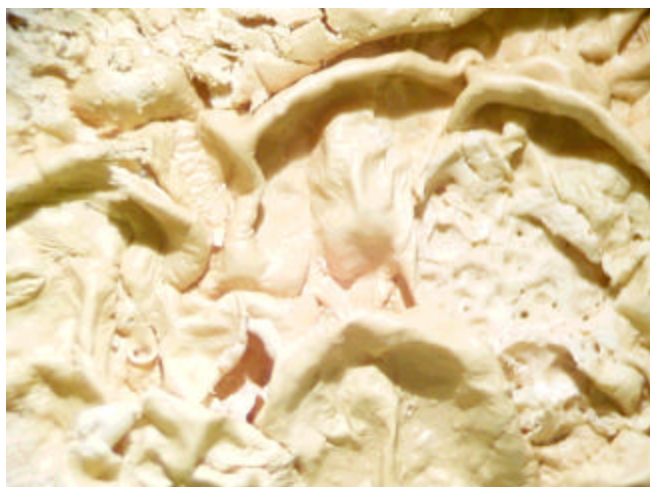
Figure 3-44. Detail of irradiation-aged specimen in Figure 3-42 taken below the water immersion level. The blisters are of a larger size than those in Figure 3-43, and some of the blisters have ruptured and/or detached, revealing the underlying coating remnant. Original magnification 7X.

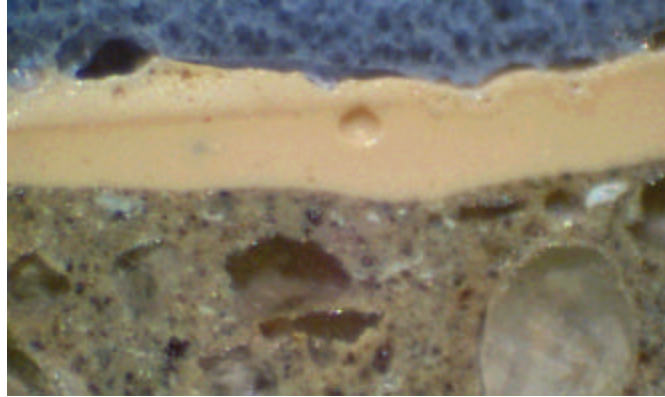
Figure 3-45. Cross-section of irradiation-aged specimen in Figure 3-42, taken from above the water immersion line. Note the presence of pores in the topcoat remnant. Original magnification 45X

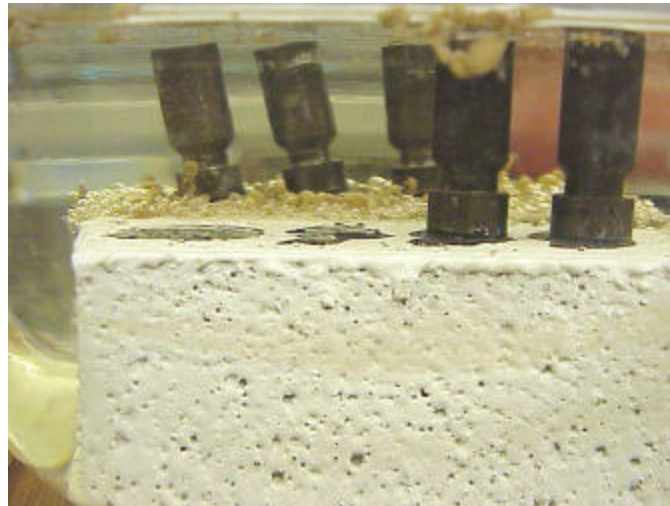
Figure 3-46. Overall view of non-irradiated System 2 specimen, submerged overnight in 200° F water

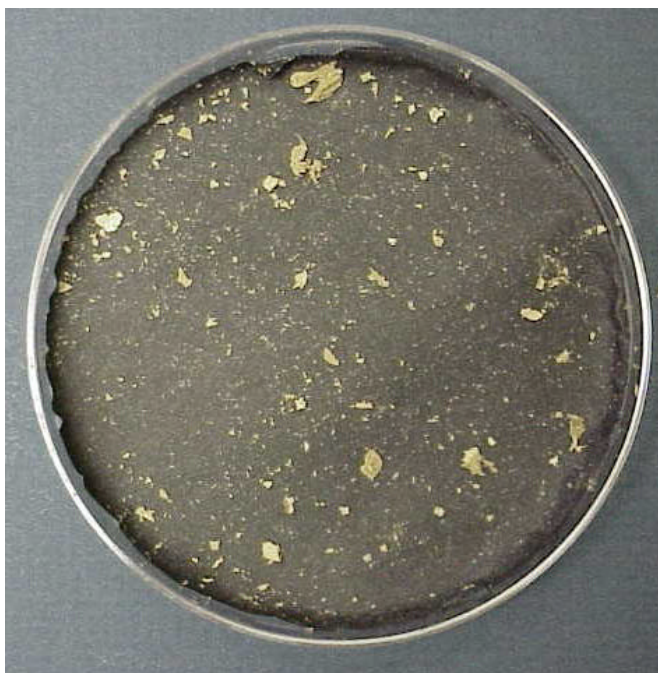
Figure 3-50. Overall view of some of the debris removed from the vessel used to soak the specimens

Image analysis techniques may be used to characterize coating debris. Figures 3-50 through 3-52 show images of the System 2 coating debris at increasing magnification. Some of this debris was collected onto 20-micron filter paper for characterization of the larger particles. Particles smaller than approximately 0.1 cm in size were deliberately omitted in this analysis, due to limitations in optical imagery.

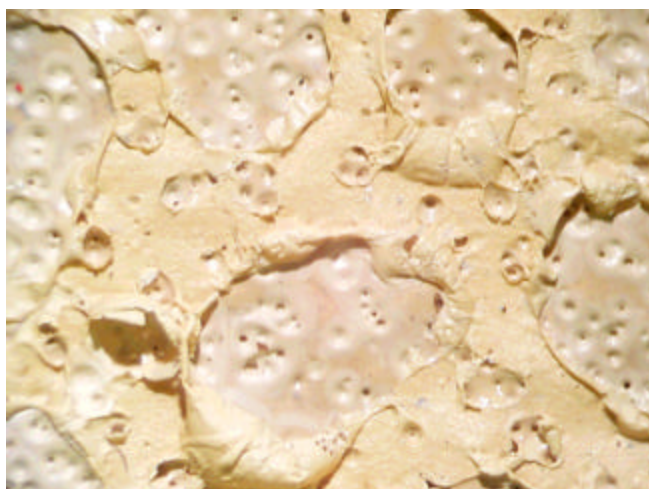
Figure 3-53. Detail of the surface of the irradiation-aged immersion test specimen illustrating the extent of blister formation and detachment. Note the presence of pores in the topcoat remnant. Original magnification 7X.

The debris which is formed during immersion of the irradiation-aged coating consists of thin blisters which form in the outermost layer of the topcoat (Figure 3-55), and then break free due to the buoyancy of the gas they contain. Therefore, the surface area of these blisters is significantly larger than the surface area of the coating from which they arise, due to the ductility of the wet coating (Figures 3-51 – 3-53).

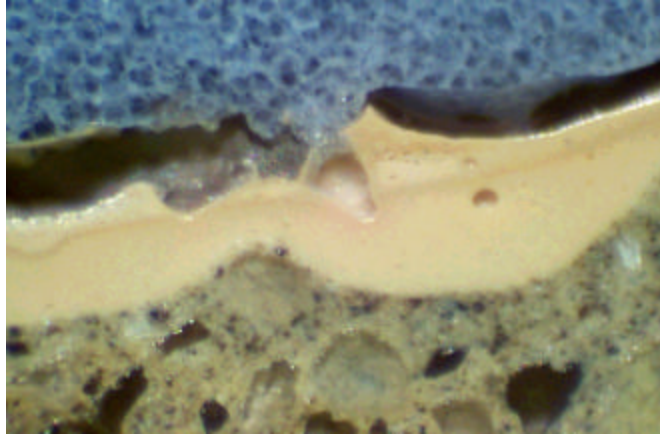
Figure 3-54. Cross-section of the surface of the irradiation-aged soak test specimen. Note the presence of pores in the topcoat remnant. Original magnification 45X.

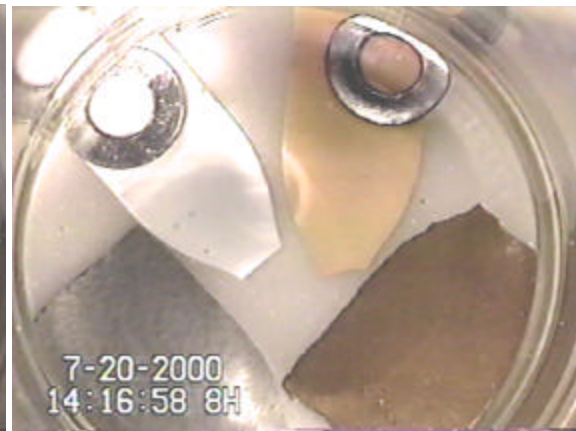
Figure 3-55b

Figures 3-55 a-d. Effect of Temperature on Blister Development for Non-irradiated and Irradiated Phenoline[®] 305 and Starglaze[®] 2011S in Water Immersion. The top row in each photograph, left to right, is non-irradiated and irradiated Phenoline[®] 305. The bottom row, left to right, is non-irradiated and irradiated Starglaze[®] 2011S. The test was begun at room temperature. Figure 'a' shows the starting condition. Figure 'b' shows the results after a soak at 150°F for 2 hours. Figure 'c' shows the results after a soak at 175°F for an additional 2 hours. Figure 'd' shows the results minutes after the water temperature approached 200°F. (Note: Clock time is shown in the bottom-left of each photograph in the series.)

The formation of blisters has been observed during immersion testing of coated specimens of both steel and concrete, and in every case, the blistering has been confined to the outermost layer of the topcoat. Therefore, water immersion testing was performed on free-film specimens of the topcoat and the underlying surfacer, in order to determine the origin of the gases responsible for the blistering. Observations made during free-film immersion testing (Figures 3-55 a – d) confirm that most or all of the gases which contribute to the formation of coating blisters, originate within the topcoat.

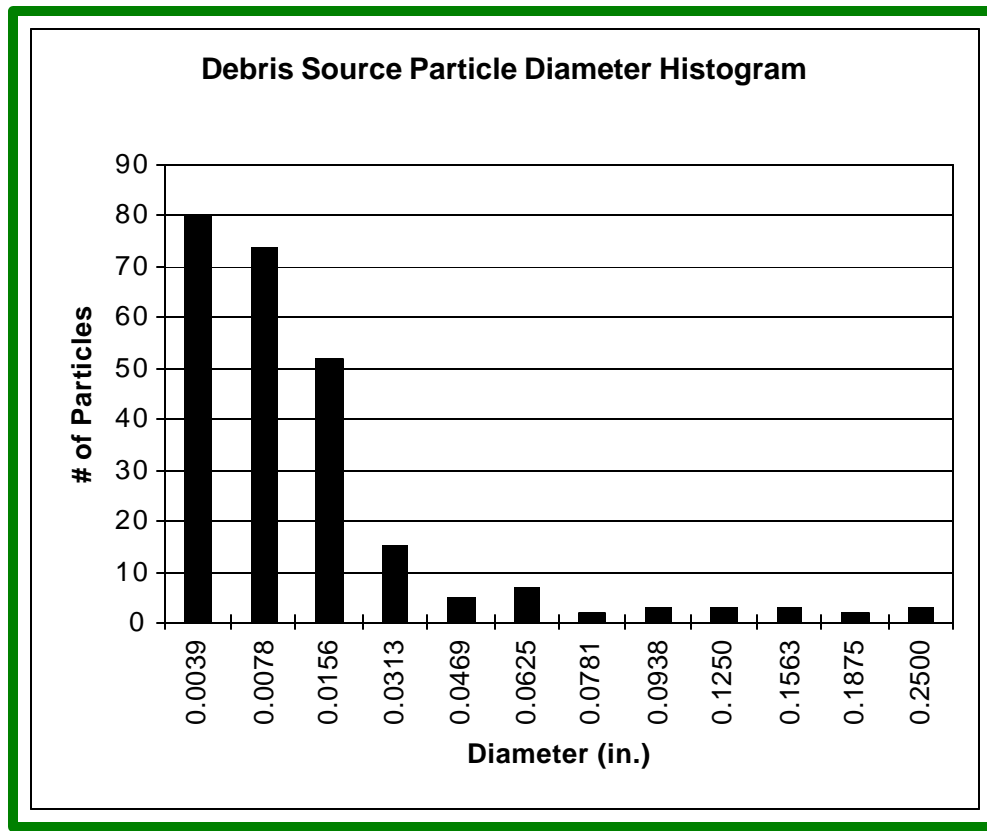
Figure 3-56. Frequency Histogram of Debris Size Distribution

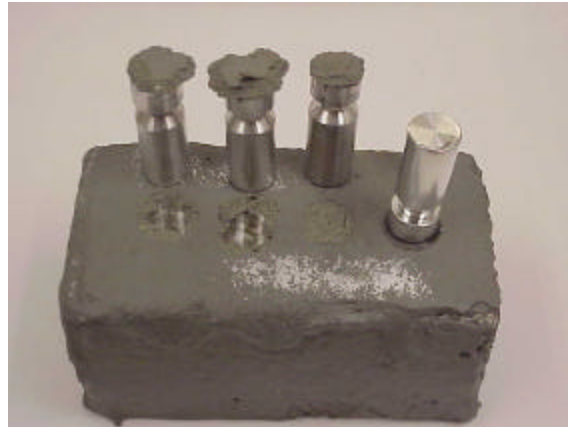
Figure A-1. Aluminum pullers as they appear affixed to a test coupon with epoxy adhesive, and after testing.

In these tests the displacement of the puller was measured with a single-arm extensometer that was mounted to contact the top of the puller. The extensometer was a Materials Testing Systems model number 632-06B-20 with a full-scale range of ± 0.160 in. and capable of operating to 300°F.

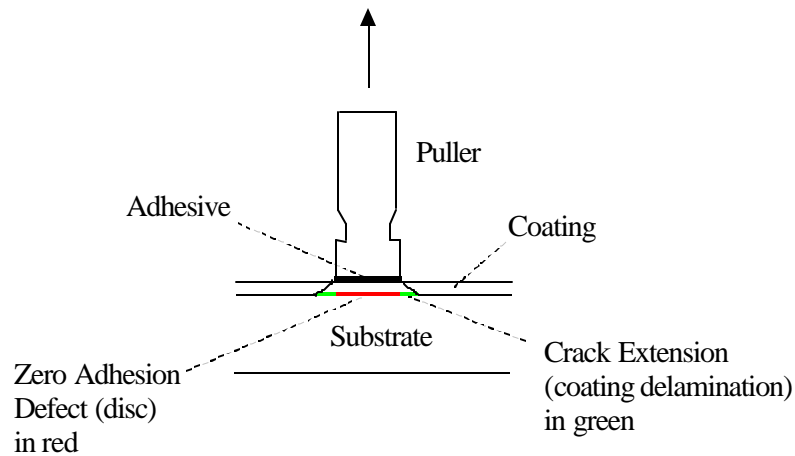
Figure A-5. Schematic diagram of the adhesion G-value test.

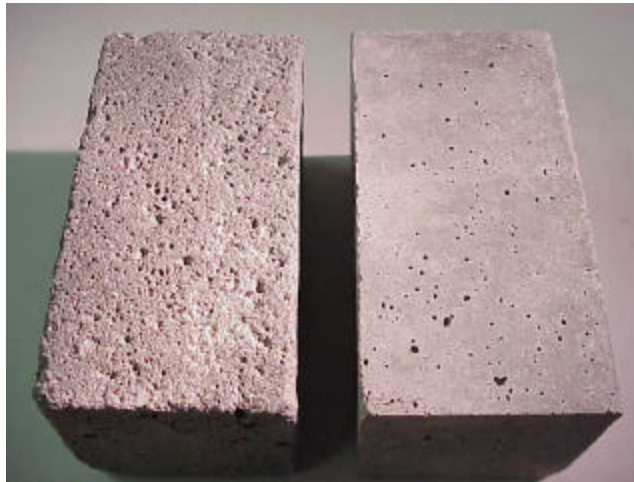
Figure A-7. Appearance of concrete blocks before (right) and after (left) preparation of surface.

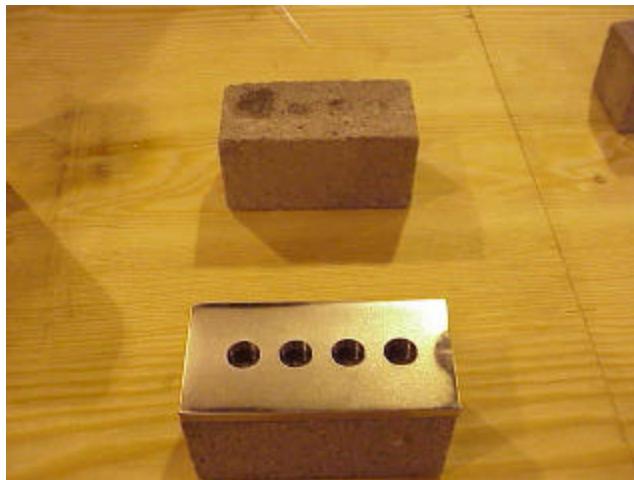
Figure A-8. Mask used to position 12 mm diameter glass disks prior to application of surfacer.

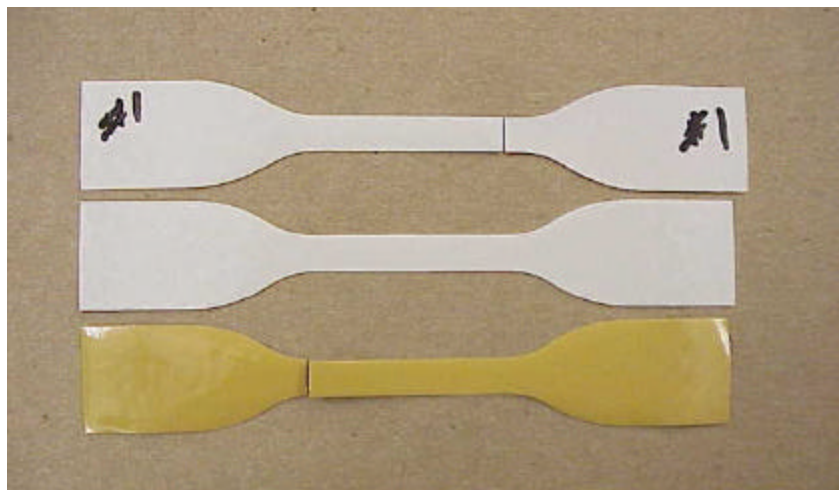
Figure A-9. Tensile specimens of Phenoline 3050, as cured (above) and irradiated and tested to failure (below). Note minor changes in specimen length observed as a consequence of test conditions.

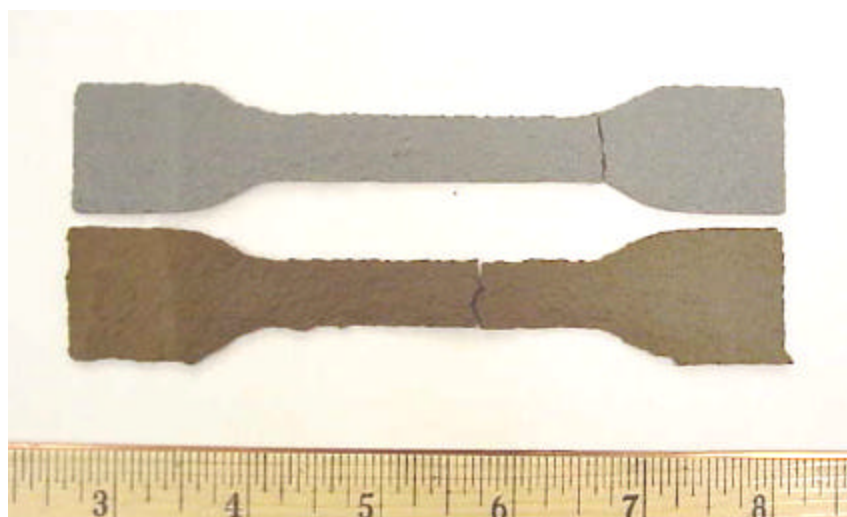
Figure A-10. Starglaze 2011S surfacer tensile test specimens: as cured, top; irradiated, bottom.

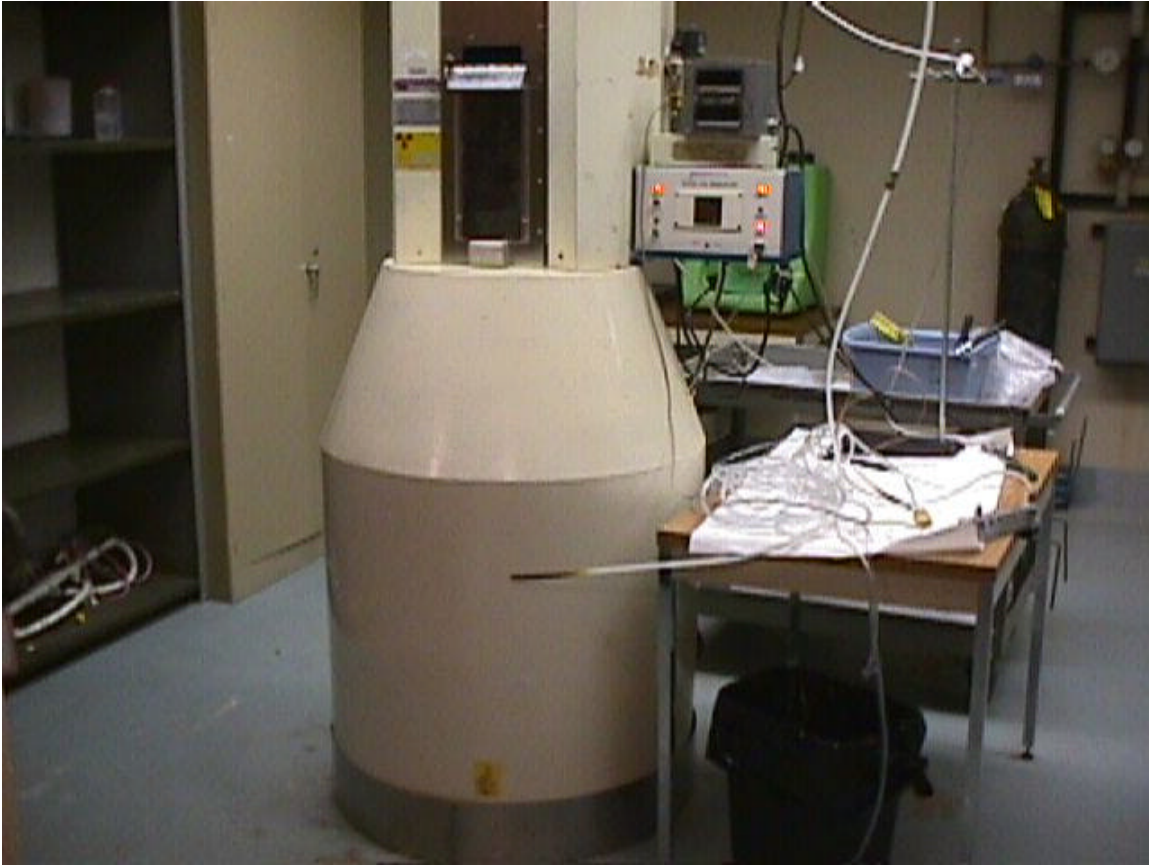
Figure B-1. GammaCell 220

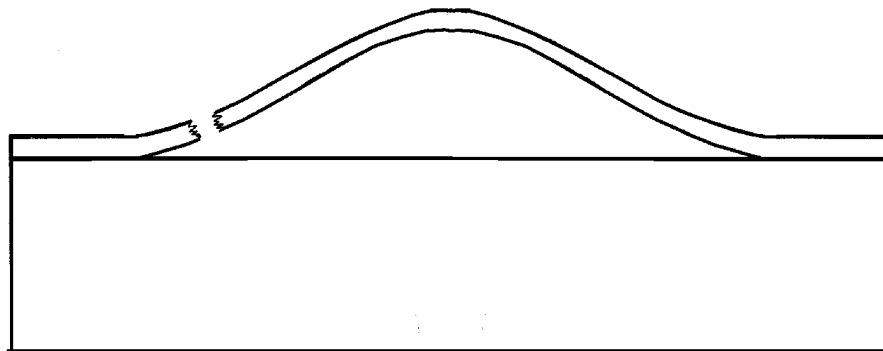
Figure C-2. Mode 1 Coating Failure

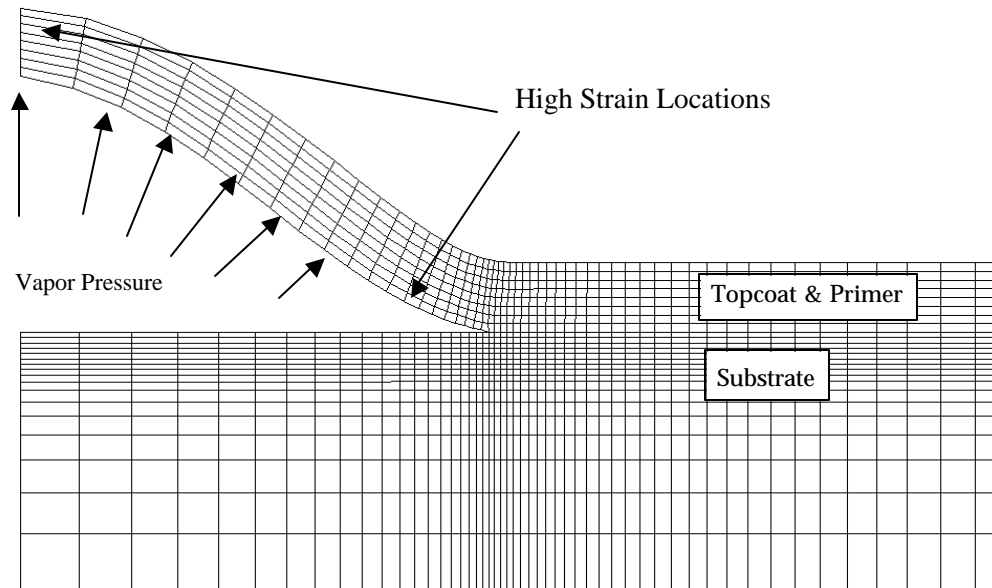
Figure C-3. Blistering due to buckling and/or vapor pressure loading

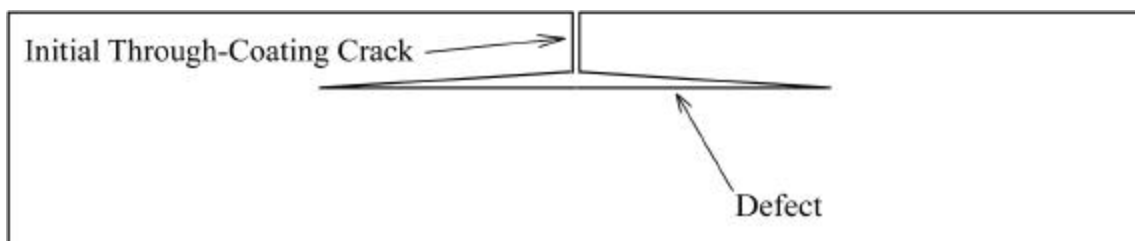
Figure C-4. Model for Mode 2 Coating Defect Analysis

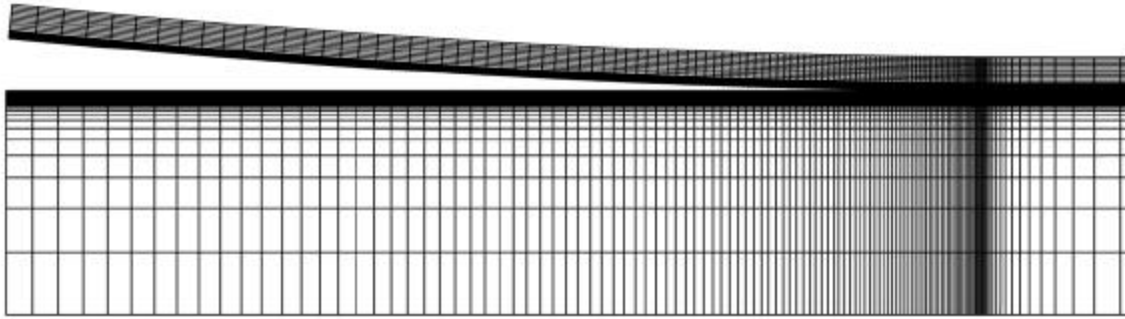
Figure C-5 - Peel-Back due to thermal expansion mismatch ($\alpha_{\text{topcoat}} < \alpha_{\text{primer}}$)

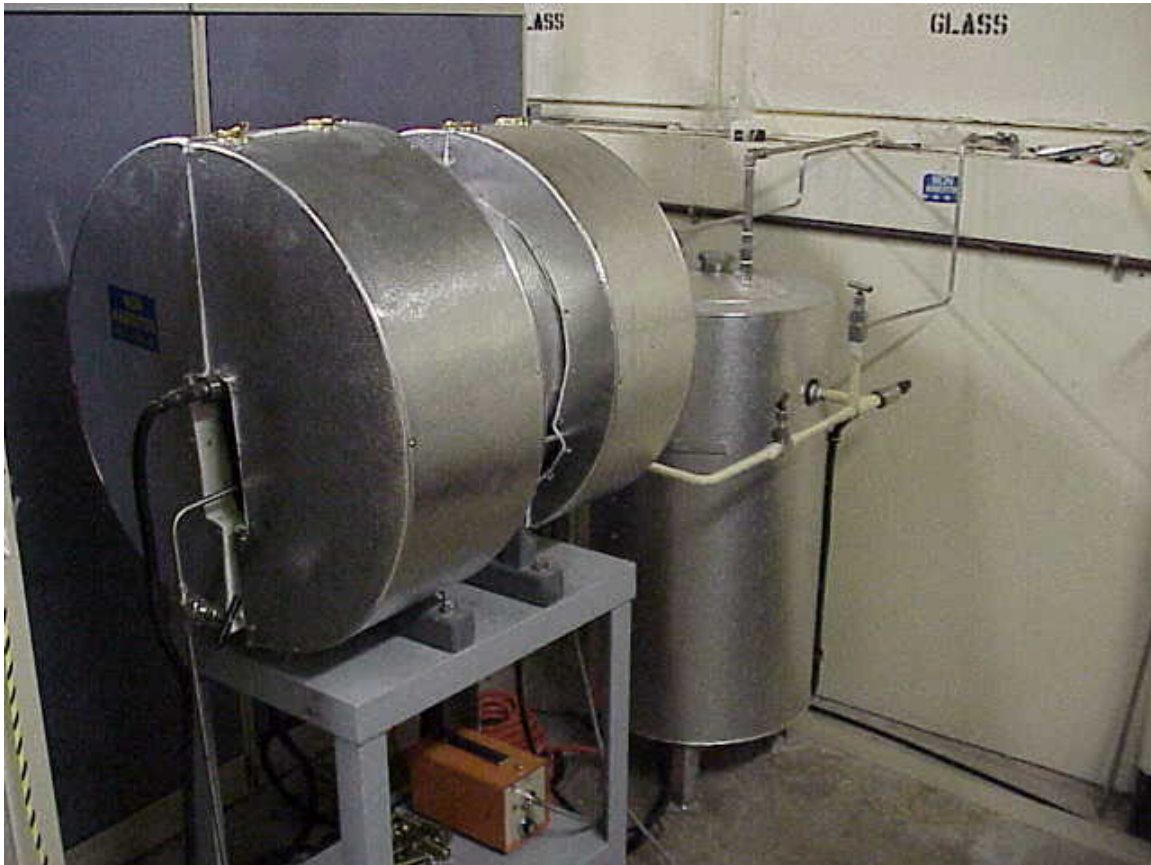
Figure D-1. SRTC Coatings Performance Evaluation System. Insulated environmental test chamber is shown on the left, the 10 gallon steam generator is on the right.

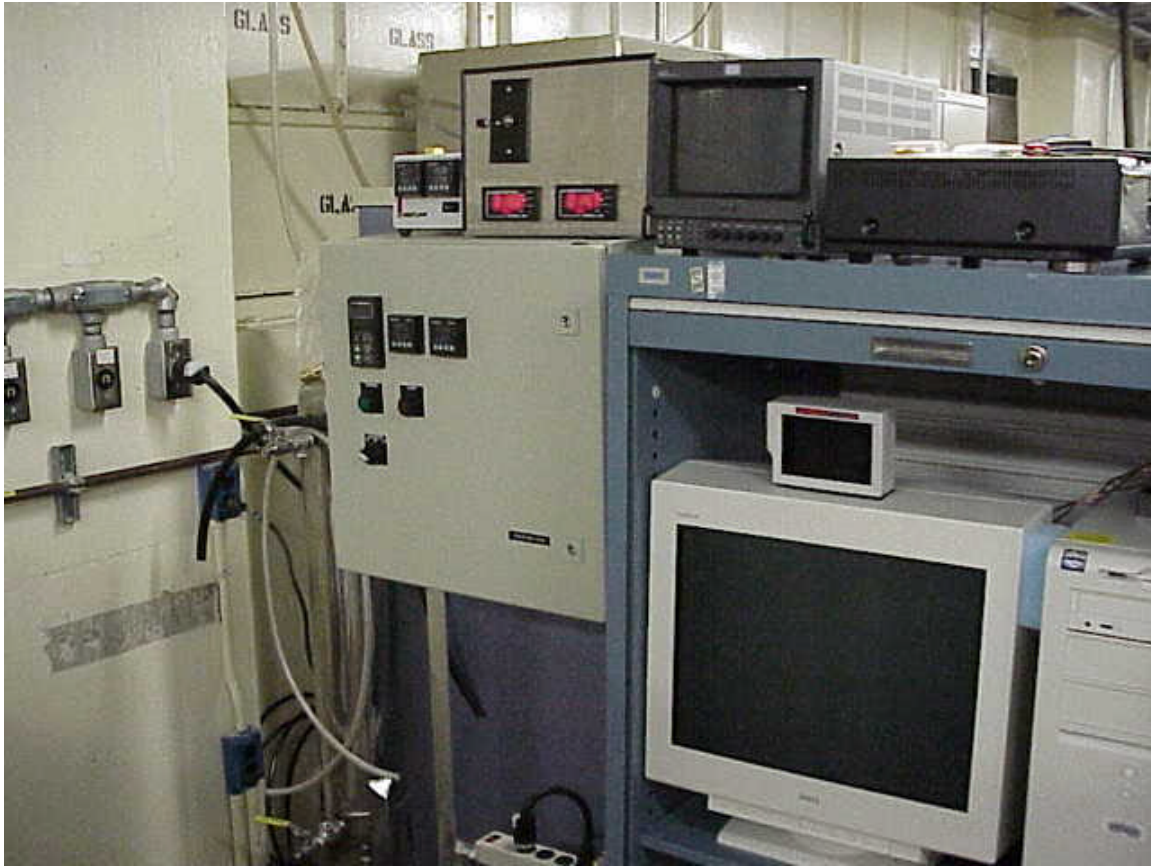
Figure D-2. Overall view of the heater control console and the video monitoring and data acquisition systems for the SRTC Coatings Performance Evaluation System
