**Degradation and Failure Characteristics of
NPP Containment Protective Coating Systems
Interim Report No. 2**

SRTC Coating System No. 2

(Phenoline[®] 305 epoxy-phenolic topcoat, Starglaze[®] 2011S surfacer, concrete substrate)

M. E. Dupont, N. C. Iyer, P. S. Lam, R. L. Sindelar,
T. E. Skidmore, F. R. Utsch, and P. E. Zapp
Savannah River Technology Center
Westinghouse Savannah River Company
Aiken, SC 29808

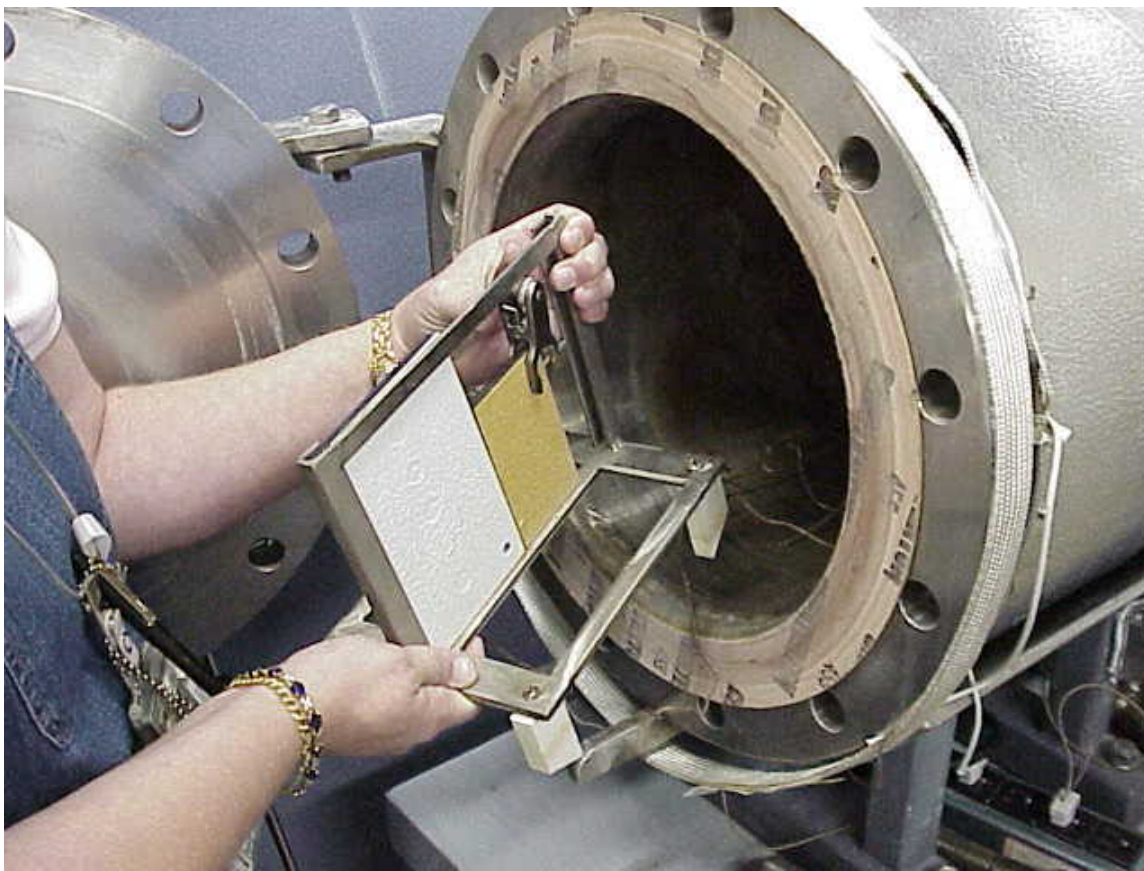
Figure D-3. Test Specimen being placed into the Coatings Performance Evaluation System

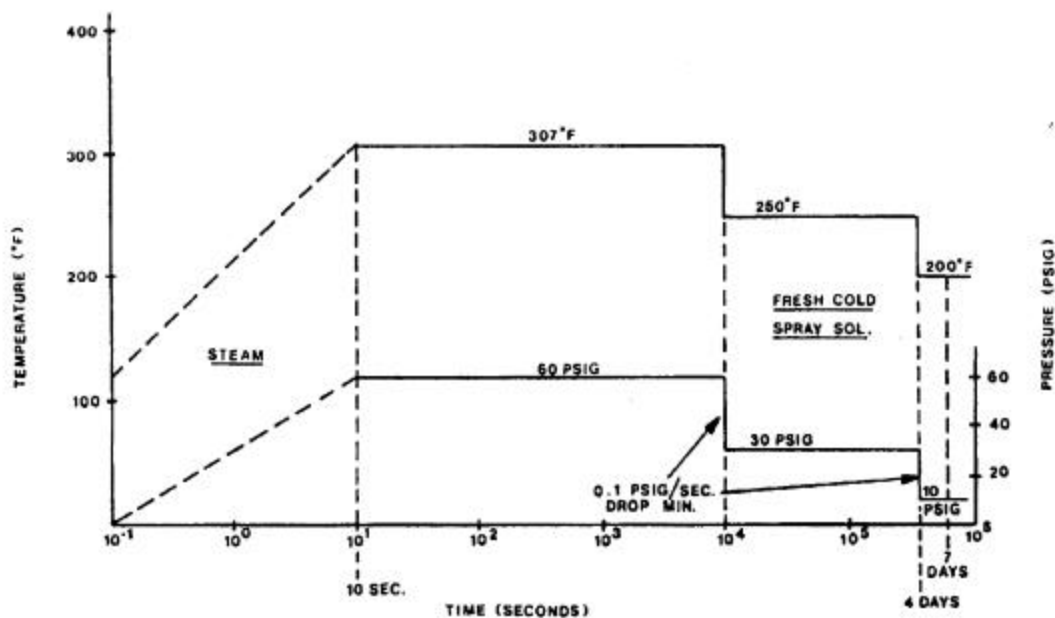
Figure D-4. Typical Pressurized Water Reactor Design Basis Accident (DBA) Testing Parameters (from ASTM D3911-95). (Note: The ASTM figure contains an error: 30 psig should be 15 psig, which is equivalent to 30 psia).

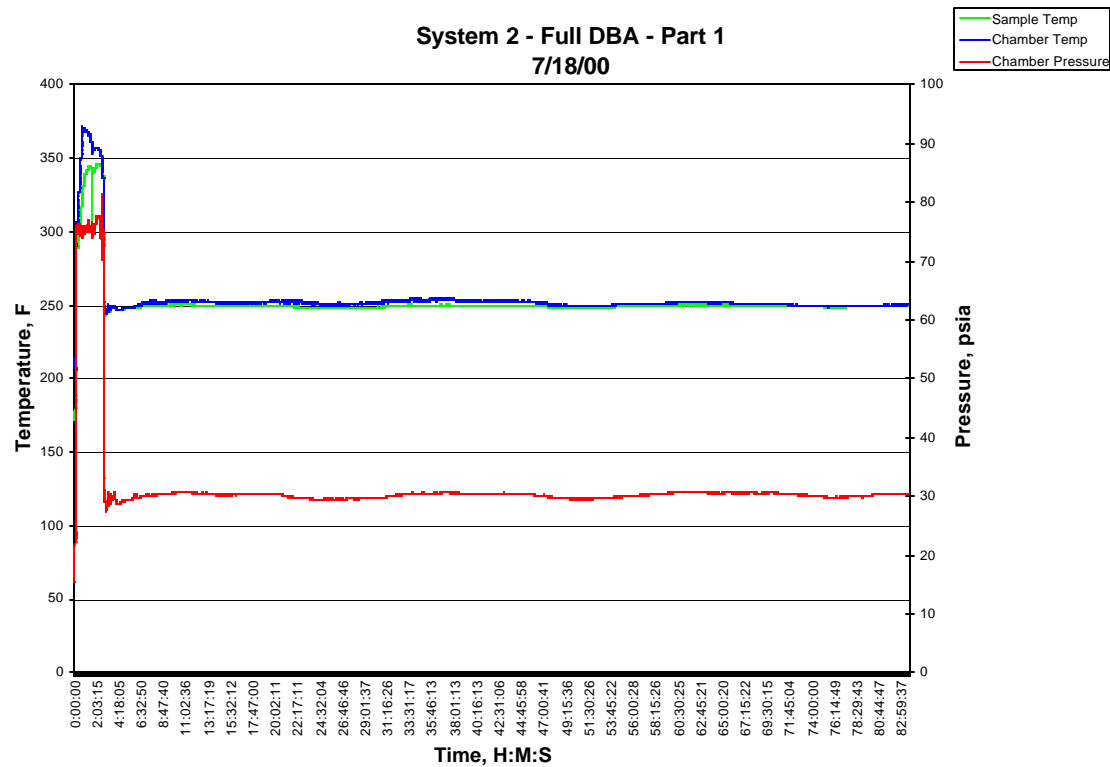
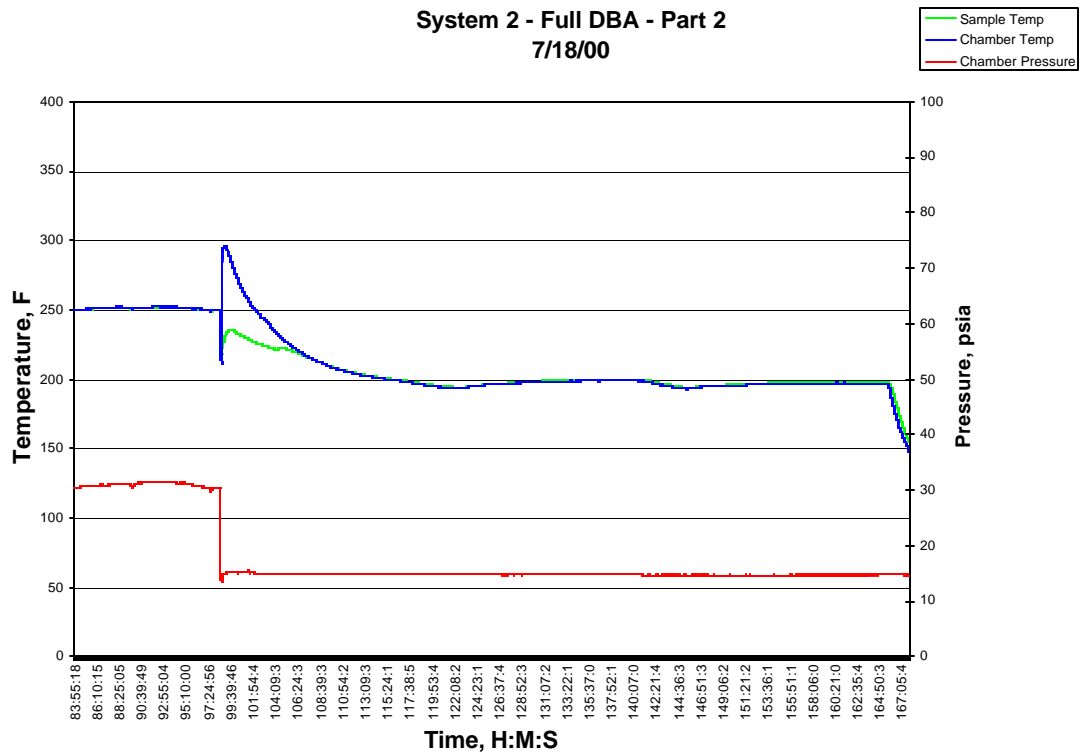
Figure D-5. Typical SRS DBA Test Cycle.

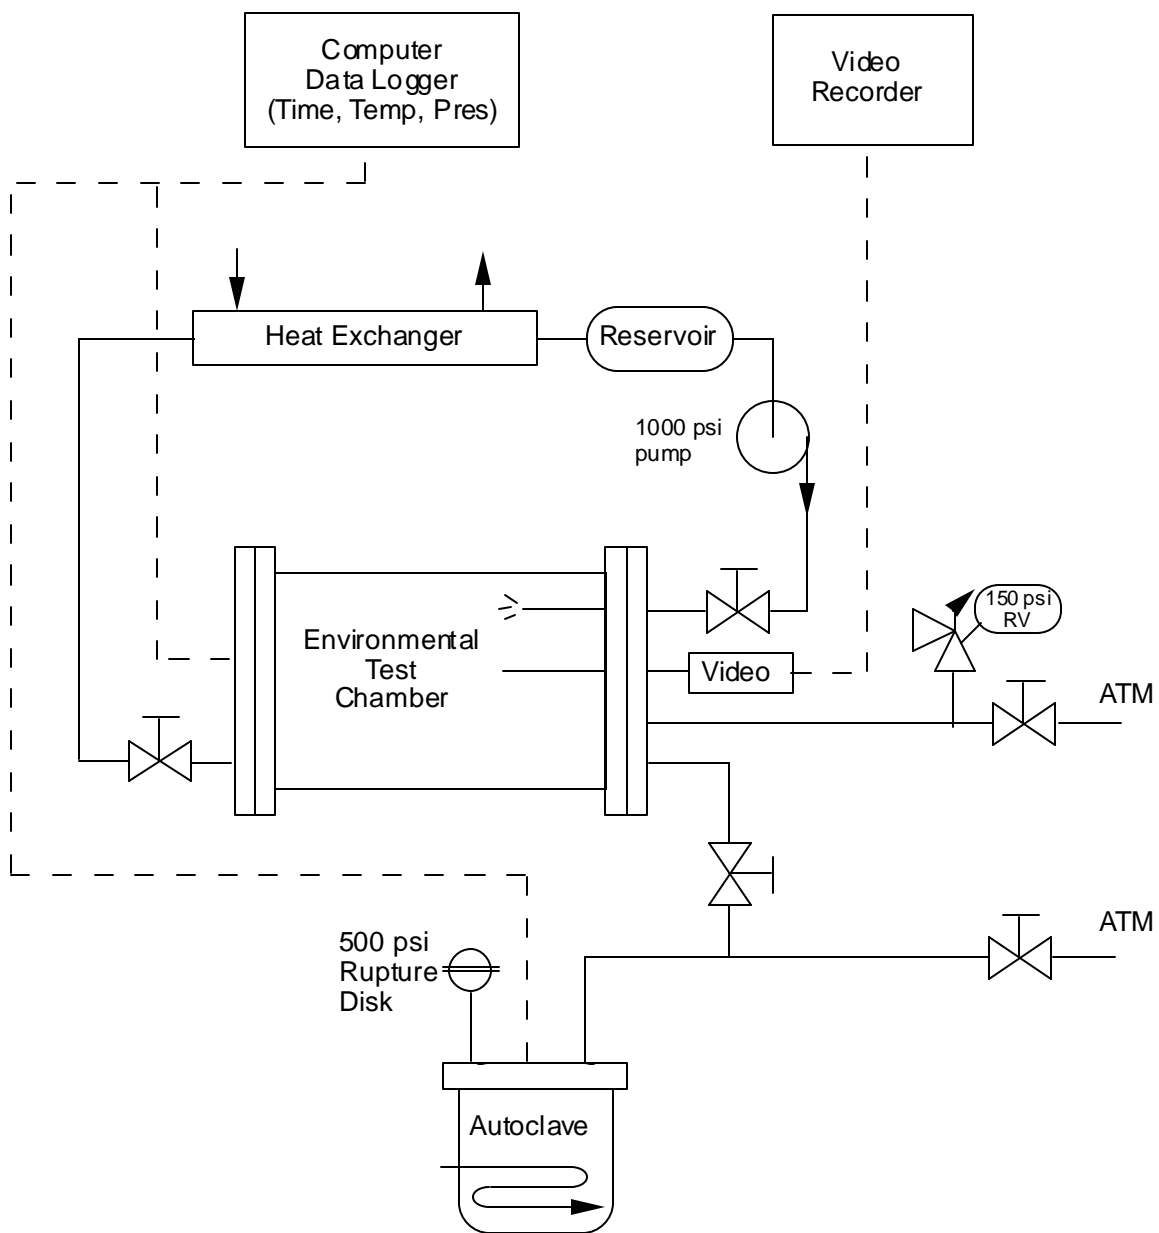
Figure D-6. Process schematic of coatings performance evaluation system

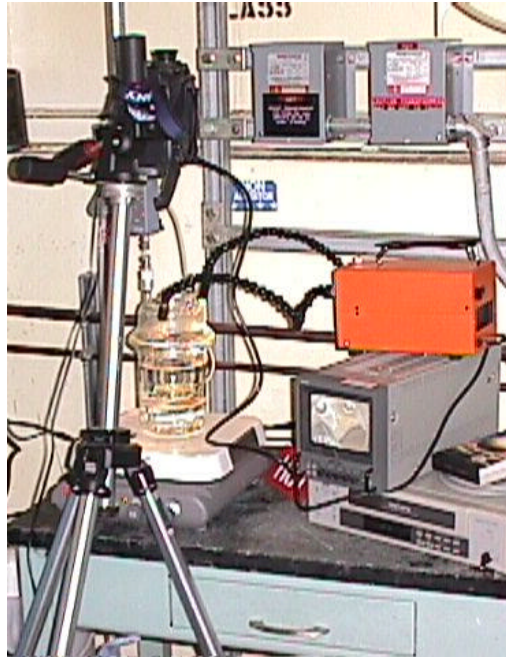
Figure D-9. Overall view of soak test system, illustrating video camera (on tripod), fiberoptic lighting system (orange box), time-lapse video recorder, and video monitor.

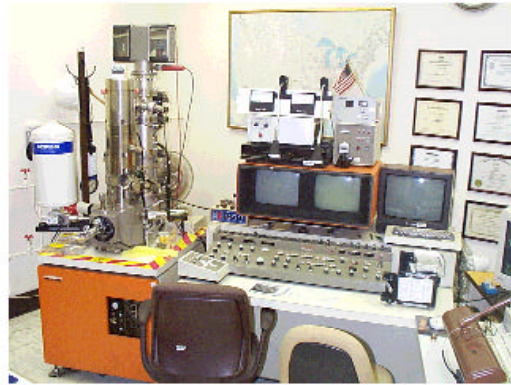
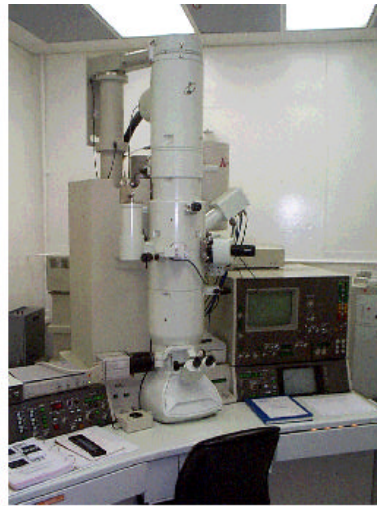
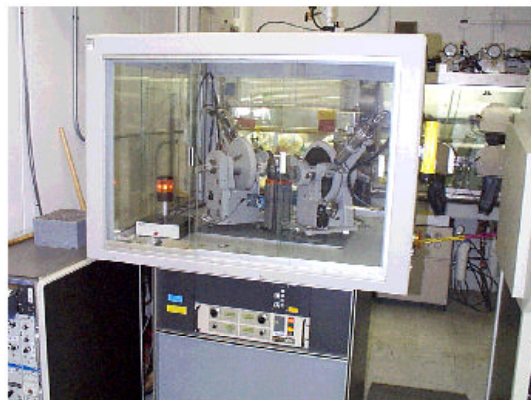
Figure F-1. SRTC Analytical Capabilities: Scanning Electron Microscope (top), Transmission Electron Microscope (middle), and X-ray Diffraction Unit (bottom)

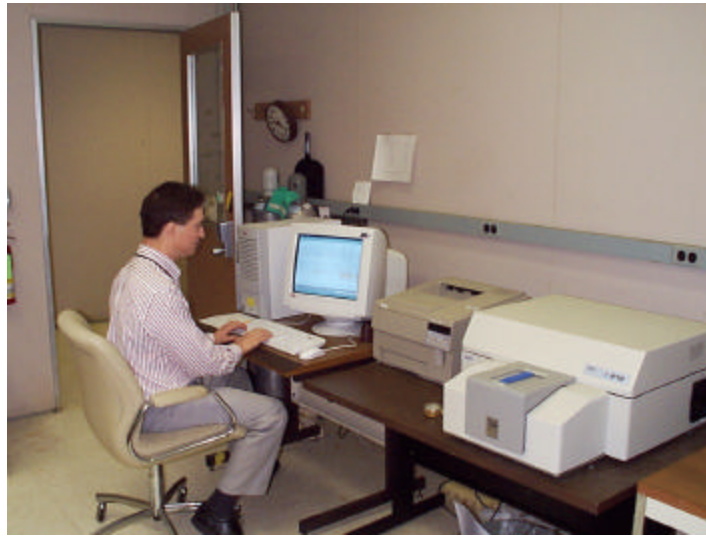
Figure F-2. FT-IR Spectrophotometry Equipment

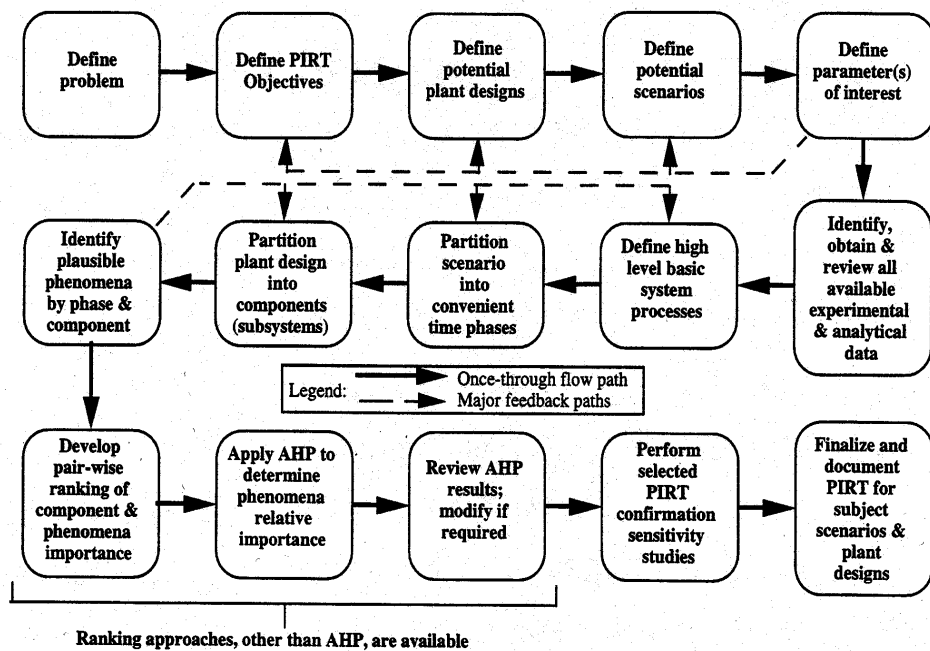
Figure G-1. PIRT Process

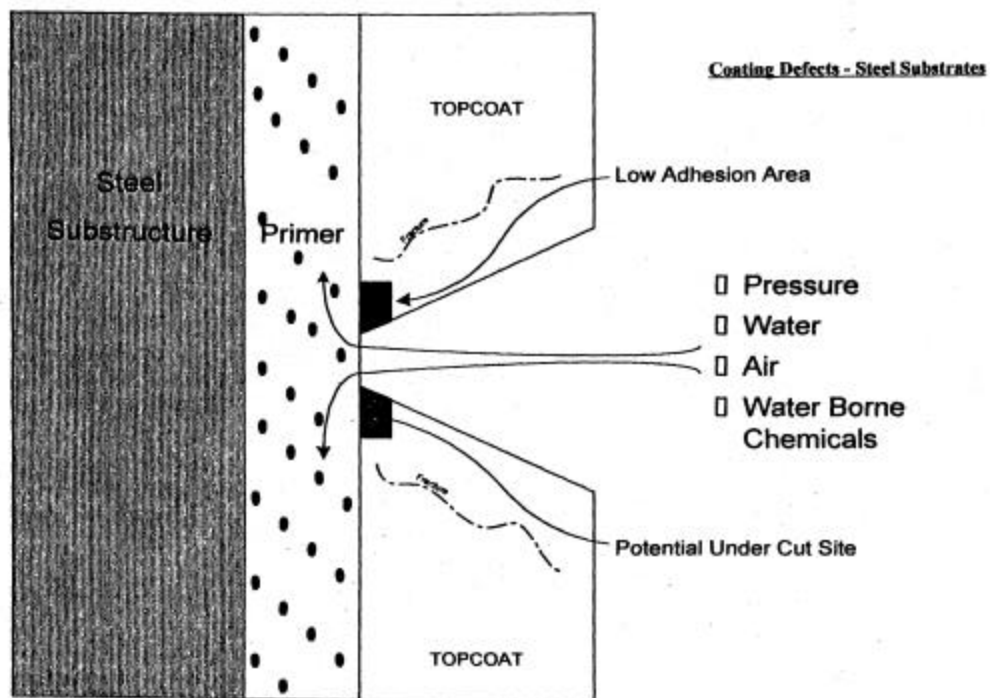
Figure G-2. Coating Defects and Phenomena of Importance
