# **FY04 Inspection Results for Wet Uruguay Fuel in L-Basin (U)**

**Philip R. Vormelker and Dennis W. Vinson**

Savannah River National Laboratory  
Materials Science and Technology

**DOCUMENT:** WSRC-TR-2005-00216

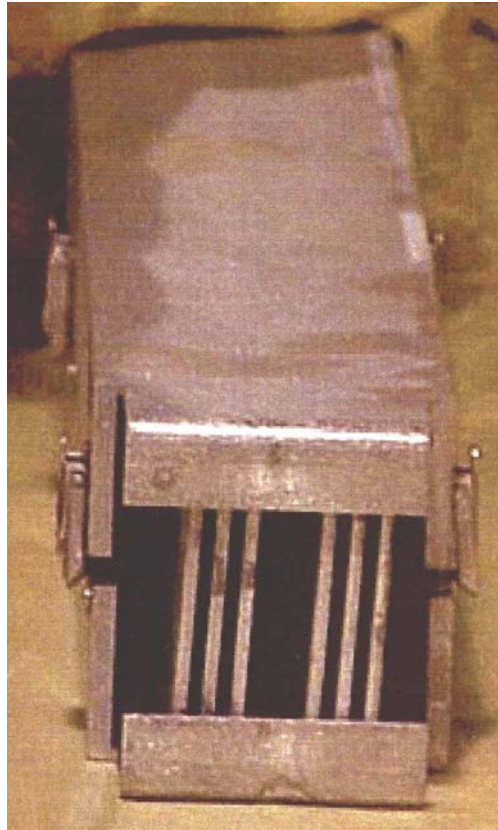
**Figure 13.** Bottom of clamping plates from B-3 fuel assembly showing position of six fuel plates from inspection in 2001.
