DP-971

PERFORMANCE OF HWCTR SAFETY ROD AND CONTROL ROD DRIVE SYSTEMS

October 1965

E. I. DU PONT DE NEMOURS & COMPANY
SAVANNAH RIVER LABORATORY
AIKEN, SOUTH CAROLINA
CONTRACT AT(07-2)-1 WITH THE
UNITED STATES ATOMIC ENERGY COMMISSION

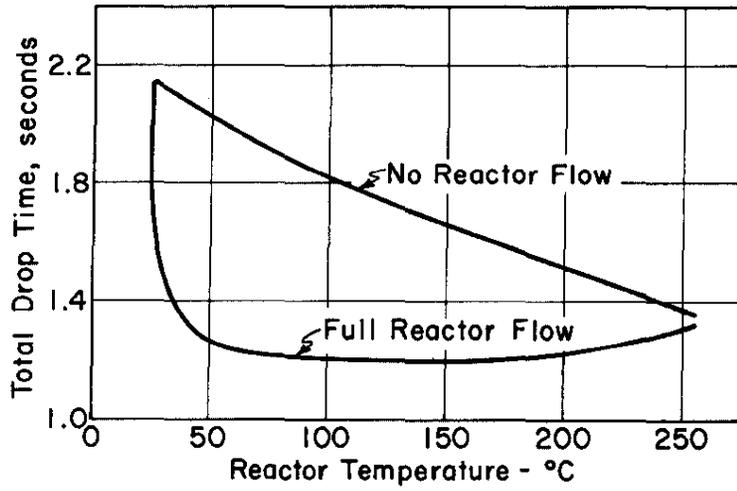
FIG. 18 SAFETY ROD DROP TIMES AT VARIOUS MODERATOR TEMPERATURES

Additional drop tests were made at various moderator temperatures and flow conditions to determine their effect on scram times. Total drop times for temperatures up to 250°C are shown in Figure 18. Rod displacement and velocity curves are shown in Figure 19. The average time required for 90% insertion was 1.16 seconds at 25°C, and 1.08 seconds at 240°C. The maximum acceleration achieved was from 0.8 to 1.3 g.
