DP-MS-87-66

**REMOTE REACTOR REPAIR: GTA WELD CRACKING CAUSED BY
ENTRAPPED HELIUM**

W. R. Kanne, Jr.

**HELIUM EMBRITTLEMENT CAUSED WELD TOE CRACKING ON THE IRRADIATED
WALL OF A NUCLEAR REACTOR TANK**

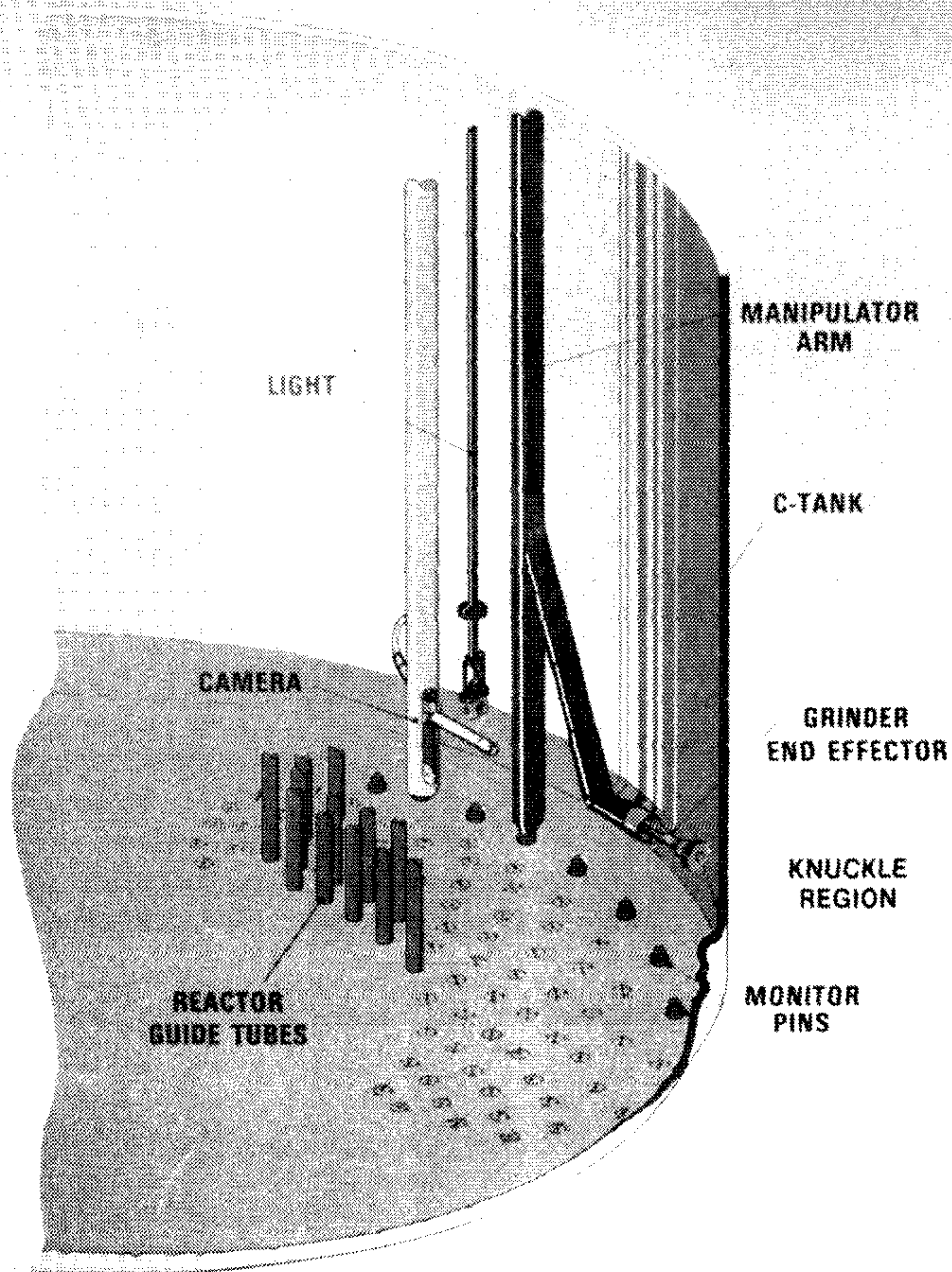
One of the reactors not presently operating is uniquely different from the other four in that it has a curved knuckle transition piece joining the tank side wall to the bottom. This region was sensitized during tank fabrication and developed stress corrosion cracks during service (Fig. 1). Cracks resulted in leaks that were first repaired in 1968 (Ref. 1) using GTA welding to place 0.25-inch-thick patches on the tank wall. The tank leaked again in 1984 and a program was initiated to repair the new leaks.

FIGURE 1. SAVANNAH RIVER NUCLEAR REACTOR SCHEMATIC SHOWING LOCATION OF MODERATOR WATER LEAKS THROUGH "KNUCKLE" REGION.

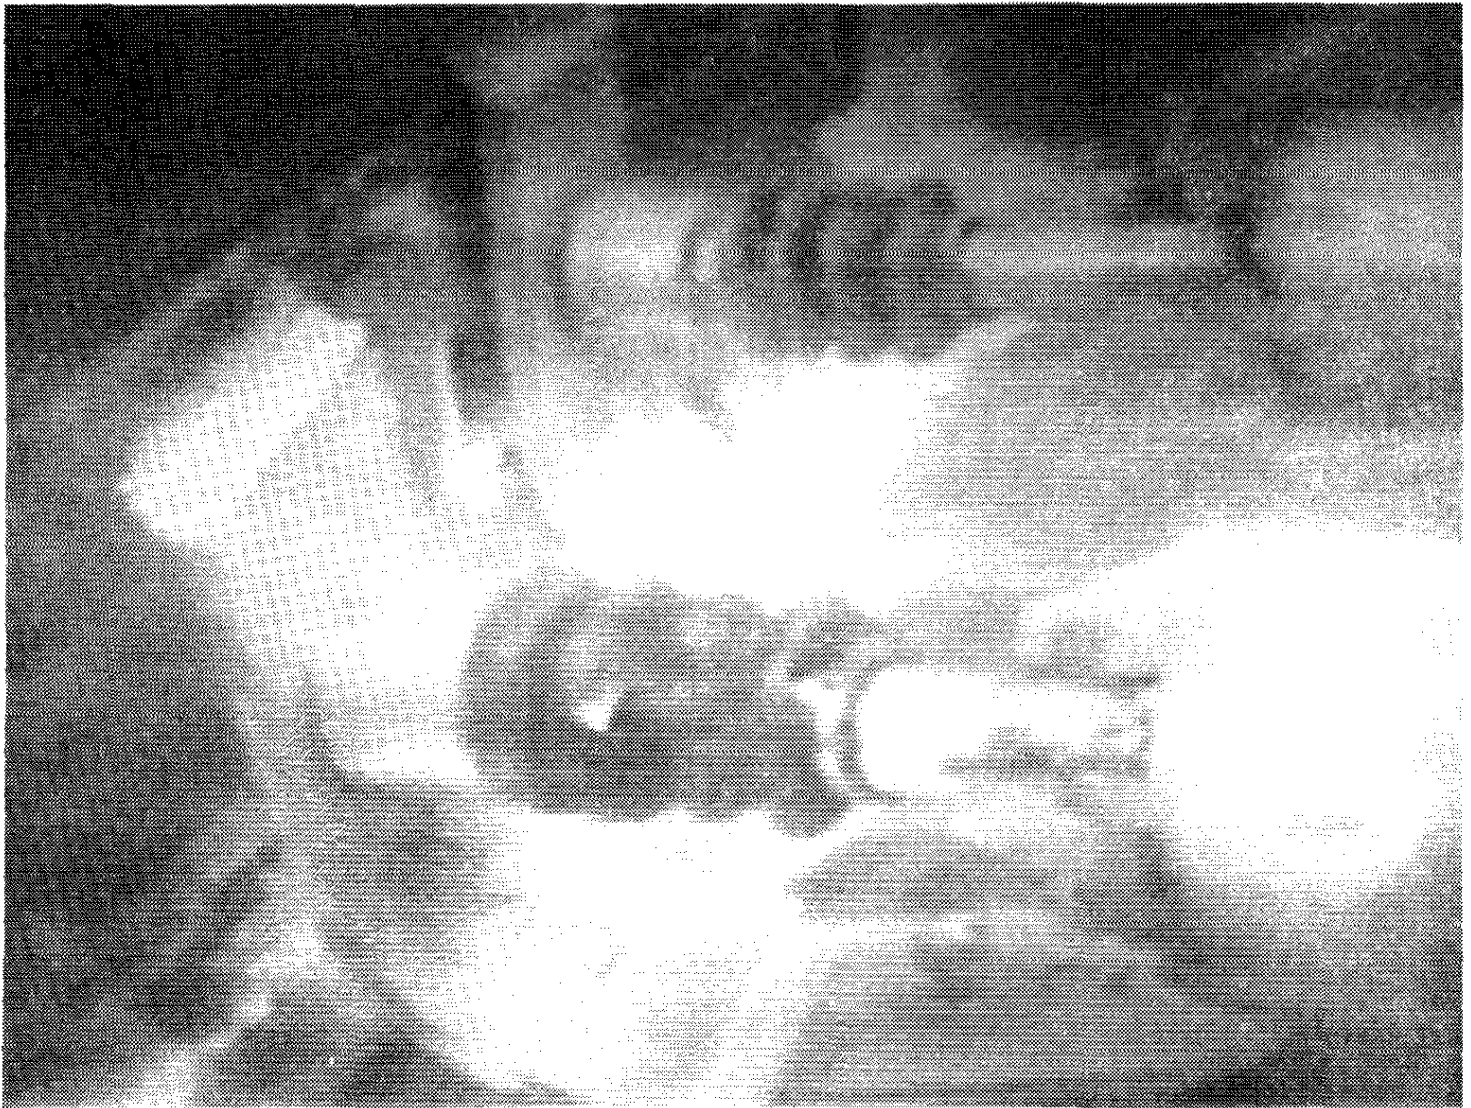
FIGURE 4. PATCH DESIGN COVERING KNUCKLE AND OLD PATCH.

to cover the entire knuckle region so that the top and bottom welds would not be on the knuckle. The patch had to be made up of curved segments that could fit through the 4.4-inch-diameter-holes in the reactor top and then conform to the curved knuckle area. Final design of segments is shown in Fig. 4. Segments were only 0.070-inch-thick in the center to accommodate thermal stresses and were 0.25-inch-thick along the patch segment perimeter.

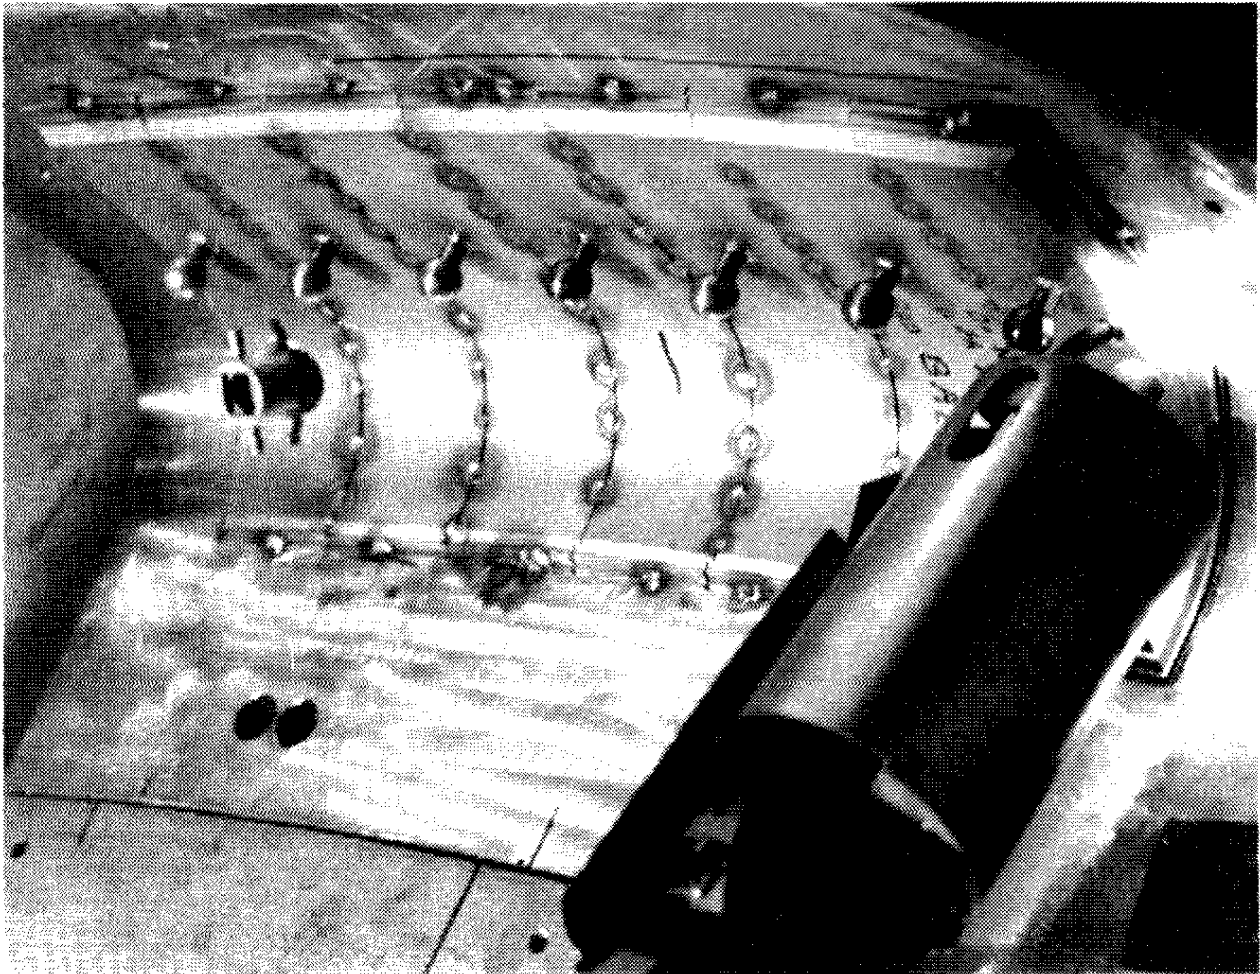
FIGURE 5. PLACEMENT OF FIRST TWO PATCH SEGMENTS IN REACTOR TANK. PHOTO FROM TV MONITOR SHOWS PATCHES (LEFT) HELD BY GRIPPING END EFFECTORS ON TWO ROBOT ARMS.

Seven segments were welded together to form the first patch. Patch segments were individually fitted to the complex tank wall configuration twenty feet below the tank top (Fig. 5). Autogenous GTA welding was used to join the patch segments to the wall and to each other, except where wire feed was required to close gaps between the patch segments and the tank wall. Patch segments were first tack welded to the tank wall as shown in Fig. 6. Welding of the lap joints joining patch segments to each other and of the fillet weld joints joining segments to the tank wall was demonstrated by extensive testing in a mockup facility. Design and configuration of the lap and fillet welds are shown in Fig. 7 and 8. Welds were made with pulsed current of 190/90 amperes (fillet welds) or 120/80 amperes (lap welds) for 0.5 second at each level at a travel speed of 2.0 inches per minute using argon, or argon - 25% helium, torch gas.
