IJTC2007-44017

RELATIONSHIP BETWEEN VIBRATIONS AND MECHANICAL SEAL LIFE IN CENTRIFUGAL PUMPS

Robert A. Leishear

Washington Savannah River Company
Aiken, South Carolina, 29803
803-641-6753, Robert.Leishear@SRS.gov

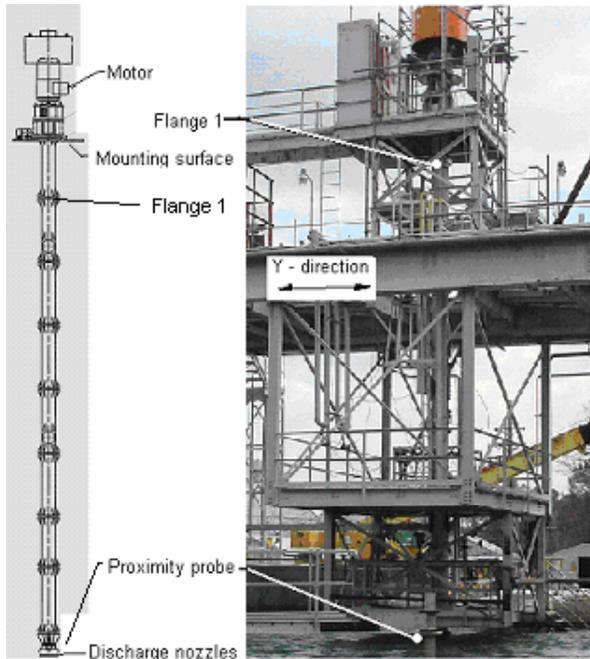
Several pumps with similar designs were supplied by different manufacturers. One such pump is shown installed in the test facility at SRS in Fig. 1. The only significant difference between the installation at the test facility and the final installation on waste tanks is the fact that the pump is accessible for inspection and testing at the test facility. At the top, the mounted motor is connected to the impeller at the bottom with a drive shaft surrounded by an encasing column of water. The pump suction at the bottom of the pump draws waste up through the impeller and discharges the waste to mix the material in waste tanks. The water in the column is used as a lubricant for bearings and also as a buffer between the waste and the environment. The location of the installed mechanical seal which typically leaks is located just above the impeller.

Figure 1: Long Shaft Vertical Pump Installed at the Test Facility

Vibration testing was performed at the test facility prior to installing the pumps in nuclear waste tanks. Vibrations were measured in orthogonal directions near the top of the pump at a point denoted as flange 1 shown in Fig. 1. Two transducers were attached to the pump to measure vibrations transmitted in the two directions, X and Y. The Y direction is shown in Fig. 1, and the X direction is perpendicular to the Y direction in a horizontal plane.

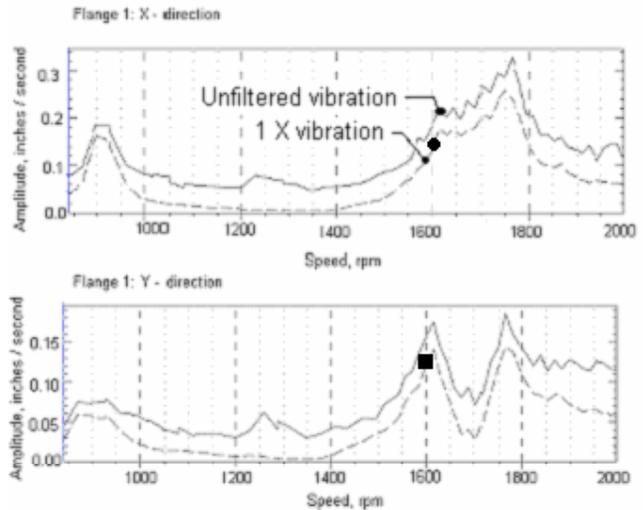
The vibration data is presented in different forms and formats, e.g., acceleration, velocity, or displacement; filtered or unfiltered. For this work, the vibration is typically measured as a velocity using Velomitors, which transform a piezoelectric acceleration signal to a velocity. Once the velocity data was obtained, the analyzer software converted the data into unfiltered vibration plots, which represent a summation of sine waves associated with each of the discrete vibrations comprising the unfiltered wave. That is, the unfiltered vibration is decomposed into several filtered vibrations. A display of these vibrations is shown in Fig. 2, which shows the maximum value of the unfiltered vibration at numerous operating speeds of a pump. The peak value of the unfiltered vibration is displayed for the vibrations, which were measured in two orthogonal directions, X and Y. In this graph, the 1X vibration shows the vibrations which occur at the operating speed of the pump.

Figure 2: Vibration Plots of Vibration Amplitude vs. Speed
