Excitation of Structural Resonance Due to a Bearing Failure

ABSTRACT

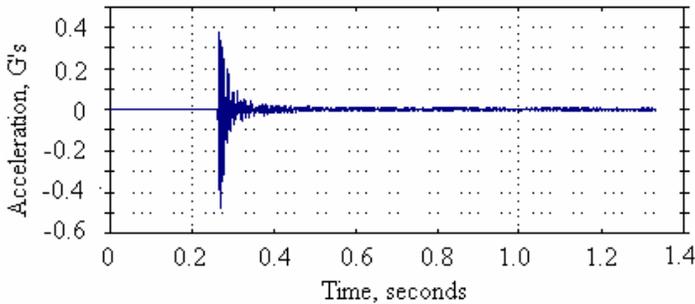
Figure 15: Unfiltered Axial Vibration Measured on the Pump Casing, PLZ

numerous locations along the length of a pump mounted in a test platform (Leishear and Stefanko [5]). Known as a bump test, the test consisted of striking the pump and measuring the excited natural frequencies. Again, each of the frequencies corresponds to the vibration of a specific pump component. The results of interest were axial vibrations (PLZ), which were measured on the pump casing as shown in Figs. 2 and 3. The overall, or unfiltered, response to striking the casing is shown in Fig. 15. A filtered response due to the bump test was obtained from the vibration analyzer used to record the data and is shown in Fig. 16. The filtered response identifies vibration at specific frequencies. Note that a peak vibration occurs at approximately 271.3 Hz, which is nearly coincident to one of the ball spin frequency multiples noted in Fig. 13.
