# Laser Engineered Net Shaping® for Repair and Hydrogen Compatibility

*LENS technology seems well suited for repair of overbored reclamation-type materials, but additional process development is required for other types of repairs*

BY P. S. KORINKO, T. M. ADAMS, S. H. MALENE, D. GILL, AND J. SMUGERESKY

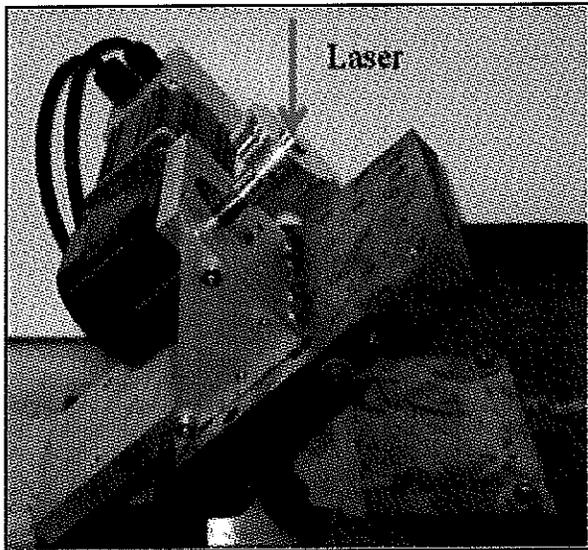
Fig. 3 — The reclamation weld bases were repaired using the 4th axis mounted in the LENS machine at 45 deg to horizontal.

from horizontal, as shown in Fig. 3. This approach was used to allow the laser to deposit material on the bottom of the bore as well as the walls. Concentric rings of material with decreasing radii were deposited on the bottom of the bore from the outside to the center. The laser then incremented up one layer and deposited the next layer from the outside to the center again. In this way, the bore was filled. In the initial efforts, the rotational speed of the weld base on the 4th axis was increased as the radius of deposit was decreased such that the apparent feed rate remained constant regardless of radius size. The method presented several challenges, however. As seen in Fig. 4, as the laser approached the center of the bore, the heat built up and caused excess powder to be entrained in the melt pool, thus creating a bump. By the second pass, the bump became tall enough to grow into the beam even when the laser was depositing at the outer edge. This caused the beam to be obscured at the outer edge and caused the bump to grow at a very high rate all the time. To address this issue, the rotational speed of the axis was increased near the center to considerably higher speeds than used previously. In addition, the very center of the part was not filled on the first several passes. This allowed high-quality material to be deposited on the walls of the part without obscuring the center. It did mean that the center material did not adequately fuse with the layer below it. This attribute was not important since the center of the hole is sacrificial material and would be removed as part of the RW preparation of the test bases. In fact, the center material was just provided to allow the hole to be drilled, if desired, rather than helically interpolated with a mill, which is a more time-consuming process.

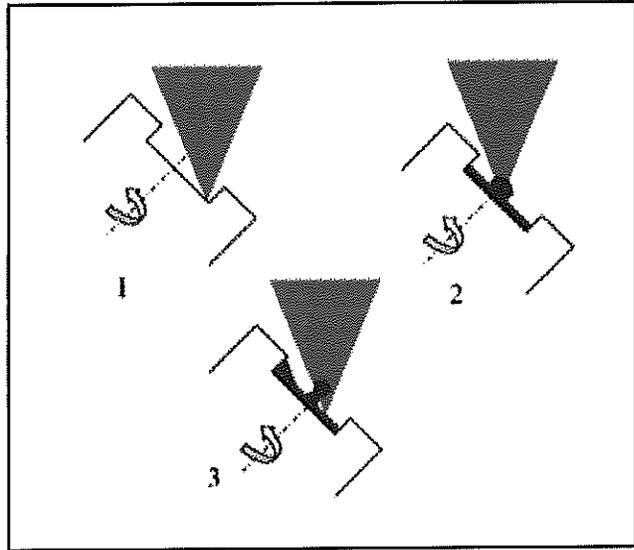
Fig. 4 — The repair proceeded from the outside to the center of the bore with the axis greatly increasing in rotational speed for each subsequent ring.

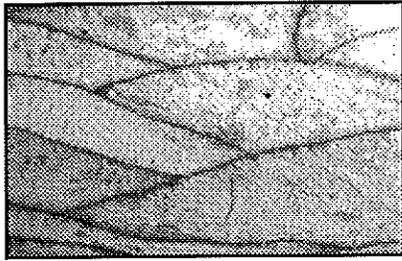
Fig. 10 — Representative microstructure of as-processed 304L LENS materials [polished and electrolytically etched (10% oxalic acid)].

by SNL was sectioned, mounted, polished, and examined using light optical microscopy. The multilayered structure displayed in Fig. 10 is characteristic of LENS-deposited materials and depicts the nature of the multipass deposition technology with very fine grains and interpass and interlayer interfaces. Unfortunately, higher magnification images were not taken so the solidification morphology and primary solidification mode cannot be discerned.

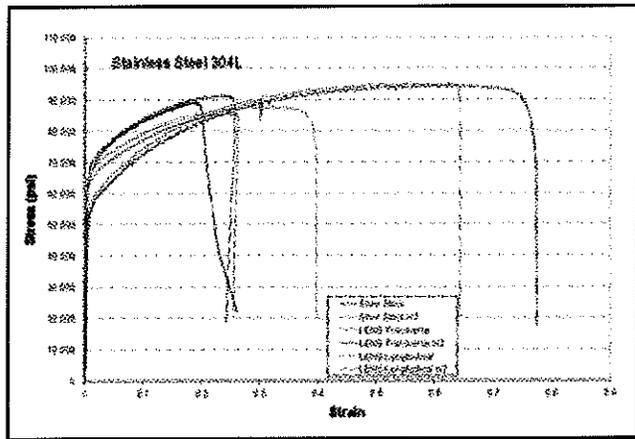
Fig. 15 — Tensile testing curves for 304L sheet stock and LENS materials in the hydrogen-charged and baseline conditions.

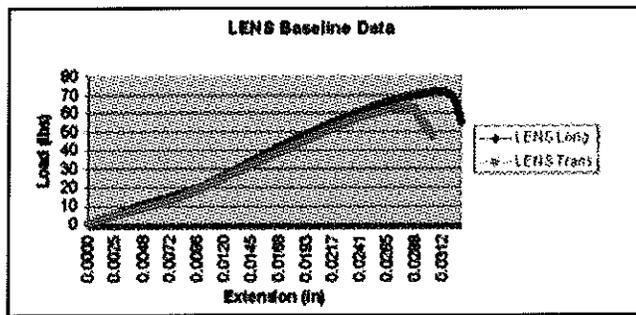
Fig. 16 — Small sample punch testing curves for Type 304L LENS materials in the following conditions: A — Baseline; B — hydrogen charged.

Table 3 — Estimated Decrease in Fracture Toughness for 304L LENS® Materials Exposed to Hydrogen

Material and Condition	$\epsilon_{qf}$	Estimated $J_{IC}$ (kJ/m <sup>2</sup> )
LENS® 304L Longitudinal — Air	1.250	300
LENS® 304L Transverse — Air	1.112	261
LENS® 304L Longitudinal — Hydrogen	0.630	126
LENS® 304L Transverse — Hydrogen	0.564	108

Analysis of the small sample punch test data in Fig. 16 to estimate the reduction in fracture toughness of the LENS process 304L material upon exposure to hydrogen has been performed. Calculation of the biaxial fracture strain  $\epsilon_{qf}$  using Equation 1,
