Journal of Nuclear Materials Management

**Stainless Steel Interactions with Salt Containing Plutonium
Oxides**

D.Z. Nelson¹, G. T. Chandler¹, K.A. Dunn¹, T.M. Stefek¹, M.E. Summer¹
Savannah River National Laboratory¹
Aiken, SC 29808

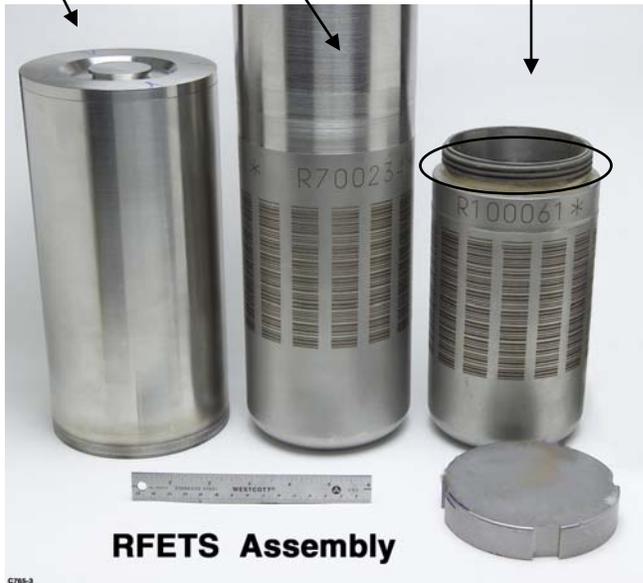
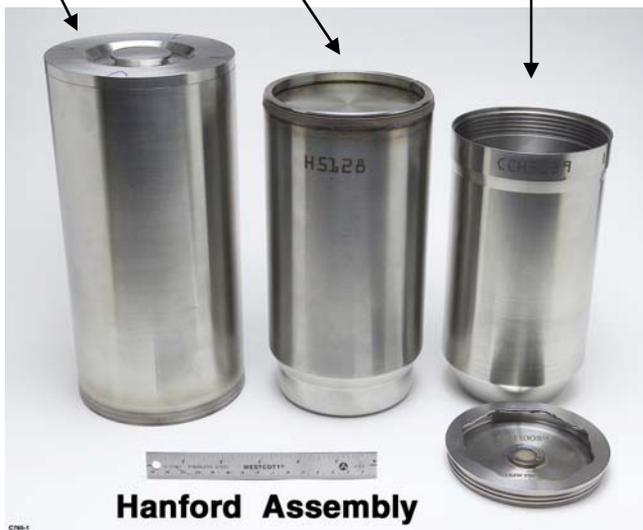
Figure 1. 3013 container configurations (a) RFETS 3013 container. Note silver coated threads on convenience container body (circled). (b) Hanford 3013 container. Difference between the two include convenience container design and lid material. Additionally, the inner container body design varied toward bottom of container.

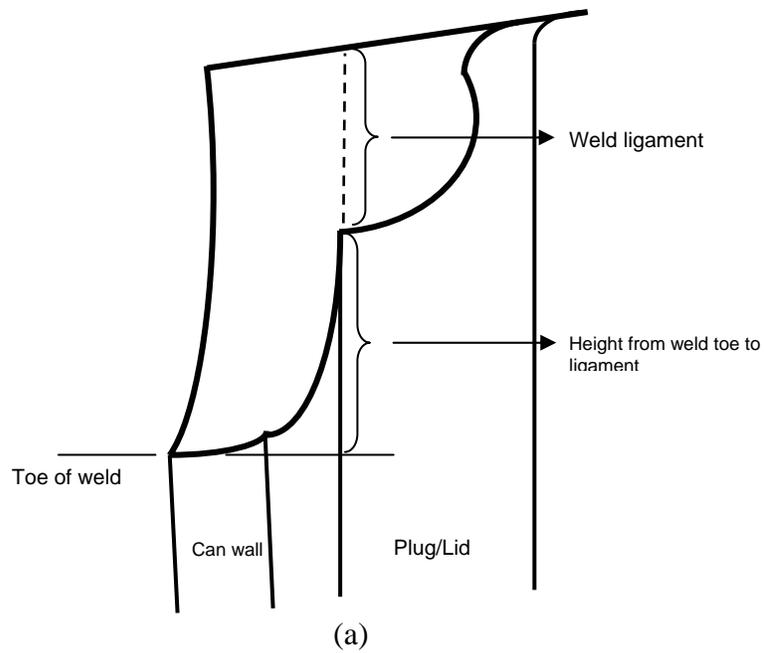
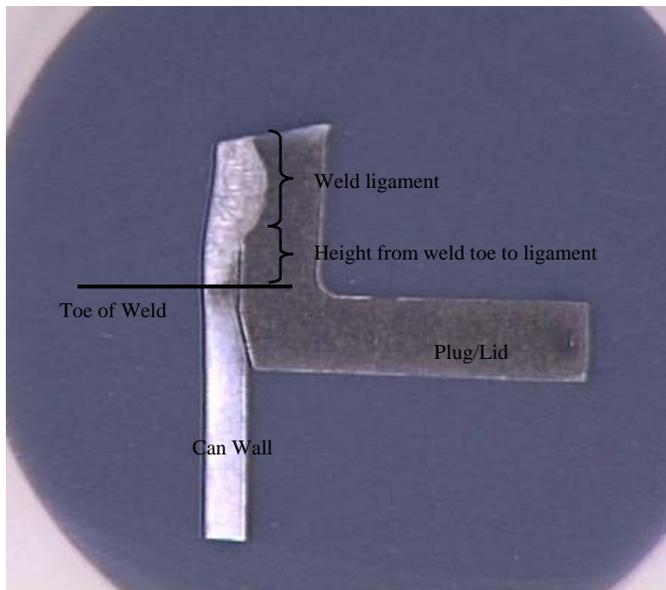
Figure 15. Inner container weld cross section (a) Schematic (b) Metallographically prepared section
