MODEL 9975 LIFE EXTENSION PACKAGE 2 – FINAL REPORT

Savannah River National Laboratory
Materials Science & Technology

Publication Date: April 2010

Document No. SRNL-STI-2010-00185 **Rev. No.** 0

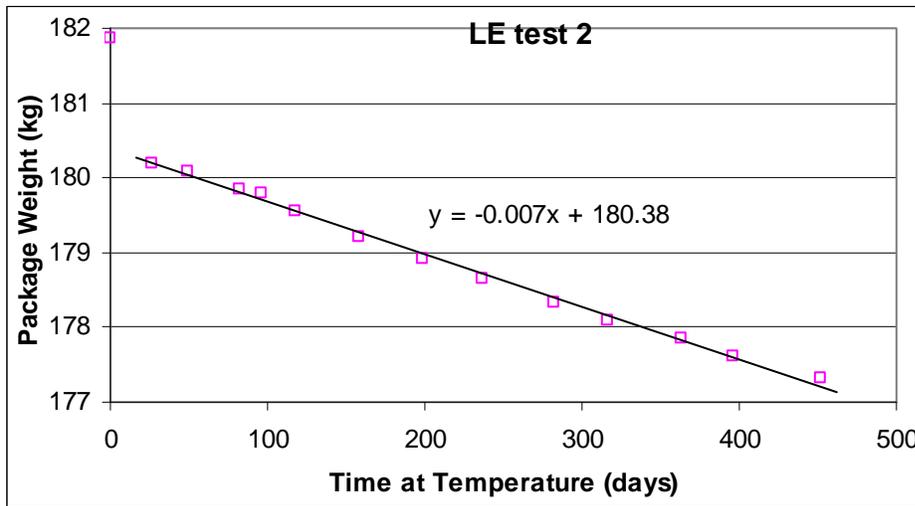
The package as a whole lost weight at an average rate of 0.004% /day. The package contains 32.156 kg of “dry” fiberboard (based on the initial weight of both fiberboard assemblies and removable sections, minus the weight of bearing plates and air shield, minus the initial package weight decrease due to moisture loss). Accordingly, the overall average rate of fiberboard weight loss is 0.022 %/day, or 7.9 %/yr. Similarly, using the data from Figure 7, the average fiberboard weight loss rate for the upper assembly is 0.028 %/day (10.4 %/yr). The average weight loss for the small (upper) removable fiberboard section is 0.012 %/day (4.4 %/yr).

Figure 6. Package weight of LE2 over time. The variation following the initial drop is approximated well by the linear trendline. The magnitude of the initial drop represents moisture loss.

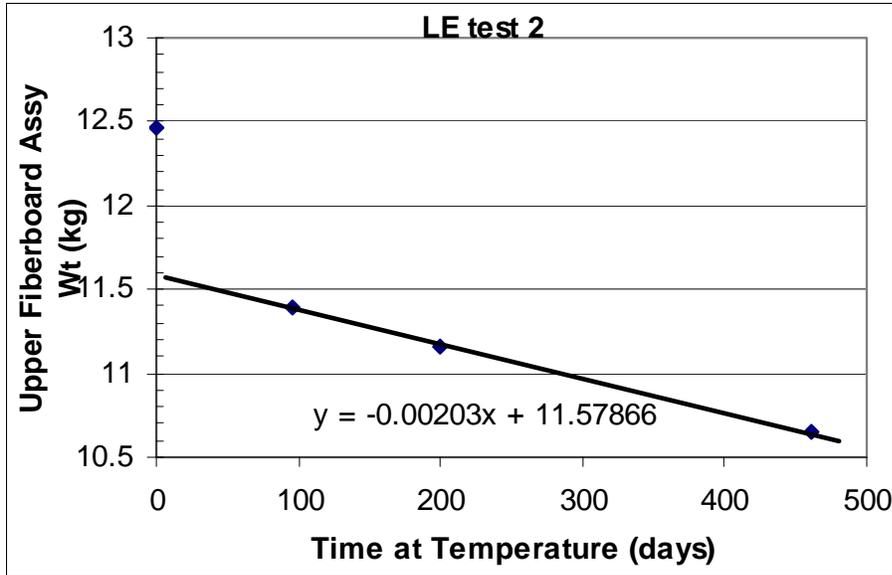
Figure 7. Weight variation for LE2 upper fiberboard assembly.

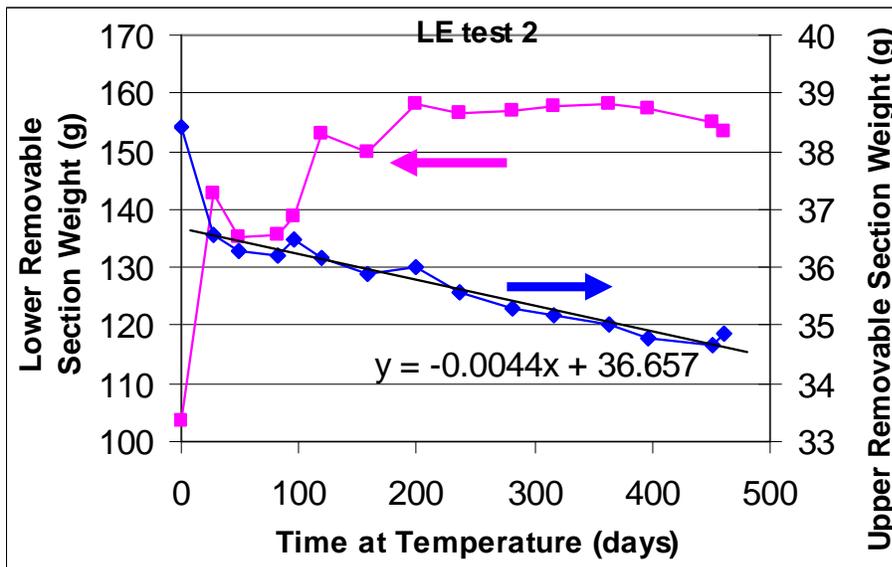
respectively. It is assumed that the change in package weight is associated with the fiberboard alone (ignoring effects of weight gain from the shield corrosion). It is further assumed that there was no significant moisture loss from the package following the initial heatup. This assumption is based on the observation that the bottom (larger) removable fiberboard section did not change weight significantly after the initial re-distribution of moisture to the bottom (Figure 8), and no significant moisture remained anywhere else within the package.

Figure 8. Weight of removable fiberboard sections from life extension test 2.

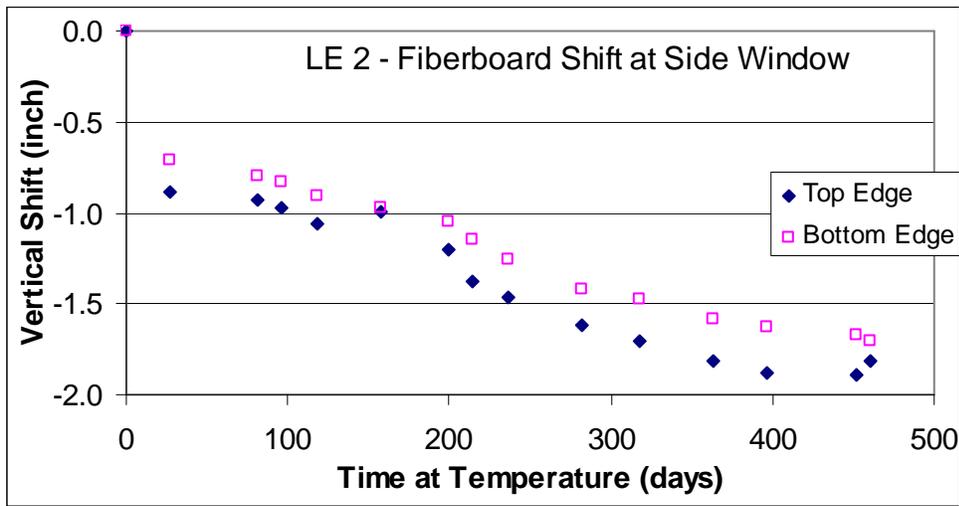
Figure 11. Vertical shift (downward) of fiberboard in LE2, as viewed through the side view port.

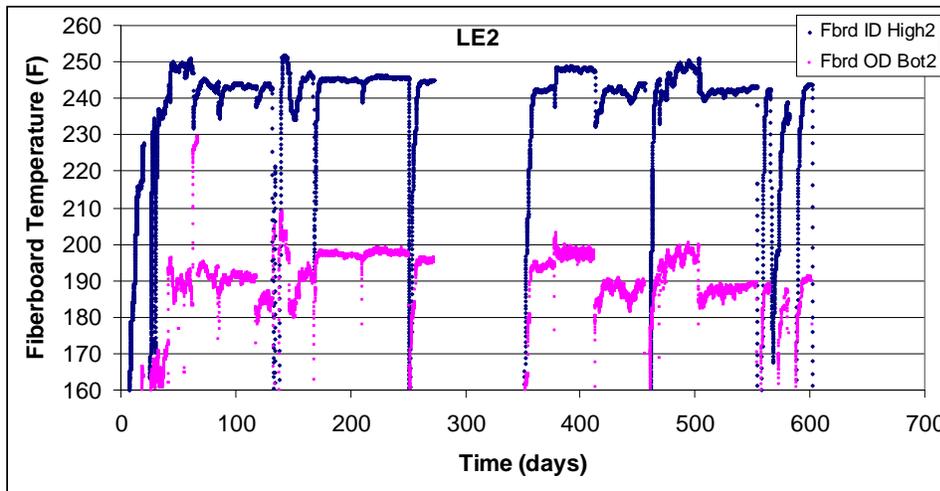
Figure 13. Temperature variation for each package at the hottest (blue symbols) and coolest (pink symbols) instrumented fiberboard locations (highest fiberboard ID location and lowest fiberboard OD location – refer to Figure 1).

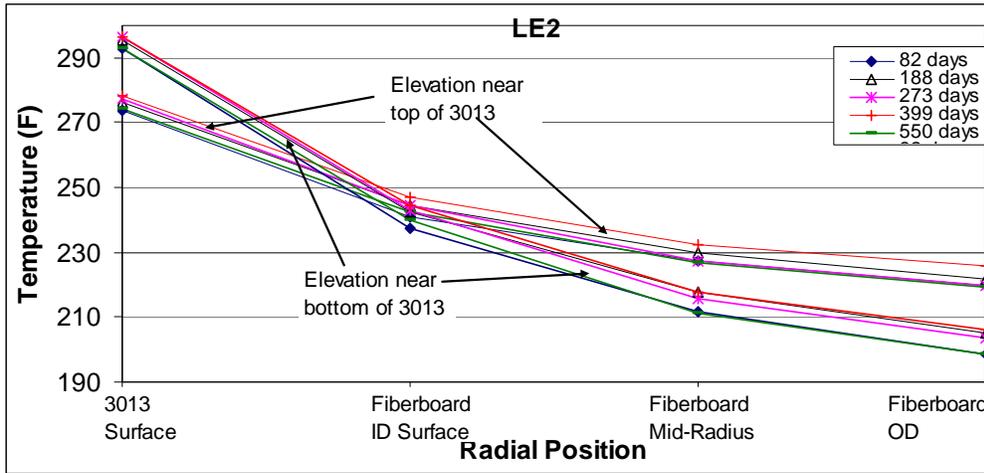
Figure 14. Radial temperature profiles at several intervals of steady state temperature.

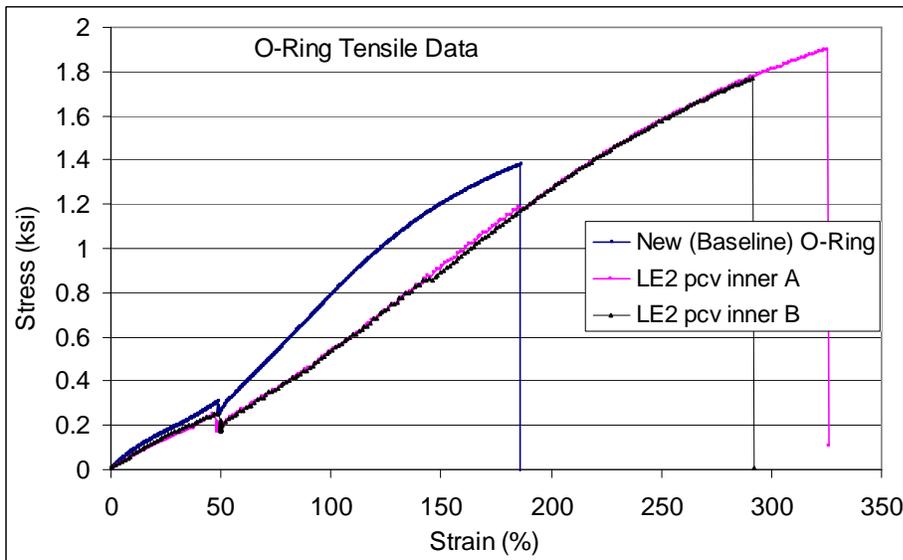
Figure 15. PCV inner O-ring tensile stress-strain curves, compared to non-aged O-ring.

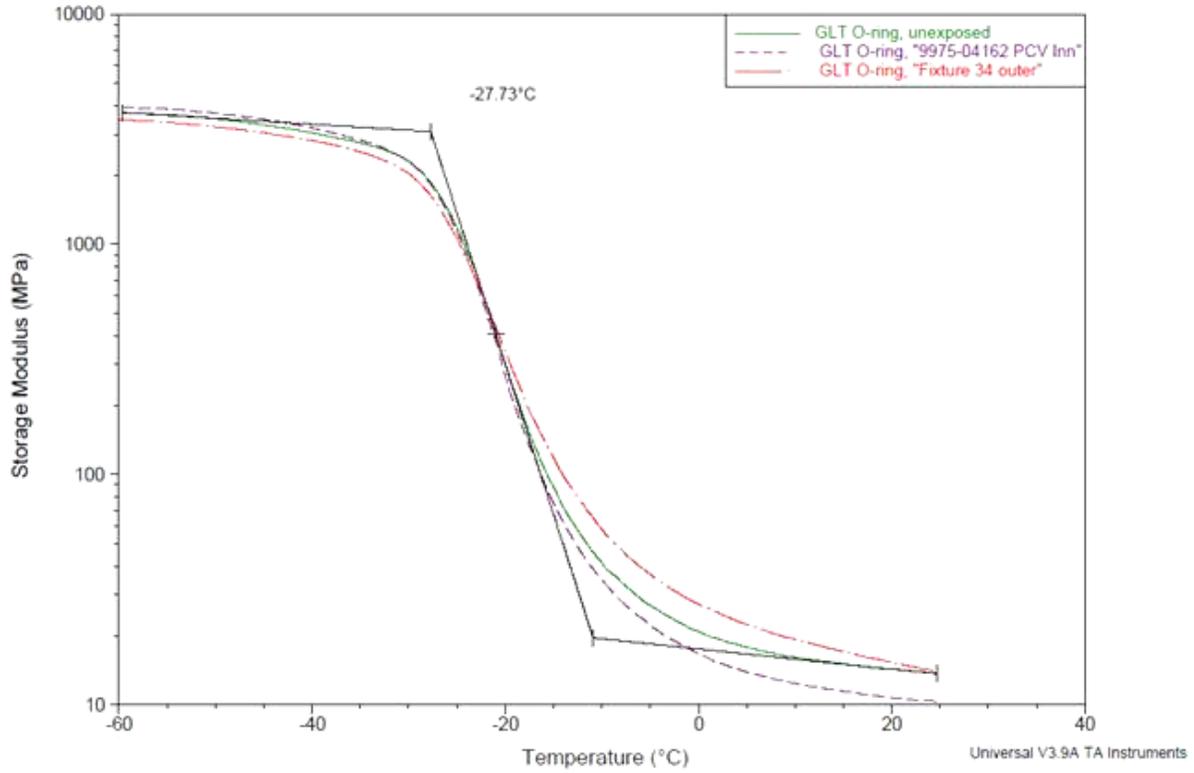
Figure 16. DMA results showing the glass transition temperature for the LE2 PCV inner O-ring. For comparison, results from a non-aged O-ring and an O-ring with a more severe aging history are also shown. The glass transition temperature for each sample was nearly identical, ranging from -27.7 to -28.6C.

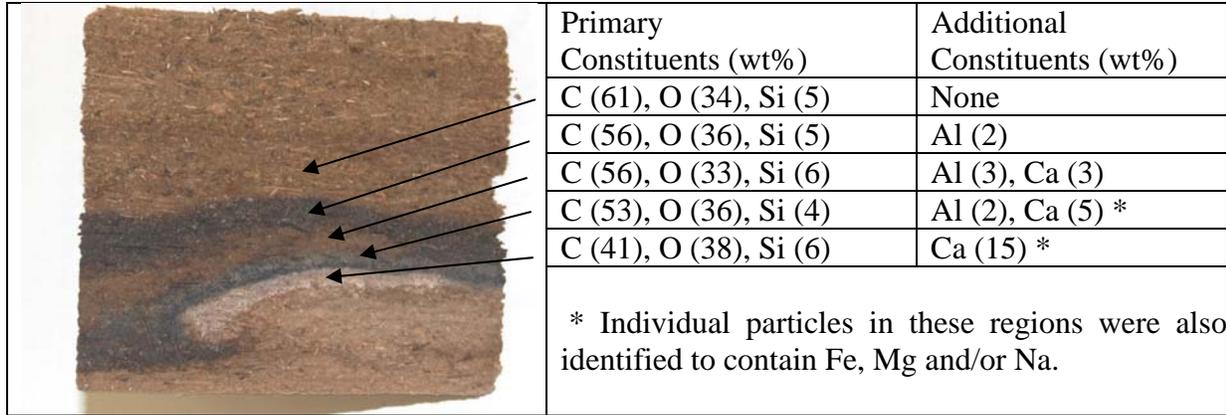
Figure 18. Scanning electron microscope elemental analysis for region near bottom of fiberboard.

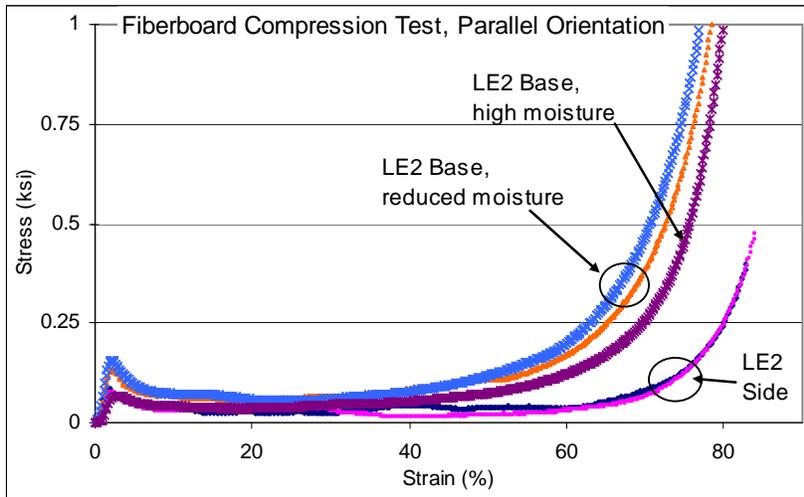
Some variation is seen in the compressive strength of the LE2 fiberboard samples for both test orientations (Figures 19, 20). A greater degree of variation is seen between these samples and undegraded fiberboard. Figures 25 and 26 compare these compression data with several laboratory samples, for the two test orientations. Comparative metrics for the various conditions are summarized and compared to laboratory samples in Table 4.

Figure 19. Compression stress-strain curves for LE2 fiberboard samples, parallel orientation.

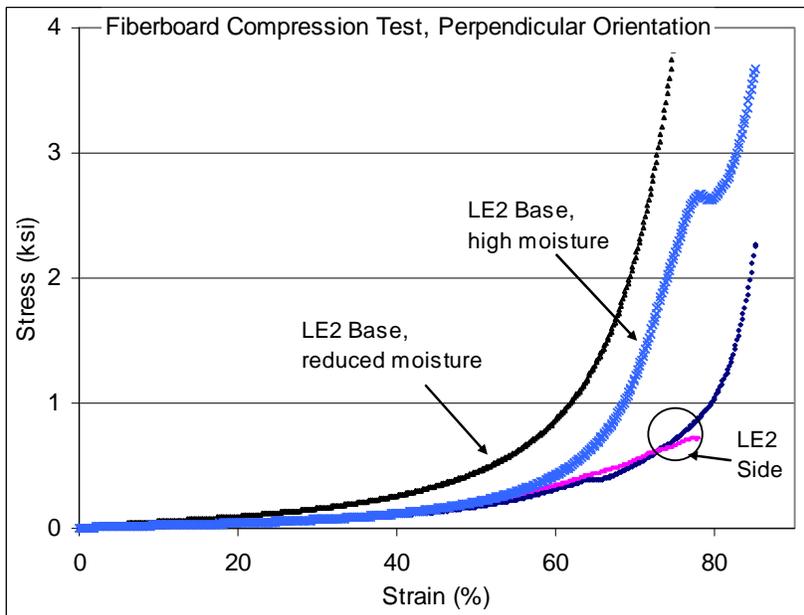
Figure 20. Compression stress-strain curves for LE2 fiberboard samples, perpendicular orientation.

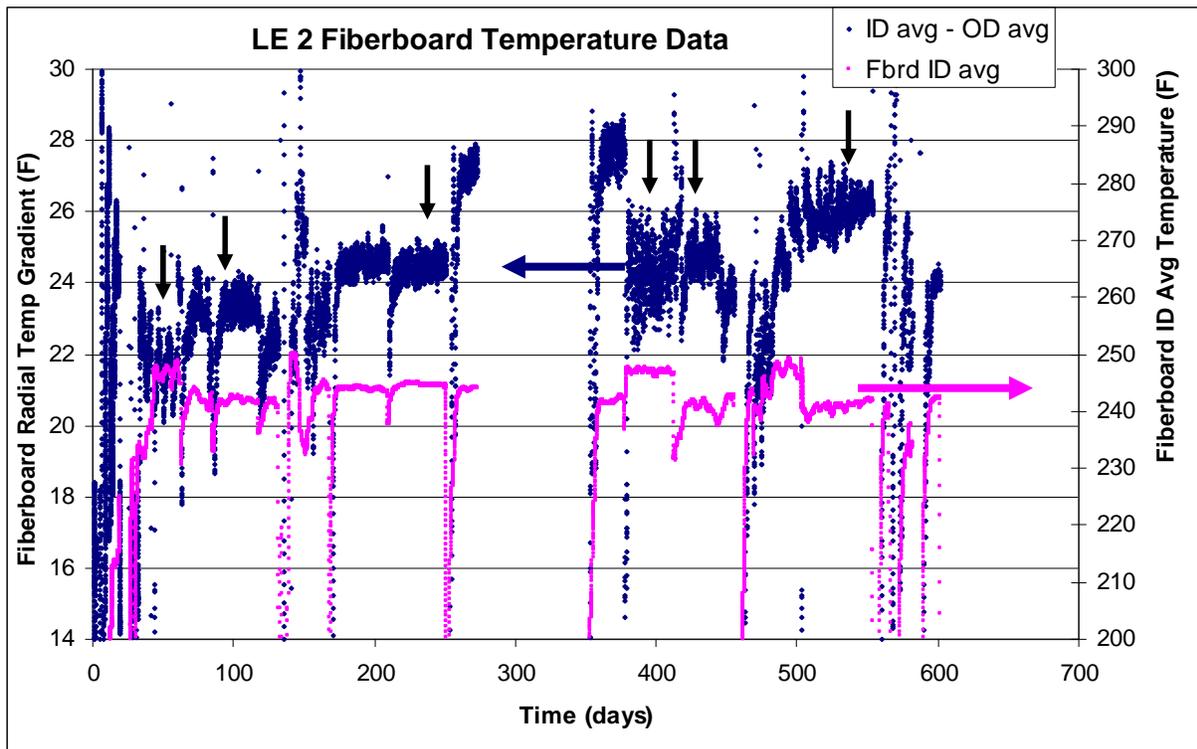
At each of the arrows in Figure 22, the radial temperature gradient and lower assembly thickness are combined per this relationship to get a value proportional to the thermal conductivity (see Table 6). Any change in this value over time is proportional to the change in actual thermal conductivity. (Since the actual heat flux through this region of fiberboard is unknown, the actual thermal conductivity cannot be calculated directly.)

Figure 22. LE package 2 average radial temperature gradient (blue symbols) in the fiberboard based on the upper 3 fiberboard ID thermocouples and the upper 3 fiberboard OD thermocouples, and average fiberboard ID temperature (pink symbols). The vertical arrows indicate times during steady state operation for which the relative thermal conductivity of the fiberboard was estimated.

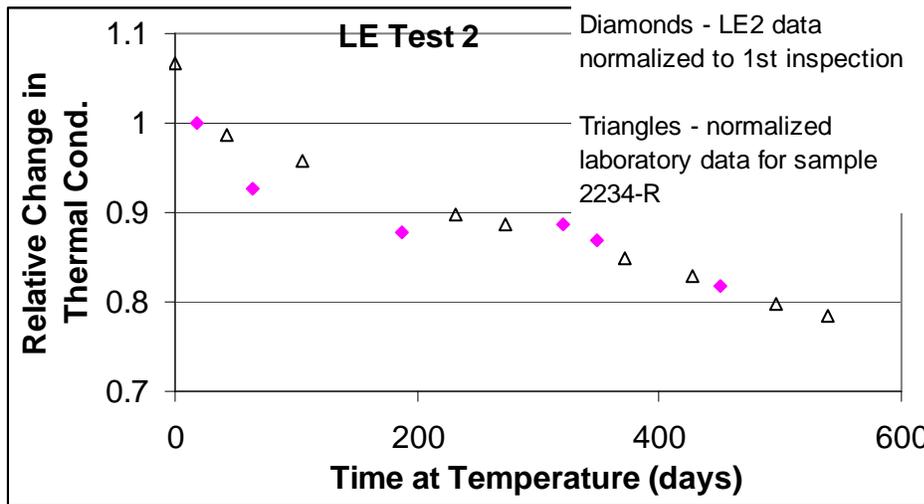
In Reference 6, the value at the first arrow in Figure 22 (at 52 days in test, 18 days at temperature) was taken as a reference point, and the values for subsequent data points show the change in thermal conductivity relative to this first data point. This produced the curve shown in Figure 23, which shows a net decrease over time comparable to that seen in laboratory samples conditioned at 250°F. Further review suggests that the assumption of constant heat flux might not be valid for the first data point (52 days in test), based on the following:

Figure 23. Relative change in radial thermal conductivity estimated from LE2 thermal gradient data, as reported in Reference 6. Comparable data from lab sample 2234-R for a mean test temperature of 185°F following conditioning at 250°F are also shown. These results are superseded by those shown in Figure 24.

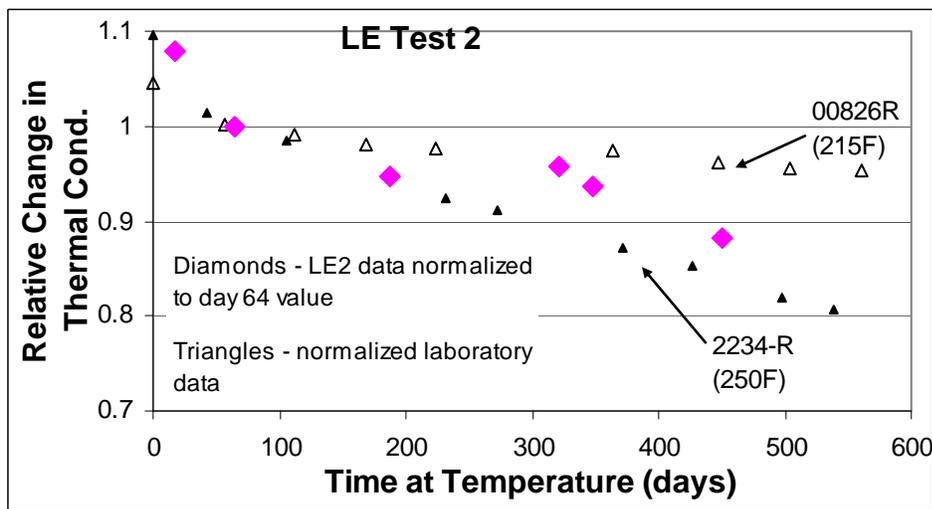
The second arrow in Figure 22 represents approximately 99 days in test (64 days at temperature). The data from this point and later are expected to better meet the assumption of constant heat flux. Accordingly, the relative change in thermal conductivity values were re-normalized to the second value after 64 days at temperature. These results are listed in Table 6 and plotted in Figure 24, along with normalized laboratory data for samples conditioned at 215 (sample 00826R) and 250°F (sample 2234-R) and tested at 185°F. In this presentation, the relative thermal conductivity values for LE2 show a decrease with time, and fall between the trends for the two laboratory samples. This intermediate behavior for LE2 is consistent with the estimated average sidewall temperature of ~235°F, which falls between the conditioning temperatures of the two laboratory samples.

Figure 24. Relative change in radial thermal conductivity estimated from LE2 thermal gradient data, re-normalized to the result for 64 days at temperature. The first data point (following 18 days at temperature) might not meet the assumption of constant heat flux compared to subsequent data points. Comparable data for laboratory samples 2234-R (conditioned at 250°F) and 00826R (conditioned at 215°F) are also shown. The mean test temperature for both laboratory samples was 185°F.

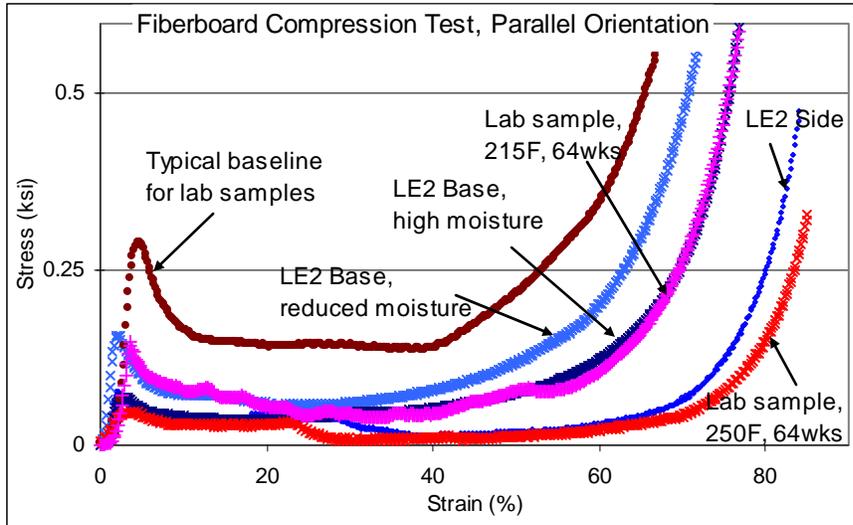
Samples tested with the load applied parallel to the fiberboard layers are compared in Figure 25. (This orientation is relevant to a side impact scenario, such as a forklift impact.) All the LE2 samples are significantly weaker than baseline (non-aged) samples. The LE2 sample from the side region is similar to laboratory samples aged at 250°F for 64 weeks. The LE2 sample from the base with elevated moisture is similar overall to laboratory samples aged 64 weeks at 215°F. The key difference is that the LE2 sample has a lower initial buckling strength. The LE2 sample from the base with a reduced moisture content regained some strength relative to the elevated moisture condition, but this sample is still significantly weaker than the baseline sample.

Figure 25. Compression stress-strain curves comparing LE2 fiberboard samples with laboratory samples, parallel orientation.

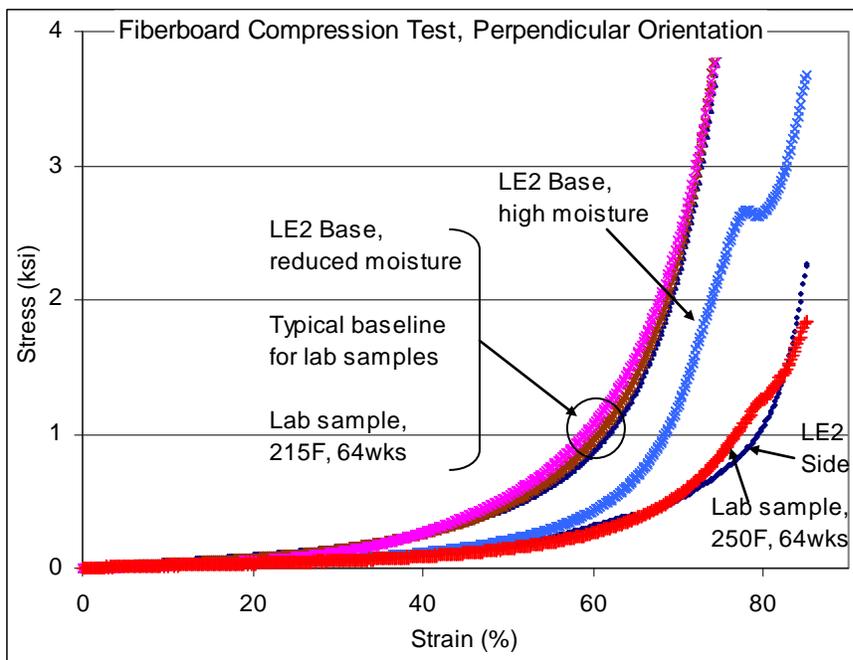
Samples tested with the load applied perpendicular to the fiberboard layers are compared in Figure 26. Similar to the parallel orientation, the perpendicular LE2 samples are consistent with laboratory samples aged at 250°F for 64 weeks. In contrast, the base LE2 samples with reduced moisture content are comparable to laboratory samples aged 64 weeks at 215F, and show no

Figure 26. Compression stress-strain curves comparing LE2 fiberboard samples with laboratory samples, perpendicular orientation.
