**DESTRUCTIVE EXAMINATION OF SHIPPING PACKAGE 9975-02168**

Savannah River National Laboratory  
Materials Science & Technology

Publication Date: November 2010

**Revision Log****Document No.** SRNL-STI-2010-00654 **Rev. No.** 0**Document Title** Destructive Examination of Shipping Package 9975-02168

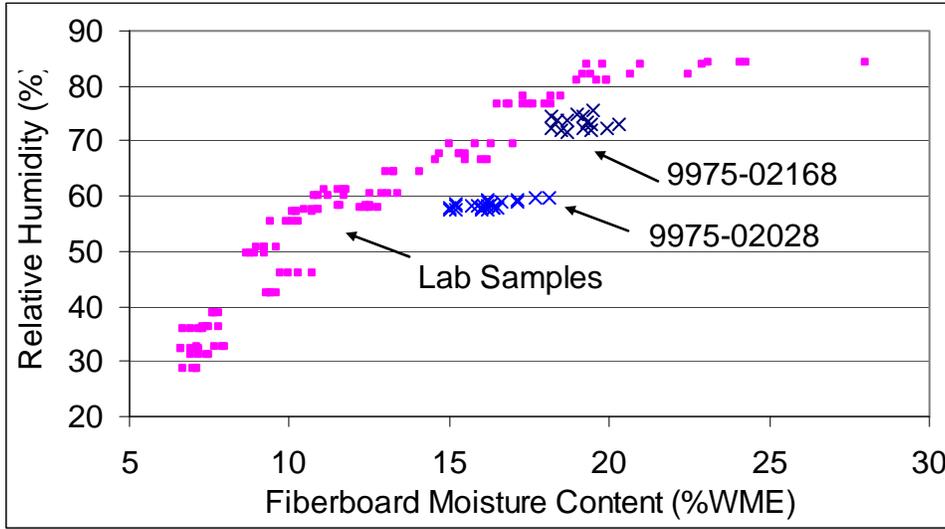
Consistent with recent efforts to correlate moisture content of fiberboard with humidity in the surrounding air, several sets of data were taken to correlate these two parameters. The fiberboard was placed back in the drum with a narrow channel cut down the side. A humidity probe was placed in this channel such that it could be raised and lowered with the drum closed. The edge of the drum lid was taped to seal around the gap created by the humidity probe cable. After the humidity came to equilibrium, humidity readings were taken at several elevations along the fiberboard, and the fiberboard was then removed to measure the moisture content at those same locations. This process was repeated several times to show the consistency in the results. These data are summarized in Figure 2, and compared to similar data from 9975-02028 and laboratory samples. All the data show a similar trend, although the data for the two 9975 packages are offset slightly from that for laboratory samples.

Figure 2. Correlation between fiberboard moisture content and relative humidity of the adjacent air. Data from 9975-02168 are shown with comparable data from 9975-02028 and laboratory samples. Measurements were taken along the fiberboard OD surface.

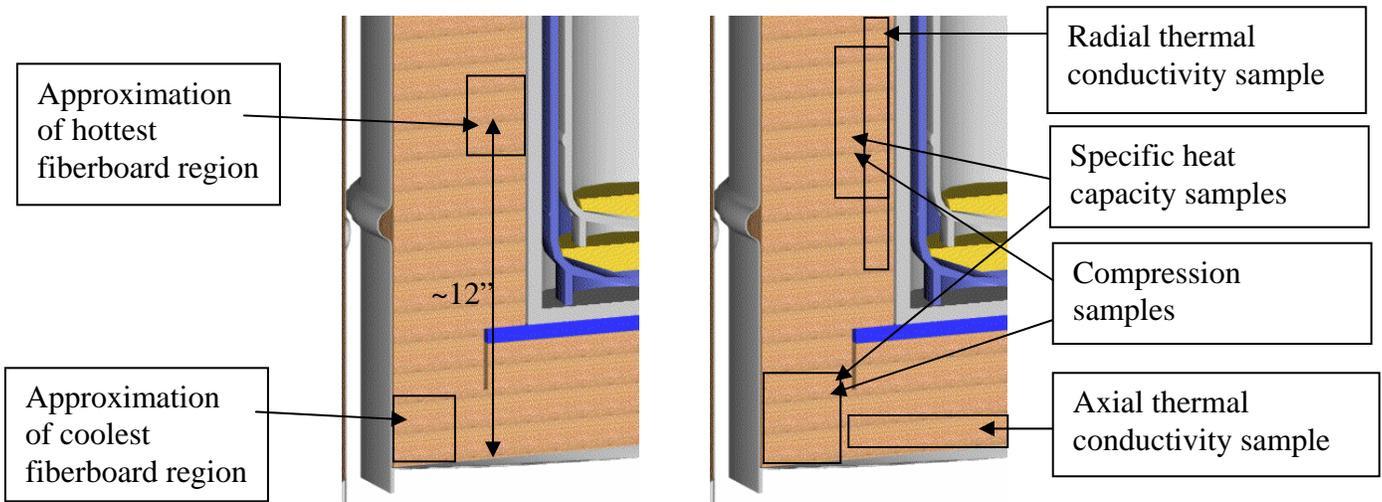
Samples of fiberboard were removed from the bottom fiberboard subassembly to measure compressive strength, specific heat capacity and thermal conductivity. The source location(s) of these samples is illustrated in Figure 3. The thermal conductivity sample from the bottom center of the subassembly is oriented for heat flow in the axial direction (perpendicular to the glue joints). The thermal conductivity sample from the side is oriented for heat flow in the radial direction (parallel to the glue joints). Testing on each sample was performed at a nominal (mean) temperature of approximately 25°C (77°F), with no environmental conditioning. Physical data on the fiberboard samples are recorded in Table 2.

Figure 3. Illustration of fiberboard regions of the bottom subassembly to be tested. Multiple samples (where used) were removed from the illustrated locations at different circumferential positions. Not to scale.

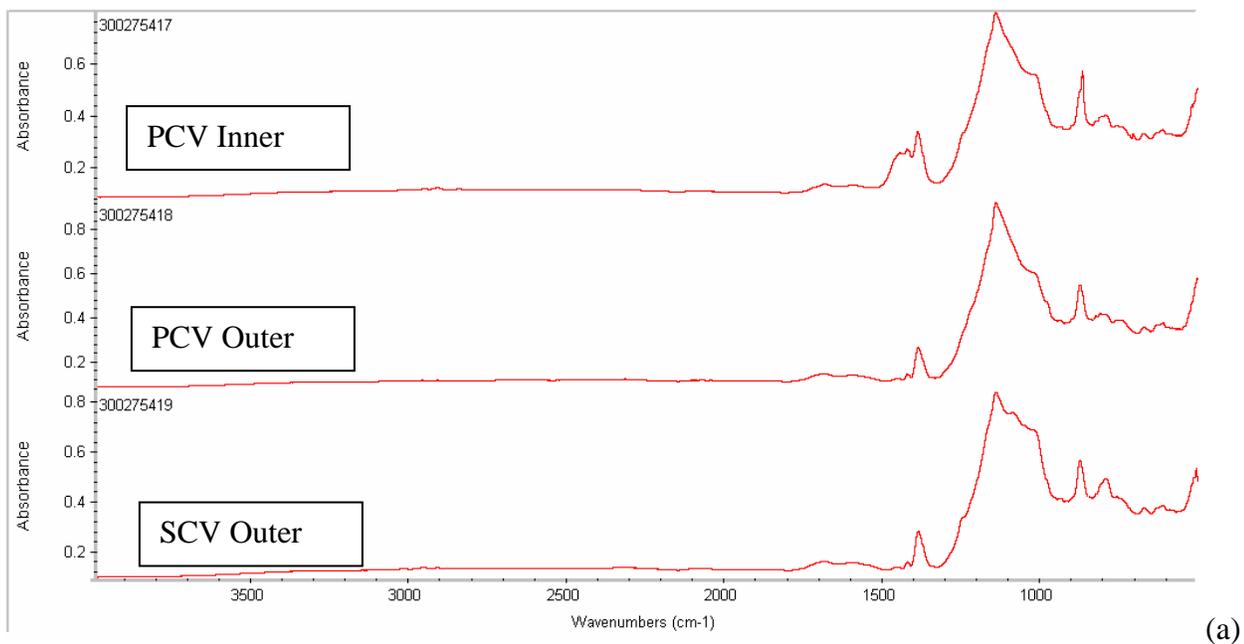
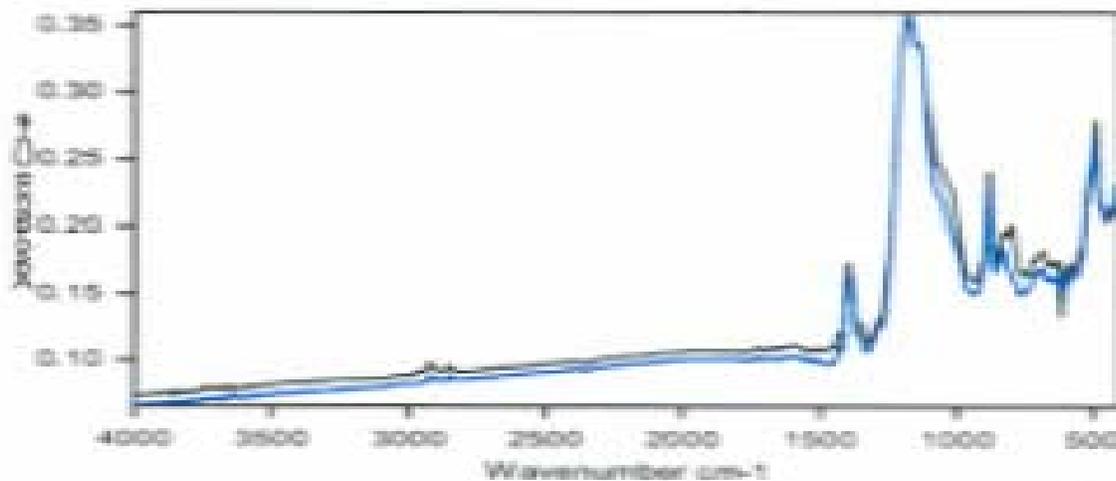
FT-IR spectroscopy generically identified the composition of each O-ring as consistent with a Viton<sup>®</sup> type fluoroelastomer (Figure 8). Viton<sup>®</sup> A produces a spectrum nearly identical to Viton<sup>®</sup> GLT, the base polymer for the specified O-ring compound (Parker Seals V0835-75) and

Figure 8. FT-IR spectra for the three tested O-rings (a). Each spectrum is consistent with a Viton® type fluoroelastomer (b).
