**MODEL 9975 LIFE EXTENSION PACKAGE 1 – FINAL REPORT**

Savannah River National Laboratory  
Materials Science & Technology

Publication Date: March 2011

**Document No.** SRNL-STI-2011-00113 **Rev. No.** 0

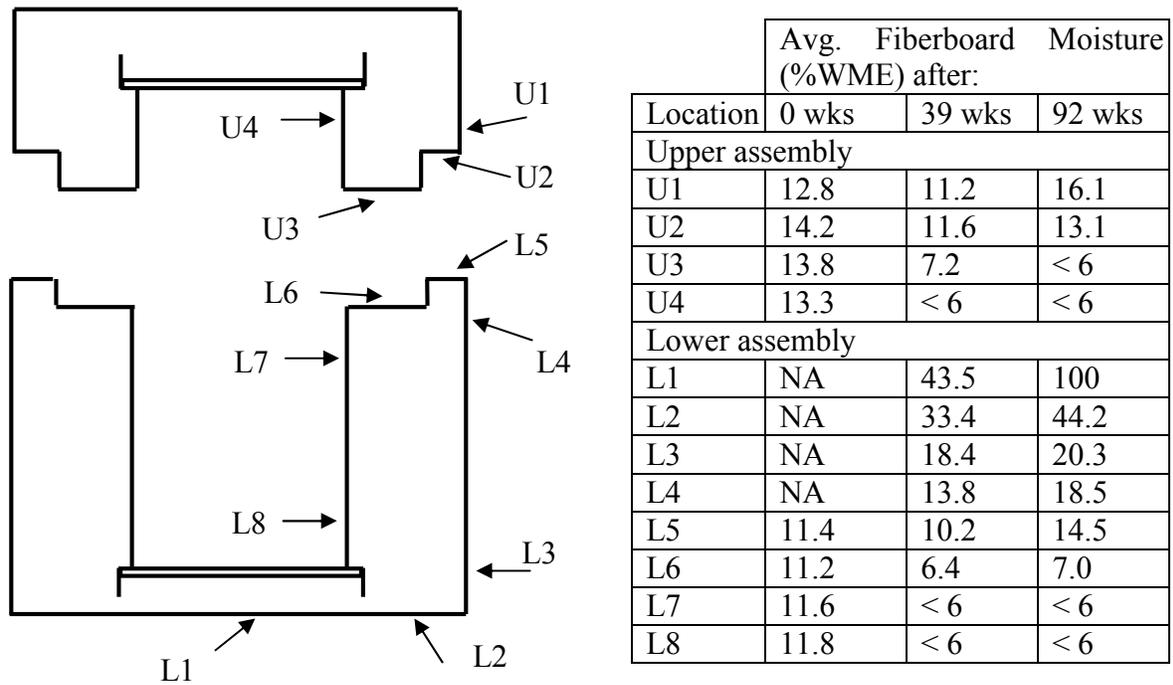
Figure 3. Summary of fiberboard moisture content variation during LE1 2<sup>nd</sup> phase.

- The moisture content of the fiberboard gradually changed throughout the test period. Moisture decreased on the inner surfaces, increased slightly on the outer side surfaces, and increased significantly on the bottom surface (Table 1, Figure 3).

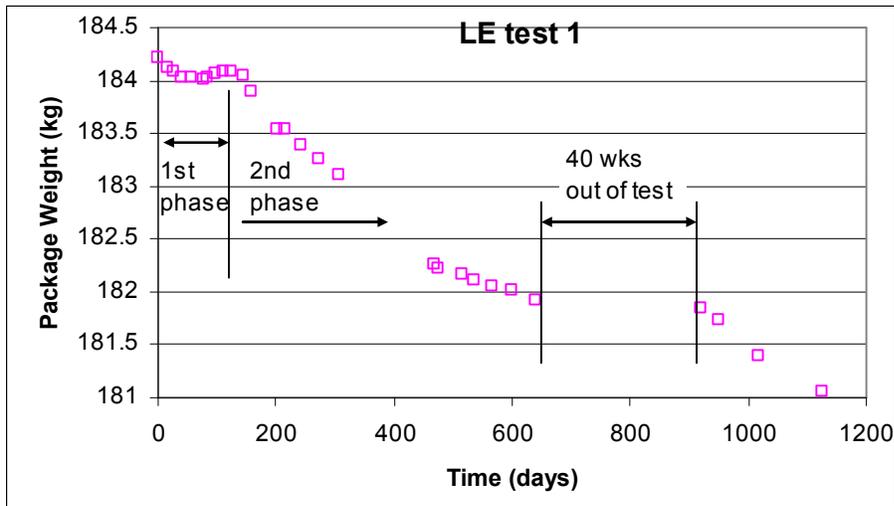
Figure 7. Package weight of LE1 over time.

Variation in the total weight of the package is summarized in Figure 7. Variation in the weight of the removable fiberboard sections is shown in Figure 8. The minor changes in weight of the removable sections trend well with the changes in moisture content of those sections, indicating relatively little actual degradation. It is assumed that the change in package weight is associated with the fiberboard alone (ignoring effects of weight gain from the shield and drum corrosion). It is further assumed that there was no significant moisture loss from the package. This assumption is based on the observation that the fiberboard moisture content and gradient remained approximately constant throughout most of the testing.

The total package weight decreased at an average rate of 0.0025% /day. The package initially contained 35.311 kg of fiberboard (based on the initial weight of both fiberboard assemblies and removable sections, minus the nominal weight of bearing plates and air shield). Accordingly, the overall average rate of fiberboard weight loss is 0.013 %/day, or 4.7 %/yr. Similarly, using the data from Figure 8, the average fiberboard weight loss rate for the small (upper) removable fiberboard section is 4.1 %/yr, and for the large (lower) removable fiberboard section is 3.3 %/yr (prior to the last inspection which saw a significant moisture (and weight) increase).

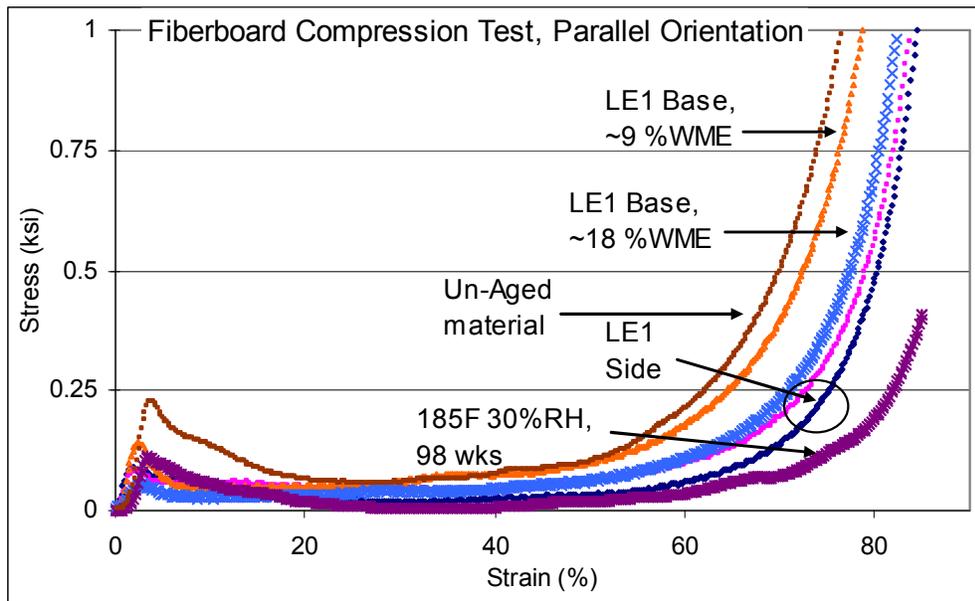
Figure 20. Compression stress-strain curves comparing LE1 fiberboard samples with unaged material and a typical laboratory sample aged a similar time at 185 °F 30%RH, parallel orientation.

Some variation is seen in the compressive strength of the LE1 fiberboard samples for both test orientations (Figures 20, 21). These figures also show the stress-strain curves for typical un-aged material. Comparative metrics for the compression tests are summarized and compared to laboratory samples in Table 5.

In comparison to the data from LE1 samples, compression testing has also been performed on samples conditioned at 185 °F 30%RH for up to 98 weeks. A stress-strain curve for this condition is also shown in Figure 20. The metrics for this case are similar to those for the LE1 package (Table 5). Comparison to test data for un-aged material shows that the LE1 fiberboard experienced a significant reduction in strength and energy absorption. It is noted, however, that the LE1 sample metrics show a minimum area under the stress-strain curve up to 40% of 14 psi. Separate analysis has shown that the package will meet energy absorption requirements during a forklift impact event even with the area under the stress-strain curve up to 40% reduced to 11 psi [7]. Therefore, it is expected that the condition of the fiberboard in LE1 would still meet the energy absorption requirement for storage.

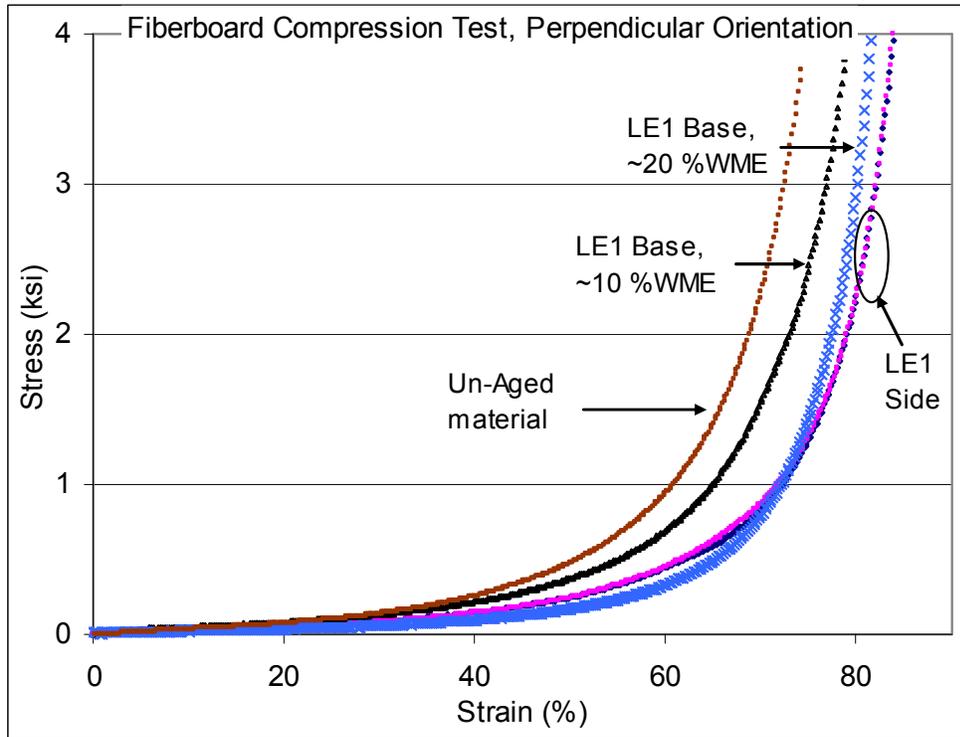
Figure 21. Compression stress-strain curves comparing LE1 fiberboard samples with unaged material, perpendicular orientation.

Samples tested with the load applied perpendicular to the fiberboard layers are compared with un-aged material in Figure 21 and Table 5. Similar to the parallel orientation data, the LE1 fiberboard is weakened relative to un-aged material, but should not compromise the mechanical property requirements for storage.

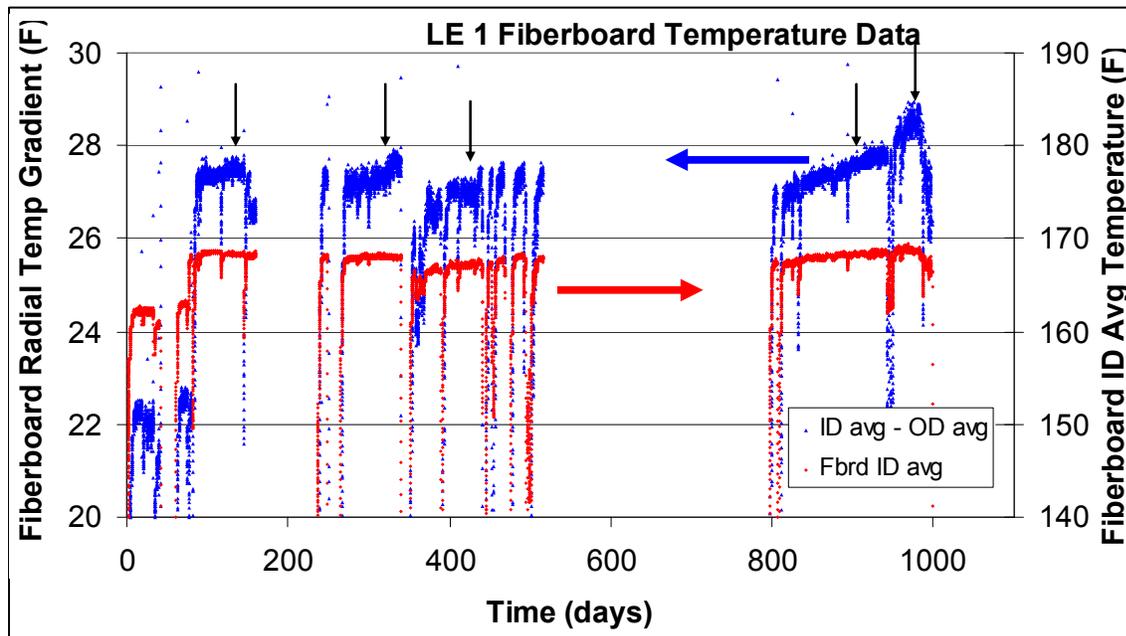
Thermal gradient information was examined at several discrete times during periods of steady state operation indicated by the vertical arrows in Figure 22. The thermal conductivity will vary with changes in the temperature gradient and fiberboard thickness, as described by:

At each of the vertical arrows in Figure 22, the radial temperature gradient and lower assembly thickness are combined per this relationship to get a value proportional to the thermal conductivity (see Table 7). Any change in this value over time is proportional to the change in actual thermal conductivity. (Since the actual heat flux through this region of fiberboard is unknown, the actual thermal conductivity cannot be calculated directly.)

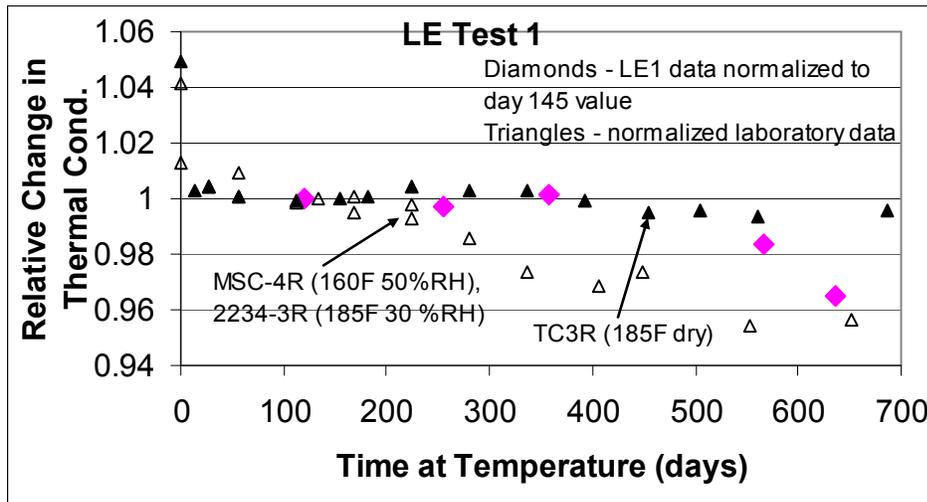
The value at the first arrow in Figure 22 (after 120 days at temperature) was taken as a reference point, and the values for subsequent data points show the change in thermal conductivity relative to this first data point. These results are listed in Table 7 and plotted in Figure 23, along with normalized laboratory data for samples conditioned at 160 °F 50%RH (sample MSC-4R), 185 °F 30%RH (sample 2234-3R) and 185 °F dry oven (sample TC3R) and tested at 185 °F. In this presentation, the relative thermal conductivity values for LE1 show a decrease with time at a rate of ~2.5 %/year, and fall within the range of trends for the laboratory samples. None of the laboratory sample trends show a significant change in thermal conductivity over time (less than 6% decrease over 1.8 years), indicating that actual storage conditions are relatively benign with regards to thermal conductivity performance. Calculations have shown that the 9975 package will perform its thermal insulation function (for normal operation and postulated fire scenario in KAMS) even with 20% reduction in fiberboard thermal conductivity [8]
