**Savannah River
National Laboratory™**

3013 DE Inner Container Closure Weld Corrosion Evaluation

September 2013

SRNL-STI-2013-00527, Revision 0

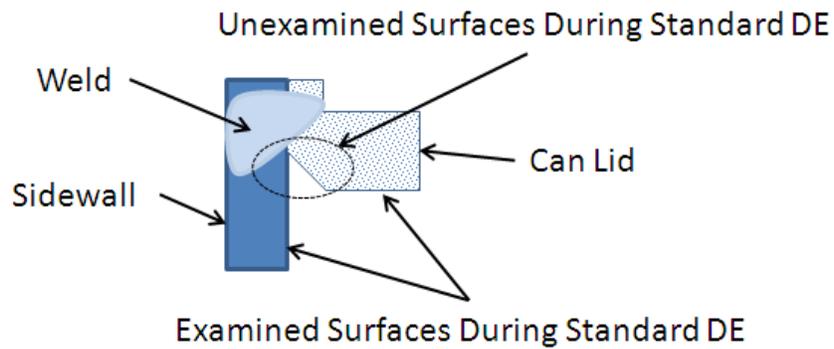
Figure 2-2 Schematic drawing showing surfaces of the inner container closure weld gap formed between the container sidewall and lid

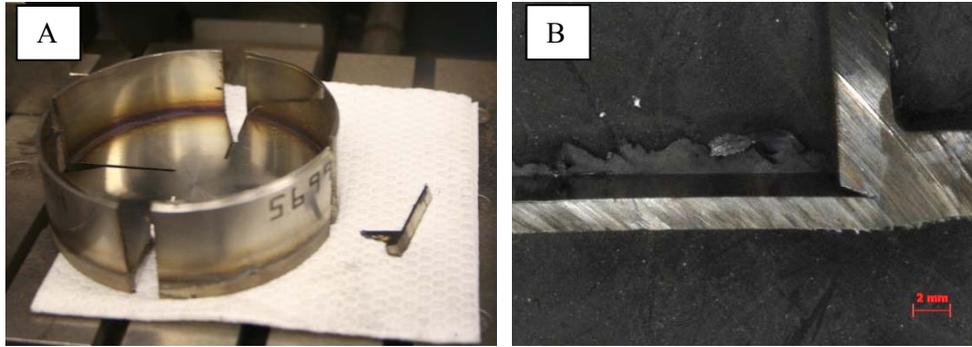
Figure 2-3 HHMC inner container lid: A) removal of pie section from for additional examination and B) side view of the closure weld gap

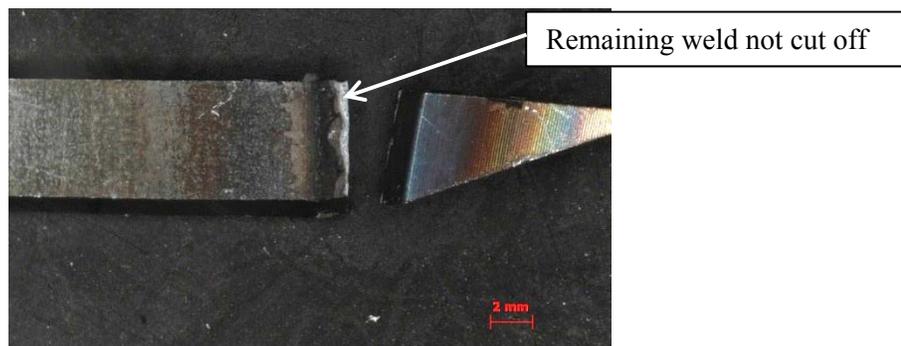
The inner container lid was sectioned at the four orthogonal positions with the 0° location being the endpoint of the welding. The quantity of material at the gap opening varied around the circumference of the lid. Once the sample was cut from the lid, the closure weld was cut off the sample and the lid piece was separated from the sidewall as shown in Figure 4-1. Compare this photograph with the side view shown in Figure 2-3 (B); note the absence of the weld section in Figure 4-1. The lid and sidewall surfaces within the gap were irregular with some corrosion products as shown by the stereo-micrograph images in Figure 4-2. The surface had a banded appearance, i.e. different surface morphologies at different locations moving from the weld towards the gap opening.

Figure 4-1 Sidewall and lid pieces from the 90° pie section of the HHMC inner container closure weld region after removal of the closure weld

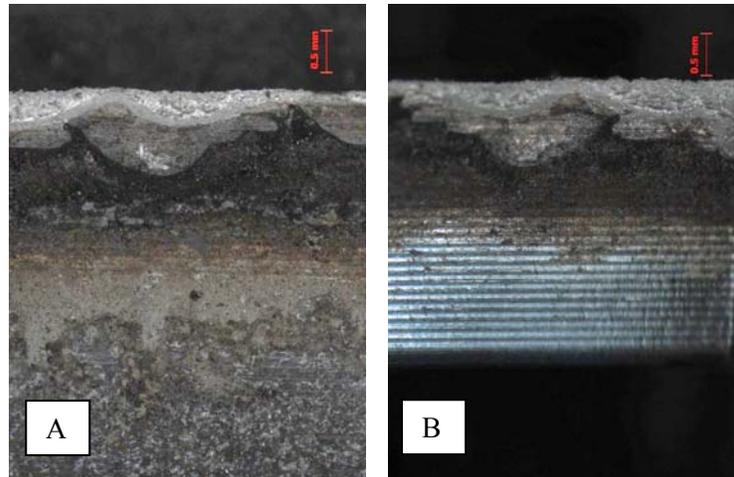
Figure 4-2 Sidewall (A) and lid (B) pieces from the 90° pie section of the HHMC inner container closure weld region after removal of the closure weld (25x)

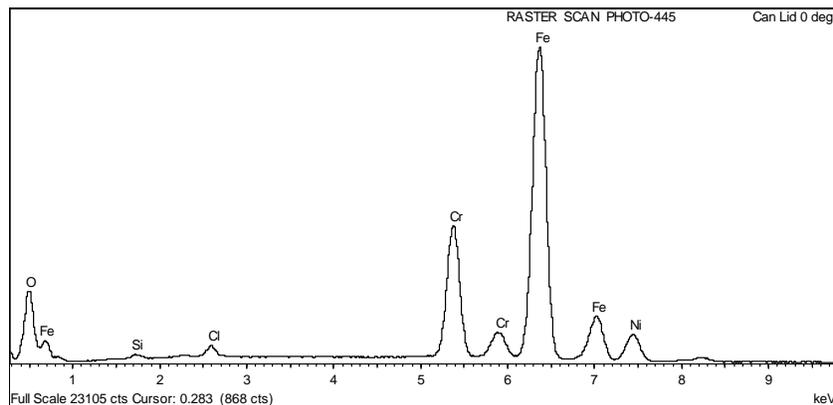
The surfaces were analyzed for the presence of chloride using EDS. A raster scan of the lid and sidewall pieces for each pie section showed chloride was present (See Figure 4-4). The chloride was found to be present with oxides and particulates that were analyzed. Chlorides were also found with these same surface features after cleaning the samples, although raster scans were not performed to evaluate the overall chloride content.

Figure 4-4 EDS spectrum from a raster scan for the sidewall piece from the 0° pie section of the HHMC prior to cleaning

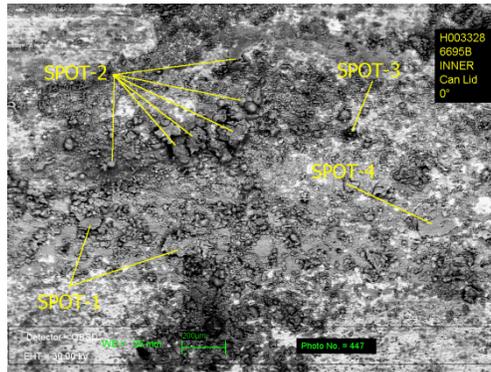
A number of features were found that were common on many of the gap surfaces from the four orthogonal pie sections. The SEM micrograph from the sidewall piece from the 0° pie section shown in Figure 4-5 is used as reference in describing the results of the EDS analysis. Aluminum, silicon and lead bearing compounds were found on many of the pieces (See Figure 4-6 (A)). The source of this material is unknown, but are not common constituents of the base metal (other than silicon). Sometimes calcium, potassium and magnesium were also associated with these features. Iron-rich and chromium-rich oxides were also identified (See Figure 4-6 (B) and (C)). These oxides may be associated with the welding process since iron-rich and chromium-rich oxides are formed [4]. Many oxides had chloride associated with them as shown in Figure 4-6 (C) and are probably associated with the observed corrosion.

Figure 4-5 Surface of the sidewall piece from the 0° pie section of the HHMC showing the locations for the EDS point analysis of various surface features

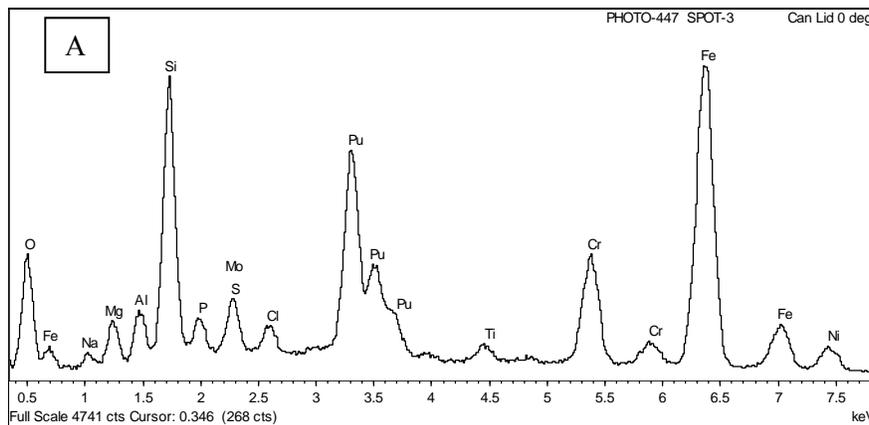
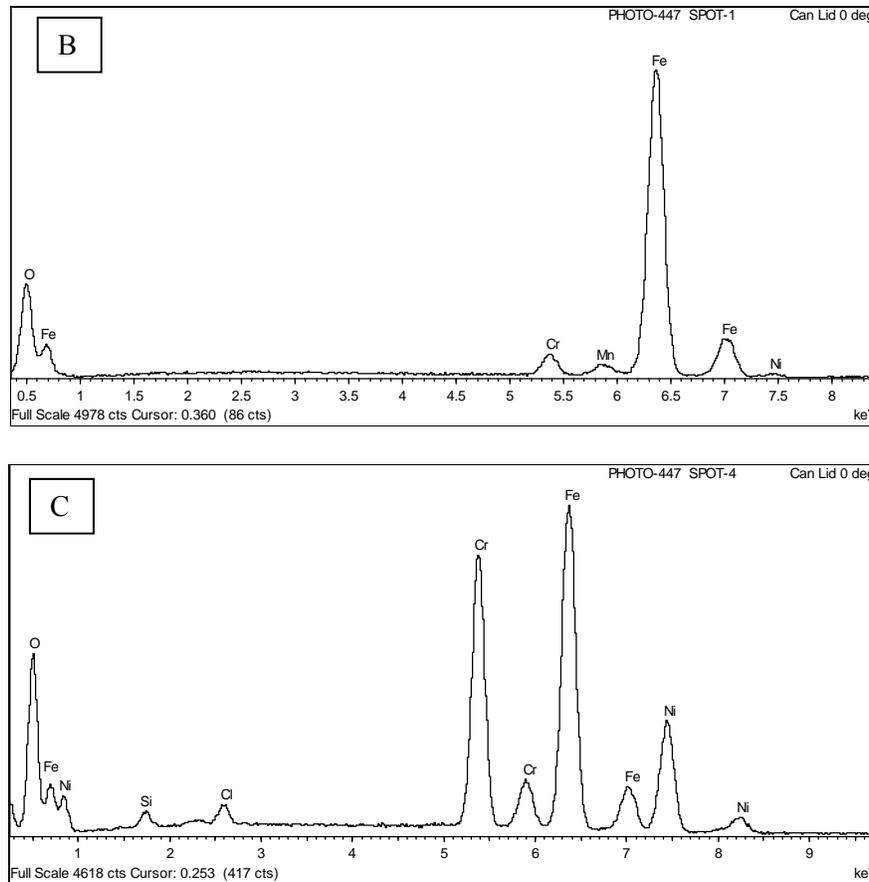
Figure 4-6 EDS spectra from point analysis of surface features on the sidewall piece from the 0° pie section of the HHMC: A) spot 3, multi-elemental feature; B) spot 1, iron-rich oxide; and C) spot 4, chromium-rich oxide (see Figure 4-5 for the location of the point analyses)

Figure 4-6 (Continued) EDS spectra from point analysis of surface features on the sidewall surface from the 0° pie section of the HHMC: A) spot 3, multi-elemental feature; B) spot 1, iron-rich oxide; and C) spot 4, chromium-rich oxide (see Figure 4-5 for the location of the point analyses)

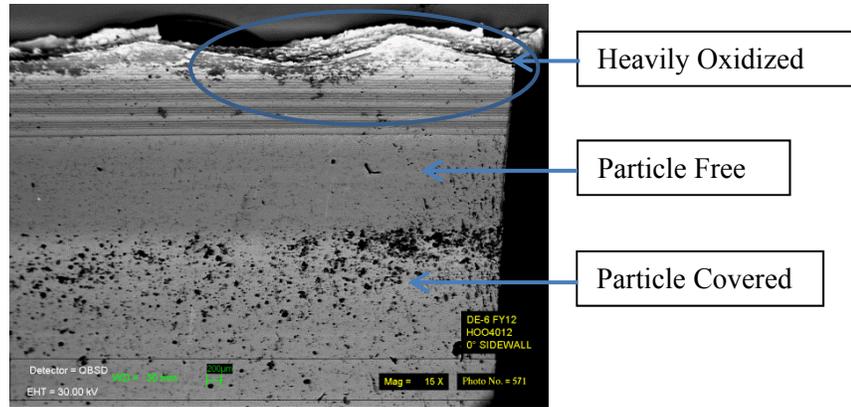
The surface of the sidewall had a banded appearance as shown in Figure 4-18 with a heavily oxidized (weld and corrosion) surface near the weld (See Figure 4-19 (A)), and then a particle-free surface near the start of the machine marks, and finally a surface with particle/oxide build up near the gap opening. Both oxides were found to be both chromium and iron rich. Figure 4-19 shows the locations that EDS spectra were taken and select spectra are shown in Figure 4-20. A comparison of the oxide spectra (Figure 4-20 (A) – (D)) with the baseline spectrum (Figure 4-20 (E)) shows the differences in chromium and iron concentrations. The presence of chloride was found only near the weld (Figure 4-20 (C)) and was associated with a large oxygen peak.

Figure 4-18 SEM micrograph (backscattered electron image, 15x) of the surface of FY12 DE6 sidewall from the 0° pie section

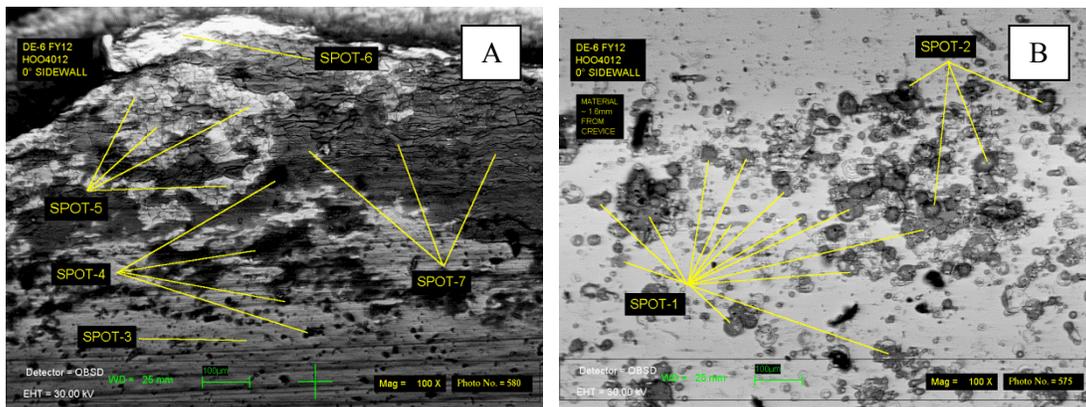
Figure 4-19 SEM micrographs (100x) showing the locations of EDS spectra for the heavily oxidized surface (A) near the weld and the particle-covered surface (B) nearer the gap opening

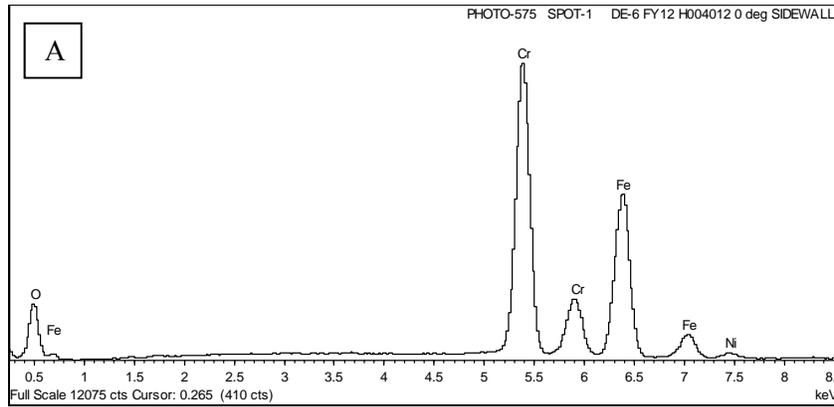
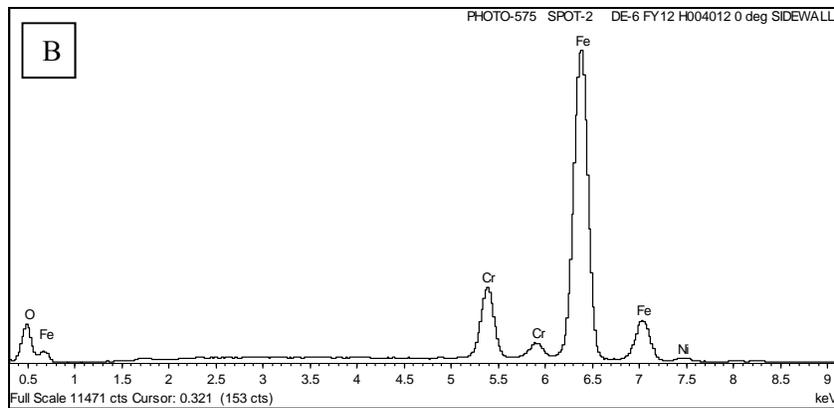
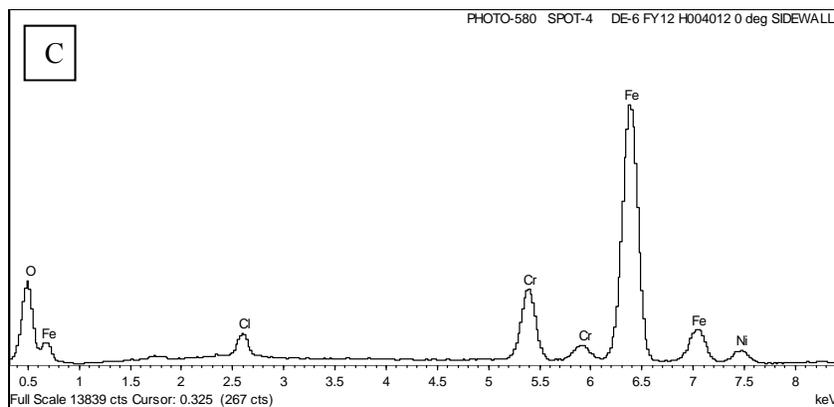
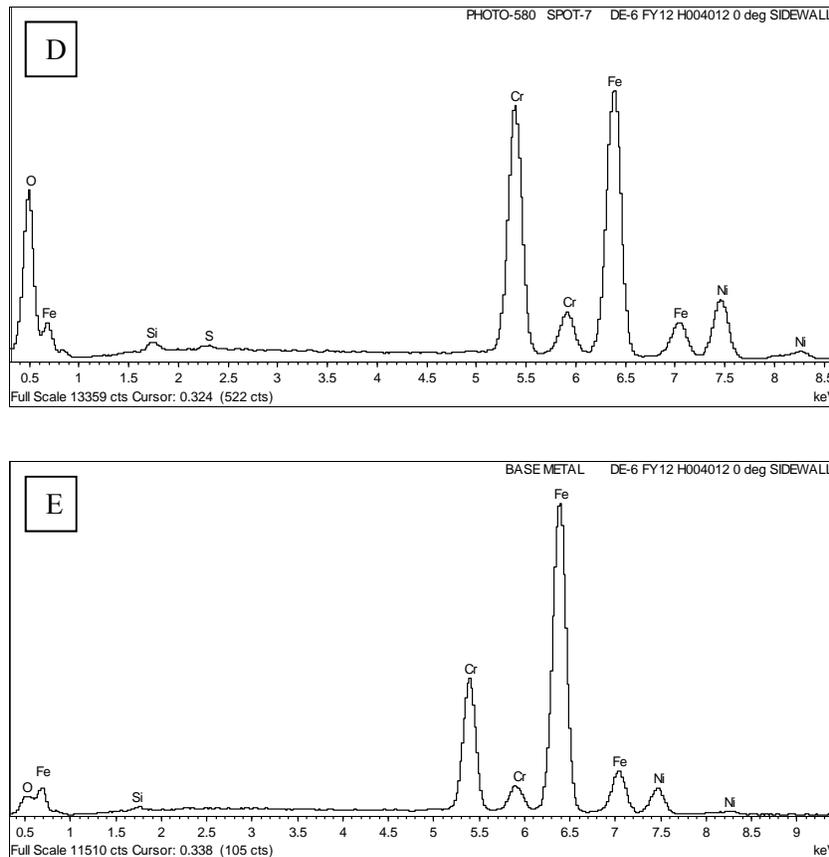
Figure 4-20 EDS spectra of spots shown in Figure 4-19: 1 (A), 2 (B), 4 (C) and 6 (D); and a base metal spectrum is shown in (E)

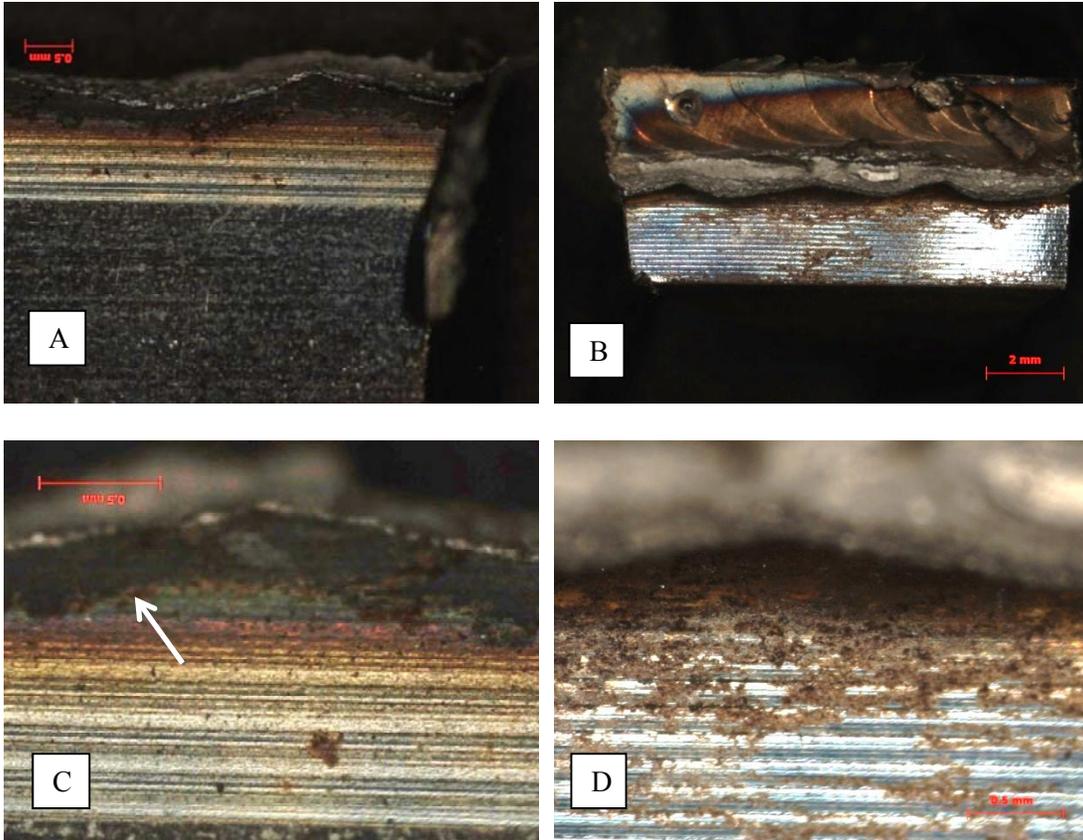
The stereomicroscope examination was performed for both the sidewall and lid pieces of the 0° pie section. Corroded areas, as indicated by the non-uniform rust-colored surface, were observed on both the side wall and lid as shown in Figure 4-21. The circled area in the SEM micrograph shown in Figure 4-18 is the same as shown in the stereomicroscope image in Figure 4-21 (A). Higher magnification pictures shown in Figure 4-21 (C) and (D) show the corrosion at higher magnification.

Figure 4-21 Stereomicroscope images of the sidewall (A, 25x and C, 63x) and lid (B, 10x and D, 50x) pieces from the 0° pie section of FY12 DE6

The large pit may be associated with the observed corroded area indicated by the white arrow in Figure 4-21 (C), which has a waviness associated with the welding process. Although the corrosion was not severe at the 0° pie section, a similar surface morphology, as shown by the SEM and stereomicroscope observations, could be expected for the 90° pie section since previous observations of multiple pie section from the HHMC and FY12 DE4 showed surfaces with similar surface morphologies.

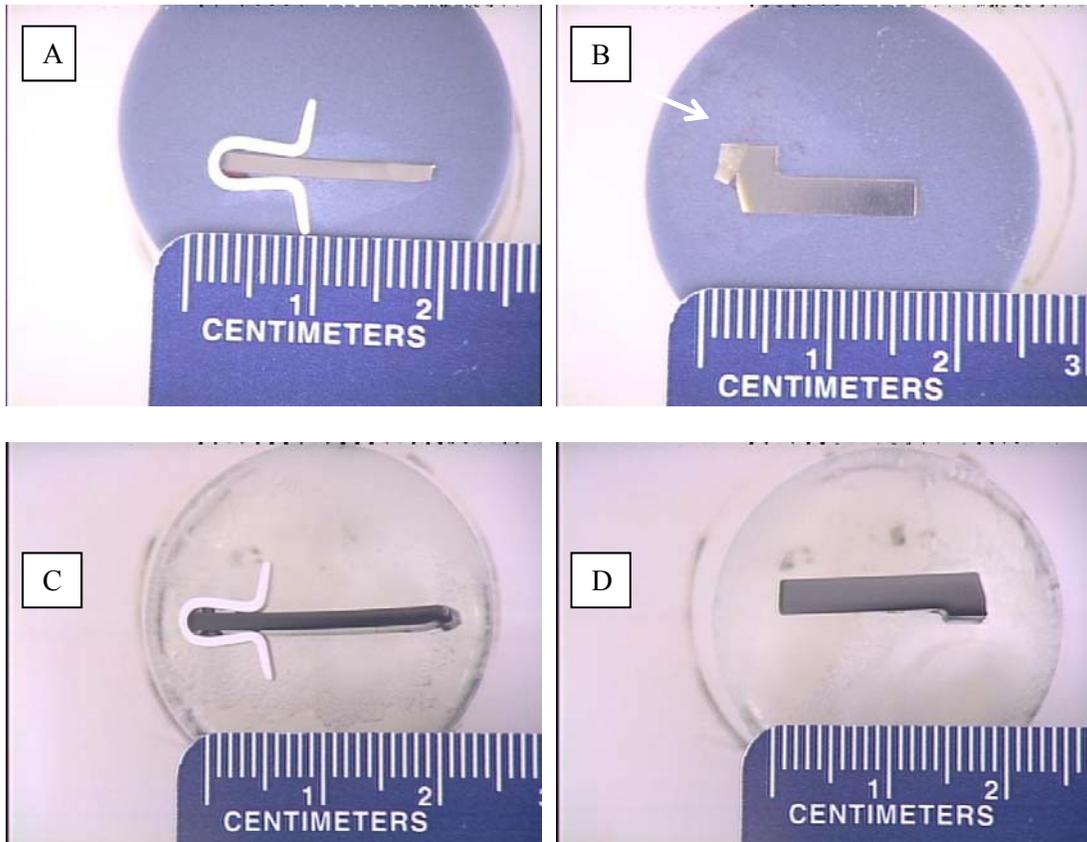
Both the 0° and 90° pie sections were mounted and examined in cross section using serial metallography. When preparing the pie sections for observation, the closure weld is removed just above the end of the gap so that the lid and sidewall container can be separated. In some cases, however the sidewall will break below the top of the gap, which keeps intact the top of the closure weld gap. Figure 4-22 shows photographs of the mounted samples for the 0° pie section where the sidewall broke below the top of the gap and the 90° pie section where the sidewall and lid pieces separated cleanly. The arrow in Figure 4-22 (B) shows the sidewall ligament remaining connected to the lid.

Figure 4-22 Mounted sidewall and lid pieces from the 0° (A and B, respectively) and 90° (C and D, respectively) pie sections of FY12 DE6

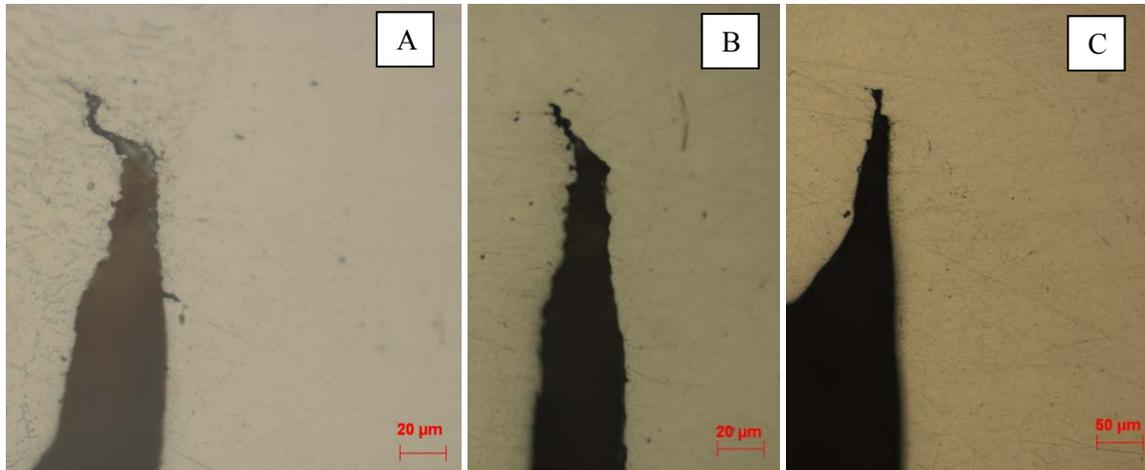
For the 0° pie section, a crevice was found at the top of the gap as shown in Figure 4-23. Some small pits were observed in this region as shown in Figure 4-23 (A and B), but they are superficial (<5 μm). The crevice is characterized by the narrow opening (<5 μm) with a longer path (~ 20 μm). No other degradation was observed on the sidewall or the lid pieces.

Figure 4-23 Progressive changes with grinding and polishing in the crevice at the top of the 0° pie section from the inner container closure weld gap for FY12 DE6; (A), (B), and (C) are different planes with (A) being closest to the edge of the pie section, 200x

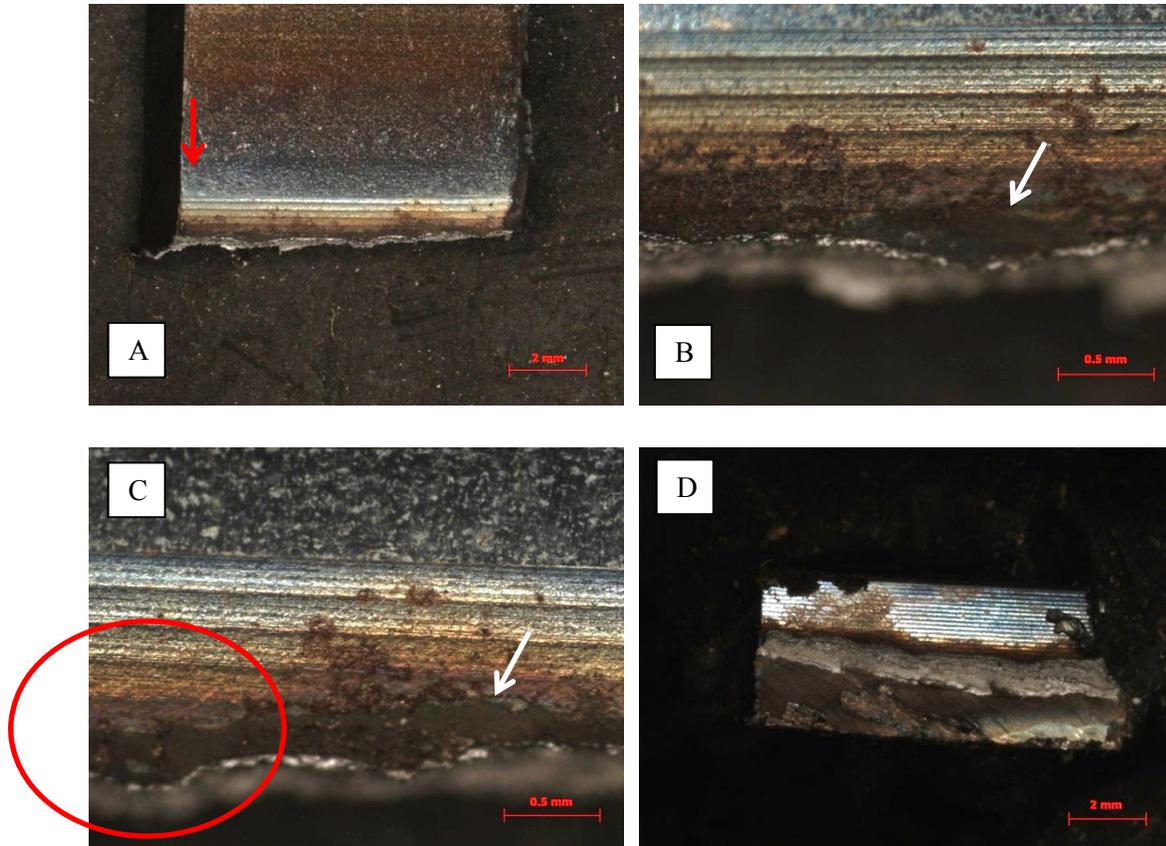
The stereomicroscope photographs of the 0° pie section showed that both the sidewall and lid had corroded as shown in Figure 4-26. The sidewall had features that appeared to be pits (Figure 4-26 (B) and (D)) while the lid piece showed general surface breakdown. Near the edge of the fractured weld as shown by the white arrows in Figure 4-26 (B) and (D), some areas of the surface showed a trough like feature since their focus plane laid below that of the image. This trough does not run down the length of the sample.

Figure 4-26 Stereomicroscope photographs of the sidewall and lid pieces from the 0° pie section for FY12 DE7: (A) sidewall, 10x; (B) sidewall, 50x; (C) sidewall, 50x; and (D) lid, 10x

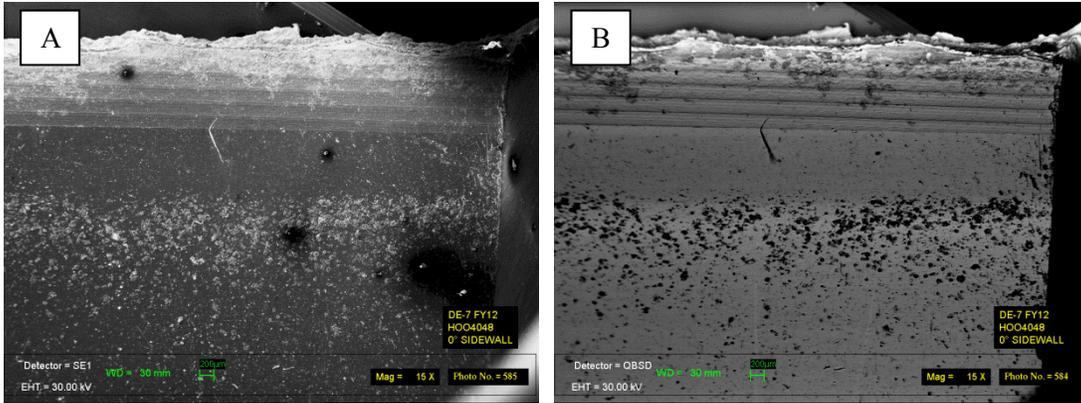
The SEM analysis showed that the sidewall from the 0° pie section was similar to that observed for FY12 DE6. The surface had a banded appearance with three areas (See Figure 4-27): close to the weld had oxides and corrosion products, an area free of particulate and closer to the gap opening a heavy density of particulate on the surface. Pitting, if present, was obscured by the presence of corrosion oxide and particulates.

Figure 4-27 SEM micrographs (15x) of the sidewall from the 0° pie section for FY12 DE7: (A) secondary electron image and (B) backscattered image

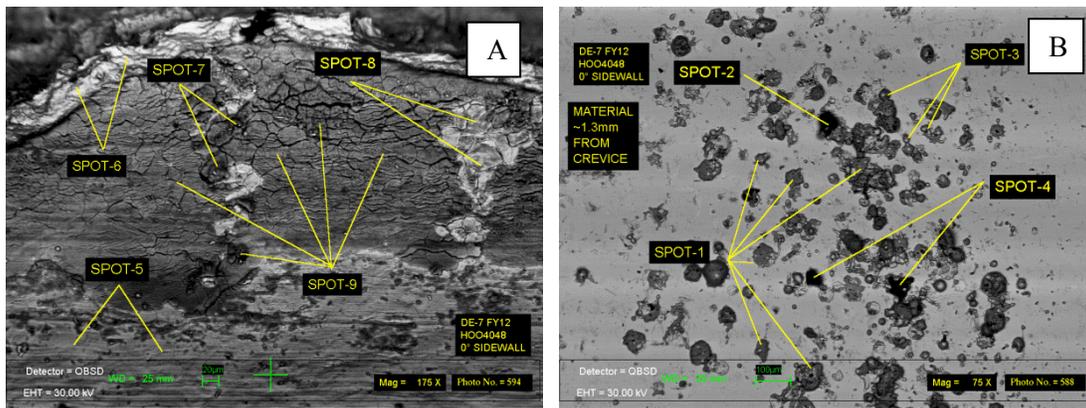
The EDS spectra showed that the oxides were a combination of chromium-rich, iron-rich and nominal composition (as compared to a base metal scan). The locations of the spot analyses are shown in the micrographs in Figure 4-28, which were taken near the weld (A) and near the gap opening (B). The spectra are shown in Figure 4-29. The area near the weld shown in Figure 4-28 (A) is the same as that shown by the red circle in Figure 4-26 (C). Figure 4-29 (A) shows the spectra for the base metal taken as a raster scan of the sidewall away from the gap region. Chromium-rich oxides were observed in both locations (spots 2 and 9), while iron-rich oxides were only identified near the weld (spot 8). The presence of the Al/Mg/Si/Ca compound was identified only near the gap opening.

Figure 4-28 SEM micrographs showing the locations of EDS spectra for the heavily oxidized sidewall surface near the weld (A, 175x) and the particle-covered surface close to the gap opening (B, 75x) from the 0° pie section for FY12 DE7

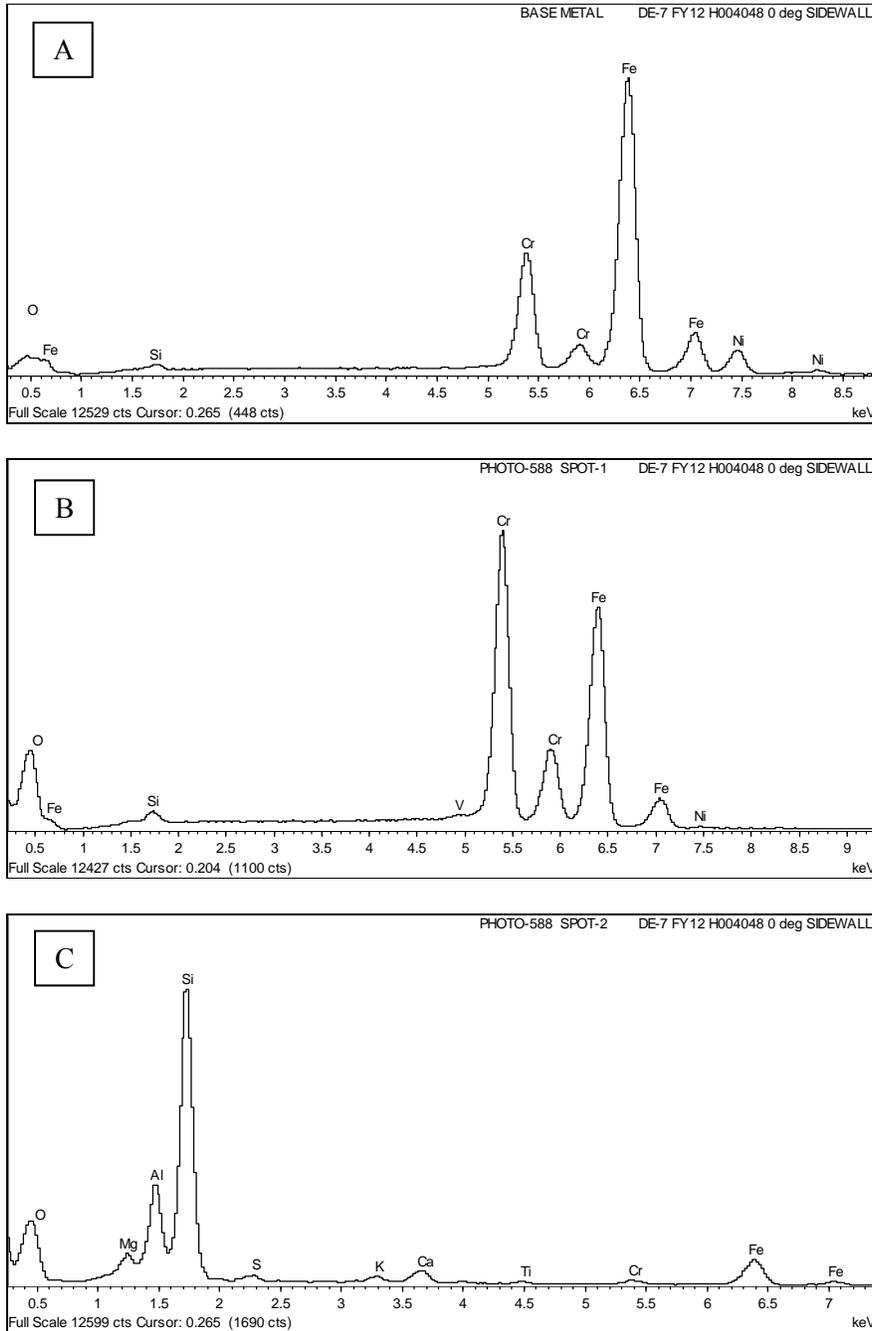
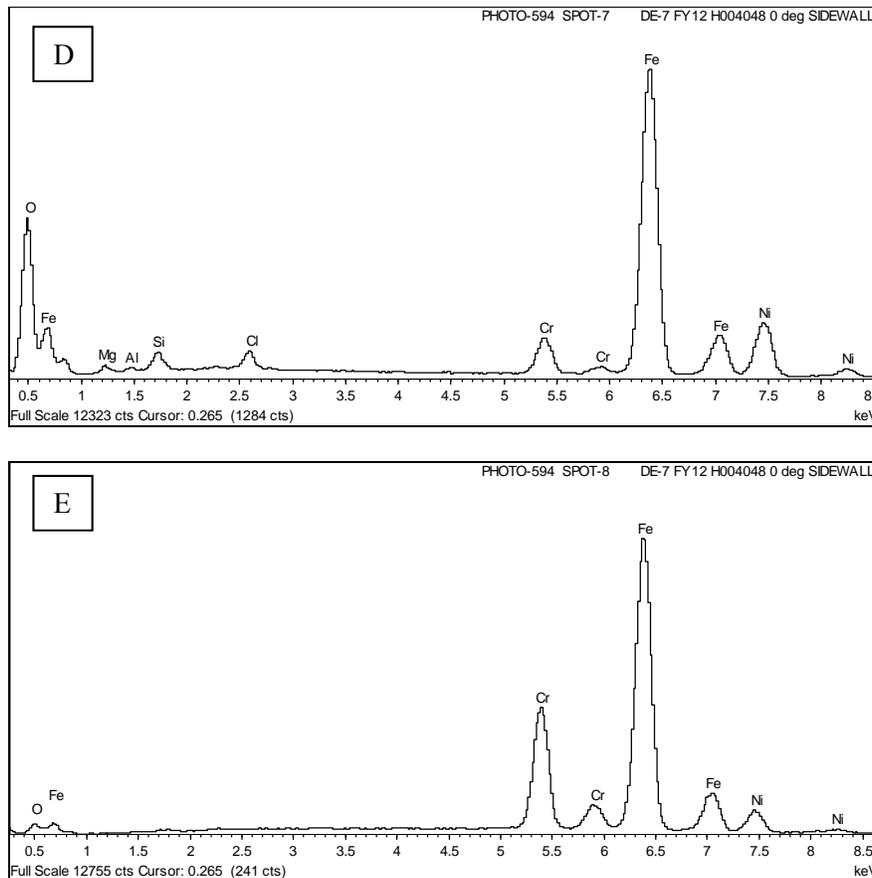
Figure 4-29 EDS spectra of the sidewall from the 0° pie section for FY12 DE7; spots identified in Figure 4-28: (A) base metal raster scan; (B) spot 1, Cr-rich oxide; (C) spot 2, Al/Si/Mg/Ca from particulate heavy area; (D) spot 7, Fe-rich oxide; (E) spot 8 oxide of nominal composition (compare to base metal scan)

Figure 4-29 (Continued) EDS spectra of the sidewall from the 0° pie section for FY12 DE7; spots identified in Figure 4-28: (A) base metal raster scan; (B) spot 1, Cr-rich oxide; (C) spot 2, Al/Si/Mg/Ca from particulate heavy area; (D) spot 7, Fe-rich oxide; (E) spot 8 oxide of nominal composition (compare to base metal scan)

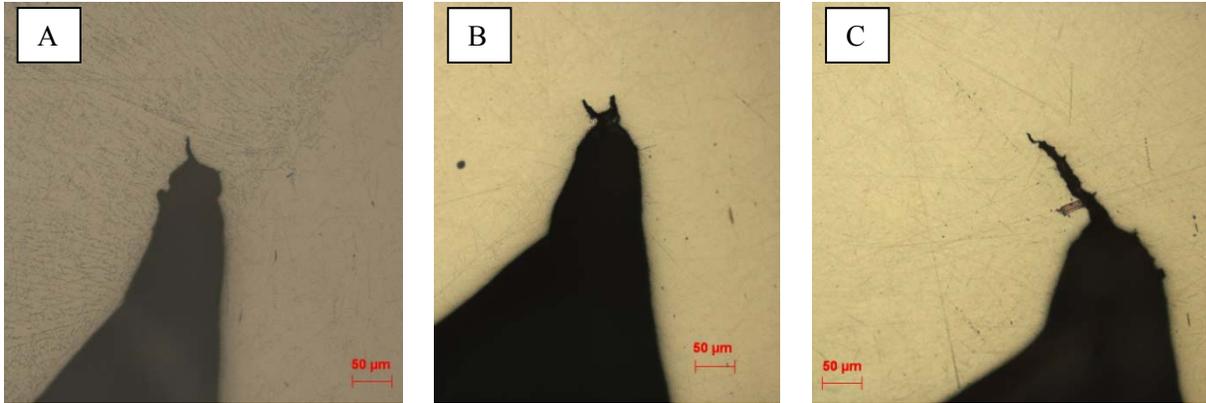
For the 0° pie section, pitting was observed only in the top of the gap where a crevice is located. The morphology of the crevice is shown for the three planes investigated in Figure 4-30. The first plane was etched to reveal the microstructure. Some small pits were observed in this region as shown in Figure 4-30 (A and C). An oxidized layer was not observed in this region. For the three planes that were investigated, the remainder of the sidewall and the lid pieces did not have any pitting.

Figure 4-30 Micrographs (200x) showing progressive changes with grinding and polishing in the crevice at the top of the 0° pie section closure weld gap for FY12 DE7; (A), (B), and (C) are different planes with (A) being closest to the edge of the pie section (shown by red arrow in Figure 4-26 (A))

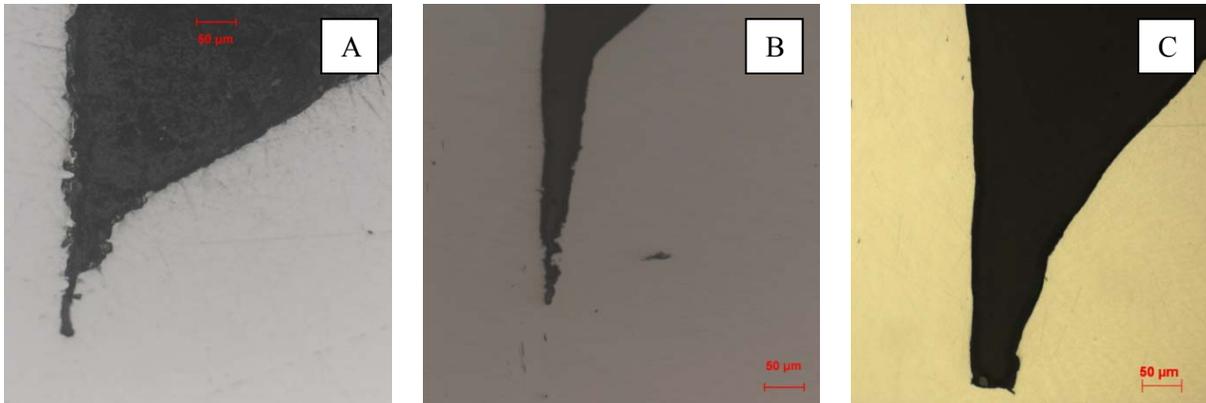
For the 90° pie section, the top of the gap showed a crevice that changed in dimensions for the three planes investigated. The first plane shown in Figure 4-31 (A) had a crevice (75 µm long, 10-20 µm wide) with some small pits. The next plane the crevice was bigger (~200 µm long, variable width) but without any significant pits. In the third plane (Figure 4-31 (C)), neither a crevice nor pitting was observed. No pitting was observed on the separate sidewall piece or the lid outside of the crevice area.

Figure 4-31 Micrographs (200x) showing progressive changes with grinding and polishing in the crevice at the top of the 90° pie section closure weld gap for FY12 DE7; (A), (B), and (C) are different planes with (A) being closest to the edge of the pie section

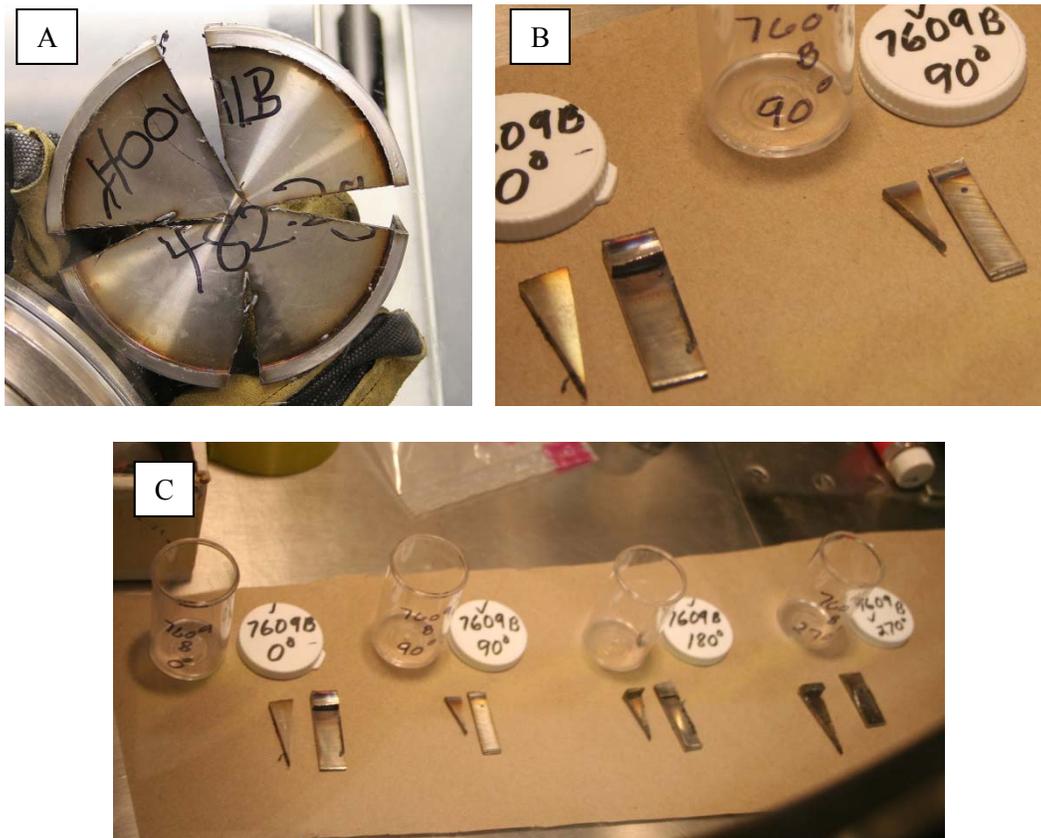
Sectioning of the inner container lid during DE was performed for the first time with FY09 DE2 to get a better depth analysis of pits in the halo. The sidewall and lid pieces from the pie sections were not separated by removing the closure weld as was done for the HHMC, FY12 DE4, DE6 and DE7. The pie sections cut from the inner container lid for FY09 DE2 are shown in Figure 4-32. The cutting of the pie sections into separate pieces was not done the same for all pie sections. The cut lines are shown schematically in Figure 4-33. The 90° pie section was the only sample cut through the closure weld which allowed the gap to be opened and the surfaces examined. The other pie sections kept the gap intact.

Figure 4-32 Sectioning of the FY09 DE2 inner container closure weld region: (A) remainder of sectioned lid; (B) 0° and 90° pie sections; (C) all pie sections

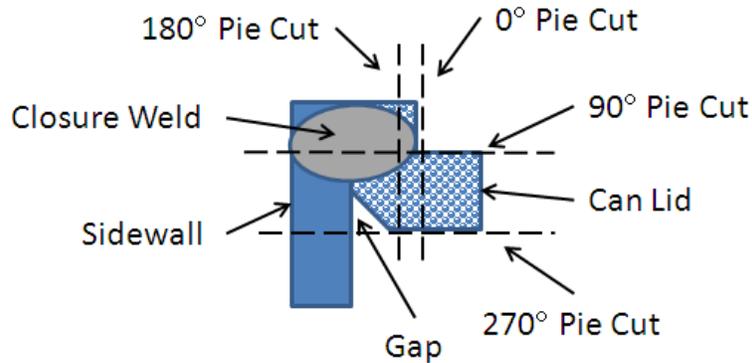
Figure 4-33 Schematic drawing showing the different cut lines used for removing pieces of the sidewall from the pie sections for FY09 DE2

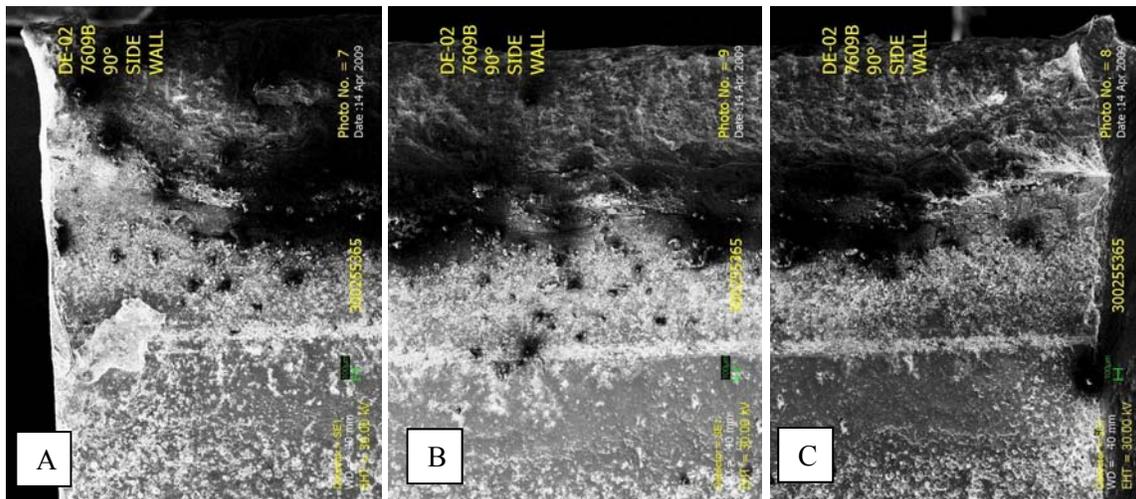
The lid and sidewall surfaces within the gap were examined using the SEM and stereomicroscope for the 90° pie section. Micrographs from both these analyses are shown in Figures 4-34 and 4-35. Figure 4-34 shows three SEM micrographs placed together showing the entire sidewall surface within the gap region (Note: there is some overlap in each micrograph). In Figure 4-35, a stereomicroscope micrograph of similar magnification is shown of the center of the sidewall gap surface and is the same as that shown in Figure 4-34 (B). From the micrograph in Figure 4-35, rust-colored corrosion products are seen on top of the weld oxide. Rust-colored corrosion products were also observed on the lid surface within in the gap as well as outside the gap region on the both the lid and sidewall (See Figure 4-36). All pie sections showed these types of corrosion products on both the sidewall and the lid for surfaces just outside the gap. All gap surfaces have not been examined at this time because of the way the initial cuts were made as shown in Figure 4-33.

Figure 4-34 SEM micrographs (25x) of the sidewall surface from the inner container closure weld gap for the 90° pie section from FY09 DE2

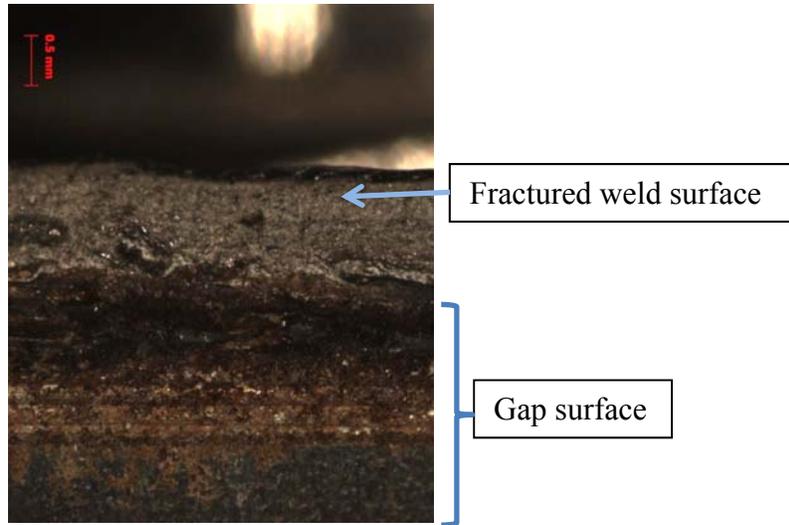
Figure 4-35 Stereomicroscope micrograph (25x) of the sidewall surface from the inner container closure weld gap for the 90° pie section from FY09 DE2 (same as that shown in Figure 4-34 (B))

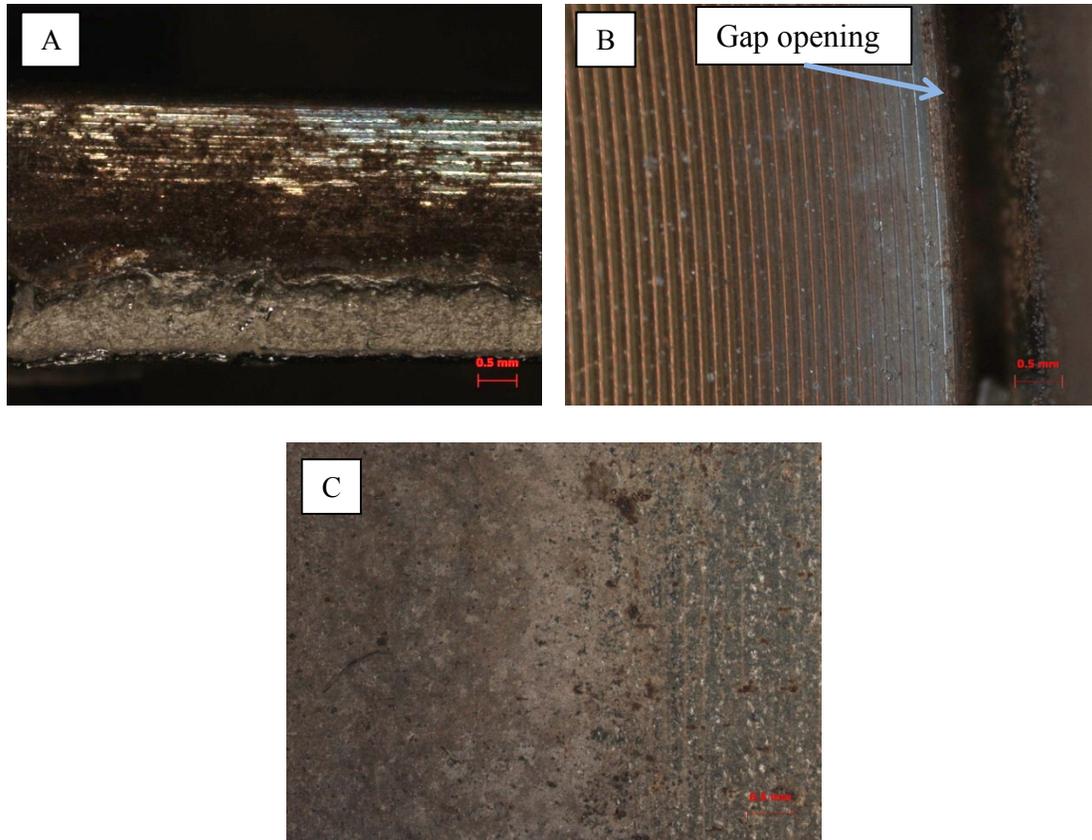
Figure 4-36 Stereomicroscope micrographs of the inner container closure weld region for FY09 DE2: (A) gap surface of the lid from the 90° pie section, 20x; (B) lid outside the gap from 180° pie section, 25x; and (C) sidewall surface outside the gap from the 180° pie section

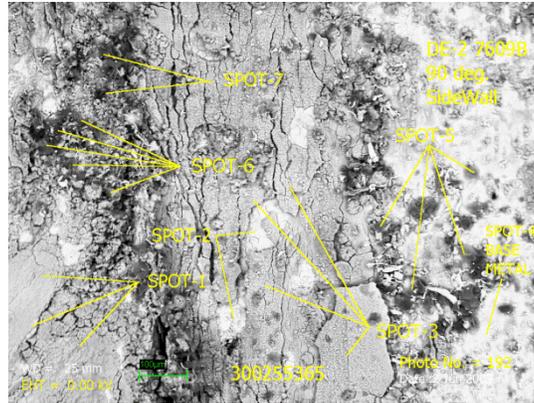
During the SEM investigation of the 90° pie section sidewall, EDS analyses were also performed on the surface oxides and particulate (See Figure 4-37). Iron-rich and chromium-rich oxides were found indicative of the weld oxide (Figure 4-38 (A) and (B)). Corrosion products were also identified and contained a significant chloride peak (Figure 4-38 (E)). Other compounds found on the surface contained Al/K/Si/O (Figure 4-38 (D)), which were also identified on the lid surface just outside the gap. The halo of pits on the lid section of the 0° pie section was also analyzed by EDS, which showed that all analyzed corrosion products were associated with Al, Si and Cl. A base metal scan is shown in Figure 4-38 (C) for comparison.

Figure 4-37 SEM micrograph (100x) showing the location of EDS point analysis for the sidewall surface for FY09 DE2 90° pie section (spectra are shown in Figure 4-38)

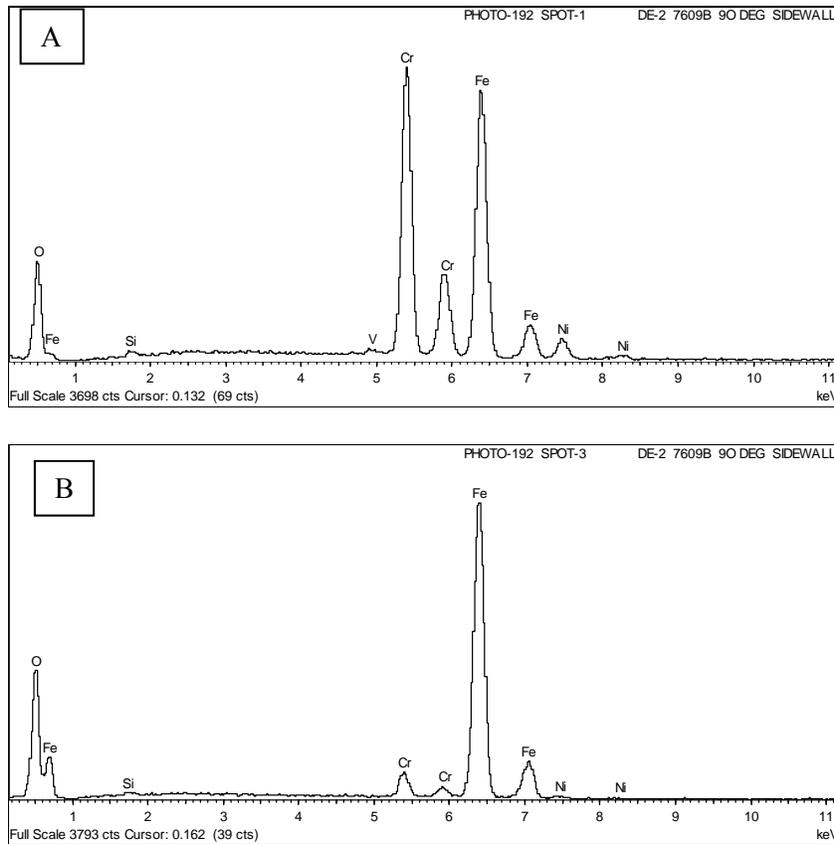
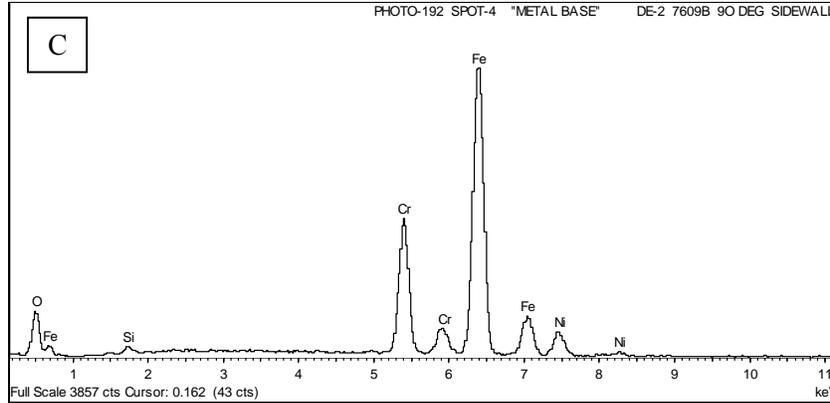
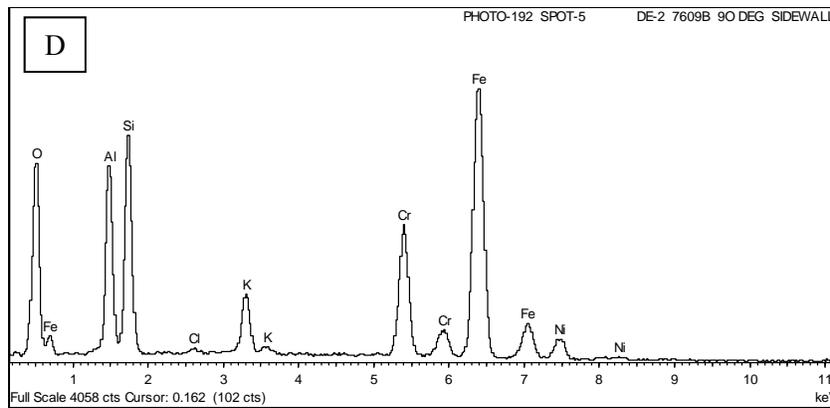
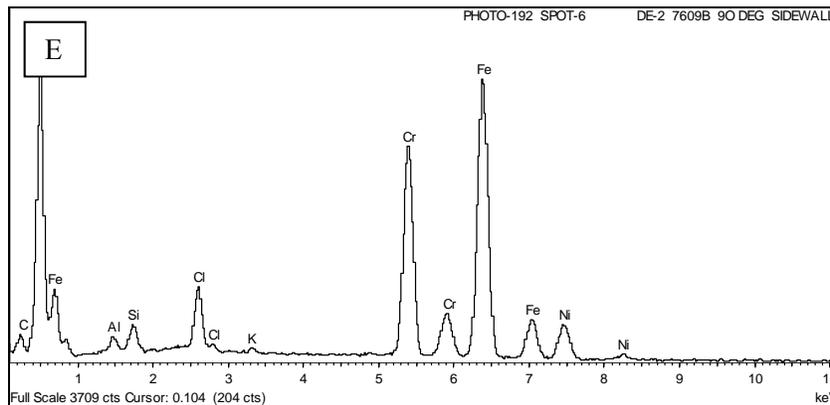
Figure 4-38 EDS spectra from spot analysis of the sidewall gap surface for the 90° pie section from FY09 DE2 (see Figure 4-37 for location of spots): 1 (A), 3 (B), 4 (C) and 5 (D); and 6 (E)

Figure 4-38 (Continued) EDS spectra from spot analysis of the sidewall gap surface for the 90° pie section from FY09 DE2 (see Figure 4-37 for location of spots): 1 (A), 3 (B), 4 (C) and 5 (D); and 6 (E)

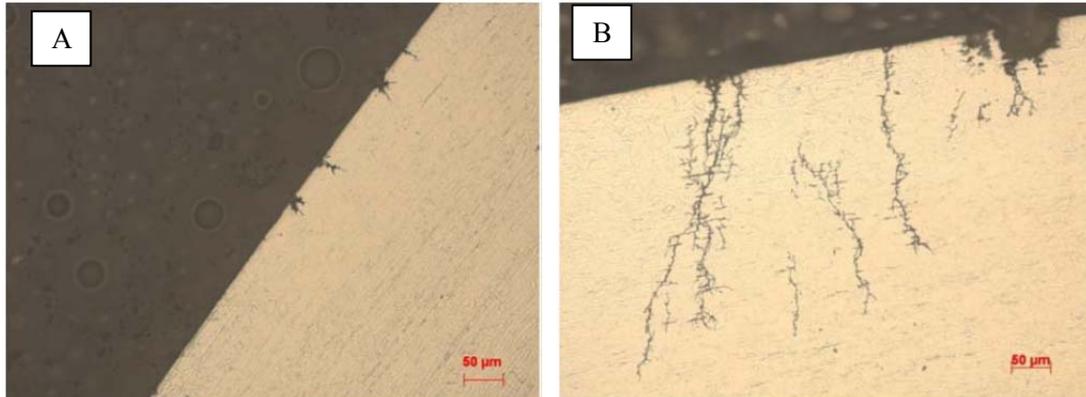
In Phase II, the testing was designed to determine a threshold RH for SCC and evaluate the dependence on configuration (direct contact with plutonium-bearing material or vapor exposure only) needed for SCC initiation and propagation. The first test series of this phase was set up to duplicate the Phase I testing, although the moisture content was lower at approximately 0.5 wt% [9]. Small cracks were observed after 85 days with a maximum pit depth of 74 μm . Pit depths did not appear to increase with time beyond the 85 days, but a crack grew through wall after 340 days. Cracks generally appeared to be associated with pits, although whether they initiated at pits was not determined. Figure 5-1 shows the observed cracking and pitting after 85 and 175 days. Cracking was not observed for pits in the vapor space.

Figure 5-1 Cross-sectional micrographs (200x) showing pit morphology for teardrop-shaped coupon after exposure to plutonium oxide/chloride salt mixture loaded with 0.5 wt% water: A) 85 days and B) 175 days
