**Savannah River
National Laboratory™**

3013 DE Inner Container Closure Weld Corrosion Evaluation

September 2013

SRNL-STI-2013-00527, Revision 0

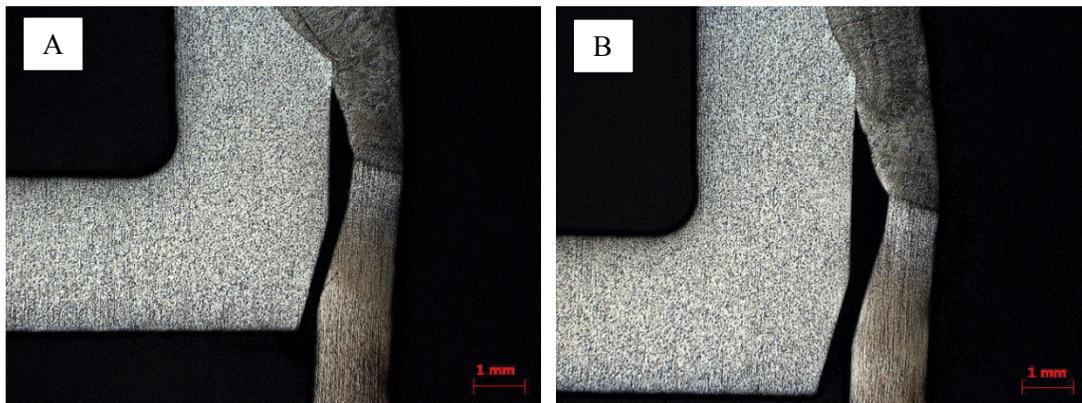
The physical size of the gap that is formed by the lid and sidewall is generally about the same but can vary in length. The gap lengths are difficult to determine with the separation of the lid and sidewall, but for the 90° pie section from FY09 DE2 the gap length was measured at 2.7 mm. The gap size measured for mounted pie sections from FY08 DE7, which were archived from baseline metallography, varied from approximately 4.8 mm to 5.8 mm. Figure 6-1 shows cross-

sectional micrographs of the inner container closure weld region for FY08 DE7 and shows the difference in length.

Figure 6-1 Cross-sectional micrograph (12x) of the inner container closure weld region for FY08 DE7: A) 90° pie section and B) 270° pie section
