Evaluation of Pad 18 Spent Mercury Gold Trap Stainless Steel Container Failure

August 2016

SRNL-STI-2016-00443, Revision 0

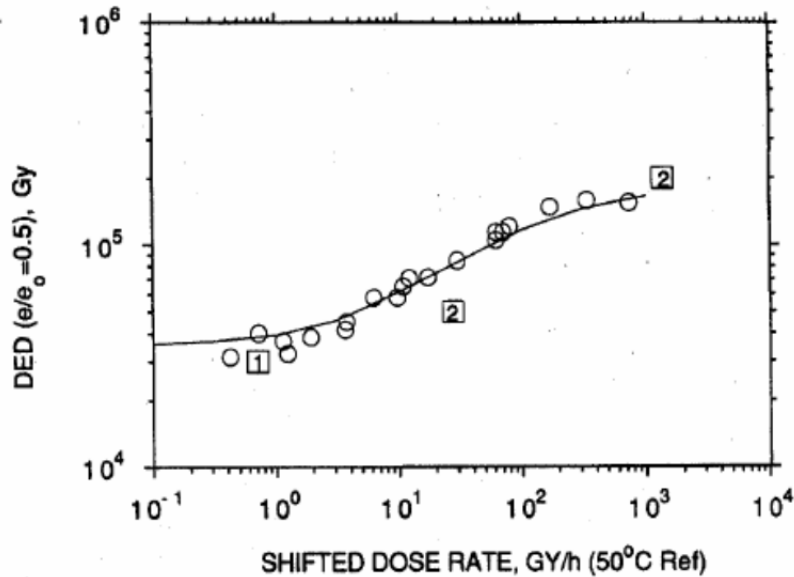
Figure 6. Dose Rate Effects in PVC-jacketed, LDPE-insulated cable (SRS K-Reactor) [35]

A complicating aspect of radiolytic degradation of polymers is that many polymers have been found to be sensitive to the radiation dose rate. A notable industry failure of PVC-insulated cables occurred in the SRS K-reactor in the mid-1970s [35]. PVC-jacketed, LDPE-insulated cables that were qualified for 40-year service based on high dose rate qualification protocols failed in approximately 12 years at a dose rate of approximately 25 rad/hr. Post-failure investigation found that the cable insulation polymers were quite sensitive to the dose rate, Figure 6. Many studies have since been performed on cable insulation polymers to evaluate dose rate effects [36-37]. HCl generation from flexible PVC electrical cable insulations is one of the reasons for the development and use of halogen-free cable insulations in commercial nuclear facilities.

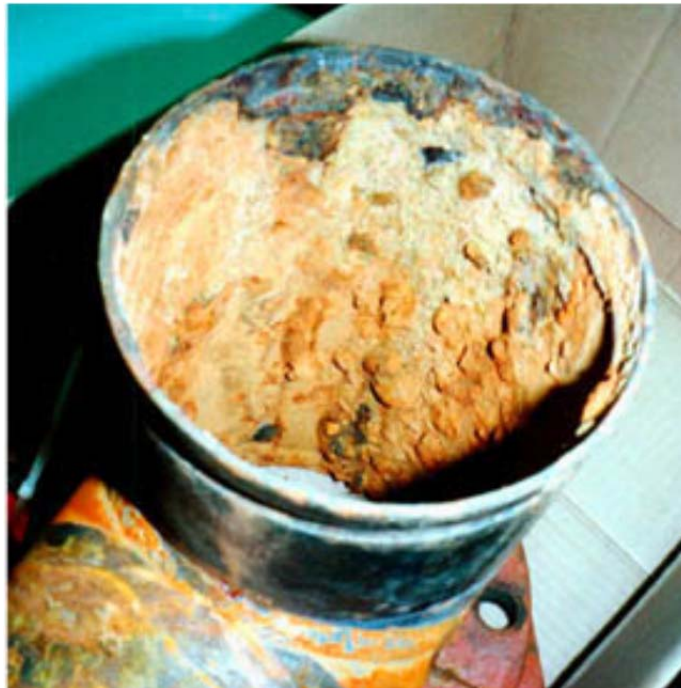
Figure 12. Microbiologically-induced corrosion in a pipe (not SRS piping) [61]

Microorganisms present in aqueous solutions can form films and deposits on exposed metals and alloys. These films and deposits, along with the metabolic activity of the microorganisms, can influence corrosion of the exposed metal (Figure 12). This mechanism is broadly called microbiologically-induced corrosion (MIC). MIC is briefly discussed as it has occurred in SRS systems, but it is not considered a primary mechanism of failure of the spent mercury gold trap waste container.

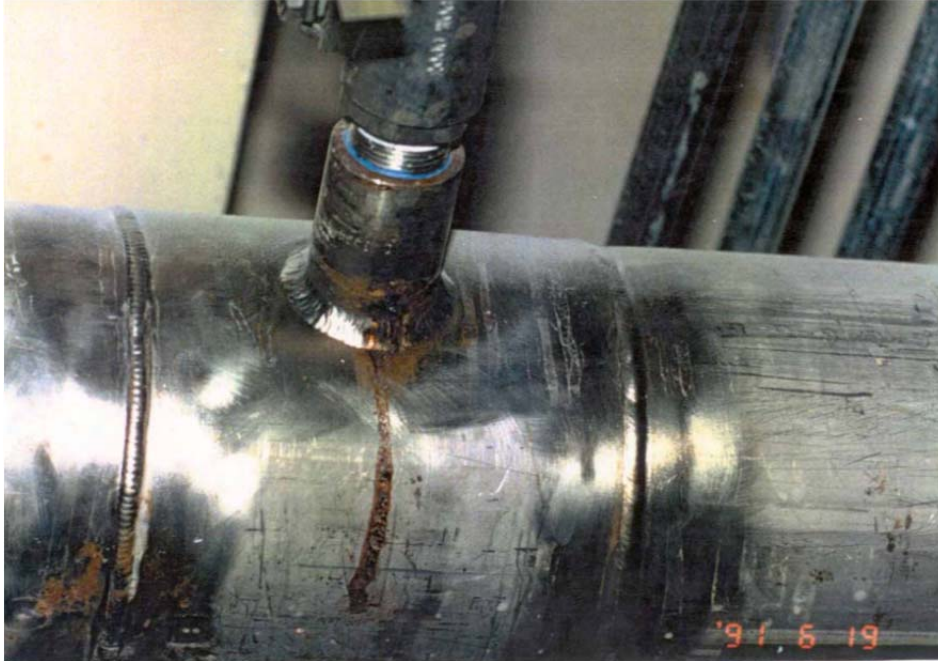
Figure 14. Evidence of MIC on the exterior of DWPF cooling water pipe [62].

Several cases of MIC in stainless steel and galvanized piping at SRS have been documented cases of MIC [62-63]. In 1991, during a routine walk-through inspection of the Melter Cooling Water System (MCWS) in the Defense Waste Processing Facility (DWPF), rust colored “bleed-through” was observed on the exterior of the piping near the welds (Figure 14). The MIC occurred due to initial system testing and flushing with neutral water without any biocide. When water quality problems were noted, the system was also drained and flushed with de-ionized water that was also not treated. The water was left stagnant in the line for several months. Even DI water has been shown to possibly promote MIC.
