MODEL 9975 LIFE EXTENSION TEST PACKAGE 3 – INTERIM REPORT

W. L. Daugherty

January 2017

SRNL-STI-2017-00045, Revision 0

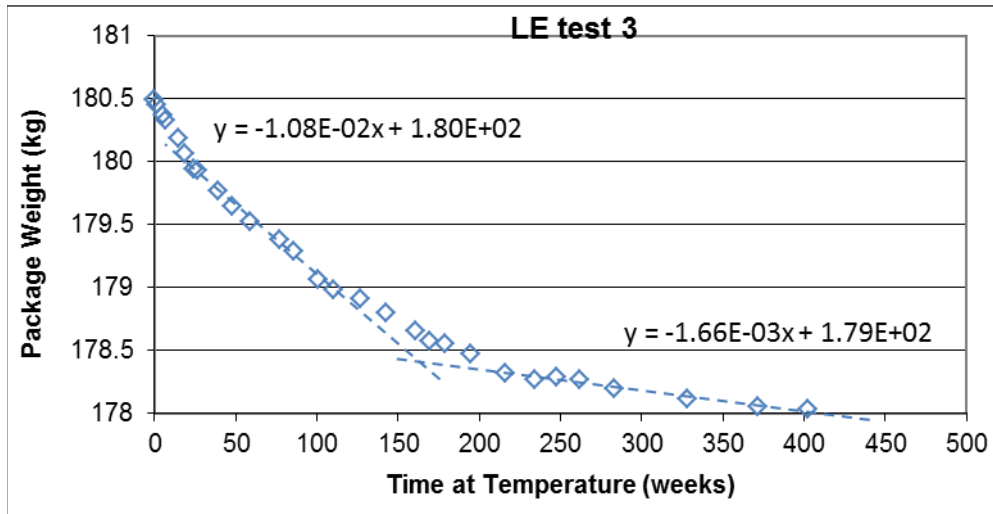
Figure 9. Package weight of LE3 over time. The trend lines illustrate two regions of relatively constant weight loss.

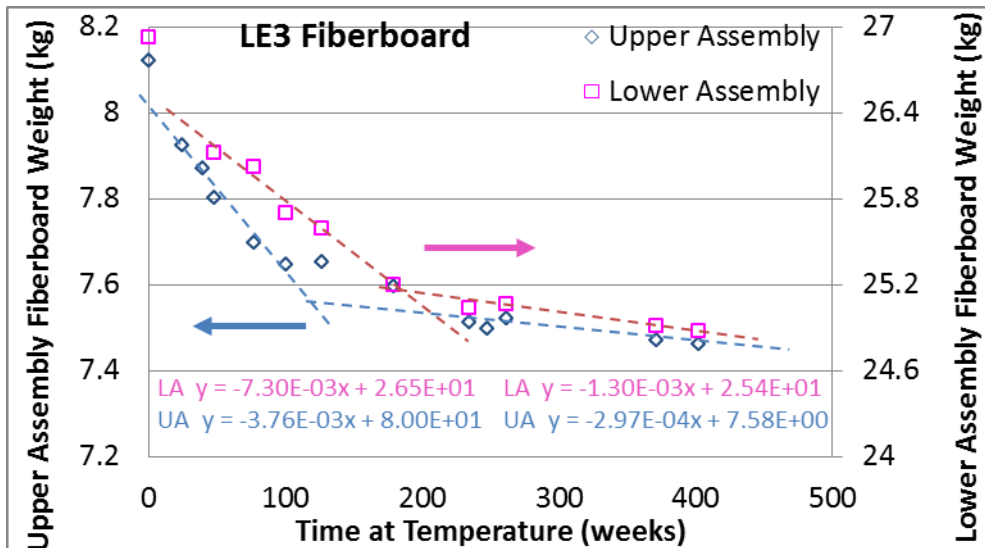
Figure 10. Weight loss of LE3 upper and lower fiberboard assemblies. The nominal weight of bearing plates and the air shield were subtracted from the recorded weight to give the weight of fiberboard only. The trend lines illustrate two regions of relatively constant weight loss for each assembly.

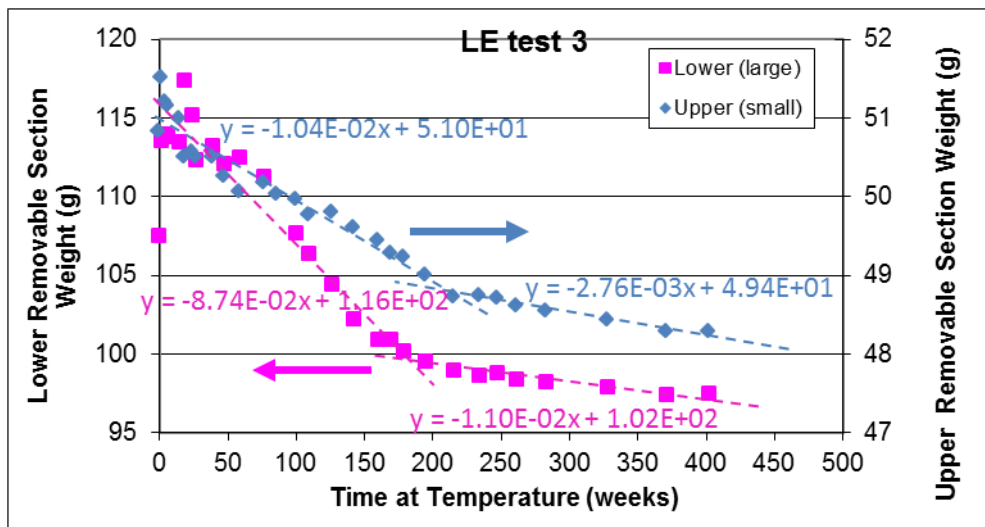
Figure 11. Normalized weight loss of LE3 removable fiberboard sections. The trend lines illustrate two regions of relatively constant weight loss for each section.

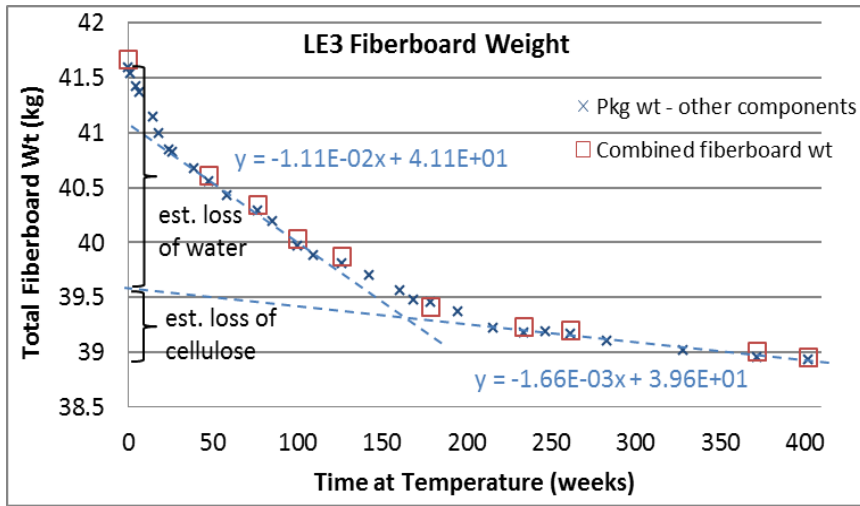
only. Figure 12 illustrates this rate of fiberboard weight loss extrapolated back to time zero, where the total weight loss can be divided into cellulose loss and water loss. From this we see a net loss of 2.012 kg water and 0.646 kg fiberboard (cellulose) after 402 weeks at temperature. With movement of this amount of water through the package, the amount of condensation on the lid and air shield shown in Figure 3 is not surprising. It is noted that significant water staining from condensation on the lid and air shield was also observed on the second life extension package [3], however, that package was not opened for inspection until after 19 weeks, at which time the moisture was no longer present.

Figure 12. Variation in total fiberboard weight over time based on two methods. The combined fiberboard weight (red squares) is the total weight of all fiberboard sections. The blue “x”s show the difference between the total package weight and all non-fiberboard components.

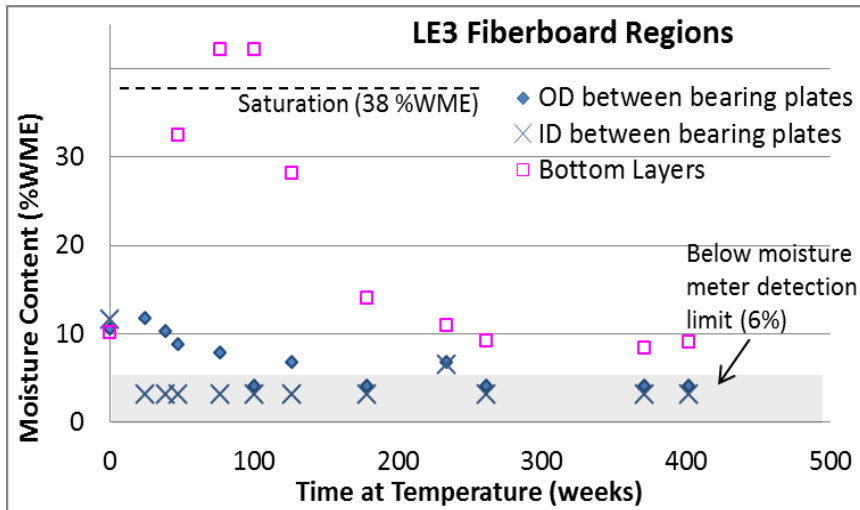
Variations in regional fiberboard moisture content are shown in Figures 13 and 14. As discussed elsewhere [9], moisture within the fiberboard tends to seek equilibrium with moisture in the surrounding air within the package, and with moisture in the air outside the package. The absolute humidity of the air tends to remain approximately constant throughout the package, while the relative humidity varies significantly with any temperature gradient. The equilibrium moisture concentration of the fiberboard for a given moisture concentration in the air also changes with temperature. At the same time, a slow transfer of air between the package interior and the room allows for a net transfer of moisture into or out of the package, although this tends to be a very gradual process. With this in mind, the trends in Figure 13 indicate much of the fiberboard moisture initially was driven to the bottom fiberboard layers, and a gradual net loss of moisture from the package was active through the first ~200 weeks at temperature. Since that time, the moisture levels within the package appear to have been roughly constant.

Figure 13. Moisture content history of three fiberboard regions. The regions between the bearing plates include portions of the upper and lower fiberboard assemblies. Values below the moisture meter detection limit (gray box) were assigned an arbitrarily value for illustration purposes. Similarly, the values above saturation were assigned an arbitrary value since the WME scale becomes non-linear above saturation.

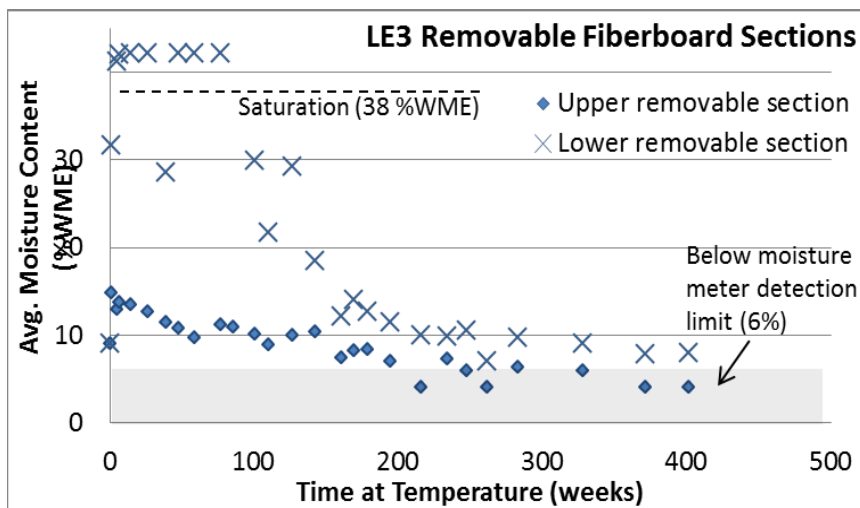
Figure 14. Average moisture content history of the two removable sections within the lower fiberboard assembly. Values below the moisture meter detection limit (gray box) were assigned an arbitrarily value for illustration purposes. Similarly, the values above saturation were assigned an arbitrary value since the WME scale becomes non-linear above saturation.

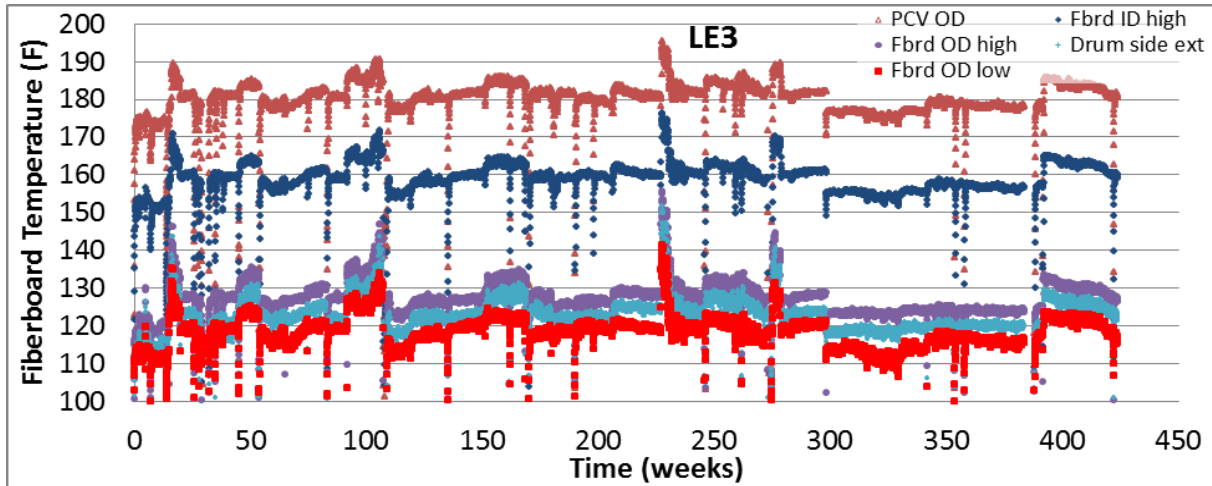
Figure 15. Temperature history for package LE3 at several locations, including the PCV OD surface, fiberboard ID and OD and the drum exterior.

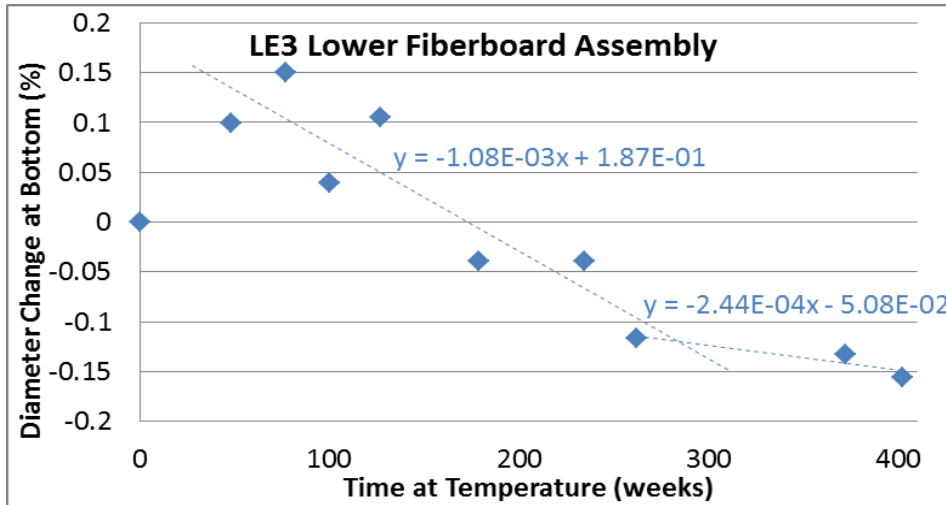
The relative diameter change for the bottom layers of the lower fiberboard assembly is shown in Figure 17. The excess moisture initially driven to the bottom layers dominates diametral changes for up to 262 weeks. The rate then decreases significantly to a value less than the rate of radial thickness loss. With the lower temperature in the bottom layers, the models based on laboratory data predict no degradation for moisture levels below 70 %RH equivalent, and are not applicable to higher moisture levels.

Figure 17. Change in diameter of the bottom layers of the LE3 lower fiberboard assembly. The trend lines illustrate two regions of relatively constant rate of diameter decrease.

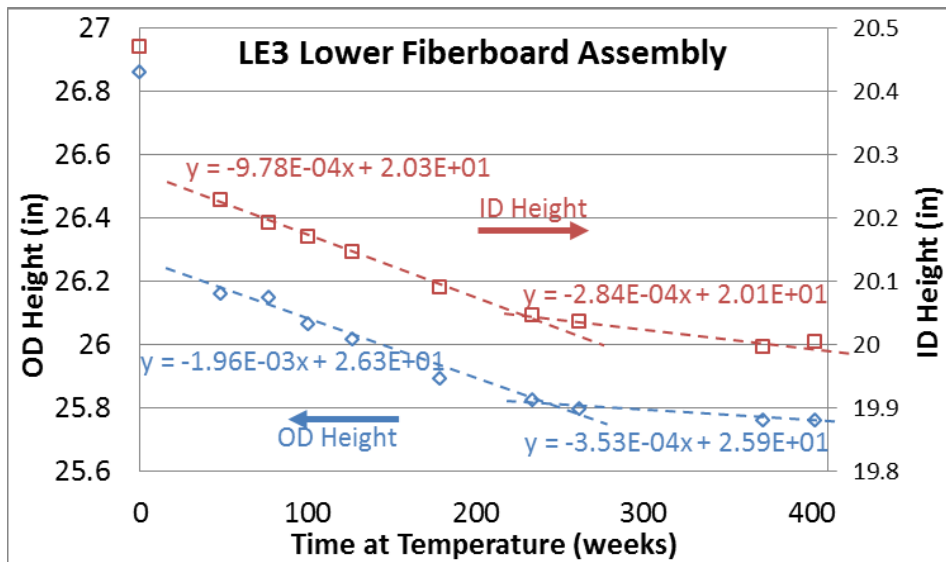
Figure 18. Change in height along the OD and ID of the LE3 lower fiberboard assembly. The trend lines illustrate two regions of relatively constant rate of height decrease for each dimension.

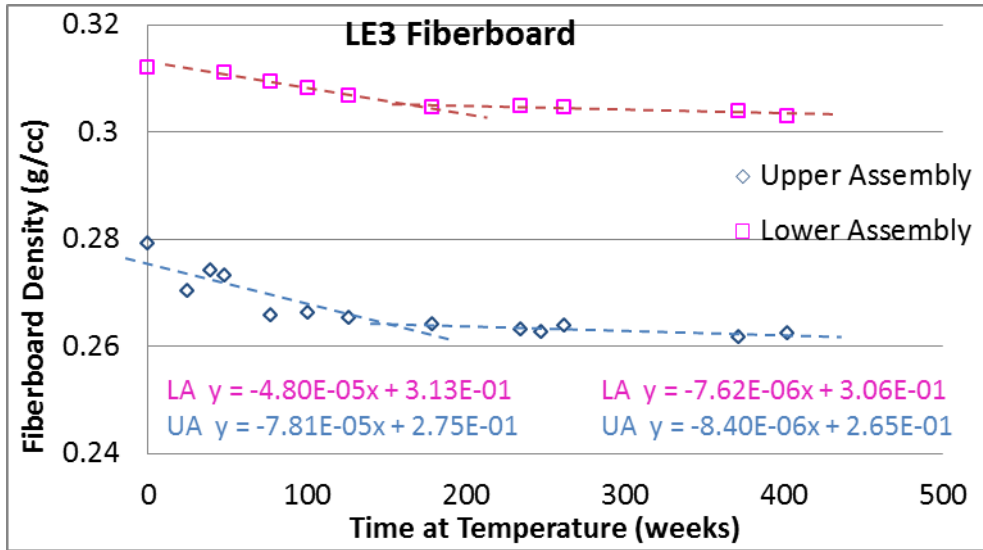
Figure 20. Density of LE3 upper and lower fiberboard assemblies. The trend lines illustrate two regions of relatively constant density change for each assembly.

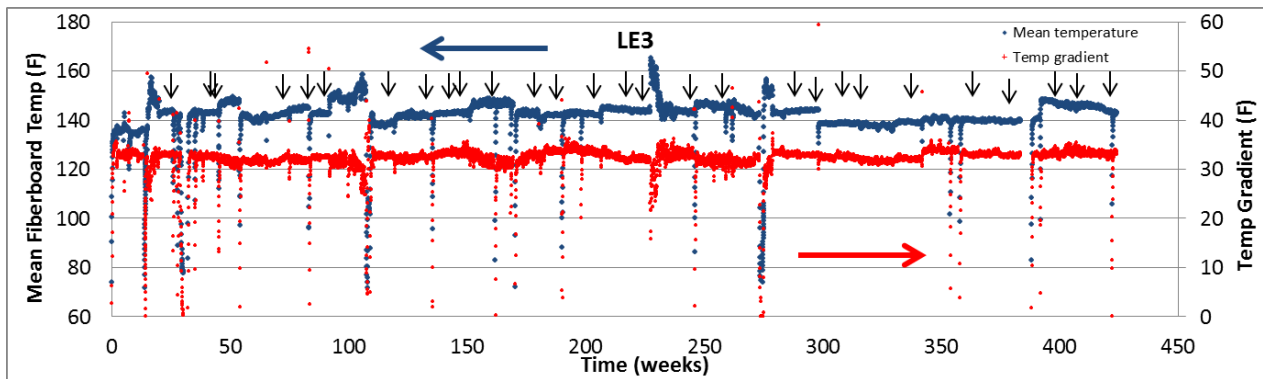
Figure 21. LE3 average radial temperature gradient (red symbols) in the fiberboard based on the upper 2 fiberboard ID thermocouples and the upper 2 fiberboard OD thermocouples, and average fiberboard temperature (blue symbols). The vertical arrows indicate times during steady state operation for which the relative thermal conductivity of the fiberboard was estimated.

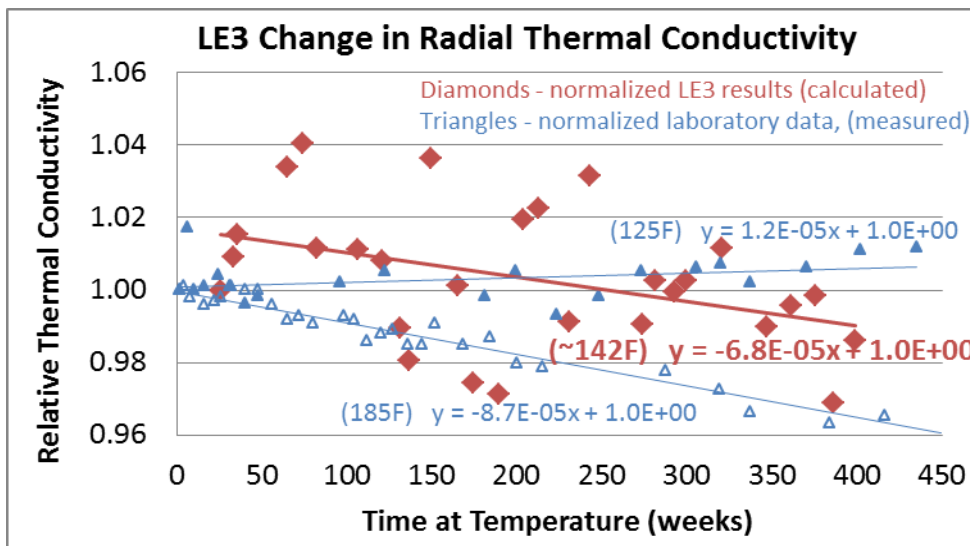
Figure 22. Relative change in radial thermal conductivity estimated from LE3 thermal gradient data. Comparable data for laboratory samples MSC-5R (conditioned at 125 °F) and TC-3R (conditioned at 185 °F) are also shown. The mean test temperature for the laboratory samples was 122 °F.
