WSRC-RP-89-1311

**FINAL SUMMARY REPORT  
FOR  
1989 INSERVICE INSPECTION (ISI)  
OF  
SRS 100-P REACTOR TANK**

Issued: December 15, 1989

**SRL SAVANNAH RIVER LABORATORY, AIKEN, SC 29808**  
Westinghouse Savannah River Company  
Prepared for the U. S. Department of Energy Contract DE-AC09-88SR18035

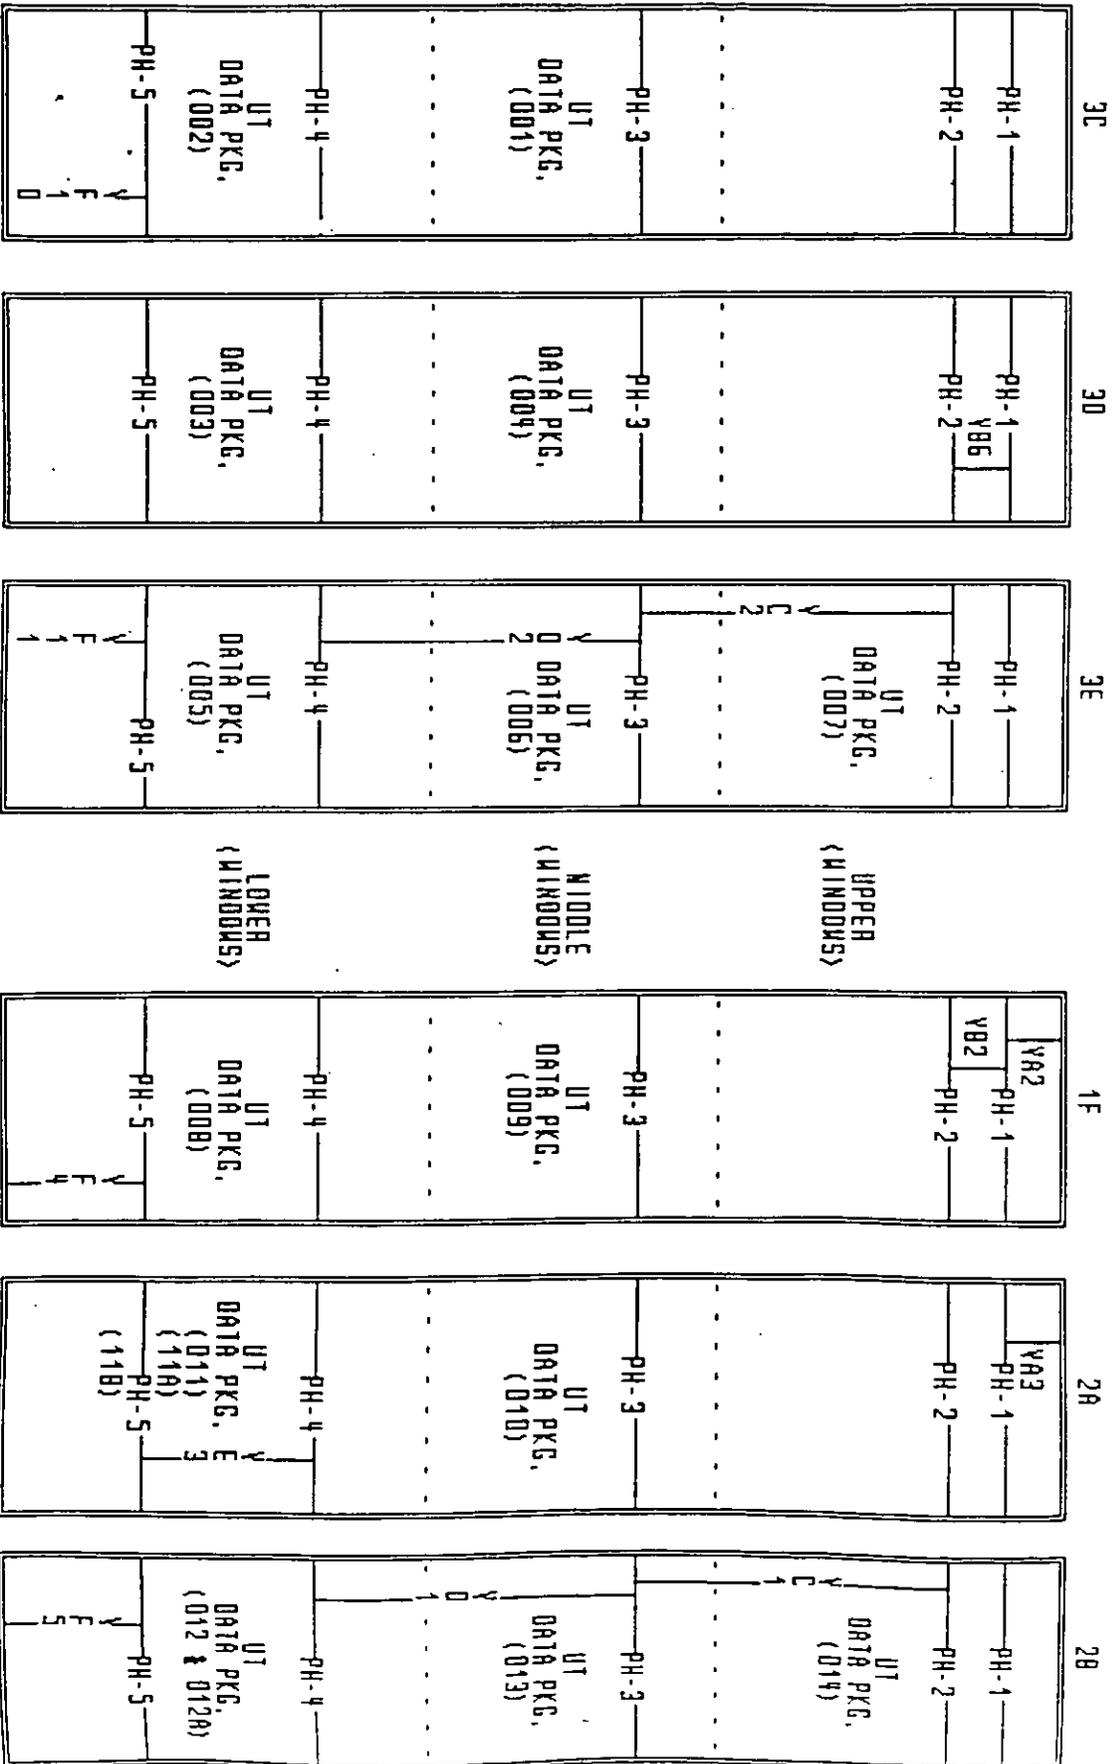
FIGURE 1-A. P-Reactoer Ultrasonic Scan Envelopes

The two inspection phases referred to above correspond to the two opposite 60° (approximate) regions of the P tank scheduled for inspection in 1989 as indicated in Figures 1-A and 1-B. These regions are also outlined on the reactor face map in Figure 6. The reactor tank was subdivided into 18 inspection sectors, each corresponding roughly to the extent of the tank circumference that can be reached by the robot from a single four-inch position. The six sectors selected for this inspection were:

The vertical inspection range of the UT/ET end effector in each robot position was adjusted in three discrete increments, or "windows" (upper, middle, and lower) to cover the entire accessible height of the tank. The locations of these windows are indicated by the horizontal dashed lines in Figures 1-A and 1-B.
