September 30, 2003

**CORROSION OF EXHAUST AND FILTRATION EQUIPMENT  
IN A RADIOACTIVE WASTE INCINERATOR**

Charles F. Jenkins  
Westinghouse Savannah River Company

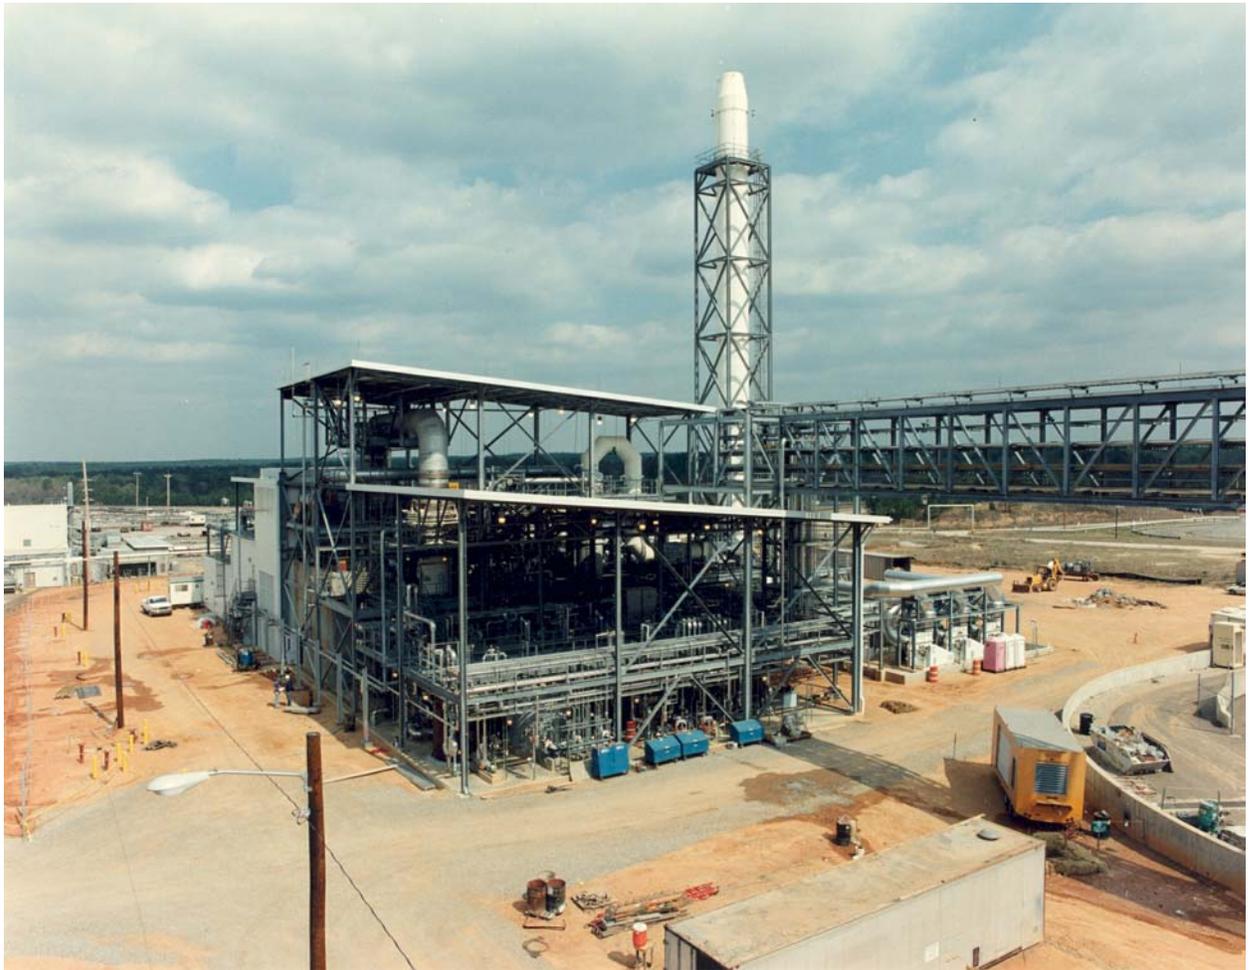
The off-gas system for the Consolidated Incinerator Facility (CIF) at the U.S. Department of Energy Savannah River Site consists of a quench and wash, separator, reheater, filters, and stack discharge (Figure 1). The cyclone separator and the ductwork upstream of the reheater are FRP. Approximately 45 m of carbon steel duct are downstream of the reheater and ahead of the high efficiency particulate air (HEPA) filters. Fans controlling the flow are downstream of the stainless steel filter housings.

Figure 1. SRS Consolidated Incinerator Facility. The stack and portions of the off gas ducts are evident.

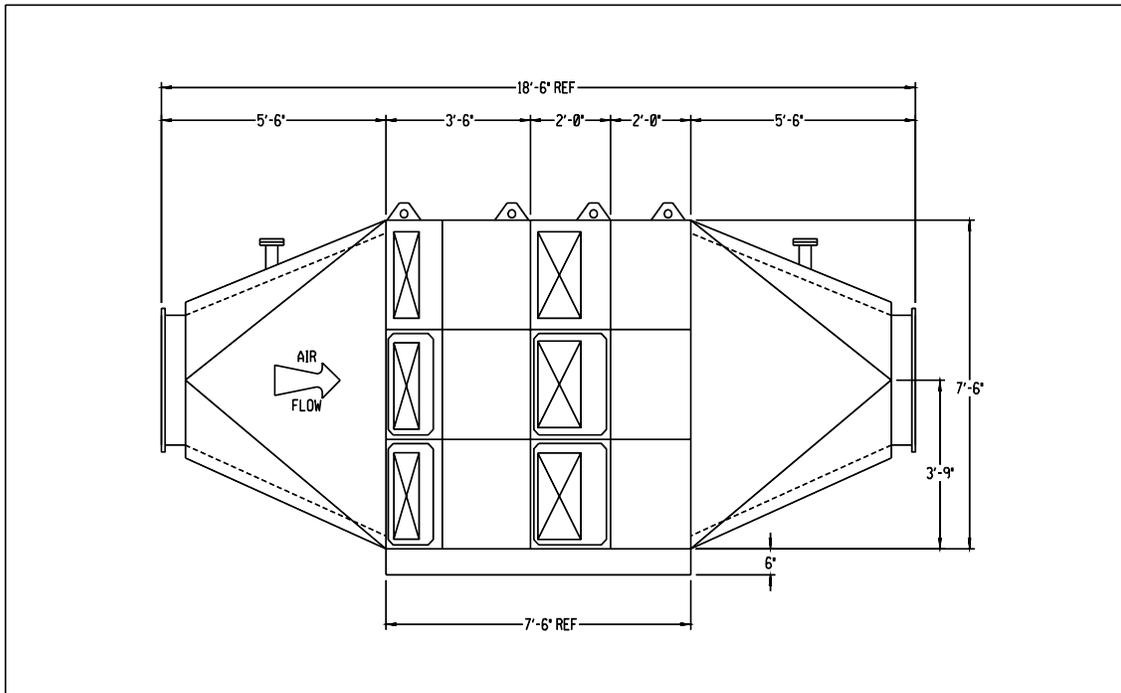
The HEPA filter housings are assemblies of stainless steel boxes (Figure 3). Inlet and outlet ports and filter access doors have EPDM elastomer seals. The entire enclosure is insulated on the exterior and covered with a welded sheet metal skin - essentially a sealed metal wrap for protection against outdoor weather conditions. This may provide some measure of secondary containment as well, though the skin is not intended to be a pressure seal. The assembled housing is pressure tested at the factory.

Figure 3. Sketch of a HEPA filter housing for the incinerator exhaust gas discharge system.

The new stainless steel HEPA filter housings have the interior lined with the same PLASITE<sup>®</sup> vinyl ester coating used on the ductwork. The coating provides the needed isolation from the chlorides. Alternate alloys that were considered for housing included AL6XN, 20Cb-3, C 276, and G 30. All are more resistant to chloride effects than Type 304L austenitic stainless steel, but fabrication costs are much higher, which precluded their use.

In practice, operation had been with two of the filters active and the third on standby. This allowed condensation to accumulate at the cold unused unit. Continuous draining of condensation is now provided at the housings, so a build up will no longer occur. However, it is desirable to eliminate the standby operation altogether. It was recommended that the three housings be run simultaneously and continuously. For changing filters, flow can be interrupted through one housing at a time, thus allowing the other two units to continue operating. The protective coating on the duct interior will eliminate steel corrosion and generation of rust particles which plagued earlier filter operations.
