EXAMINATION OF DWPF MELTER MATERIALS AFTER 8 YEARS OF SERVICE

Daniel C. Iverson, Kenneth J. Imrich, Dennis F. Bickford, James T. Gee, Charles F. Jenkins and Frank M. Heckendorn
Westinghouse Savannah River Company
Aiken, SC 29808

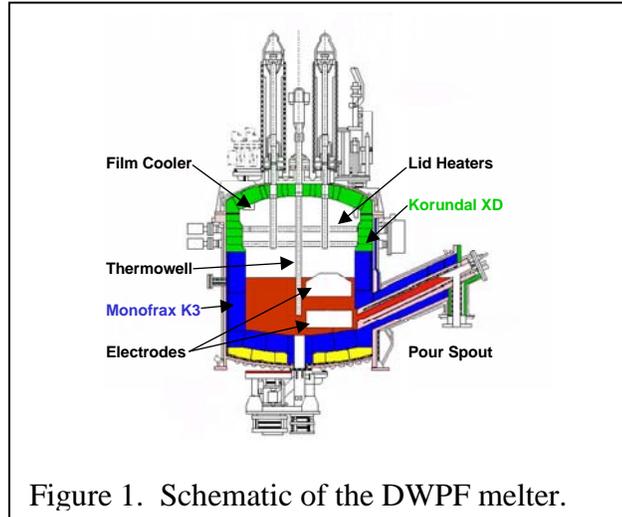
Figure 1. Schematic of the DWPF melter.

The DWPF Melter (Figure 1) is a refractory lined cylindrical vessel. Heat is provided via Joule heating of the glass and by resistance heaters located in the melter plenum, riser, pour spout, and drain valve.

Internal dimensions are approximately 1.83 m (6 ft) diameter by 2.2 m (7 ft) high. Nominal glass depth is 86 cm (34 in). Glass contact material is Monofrax™ K-3, a fused-cast chromia-alumina refractory.

Vapor space refractory is Korundal™ XD. Metal components in contact with the glass and vapor space are Inconel™ 690. These include thermowells, a bubbler, off gas film coolers, lid heaters, borescopes, and electrodes.

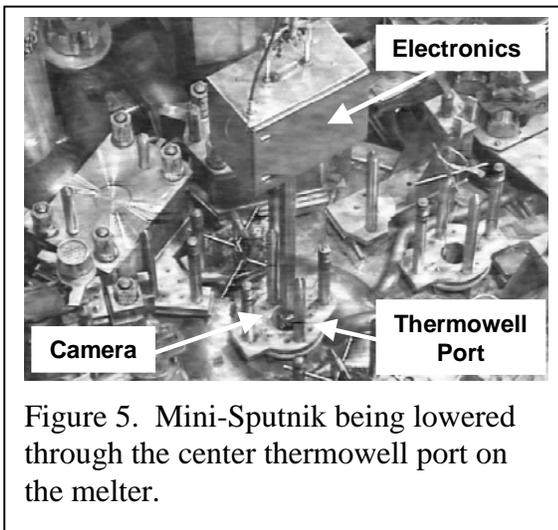
Figure 5. Mini-Sputnik being lowered through the center thermowell port on the melter.

Following melter shut down, an inspection was performed using a remotely deployed video camera suspended 12.2 m (40 ft) below the facility remote operated crane (Figure 5). This camera, called Mini-Sputnik, is a remotely controlled, video-based viewing system developed at SRS for inspecting tanks, vessels, and other difficult to access areas in the DWPF Canyon. The system was designed to be deployed in a vessel through a 6.4 cm (2.5 in) opening to a depth of 1.83 m (6 ft) using the canyon crane. An operator in the crane control room controls all system functions
