**Degradation and Failure Characteristics of
NPP Containment Protective Coating Systems**

Preliminary Evaluation of Plant Coating Specimens

Publication Date: March 2001

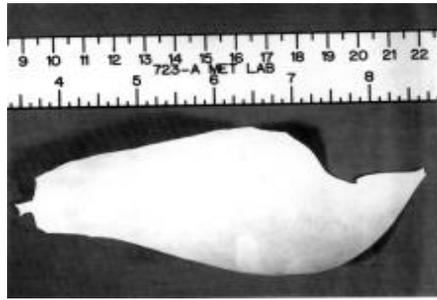
The topcoat is off-white and the IOZ primer is gray in color. A close-up view of the largest coating chip is shown in Figures 2-2 and 2-3, with the topcoat side up. Although the primer was observed to be well adhered to the topcoat, powder residue was readily removed during routine handling. In addition, the topcoat thickness appeared to be greater than that of the primer adhered to the topcoat. The amount of primer remaining on the substrate is currently unknown. It is assumed that the majority of primer thickness was left on the carbon steel substrate.

Figure 2-2. Overall photograph of largest chip as-received (topcoat-side)

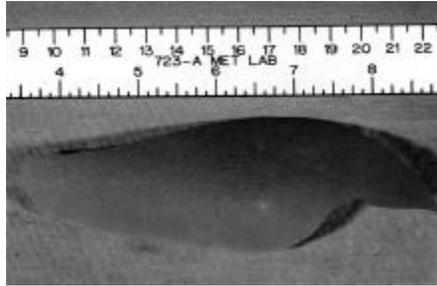
Figure 2-3. Overall view of largest chip received (IOZ primer side)

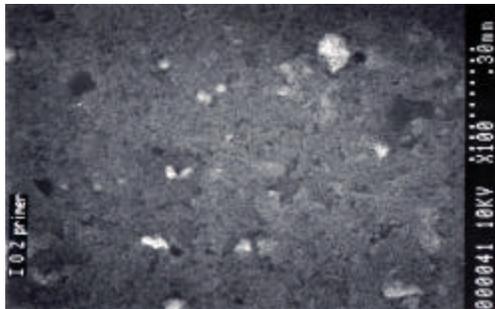
In Figures 2-5 to 2-10, higher magnification views are shown, with zinc/zinc oxide (ZnO) particles observed to be relatively spherical and intact. Although difficult to ascertain after disbondment, the presence of such uniformity indicates that the topcoat possibly failed initially due to tensile stress in the topcoat that was not supported by the IOZ primer layer. That is, tensile stresses would be expected in a coating for which volatilization of the carrier material occurs. This condition, coupled with the (assumed) low cohesion strength within the IOZ, due to possible non-uniform distribution of the ethyl silicate binder as a result of inadequate moisture and/or excessive thickness, led to cracking in the topcoat and splitting within the IOZ layer to form chips.

Figure 2-5. Surface of inorganic zinc primer (100X)

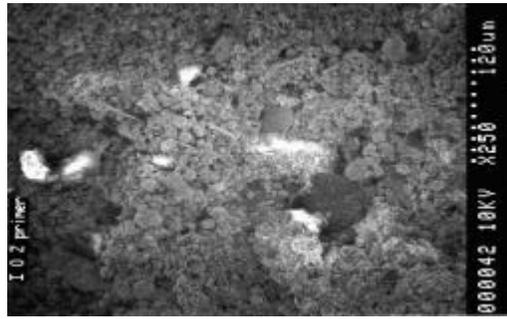
**Figure 2-6. Surface of inorganic zinc primer (250X).
(white particles are assumed to be charged regions of the epoxy-phenolic topcoat)**

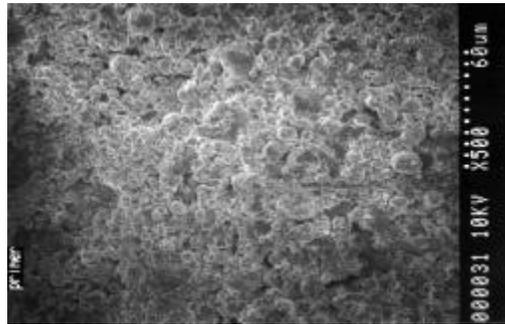
At 500X (Figure 2-7), zinc oxide particles were estimated to be approximately 10-30 microns in diameter, which closely corresponds with observations made in other studies of similar systems. Although most particles were intact, some of these were believed to have been disturbed during failure and during subsequent handling and motion. Surface particles present were believed to be dust that was lightly adhered to the underlying layers and were not necessarily representative of the actual fracture interface. Examination of the fracture surface in such a material is therefore more difficult than for a rigid crystalline material. At higher magnifications (Figures 2-8 to 2-10), cleavage or fracture lines on spherical particles were more obvious. At higher magnifications, discrimination of these features became more difficult due to low voltage beam fluctuations and surface contrast.

Figure 2-7. Inorganic zinc primer (500X).

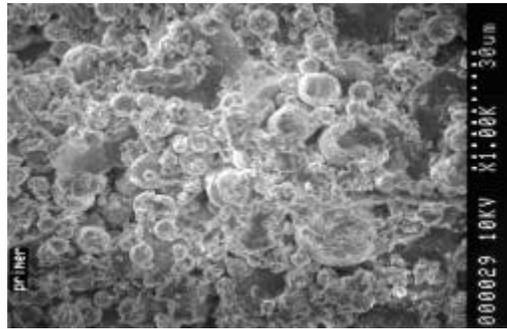
Figure 2-8. IOZ primer, with zinc/ZnO particles exhibiting cleavage planes (1000X)

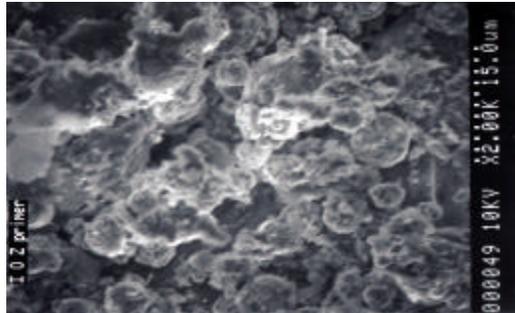
Figure 2-9. IOZ primer, zinc/ZnO particles (2000X)

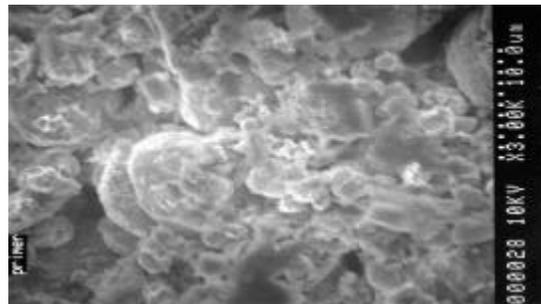
Figure 2-10. High magnification view of zinc particle in cleavage plane (3000X)

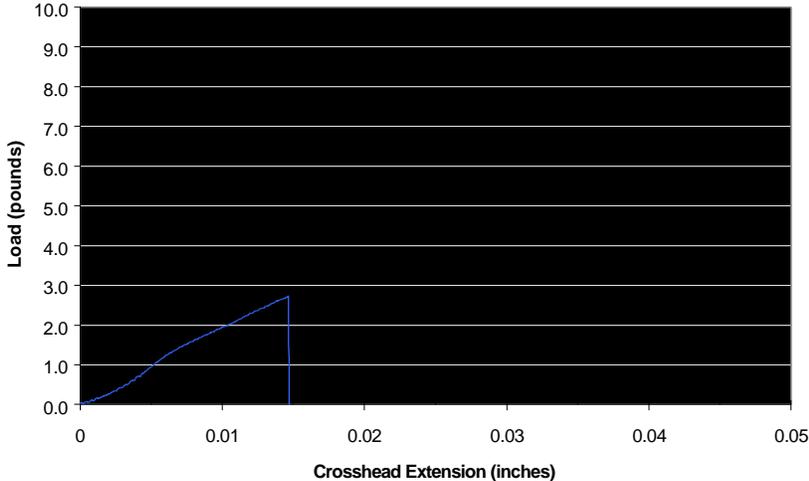
Plant Chip Tensile Test, Specimen 10 @ 38 deg C
failed outside grips

Figure 2-12. Tensile test of plant chip at 100°F (38°C)

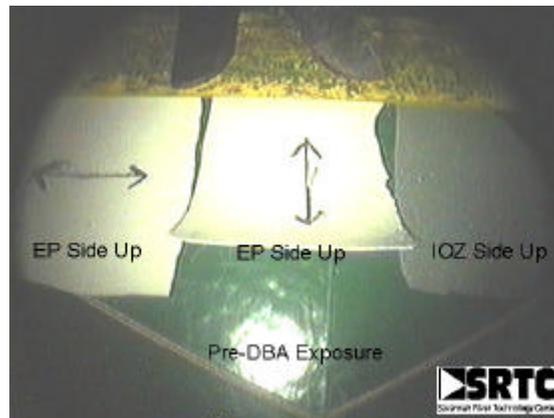
Figure 2-14. Still from video of chips before exposure to 300 °F steam for 1 hour

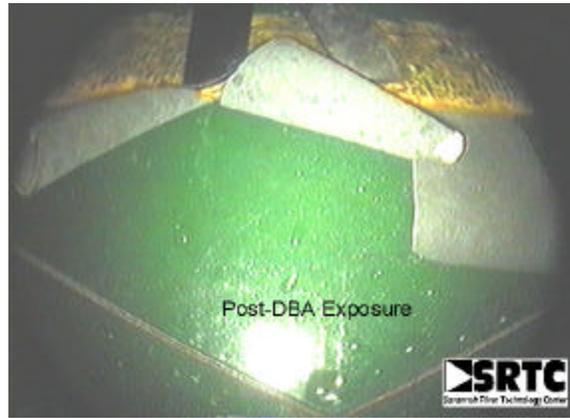
The as-received specimens had an initial curl or "curl-bias." During chamber heat-up the chips showed an initial relaxation of this curl followed by a re-curl to the initial or even greater curled condition. With steam exposure, extreme tight curling occurred at a relatively constant rate throughout the first approximately 30 minutes. A relatively minor amount of additional curling occurred beyond the first 30 minutes. A large loss of powder from the specimen was observed on the specimen holder plate. The specimens also showed an approximate 20% loss in weight. The specimens always curled with the IOZ layer on the outside and the epoxy-phenolic layer on the inside. No consistent trend of final curl direction with respect to the initial bias was noted. The steam exposure greatly softened the chips and allowed plastic flow. The effects of temperature and moisture have been observed to soften the epoxy-phenolic [ref. WSRC-TR-2001-00067]. Qualitatively, the brittleness of the exposed (curled) specimens was regained at room temperature.

The pre-irradiated specimens did not curl to the extent of the non-irradiated specimens. The irradiation embrittled the chips, as qualitatively noted by the reduction in ability to bend the specimens before breaking for the irradiated chips, compared to the non-irradiated chips. The steam exposure softened the chips and allowed plastic flow, since bending in excess of that at room temperature was observed. The IOZ layer of the irradiated chips was also observed to contain numerous small cracks following the steam exposure, as shown in Figure 2-16. This was in contrast to the non-irradiated exposed chips, which did not show formation of cracks.

Figure 2-15. Stills from video of chips after exposure to 300 °F steam for 1 hour

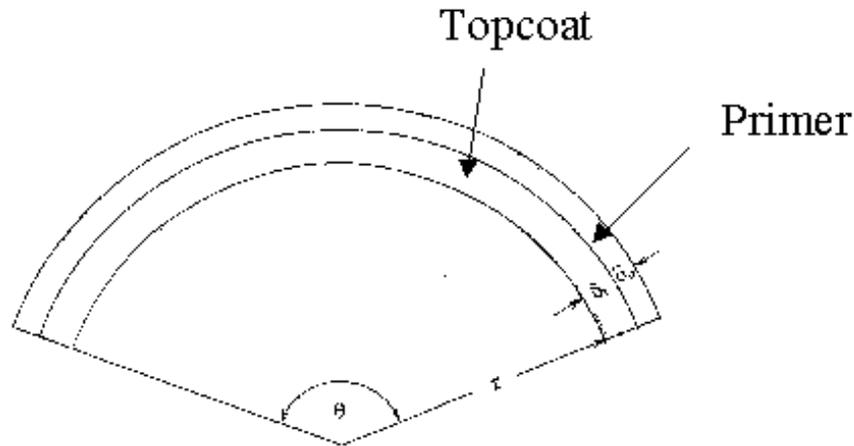
Figure 2-17. Analytical model of the radius of curvature of a two-layer chip

This model shows that, whatever the mechanisms causing the differential expansion or contraction, a difference in expansion/contraction must occur if the chips curl. The as-received chips had an initial radius of curvature of approximately 1 cm, consistent with a differential expansion/contraction of approximately one percent.

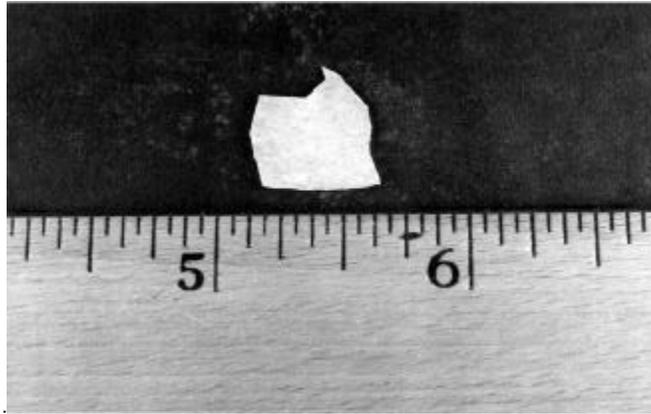
The samples were typically 1” square or less, generally smaller than the as-received chips described in Section 2, with less curling bias, indicative of curing stresses and/or excessive film thickness. There also appeared to be much less primer attached to the topcoat for these particular chips than for the other chips.

Figure 3-1. As-received coating chip, topcoat side – Rx Polar Crane location

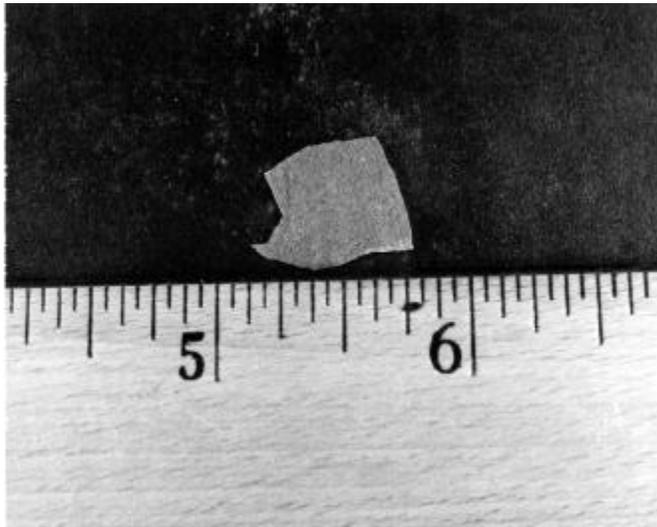
Figure 3-2. As-received coating chip, primer (inorganic zinc) side – Rx Polar Crane location

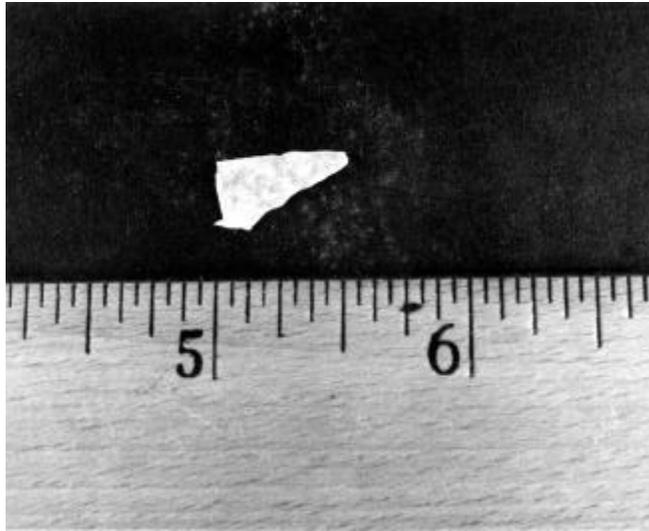
Figure 3-4. As-received chip from Rx spray – header steel location

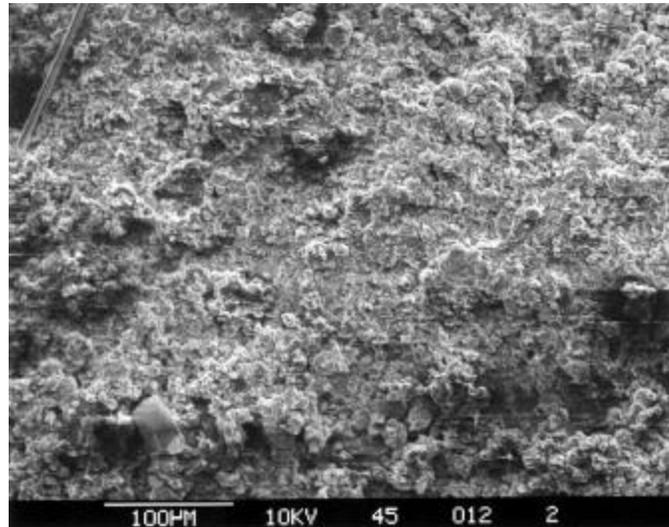
The inorganic zinc primer side of the chips (from the header steel location) was examined under the scanning electron microscope (SEM) to determine particle size and general surface texture and structure. A secondary electron image revealed the relatively rough and non-distinctive surface characteristic of inorganic zinc primer (Figure 3-5). Particles were assumed to be primarily zinc oxide in a silicate matrix, with some possible unreacted or unoxidized zinc metal in regions unexposed during curing and post-failure exposure to the environment. Due to the relatively high reactivity of zinc, however, the majority of exposed metal dust/particles were assumed to have either reacted with the ethyl silicate binder to form either a zinc silicate “polymer” or zinc oxide.

Figure 3-5. Secondary electron (SE) image of inorganic zinc primer – header steel location (200X)

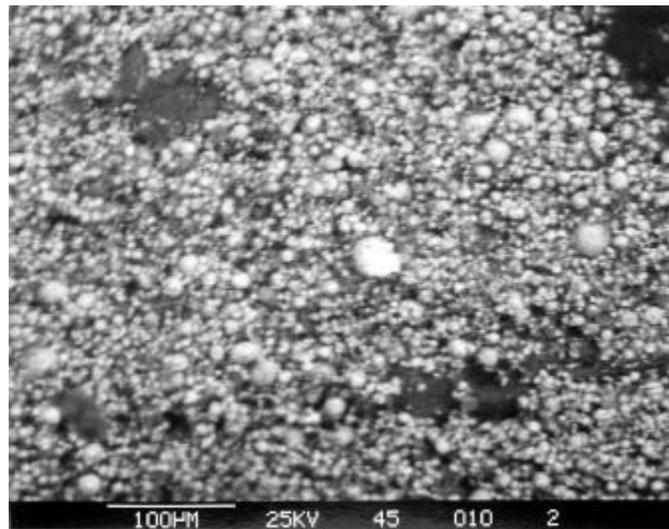
A backscattered electron image of the same area shown in Figure 3-5 is provided in Figure 3-6 to show the relative difference between the two imaging techniques. In the backscattered image, the conductive areas are shown in white with the non-conductive areas being darker. The relevant fact to note from these images is that although the inorganic zinc primer was assumed to be polymerized/oxidized, it was still relatively conductive even in the uncoated condition (uncoated with either gold or carbon typically used for imaging of non-conductive materials).

Figure 3-6. Backscattered image of inorganic zinc primer – header steel location (200X)
(same area as Figure 3-5)

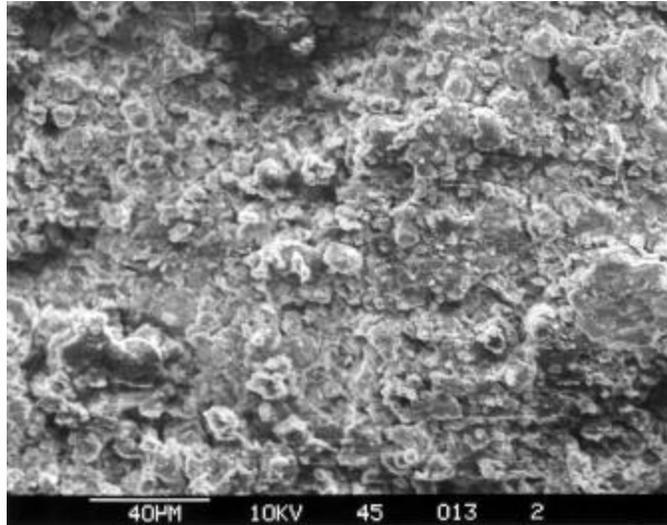
Secondary electron images of the same general area and features are shown from 500 to 5000X in figures 3-7 to 3-10, with the majority of zinc oxide particles observed to be less than 20 μm in diameter. At the higher magnifications, cleavage planes (splitting of the particulates) were observed. Cleavage of particles may have occurred during coating failure or may be an artifact of the coating curing process.

Figure 3-7. Secondary electron image of inorganic zinc primer (500X)

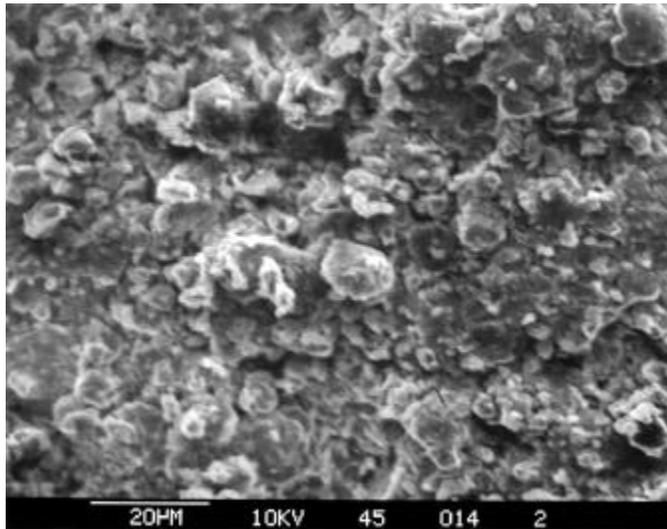
Figure 3-8. Secondary electron image of inorganic zinc primer (1000X)
Note size of Zn/ZnO particles (<20 μm)

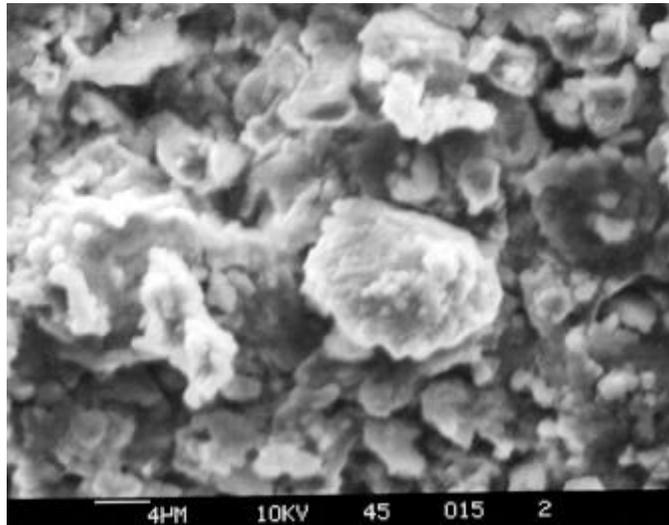
Figure 3-9. Secondary electron image of larger particle (from center of Figure 20), 2500X.

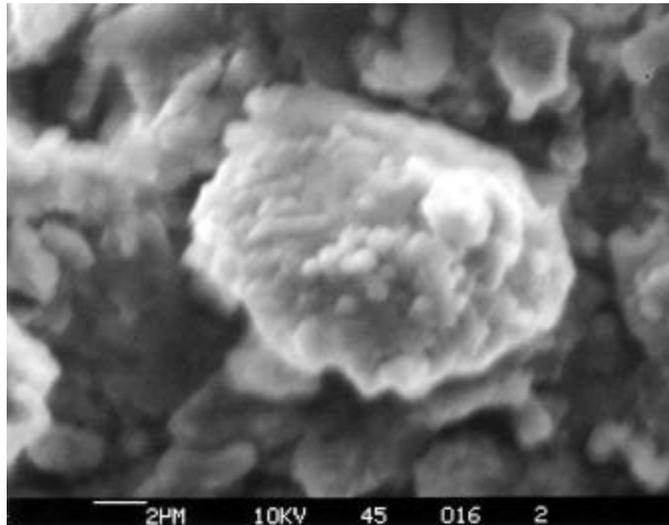
Figure 3-10. Secondary electron image of larger particle, note cleavage plane (loss of clarity at high magnification), 5000X

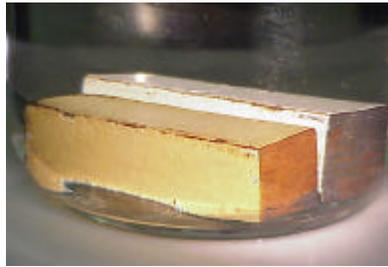
Portions of the aged and non-aged coating specimens were immersed in room temperature water, which was then heated to 200° F (Figure 4-11). As the water was heated, gas bubbles appeared on the coated surfaces of the irradiated specimen, accompanied by the formation of blisters in the coating as the temperature approached 200° F (Figure 4-12).

Figure 4-11. Overall view of the irradiation-aged (yellow, front) and non-aged (white, back) specimens in room temperature water at the beginning of immersion testing.

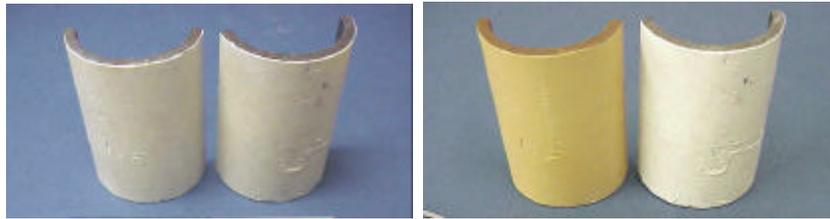
Figure 4-16. Overall views of the handrail specimen as it appeared as-received and after dividing in half (left), and after irradiation-aging of half of the specimen (right).

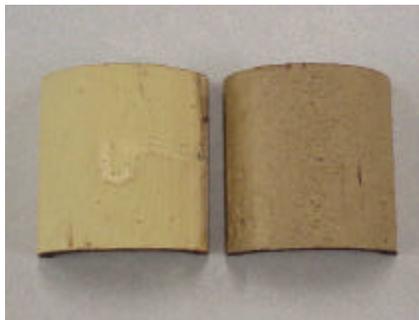
The coating did not fail, according to the acceptance criteria of the ASTM specification (Figures 4-17 and 4-18). However, under microscopic examination, there was evidence of failure of the coating in the irradiated specimen, similar to what has been observed in other irradiated specimens - by release of fine particles (Figure 4-19).

Figure 4-17. Overall view of the handrail specimens, after DBA-LOCA testing. The as-received specimen is on the left; the irradiation-aged specimen is on the right.

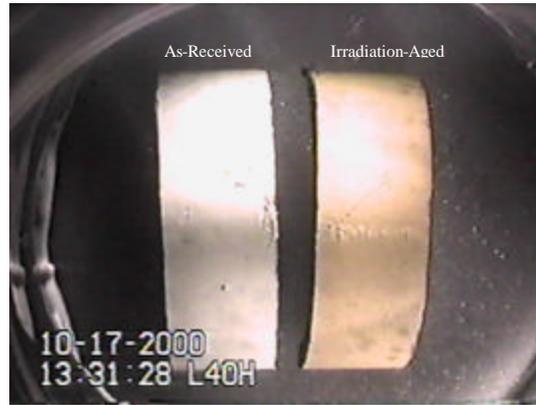
Figure 4-20. Handrail specimens immediately after immersion in water preheated to 200° F.

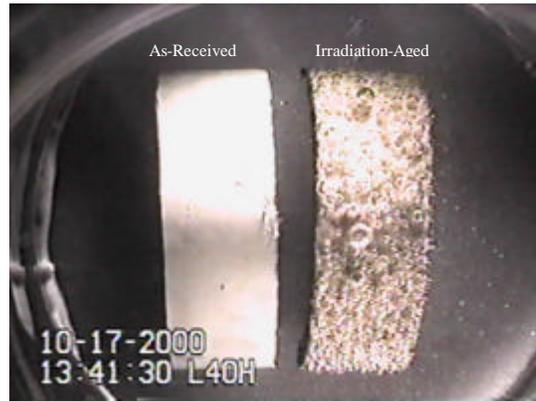
The first image (Figure 4-20) illustrates the condition of the specimens immediately after immersing them into water, preheated to 200° F. The next image (Figure 4-21) illustrates the appearance of the specimens after 10 minutes. Note the formation of a uniform layer of bubbles and blisters on the surface of the irradiated specimen. The rapid formation and release of bubbles is consistent with the hypothesis of gas formation within an epoxy topcoat during the irradiation of the specimen.

Figure 4-21. Handrail specimens 10 minutes after immersion in water preheated to 200° F.

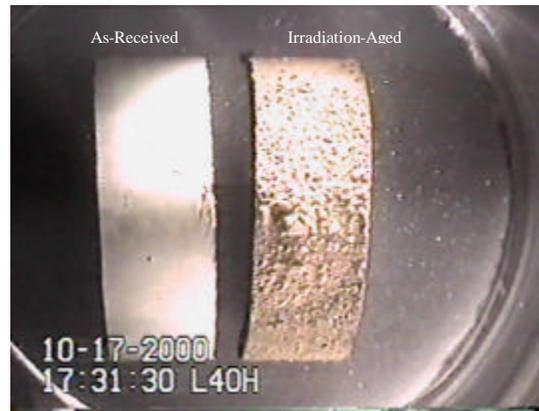
The addition of heat was terminated after approximately 2.5 hours and the specimens were allowed to cool under water. Figure 4-22 shows the appearance of the specimens after cooling for approximately 1.5 hours.

Figure 4-22. Handrail specimens at the end of the immersion tests.

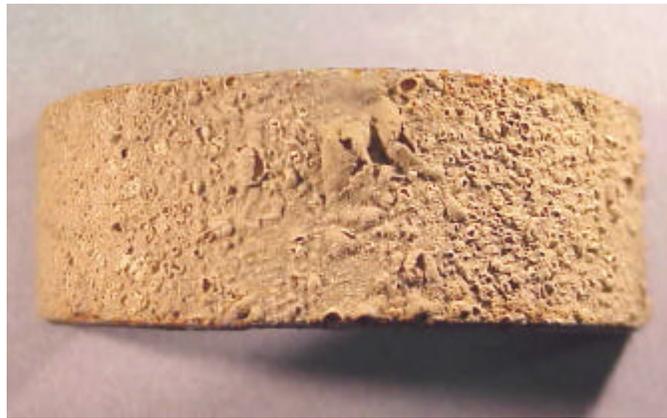
The last image (Figure 4-23) shows the appearance of the irradiation-aged specimen after removal from the immersion test. Note the extensive surface blistering, with rupture or collapse of most of the blisters. The blisters do not penetrate to the substrate, i.e., they are confined within the outermost layer of the topcoat, as has been observed in immersion testing of other irradiated epoxy coatings.

Figure 4-23. Irradiation-aged handrail specimen after removal from the water immersion test.

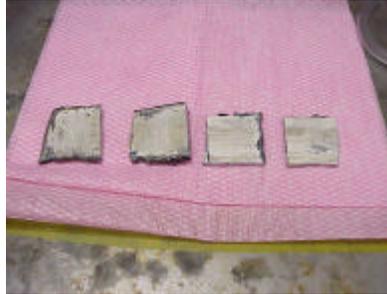
Figure 5-1 Overall view of coated steel plate specimens. The specimens are approximately 2 inches square, each, and were saw-cut from a plate which appeared to have been removed from service with a cutting torch.

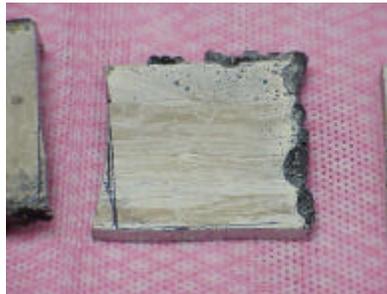
A water immersion test was performed on a coated steel plate specimen removed from an operating commercial nuclear power plant after more than 20 years of service. The coating system consisted of a Carbozinc[®] 11 primer with a Phenoline[®] 305 topcoat. The specimen had slight surface contamination, and was tested in the as-received condition only, i.e., no additional irradiation of the test specimen was performed (Figure 5-2).

Figure 5-2 Overall view of one of the coated plate specimens as it appeared prior to immersion testing.
