SRS Type II HLW Tank 15 NDE Inspection Results

Savannah River Technology Center
NDE and Materials Reliability
Materials Technology Section

February 24, 2003

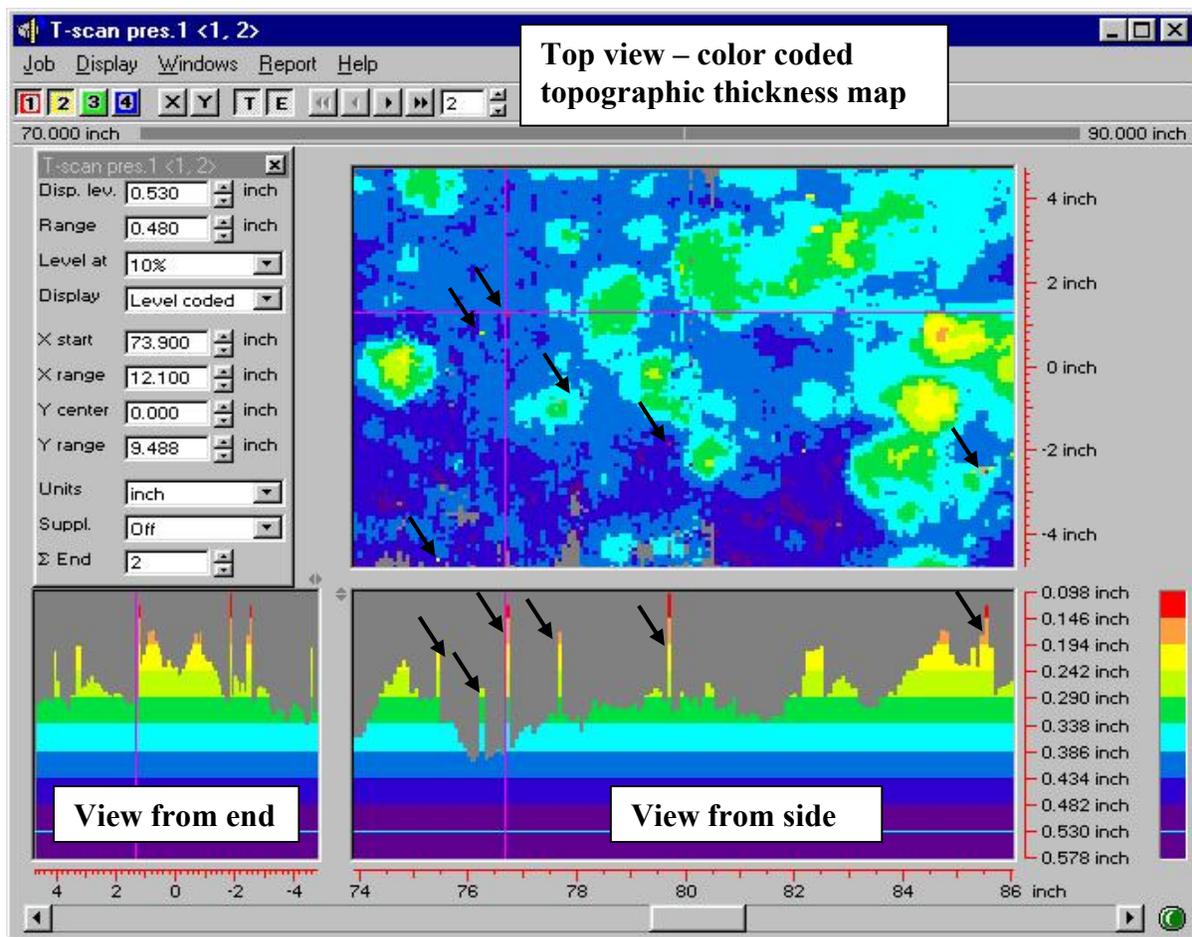
Figure 4: Explanation of Thickness Mapping Image

This figure shows actual thickness mapping data collected on a carbon steel sample. This sample data shows actual pitting corrosion in a carbon steel pipe sample at the liquid vapor interface. The image shows pitting and corrosion patterns typical of actual wall loss as well as noise spikes (also known as data dropout). The noise spikes are noted with arrows in the top and side views.

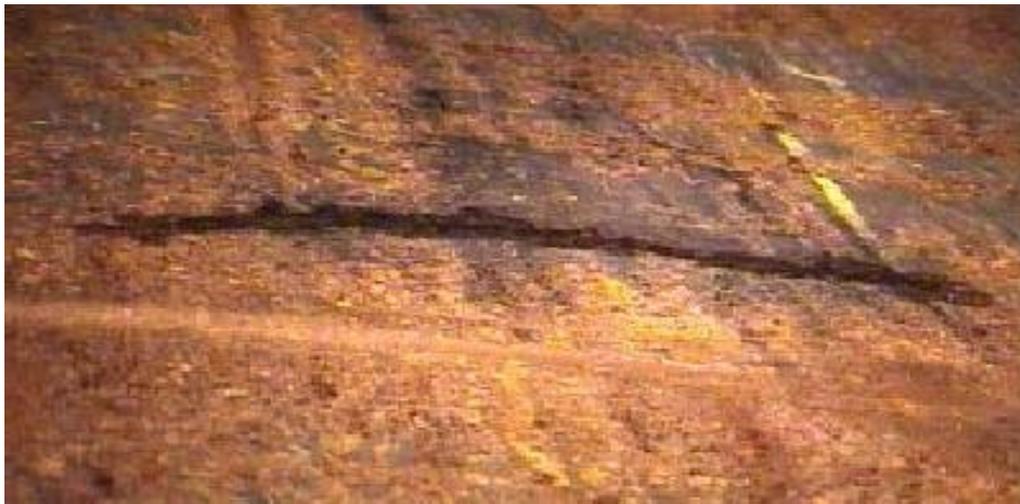
Figure 5: Example of Through-Wall Bleed-Out

Through-wall bleed-out is the term being used to describe the field implemented variation of a liquid penetrant surface inspection technique. It was noted that the water being used for UT couplant, would penetrate (through capillary action) surface cracks. Due to the elevated temperature of the tank wall (~120 degrees F), the wetted surface would dry after a few minutes. Where there was a crack open to the exterior surface, the water drawn into the crack would then bleed out providing a high contrast image of the open crack. Video cameras were utilized to view these indications and make crude measurements of length as the crawler was driven along the indication(s).

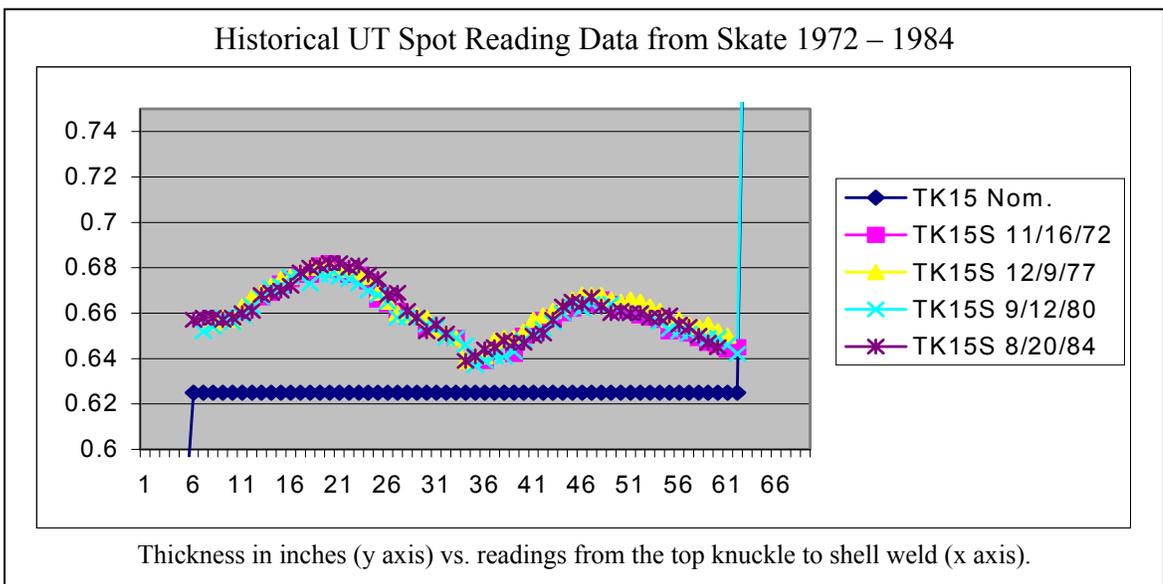
Figure 10: Historical UT Spot Readings – South Riser

Figure 10 shows a graph of the results of the historical thickness readings from Tank 15. Thickness spot readings were taken in the South riser of Tank 15 in 1972, 1977, 1980 and 1984. The readings show that there was no accelerated, general wall loss. The graph displays spot thickness data over a 12 year time period representing from 12 to 24 years in service.

The graph shows data from the two upper and lower primary shell plates between the top and bottom knuckles. This is the same area that was examined by thickness mapping in 2002. The historical spot reading data shows the typical pattern for waste tank plates where the edges of the rolled plates are thinner. The data from a given tank elevation from all successive readings are well within the 0.011 inch tolerance or uncertainty value.^{vii}

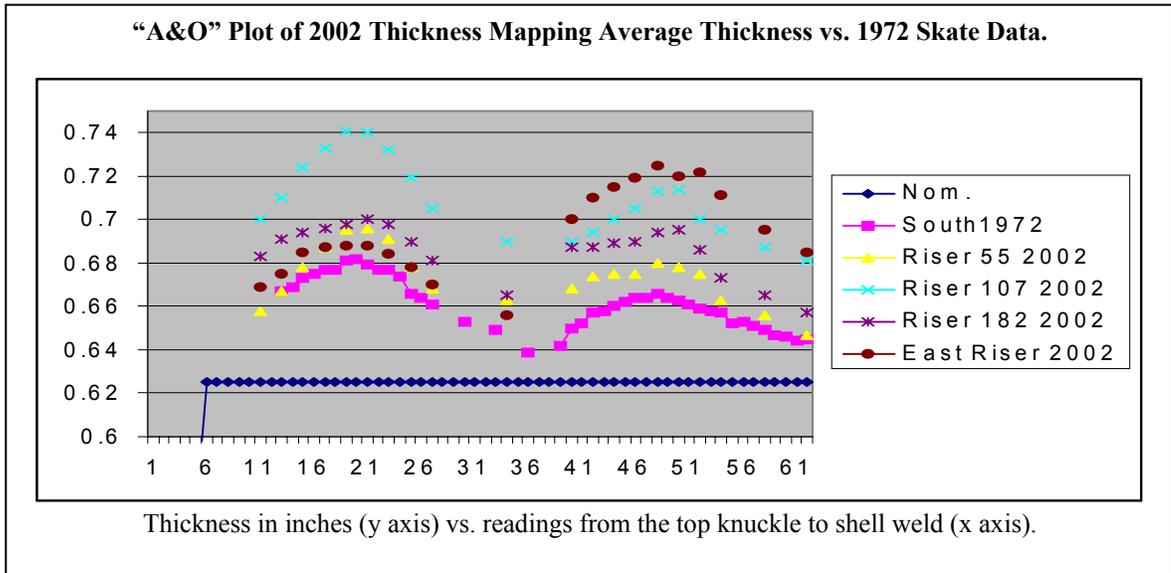
Figure 11: Average Thickness Mapping Data vs Initial Spot Reading Data

With the understanding that direct comparison is not intended, the following “Apples and Oranges” plots are provided to give an example of tank wall thickness over time (see Figures 11 and 12). Note that each set of data is from a separate riser and are therefore from separate plates of steel. Variations in thickness from one plate to the next (vertically and horizontally) are typical in tank construction. The 2002 average thickness data is typically reported to be thicker than the 1972 data. This is due to variations in the UT technique summarized earlier in this section. The pertinent information is that the typical thickness pattern remains unchanged which indicates that there is no accelerated general wall loss at any elevation in the tank.

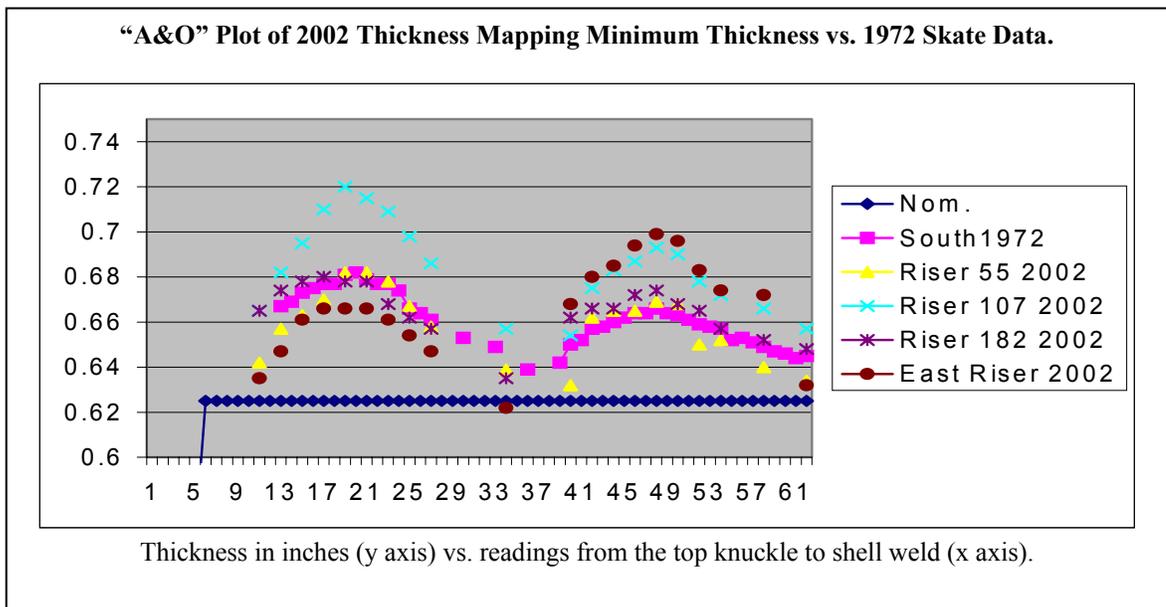
Figure 12: Minimum Thickness Mapping Data vs Initial Spot Reading Data

In the following figure the minimum thicknesses from the 2002 thickness mapping examinations are plotted along with the 1972 Spot UT thickness data. Again, the same typical, tank plate thickness profile is evident. Only 1 small area was detected with a minimum thickness below nominal thickness.
