FY2004 Corrosion Surveillance Results For L-Basin (U)

Savannah River National Laboratory
Materials Science and Technology

Publication Date: September 2005

DOCUMENT: WSRC-TR-2005-00067

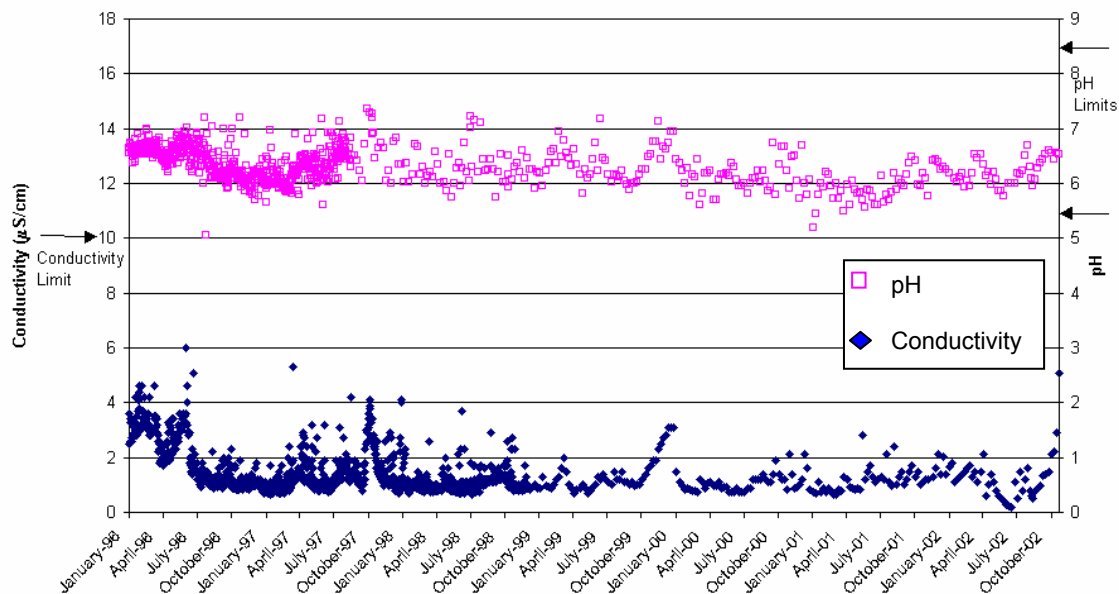
Figure 2. Time dependent water conductivity and pH in L-Basin during surveillance coupon immersion from January 1996 until October 2002.

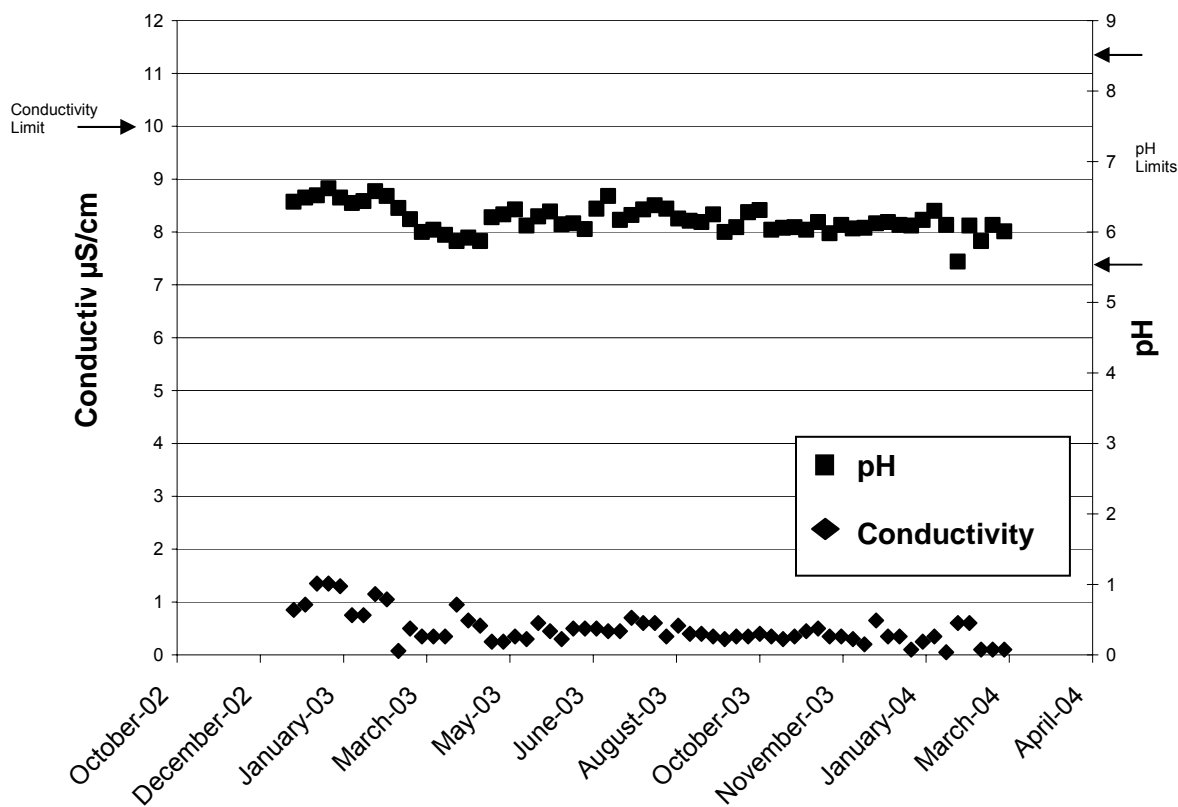
Figure 3. Time dependent L-Basin conductivity and pH from January 2003 until March 2004.

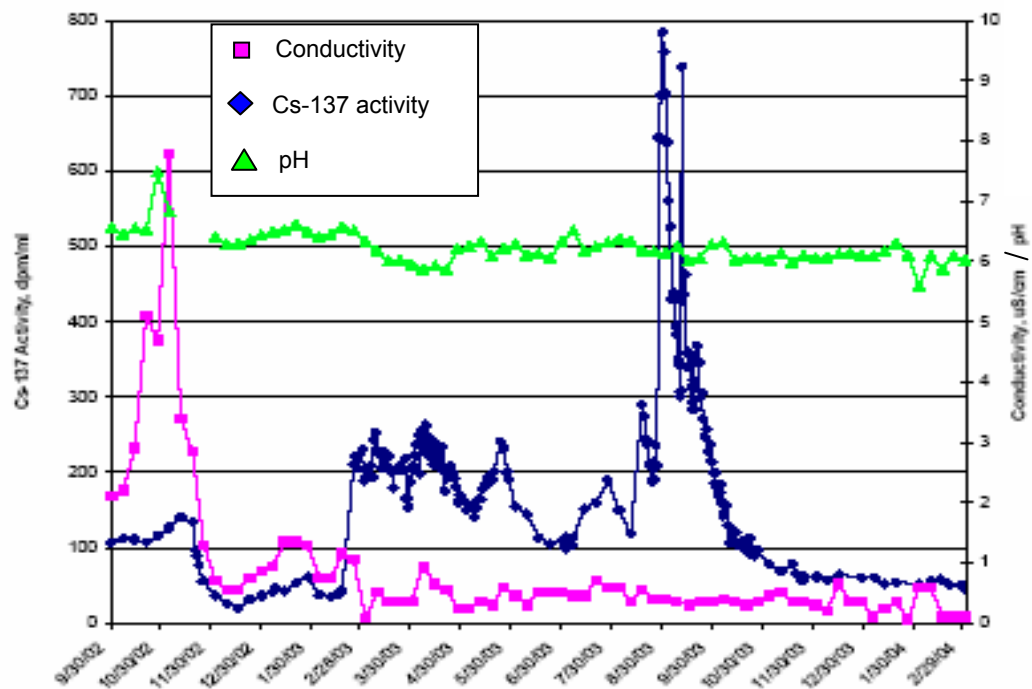
Figure 4. Time dependent Cs-137 activity levels in L-Basin versus pH and conductivity during October 2002 to the end of February 2004.

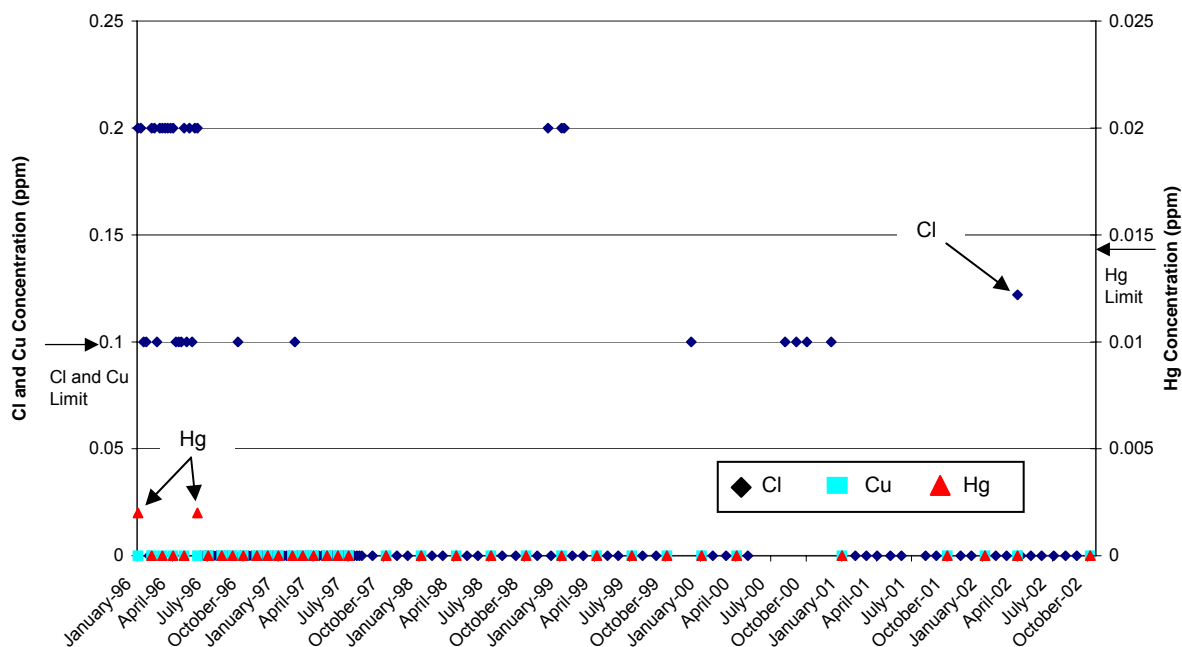
Figure 5. Time dependent concentration of aggressive species in L-Basin water during surveillance coupon immersion until October 2002.

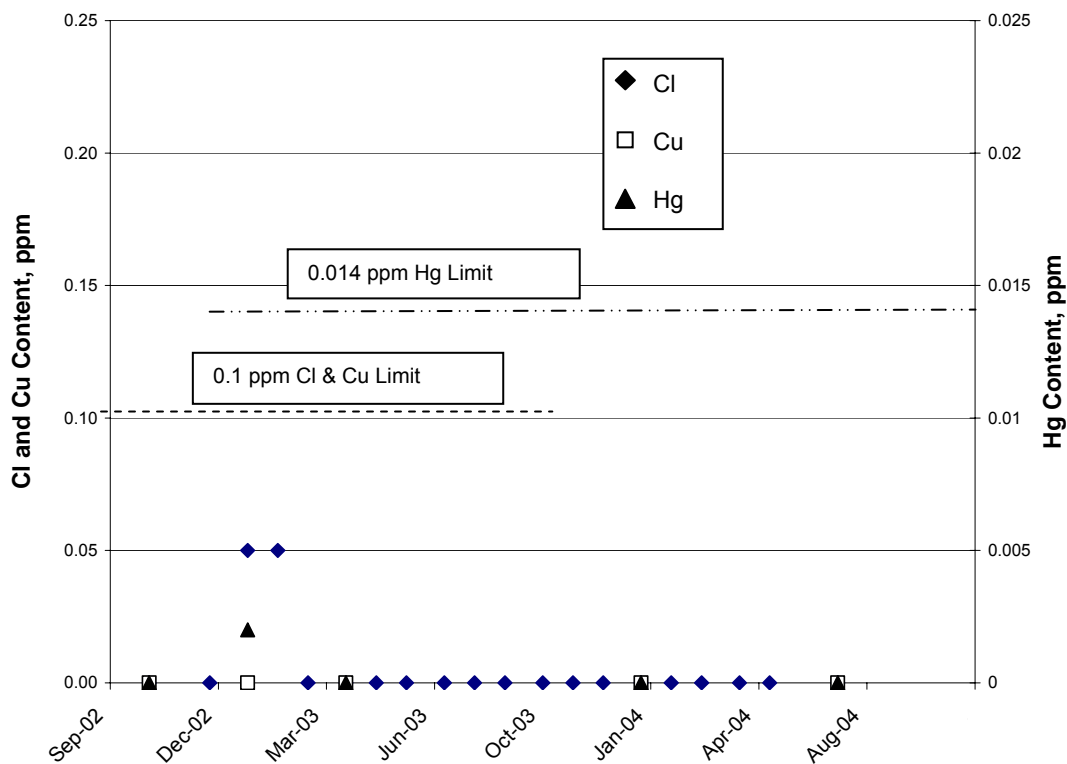
Figure 6. Time dependent concentration of aggressive species in L-Basin water during surveillance coupon immersion from October 2002 until July 2004. All species were below Chemistry Program limits.

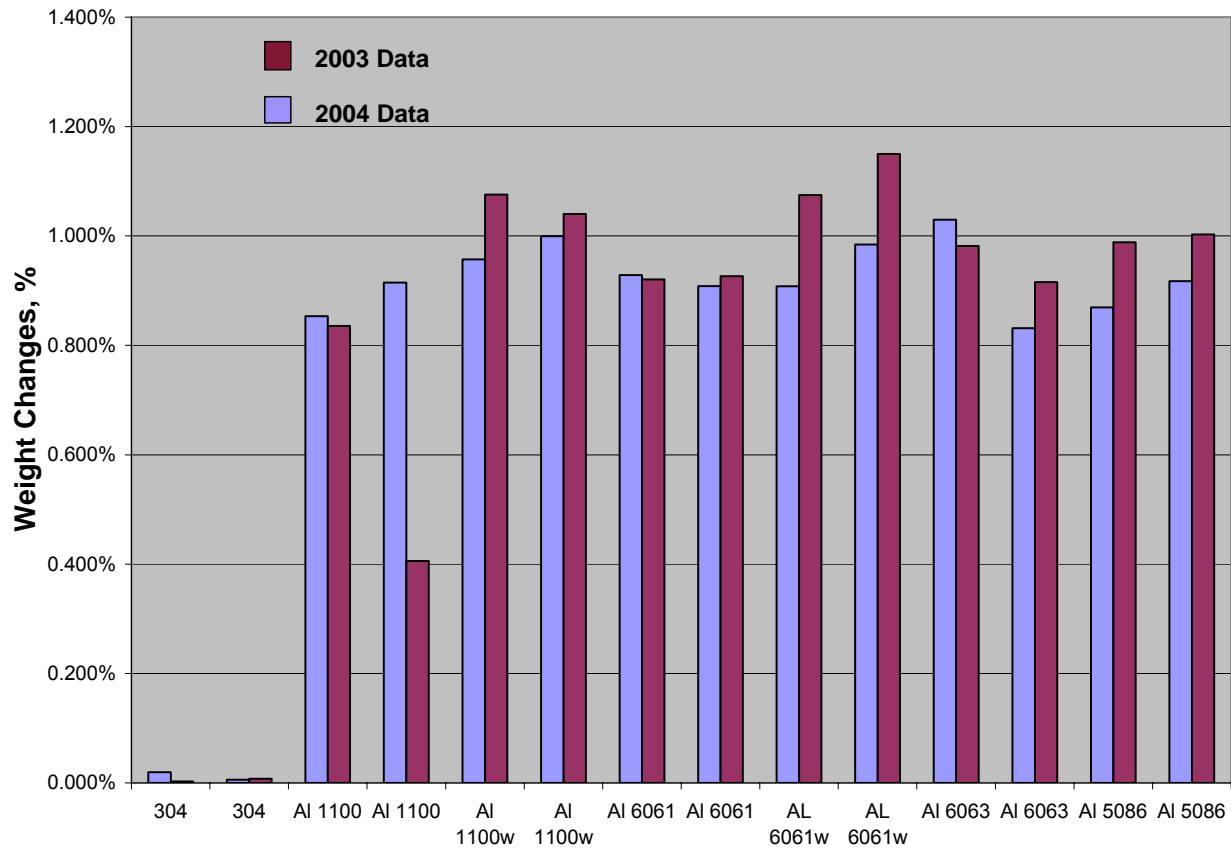
Selected images of individual 2004 surveillance coupons are shown in Figure 7. Percentage weight gains of approximately 0.85-1.05 % for the 2004 aluminum samples versus weight gains of 0.4 to 1.15% for 2003 are graphed in Figure 8. The welded coupons gained slightly more than the non-welded coupons in 2003 but this was not repeated in the 2004 coupons. One welded 6061 coupon from 2004 revealed percentage weight gains equal to or slightly less than the gains of the non-welded 6061 coupons. This is unusual since the autogeneous weld is expected to show more corrosion based on the 2003 data. One of the 1100 coupons (2003) did show a lower percentage weight gain due to slightly higher initial weight and slightly lower weight gain (± 0.5 gram) which was not repeated by the 2004 coupon results. Overall, these coupons appear visually comparable to coupons withdrawn in 2001, 2002, and 2003. The individual coupons from all four years of evaluation appear to be undergoing uniform oxidation.

Figure 8. Percentage weight gains (weight gain divided by original weight x 100) from individual metal coupons from 2004 compared with those of 2003. In most cases, the coupons from 2003 appeared to gain a slightly higher percentage of their original weight. Note that the weight gains of welded samples in 2004 (alloy designation plus “w”) were equal to or slightly more than their non-welded counterparts. The weight gain percentages of welded samples from 2003 were also higher than the non-welded samples.

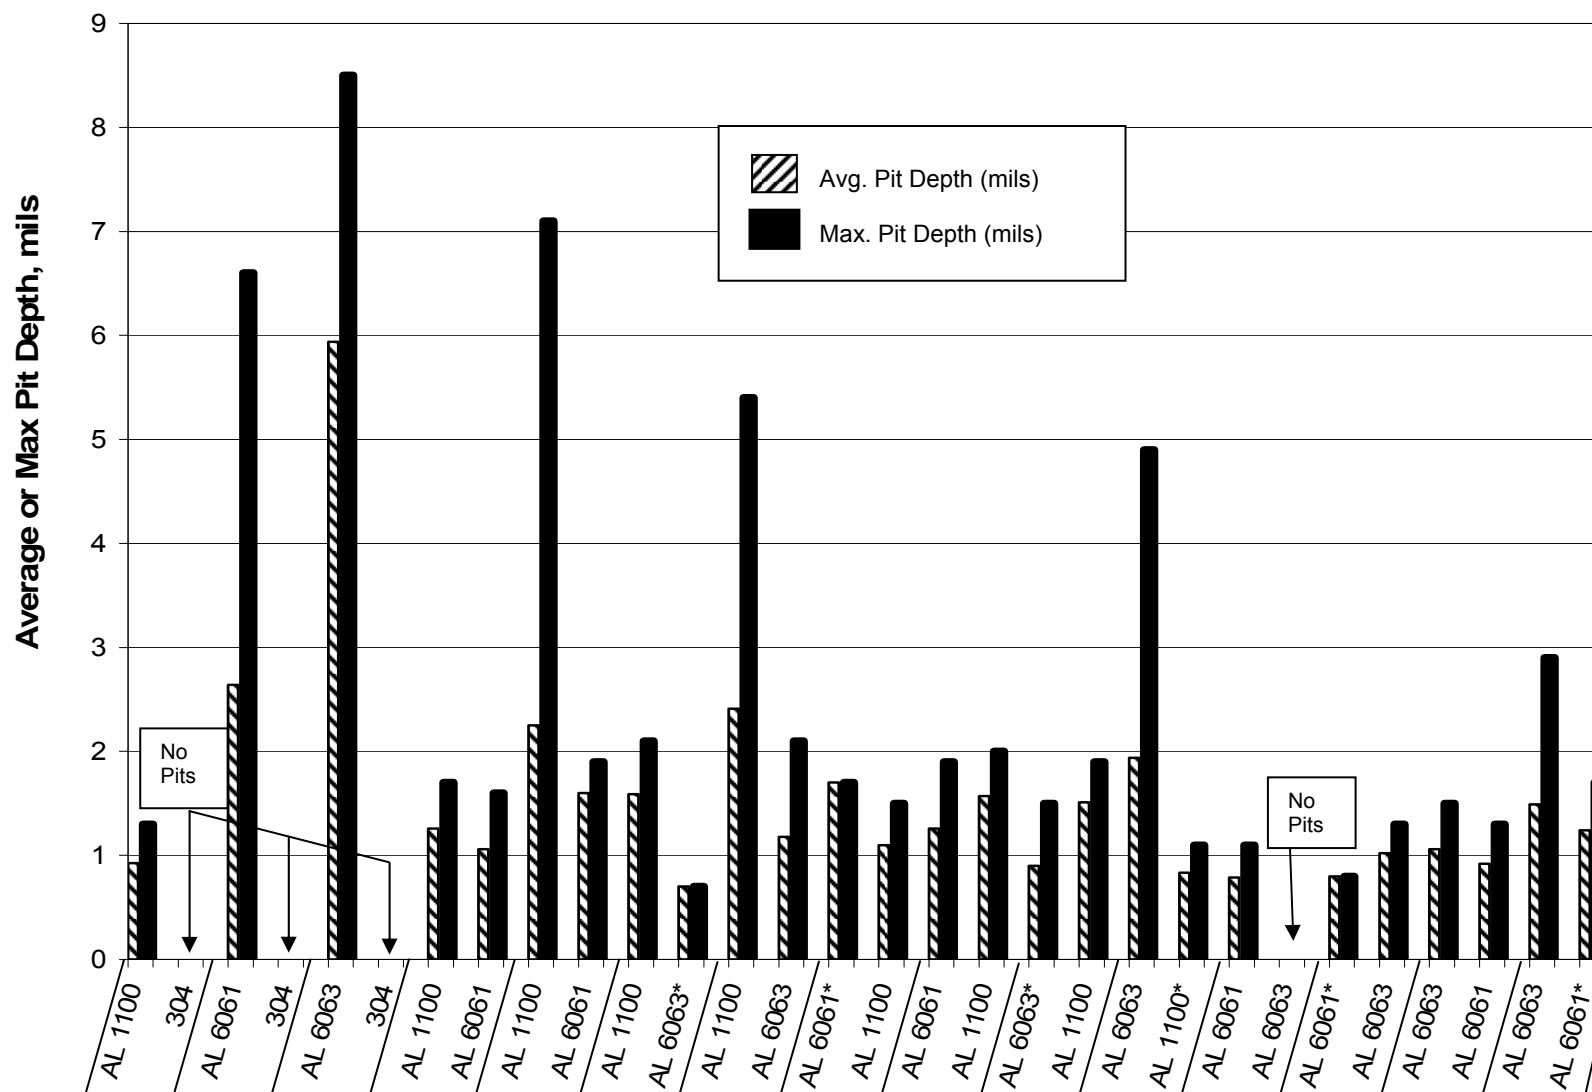
Pit depths were measured on all 2004 galvanically coupled aluminum alloy coupons and summarized in Figure 13 with a display of average and maximum pit depths. Only selected coupons from the 2003 surveillance were measured and reported. Within each two alloy groupings in Figure 13, the diameter of the specimen on the left is 32 mm and that of the specimen on the right is 70 mm. The size difference is intentional in order to accelerate pitting rates from galvanic corrosion in the smaller specimen. The highest average (~6 mils) and maximum (8.5 mils) pit depths were revealed on the 6063 coupon which was coupled with 304. These pits are probably due to a combination of galvanic corrosion and end grain effects. Similar effects were also displayed on the 6063/304 coupled coupon from 2003. Maximum pit depths on the aluminum alloy couples were located near the PTFE washer circumference and on the ID and OD of the samples. This is also an indication that crevice corrosion is ongoing beneath the PTFE washer.

Figure 13. Average and maximum pit depths of 2004 galvanically coupled coupons. Starting at left, the first coupon (group of two) is the smallest (32 mm OD), while the second mating coupon is the largest (70 mm OD). The first three bar sets are coupons mated to 304 stainless steel while the remainder of the coupon sets mate two aluminum alloys together. Maximum pit depths were measured near the edge of the PTFE washer area or at the coupon ID. On samples noted by an asterisk (*), pit depth averages were calculated with <10 pits. No pitting was observed on all 304 and one of the 6063 coupons mated to 6061.

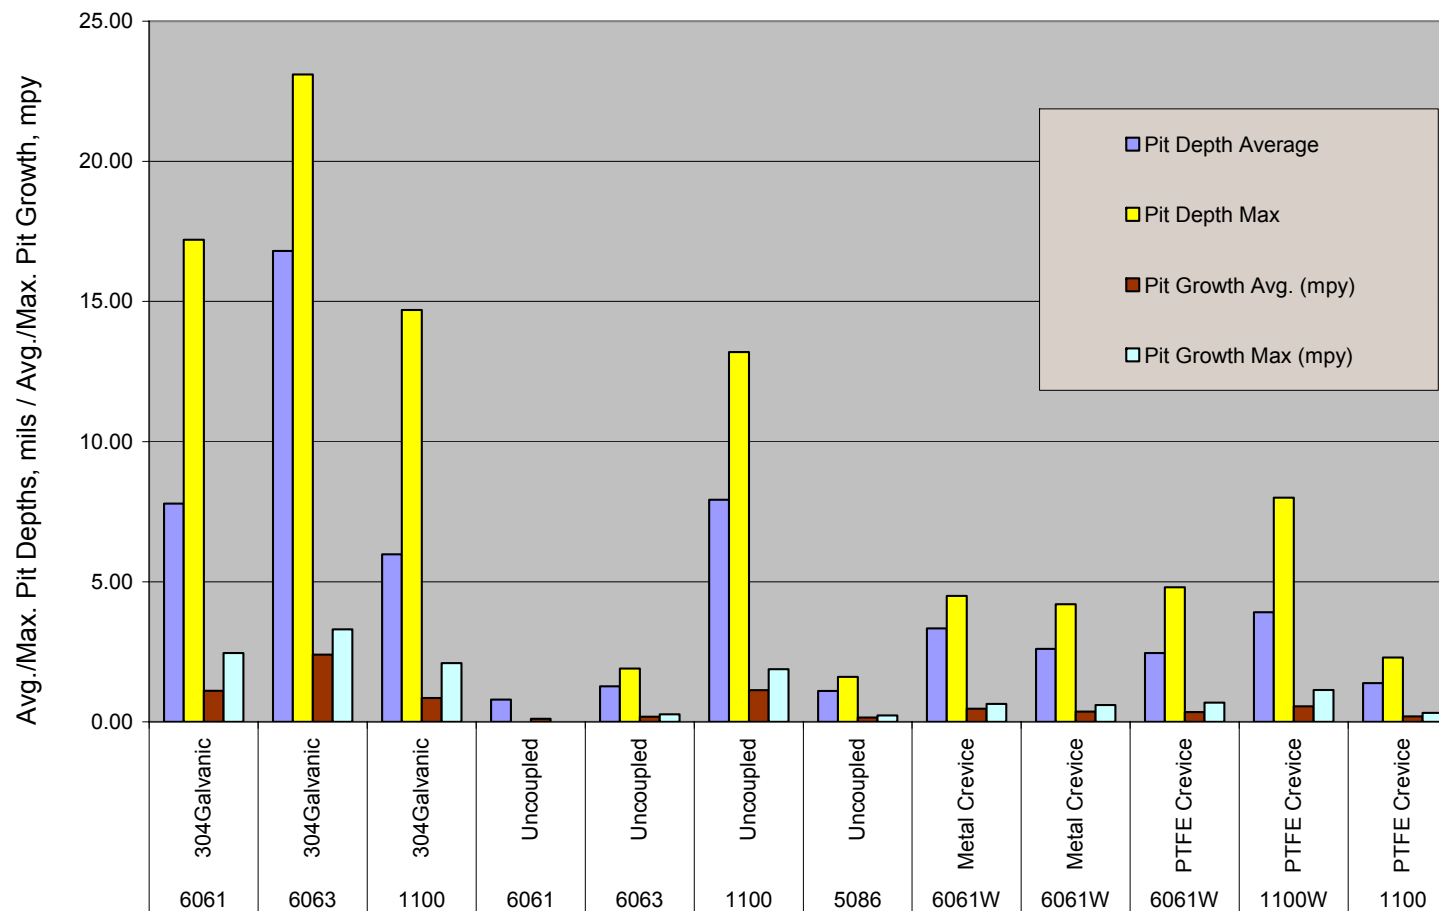
Figure 14 displays pit depth data from selected coupons shown from previous surveillance (FY2003) which shows the greatest average (17 mils) and maximum pit (23 mils) depths in the 6063 coupon mated to 304. These values are more than twice that of a similar galvanic coupon from 2004. For all samples, average pit depths were taken from the 10 deepest pits per ASTM G46.[2] From the previous data shown in Figure 14, it is evident that average and maximum pit depths are observed to be deepest in specimens coupled with 304 (stainless steel). This is expected since aluminum is highly anodic to stainless steel based on the galvanic series.[9] In addition, the pit depth values in an uncoupled 1100 coupon and a crevice 1100W (welded) coupon were observed to be elevated in comparison to the other coupons (7-8 mils average and 13 mils maximum depth for one uncoupled 1100 coupon and 4 mils average and 7-8 mils maximum depth for a welded 1100 coupon with the PTFE crevice washer). In comparison, pit depths in the second uncoupled 1100 coupon averaged less than 2 mils with a maximum pit depth less than 4 mils. Since the sample size is limited to two coupons, conclusions about the variability of the data are limited and any statistical conclusion is invalid.

Figure 14. Effect of coupon type and aluminum alloy on pit depths on 2003 coupons. The average and maximum pit depth and the pit growth rate were highest in the 6063/304 couple. As an individual coupon, 1100 revealed greater pit depths than the other three alloys in the uncoupled category.

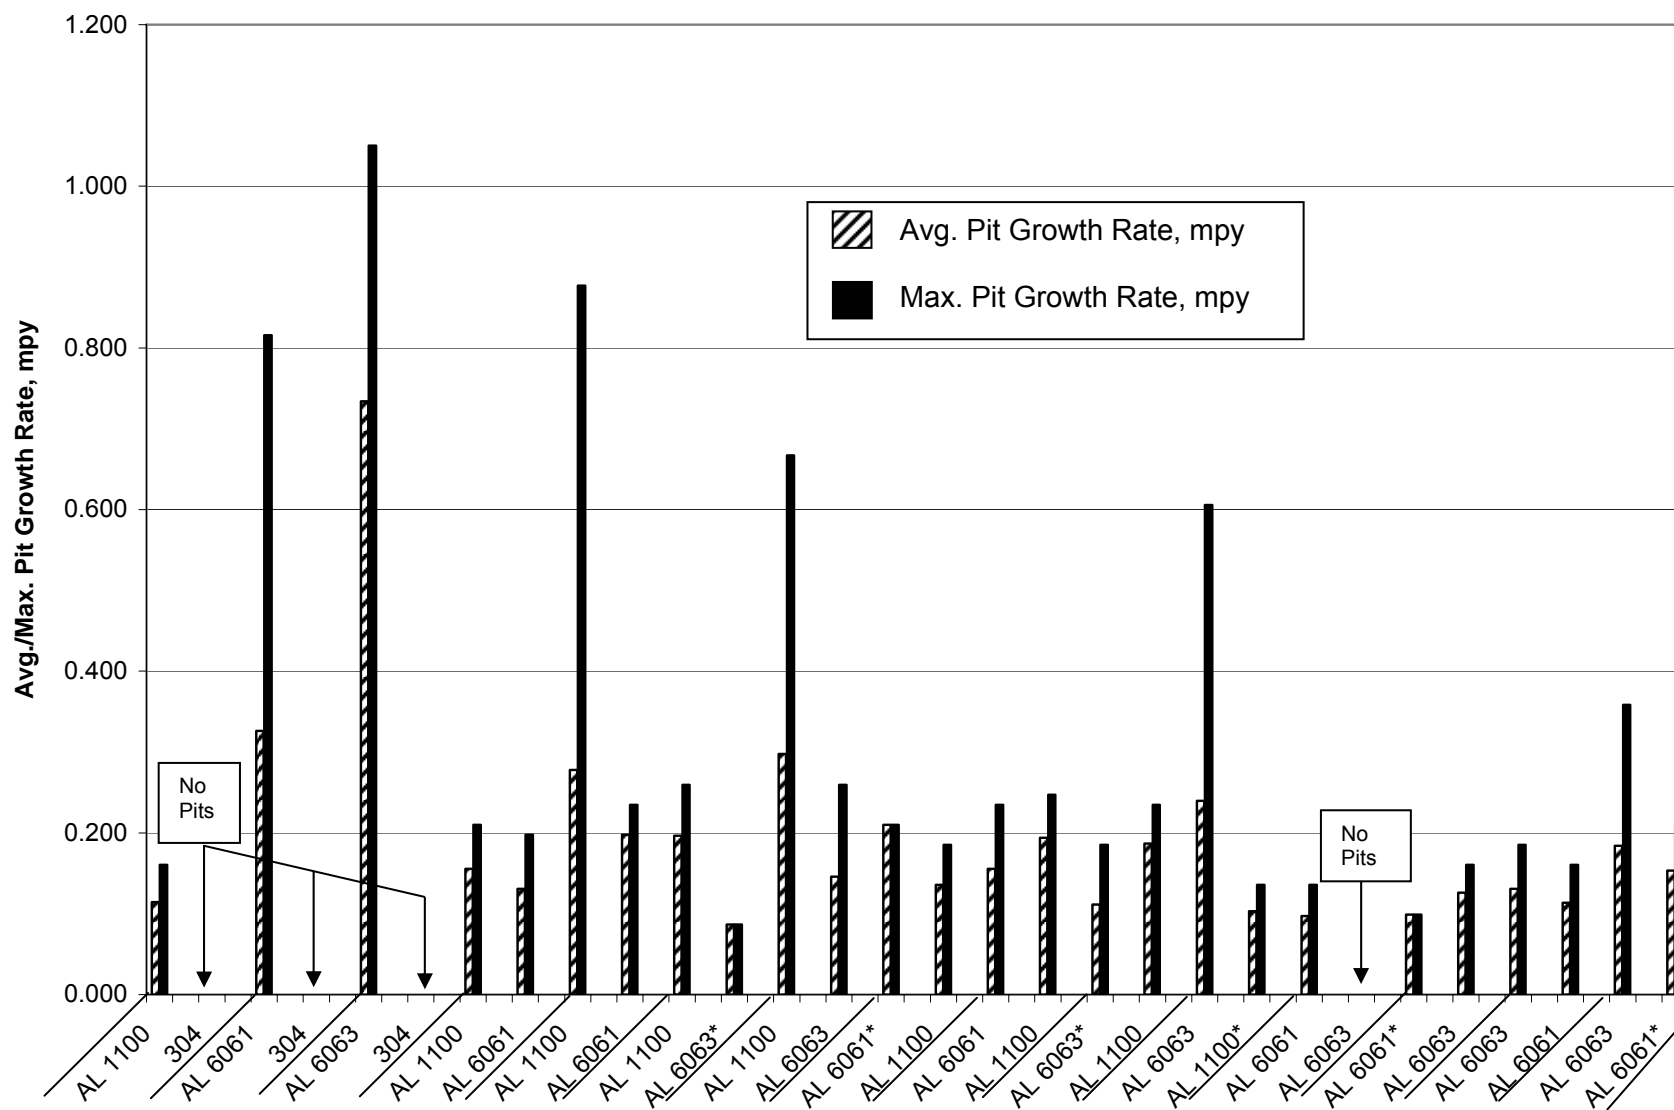
Pit growth rates for 2004 are shown in Figure 15 which reveals average and maximum growth rates for the 2004 galvanically coupled coupons. In all but one coupon set, the average growth rate is less than 0.4 mils per year (mpy). The 6063 coupon mated to 304 reveals the highest average growth rate (approximately 0.7 mpy) that is approximately 2x that of the other coupons. In Figure 14, a similar 6063 coupon mated to 304 revealed an average growth rate of < 3 mpy. The average growth rates calculated for the 2003 coupons are below 3 mpy versus 0.7 mpy for the 2004 galvanic coupons. Pit growth rate may be slowing down.

Figure 15. Average and maximum pit growth rates for 2004 galvanically coupled coupons. Coupon order and sizes are identical to those used in Figure 13. The same pit depths were used except divided by the number of years (8+) in the basin to calculate growth rates.

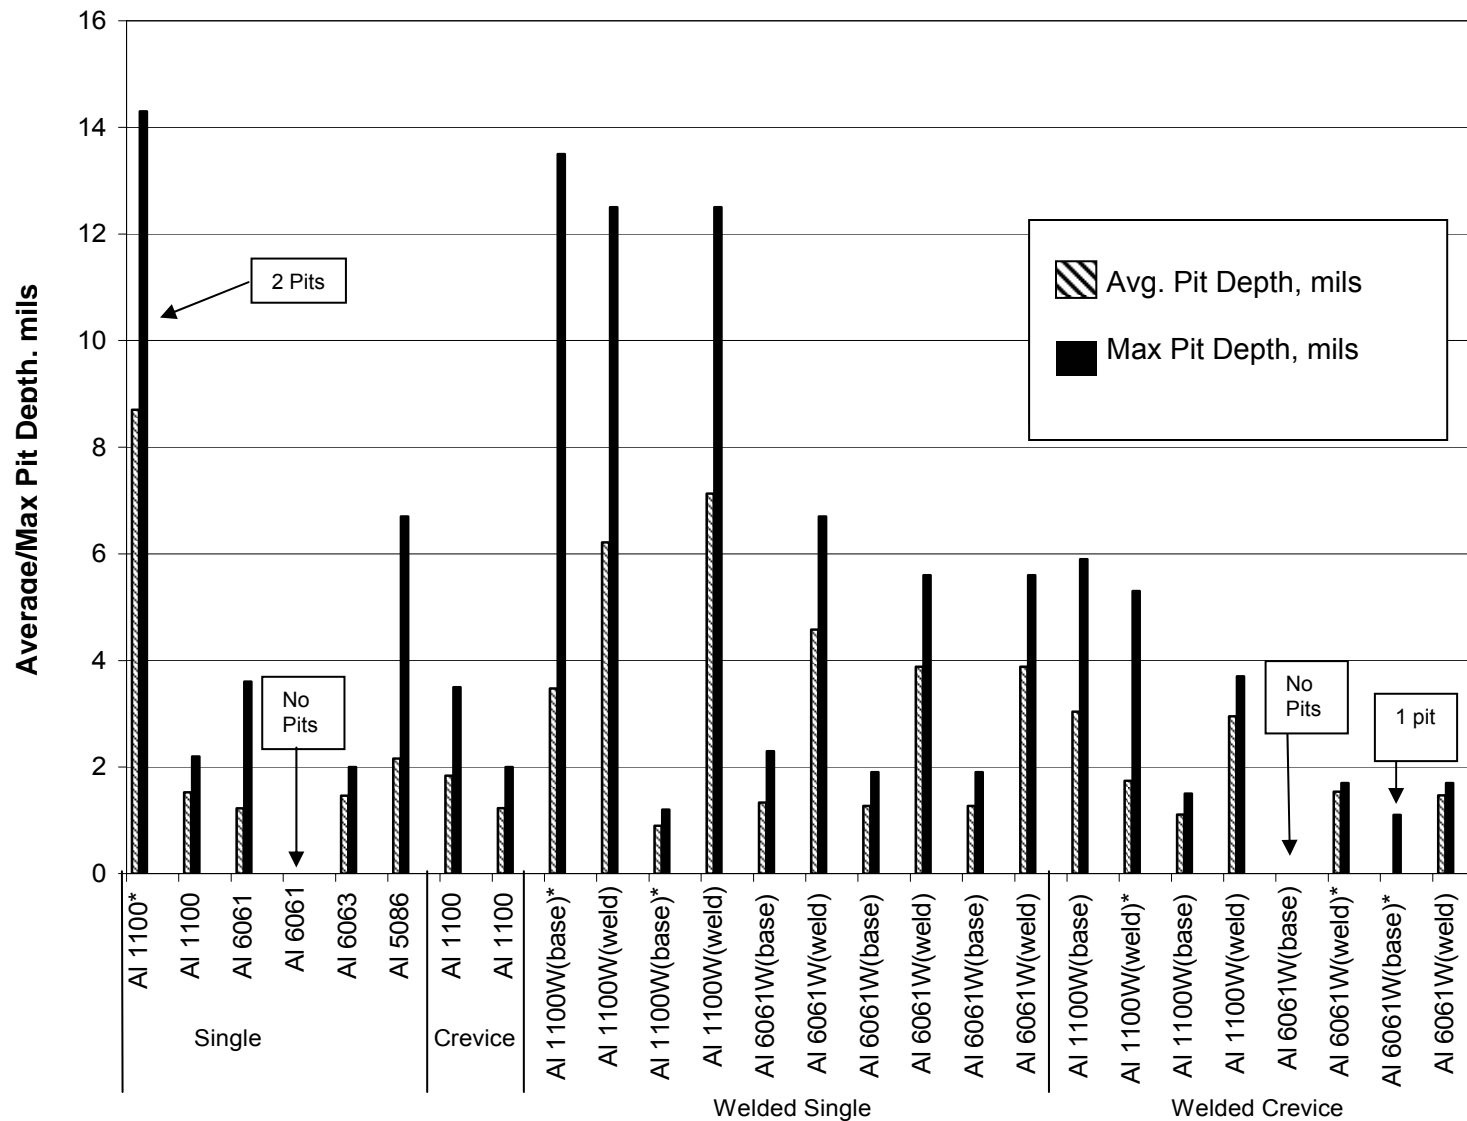
Figure 22 shows the pit depth measurements for all welded and non-welded single and crevice coupons removed from the basin in 2004. The number of examined coupons was increased over the selection made on the 2003 surveillance coupons. As mentioned above, average pit depths were taken from the 10 deepest pits per ASTM G46 (averages calculated where <10 pits were found are denoted by an asterisk (*)). Single 1100 and 1100W specimens exhibit larger pit depths than other alloys, an average pit depth of approximately 9 mils and maximum pit depth of approximately 14 mils for a single, uncoupled 1100 coupon. These pit depths are very similar to those displayed in Figure 14. As mentioned earlier for 1100 coupons, the deepest pits measured in these specimens were observed on or near the edges of the coupon. These pits are deeper as a result of their proximity to the end grains at the edge. In all single welded coupons, the weld metal contained higher average pit depths than the base metal. The same conclusion was not deduced from the welded crevice coupons. Low average pit depths of less than 3 mils were found in the weld and base metal in most of the welded coupons with a crevice washer. This implies that the PTFE crevice washer did not cause sufficient crevice conditions to increase corrosion. The lack of crevice corrosion under the crevice washer is probably due to the lack of sufficient spacing between the washer and the aluminum coupon. However, crevice corrosion was found on various corrosion coupons at the edges of the flat PTFE insulating washers which were installed on at least one side of most coupons in this study. The flat washer apparently creates greater surface area and/or volume in contact with the coupon for potential crevice corrosion.

Figure 22. Effect of single, crevice and autogenous welded 2004 coupons (with and without crevice) on average pit depths and maximum pit depths. On samples noted by an asterisk (*), pit depth averages were calculated with <10 pits. The single Al 1100* coupon data is based on two pits. Pits measured in the “base” are those outside of the weld.

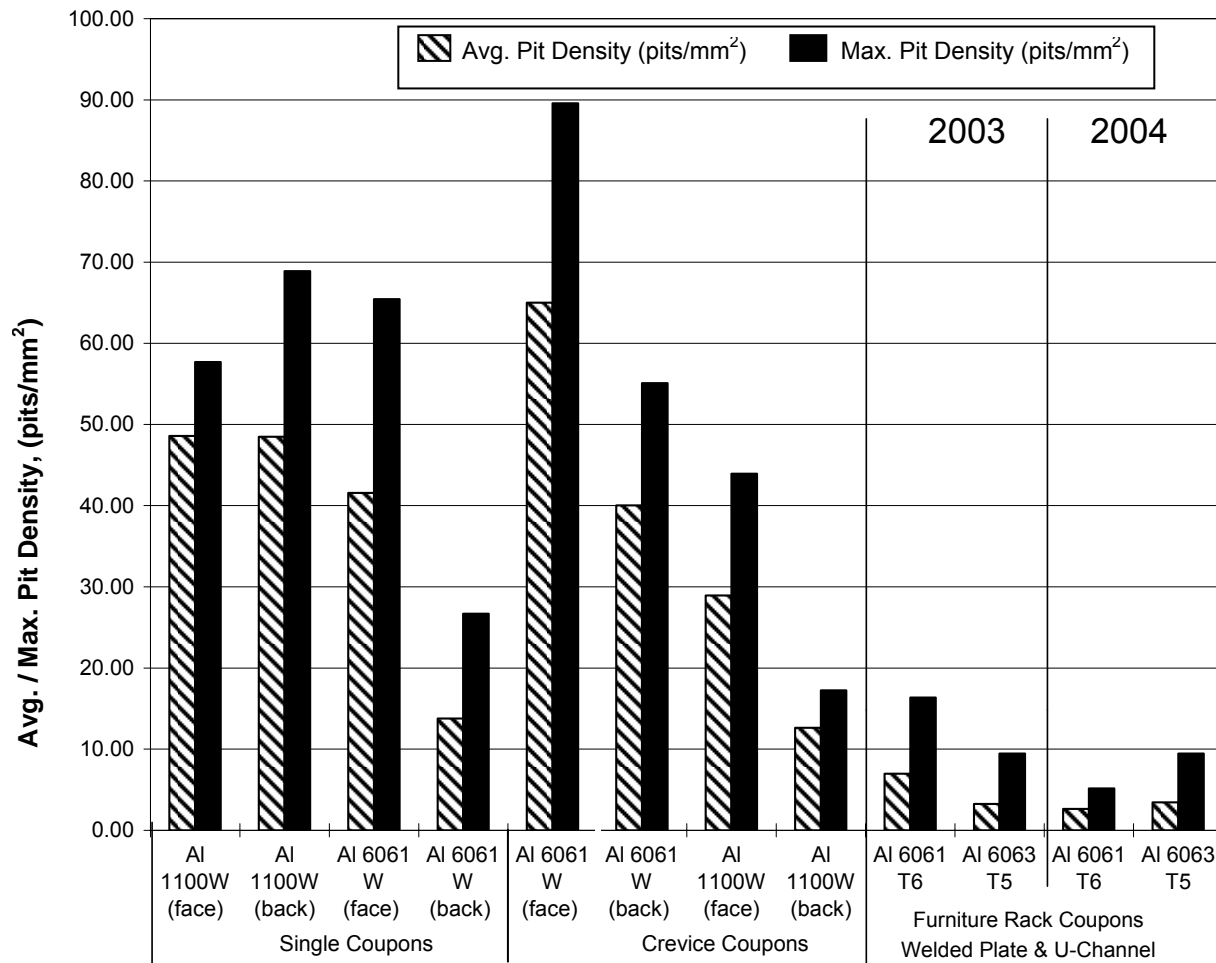
Pit density measurements were also measured for a selected number of autogenously welded and filler metal welded rack coupons. Pit densities were not measured on non-welded individual, crevice, and galvanic coupons because the number of pits within a 0.762 mm square area was less than that measured for the welded coupons. Pit density is determined by the number of pits measured within a 0.762 mm (0.030 inch) square area. The pit data from autogeneous welded disk coupons of 1100 and 6061 are shown in Figure 23 along with pit density measurements from rack coupons containing fillet welds of R4043 in Figure 24. Figure 23 clearly shows higher average (≤ 65 pits/mm²) and maximum (≤ 90 pits/mm²) pit densities in the autogeneous welded disk coupons (with and without crevice washer) versus the filler metal welded furniture rack samples (≤ 15 pits/mm²). This is most likely to be a result of the thermal profile of the autogenous weld promoting pit growth due to changes in the metallurgical microstructure (grain growth, dissolution or growth of intermetallic phases) versus the normal weld microstructure of the filler metal (R4043) used on the rack coupons.

Figure 23. Effect of welded coupon type on average and maximum pit densities. Coupons are individual (welded), crevice (welded), and furniture rack welded (plate and U- channel). The alloy designations including “face” is the side of the coupon with alloy designation and coupon number while the coupon “back” is the opposite side. Furniture rack coupons were welded with a R4043 rod versus autogenous welding of the individual and crevice coupons. Furniture rack coupon revealed the lowest pit densities of all welded coupons.

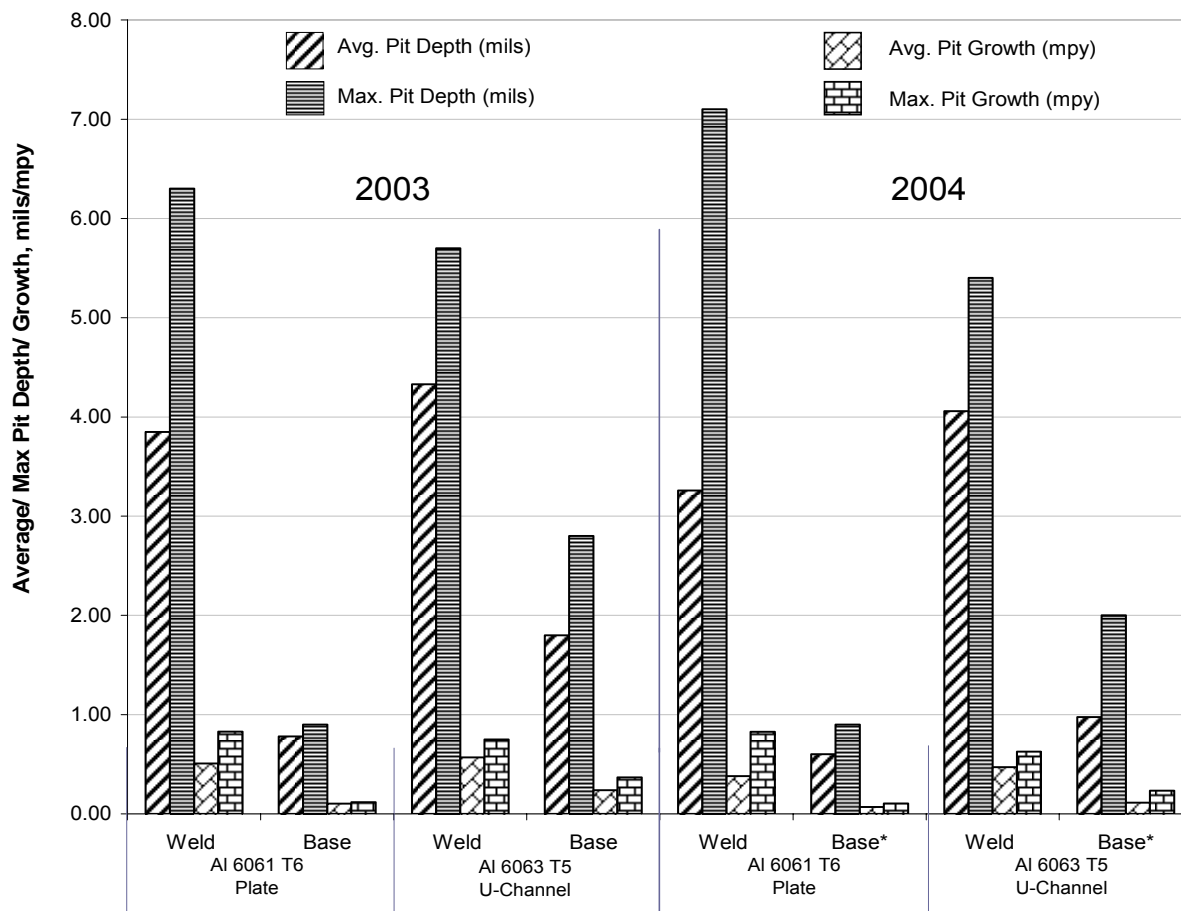
Figure 29. Effect of weld and base metal of furniture rack samples on average (Avg.) and maximum (Max.) pit depths and pit growth rates. Maximum pit depths in the welds were measured in the toe of the weld, while the highest pit densities were in the welds. Growth rates were less than 1 mpy. On samples noted by an asterisk (*), pit depth averages were calculated with <10 pits.
