AEC RESEARCH AND DEVELOPMENT REPORT

# **CORROSION OF EQUIPMENT IN THE HEAVY WATER COMPONENTS TEST REACTOR**

June 1965

E. I. DU PONT DE NEMOURS & COMPANY  
SAVANNAH RIVER LABORATORY  
AIKEN, SOUTH CAROLINA

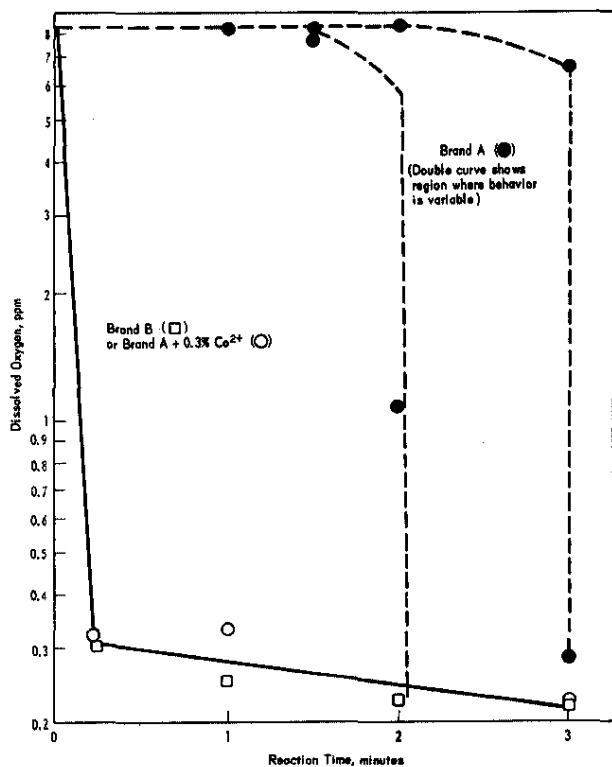
FIG. 4 RATE OF OXYGEN SCAVENGING BY CATALYZED SODIUM SULFITES IN DEIONIZED WATER

Tests of the two brands of catalyzed sulfite showed a slow reaction time for Brand A. Figure 4 illustrates the two types of behavior encountered in the tests. Either the reaction time proceeded almost to completion within one minute or it required a latent period of several minutes. Other tests showed that the reaction of Brand A was affected by both the source of water and by phosphate addition but that it could be made consistently effective by addition of 0.3%  $\text{Co}^{2+}$  as a supplementary catalyst. Figure 5 illustrates the slow reaction of Brand A with HWCTR well water in the presence of 30 ppm phosphate. This curve represents conditions within HWCTR experience during the period when corrosion occurred. It was concluded that Brand A failed to remove dissolved oxygen from the water with sufficient rapidity to minimize corrosion to the steam generator.

Based on these data, sulfite B, or sulfite A with 0.3%  $\text{Co}^{2+}$  added, was specified for use. In addition, a Hays Corporation Model 625 oxygen analyzer was installed as an independent check on the oxygen content of the feedwater. No further difficulty with water treatment occurred. The  $\text{O}_2$  content in the feedwater indicated by the oxygen analyzer normally ranged between 0.01-0.03 ppm. Sample analyses, using the modified Winkler method, corroborated these results.

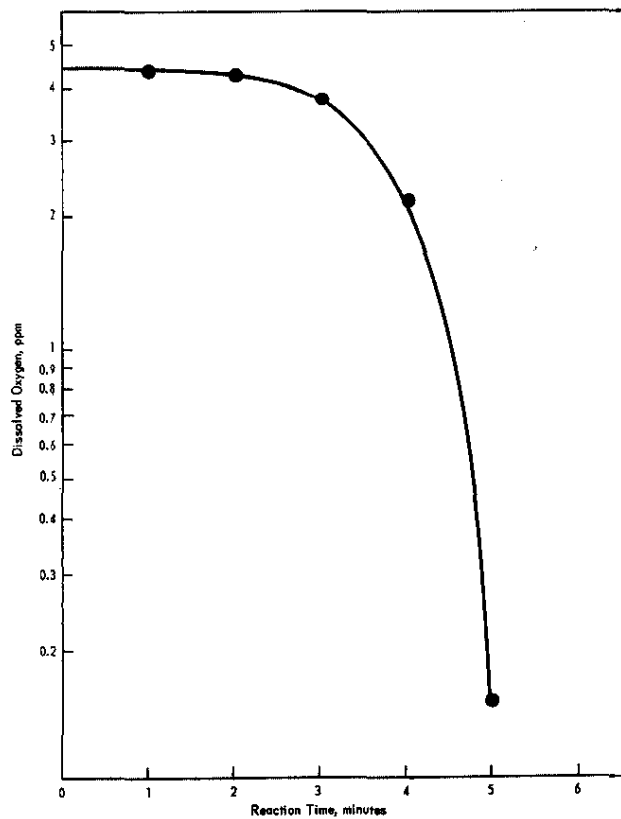
FIG. 5 OXYGEN SCAVENGING BY BRAND A SULFITE IN HWCTR WELL WATER (30 ppm  $\text{PO}_4^{3-}$  added)

An intensive, short-range, laboratory investigation was undertaken to determine the cause of the apparent presence of free oxygen in the feedwater, concentrating mainly on the sulfite oxygen reaction in the HWCTR well water with the two commercial sulfite products. All laboratory tests were run at room temperature. Some field tests augmented the laboratory results which indicated that the newer sulfite had indeed failed to react with all of the dissolved oxygen under the conditions of treatment.
