# **SRNL EPC Installation Report**

**E-RPT-A-00005**, Revision 0

During the week of August 25<sup>th</sup>, 2021, three Electric Phenomenon Cluster (EPC) sensors were installed at the Savannah River Site (SRS) owned, Dominion Energy (DE) operated 504-2G substation, shown in the figure below.

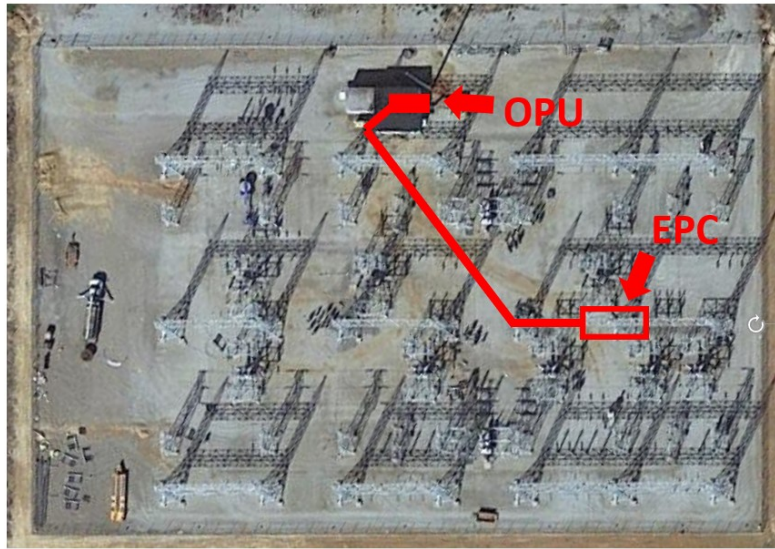
**Figure 1-2. EPC Installation at 504-2G**

The installation of the sensors took place in two separate parts: one part for the physical mounting of the sensor, conduit, and fiber optic cables performed by DE, and the other part for the connection of the EPC to the Optical Processing Unit (OPU) via specialty fiber optic cables performed jointly by SmartSenseCom (SSC), DE, and qualified SRNL personnel. The finalized connection diagram is shown in Figure 1-2 below. After the EPC sensors were connected to the OPU, remote access was configured between the Savannah River National Lab Critical Infrastructure and Industrial Control System Cyber Security lab (S-CIIC), using a cellular radio transmitter system between the substation and the SRNL campus. The installation activities concluded on September 3<sup>rd</sup>.

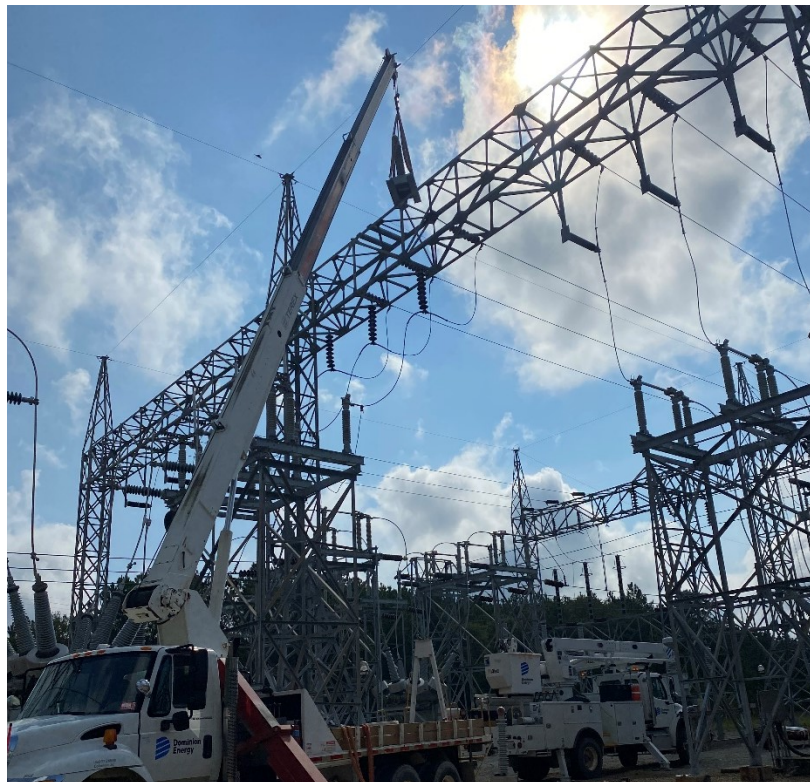
**Figure 2-1. EPC Installation on Substation Structure**

Starting the week of August 23<sup>rd</sup>, Dominion Energy began the process of installing the three 115kV rated EPC sensors. These sensors were installed at the top of the 60 ft substation structure, with fiber optic cables coming from the bottom of the sensor mounting box running through a rigid conduit down the side of the structure, which then was buried through the switchyard until the conduit terminated at the switch house. A picture showing the hoisting of the sensors to the top of the substation truss structure is shown below.

- It should be noted that the EPC sensors are normally meant to be installed on some form of flat pedestal, with a bottom plate covering the bottom face of the mounting box. For this installation, the EPC was mounted on a truss-based structure, which does not have a solid bottom mounting

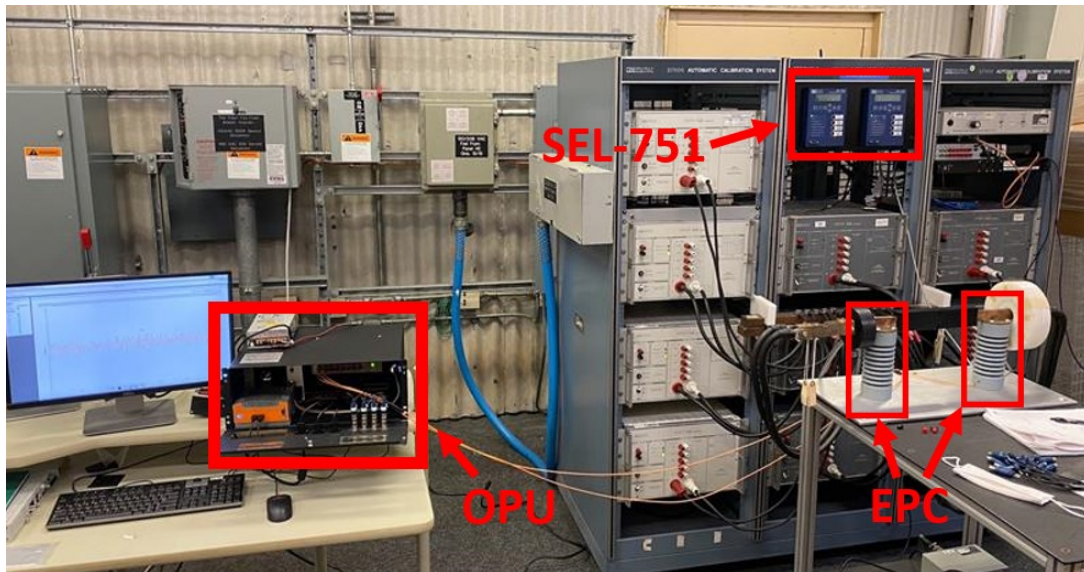
**Figure 2-2. High Current Lab OPU Field Acceptance Test Set-Up**

Pictured in the figure above is a rack of 10 current amplifiers with a combined capability of outputting accurate waveforms at the 1000 A level through a copper bus bar shown connected to the EPCs in the figure above. Also included in the figure are 2 SEL-751 protective relays, which were used for low-level input evaluation. The primary purpose of this test was to ensure that the OPU was still in functioning order after shipment. This test was done by connecting the fiber optic cables from the EPC sensors to the OPU and sending a large amount of current through the sensors to observe how the EPC displayed the information.

To recreate and test for this behavior in the test set-up shown above, the output signals from the coaxial connectors on the OPU were connected to an SEL-751 relay via the low-level interface on the SEL-751. It was observed that when connected, the OPU displayed a low-light received error, which is normally triggered when a transmit LED has either died or the signal coming back is too weak to be read accurately. However, whenever the output signal from the OPU was disconnected from the low-level inputs on the relay, the OPU began reading accurately again without error. From this, it was postulated that each of the signal leads coming from the OPU had a common leg, meaning that one of the wires for each signal pair were connected to the system ground. This is a crucial detail, because the signal coming from the circuit board within the OPU is a differential signal, requiring two separate wires to be not connected to ground in any form.

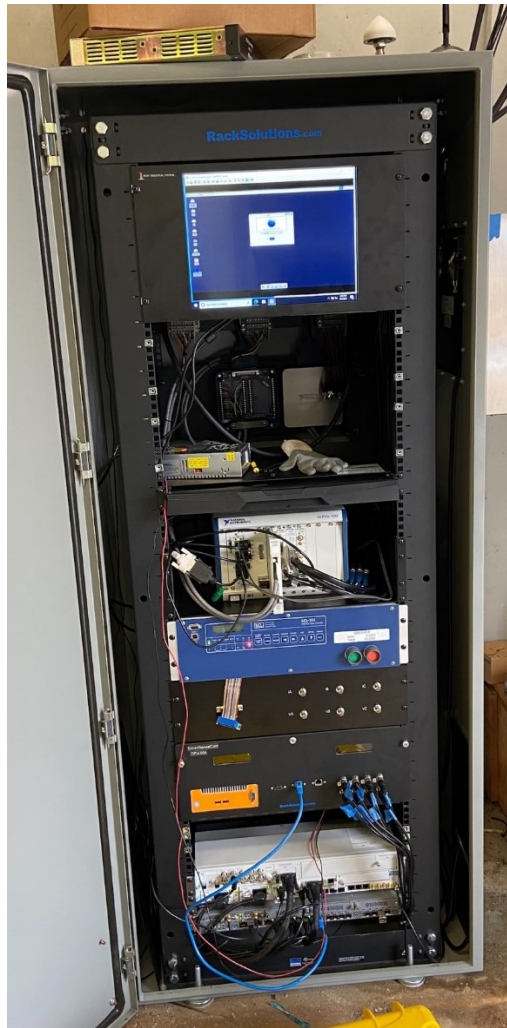
**Figure 2-4. OPU Rack of Equipment in 504-2G**

This rack included (starting from the top going down) a screen, keyboard and mouse, a National Instruments PXI chassis, an SEL-351 protective relay, an interface board to interface between the OPU signal outputs and relay low level inputs, the OPU, a GPS signal-based clock, and a Juniper cellular gateway. After the OPU was installed, remote access was configured and tested by connecting the OPU to the Juniper cellular gateway and utilizing TightVNC (a free, open-source remote desktop software server and client application) to remote desktop into the OPU.
