July 30, 2018

To: B. L. García-Díaz

From: M. J. Martínez-Rodríguez

## **Status of the Full Circumference Examination of the Inner Container Closure Weld Region for Selected 3013 DE Containers**

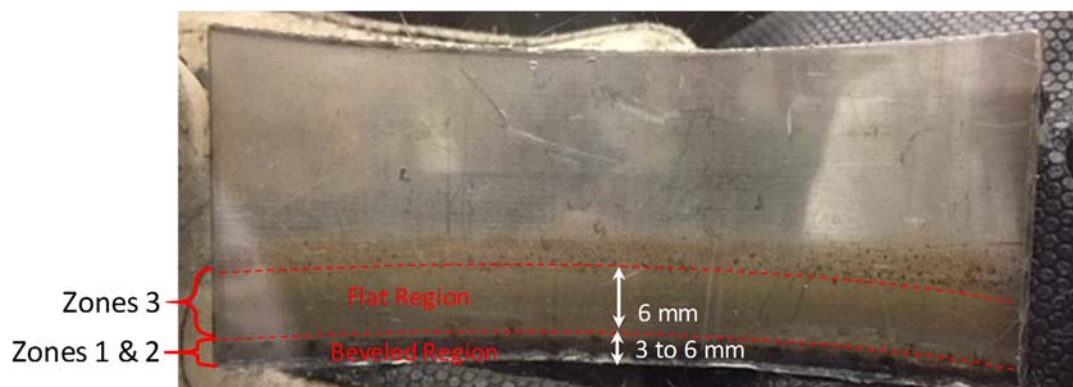
Chloride removal from the ICCWR was performed by washing the surface of each sidewall quarter section with 10 wt% citric acid at 60°C for 60 min using sonication. The first wash was performed by covering Zones 1 and 2 as shown in Figure 8 followed by a second wash in Zones 1 – 3. For the “archive” sections three washes were performed in Zones 1 – 3 in order to determine how many washes are required to remove the chlorides. The results for the chloride concentration on each section are shown in Table 1. Table 2 shows the results after normalizing for the approximate surface area of the washed zones.

FY15 DE07 and FY16 DE05 show a significant amount of chlorides with FY15 DE08 showing the less amount of chlorides. Also, the three washes in Zones 1 – 3 show a decrease in the amount of chlorides with each wash, suggesting that additional washes may be necessary to remove all the chlorides.

Figure 8. Typical sidewall quarter section showing Zones 1 and 2 (beveled region) and Zone 3 (flat region). of the ICCWR.

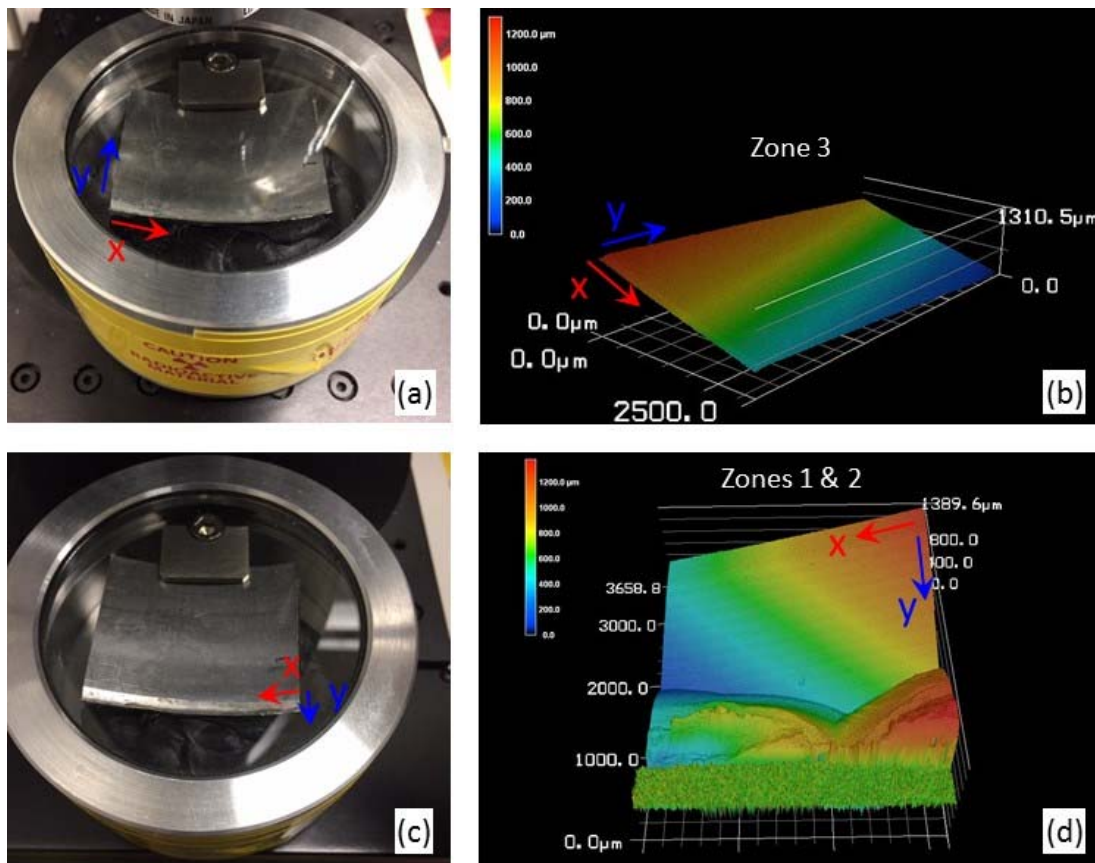
Figure 12. Sample orientation showing the x and y-directions for FY15 DE07 Section A2 mounted in (a) LCM box and (b) 3D representation of the surface of Zone 3 (Sub-section 4); and for FY15 DE07 Section A1 mounted in (c) LCM box and (d) 3D representation of the surface of Zones 1 and 2 (near Sub-section 7).

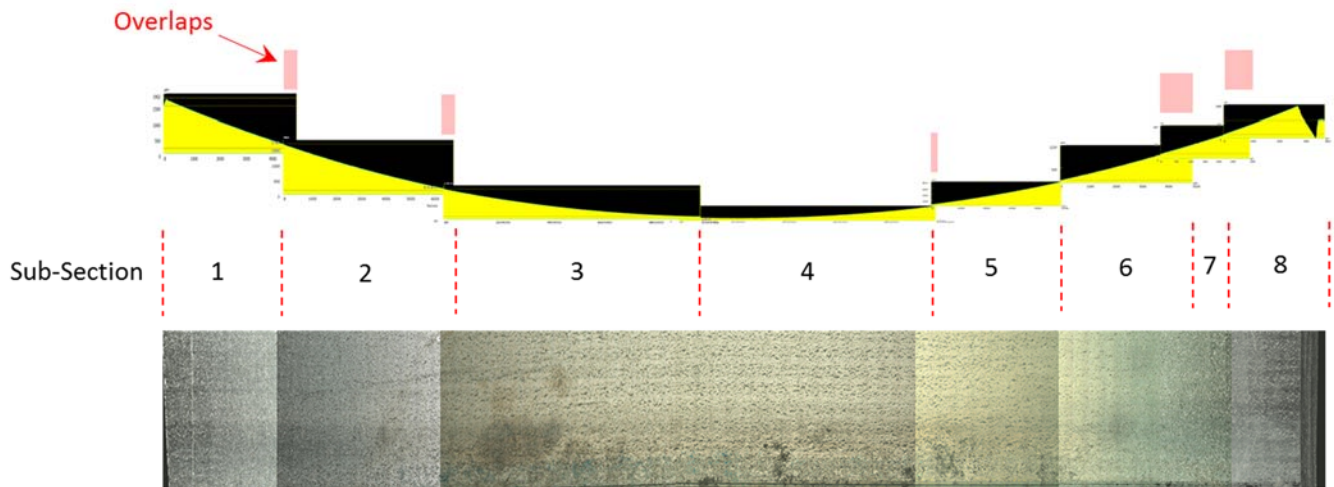
Figure 13. Cross-section profile of the sidewall of FY15 DE07 Section A1 (top) showing curvature of the sample and Zone 3 panoramic assembly (bottom) of sub-sections.

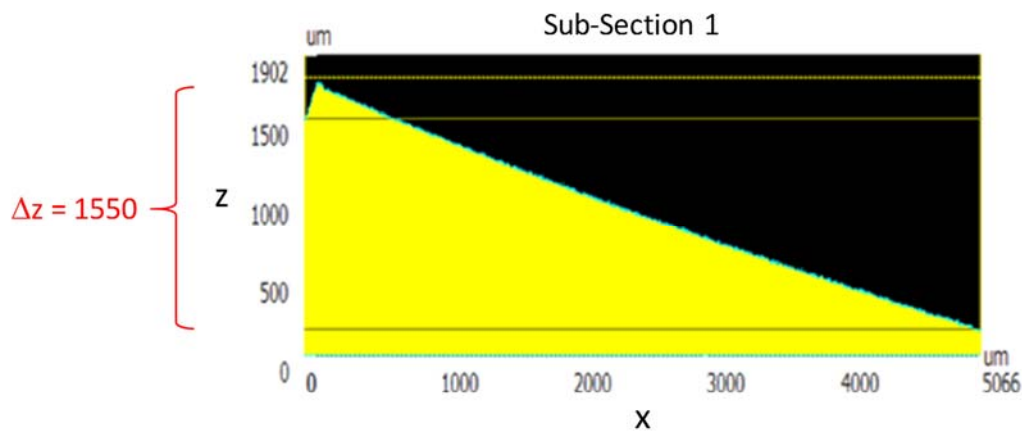
These optical data for the ICCWR full circumference of FY15 DE07 is shown in Figure B.1 through Figure B.8 in Appendix B. Each figure shows the set of assemblies that comprise the total for 1/8 section of the container. Each 1/8 container section was generally divided into 14 sub-sections for data collection because of the curvature nature of the sample in the x-direction. Figure 12 shows the sample orientation in the LCM box and axis directions with representative curvatures and slopes for Zone 3 and steeper slopes in Zones 1 and 2. The exceptions to the division into 14 sub-sections were Section A1, which was used initially to test and define the length of each sub-section, and Section B1 which was longer than the instrument stage x-range and needed an extra sub-section. As shown in Figure 13, the steeper the subsection (towards the outside edges) the longer it takes to collect data and, consequently, the smaller the sub-section was defined to expedite the data collection. Conversely, the flatter the subsection (towards the center) the shorter it takes to collect data and the larger the sub-section was able to be defined. The length of the sub-sections was established such that the total vertical distance ( $\Delta z$ ) was maintained approximately 1,600  $\mu\text{m}$  microns or less as shown in Figure 14.

Figure 14. Cross-section profile of Sub-Section 1 of the sidewall of FY15 DE07 Section A1.

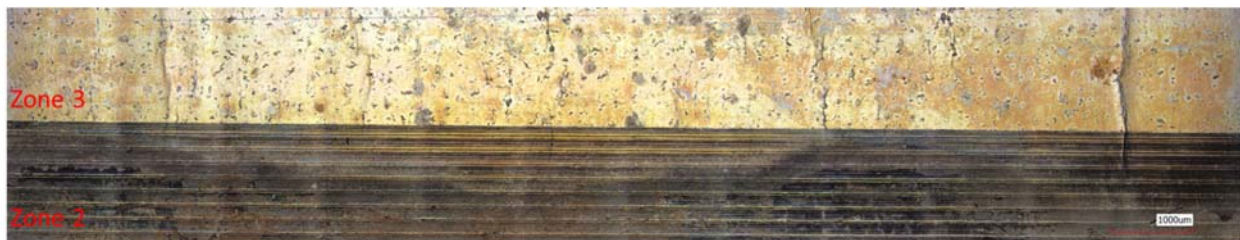
Figure 19. Optical image of ICCWR sidewall Zones 2 and 3 of DE container from boiling  $\text{MgCl}_2$  test. Note that the picture is oriented such that the weld is below Zone 2 [6].

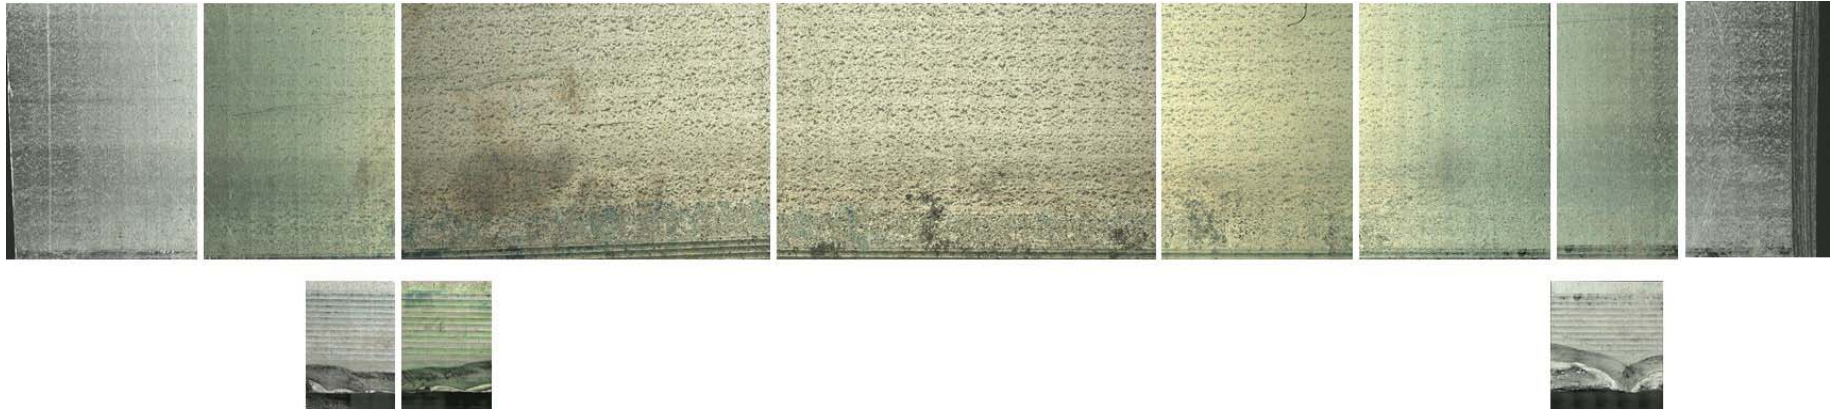
Figure B.1 Side by side LCM assemblies of Zone 3 (top) and Zones 1 and 2 (bottom) of ICCWR for FY15 DE07 Section A1. Zone 1 corresponds to the weld beads, Zone 2 corresponds to the machining marks region (above weld beads), and Zone 3 is the region above the machining marks. Each image represents an assembly of 75 to 240 individual images. Some overlap exists between assemblies to ensure data collection of 100% of full circumference.

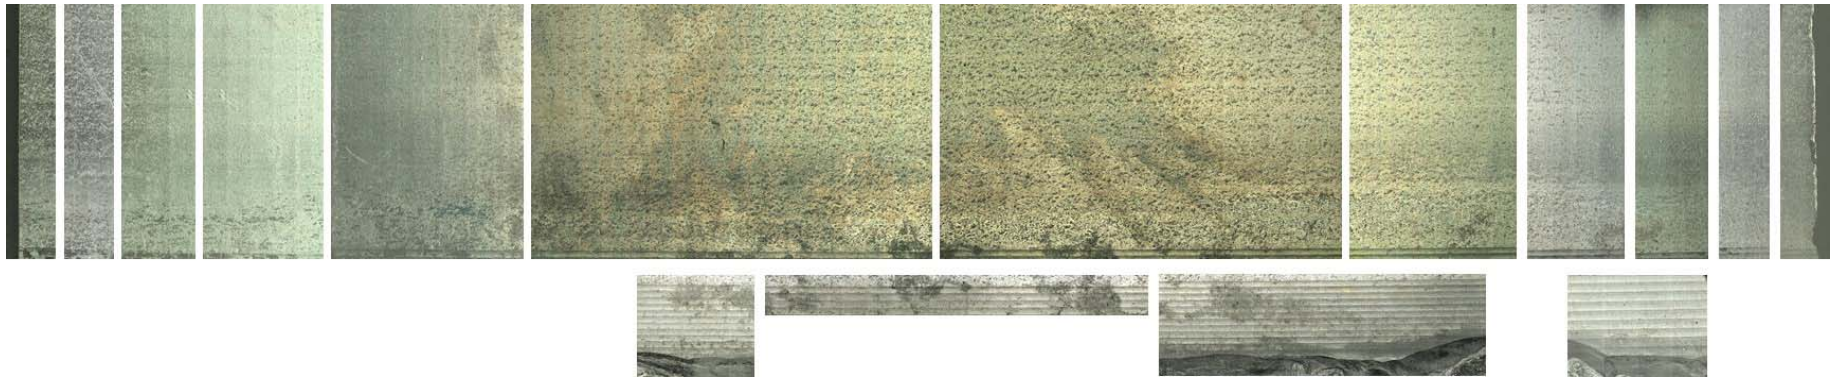
Figure B.2 Side by side LCM assemblies of Zone 3 (top) and Zones 1 and 2 (bottom) of ICCWR for FY15 DE07 Section A2. Zone 1 corresponds to the weld beads, Zone 2 corresponds to the machining marks region (above weld beads), and Zone 3 is the region above the machining marks. Each image represents an assembly of 30 to 255 individual images. Some overlap exists between assemblies to ensure data collection of 100% of full circumference.

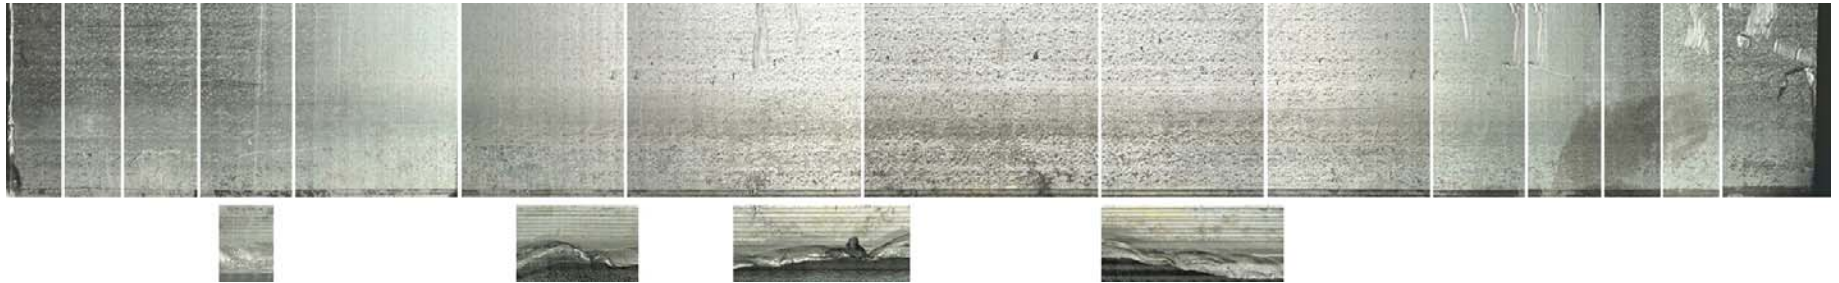
Figure B.3 Side by side LCM assemblies of Zone 3 (top) and Zones 1 and 2 (bottom) of ICCWR for FY15 DE07 Section B1. Zone 1 corresponds to the weld beads, Zone 2 corresponds to the machining marks region (above weld beads), and Zone 3 is the region above the machining marks. Each image represents an assembly of 45 to 135 individual images. Some overlap exists between assemblies to ensure data collection of 100% of full circumference.

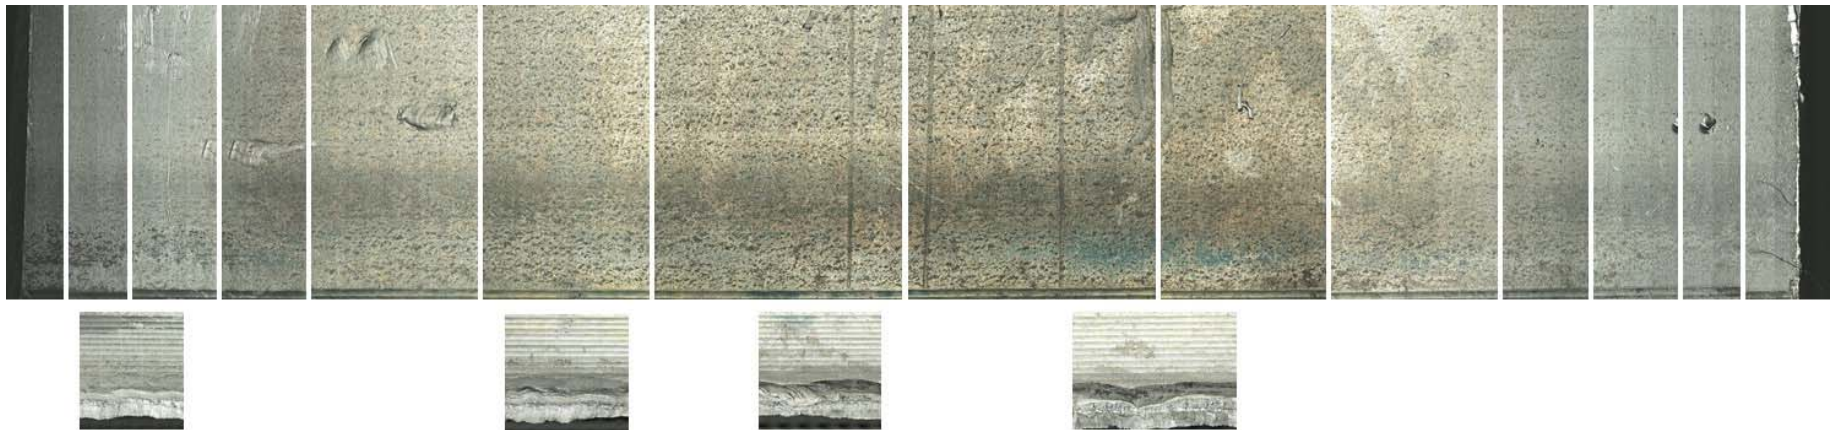
Figure B.4 Side by side LCM assemblies of Zone 3 (top) and Zones 1 and 2 (bottom) of ICCWR for FY15 DE07 Section B2. Zone 1 corresponds to the weld beads, Zone 2 corresponds to the machining marks region (above weld beads), and Zone 3 is the region above the machining marks. Each image represents an assembly of 30 to 135 individual images. Some overlap exists between assemblies to ensure data collection of 100% of full circumference.

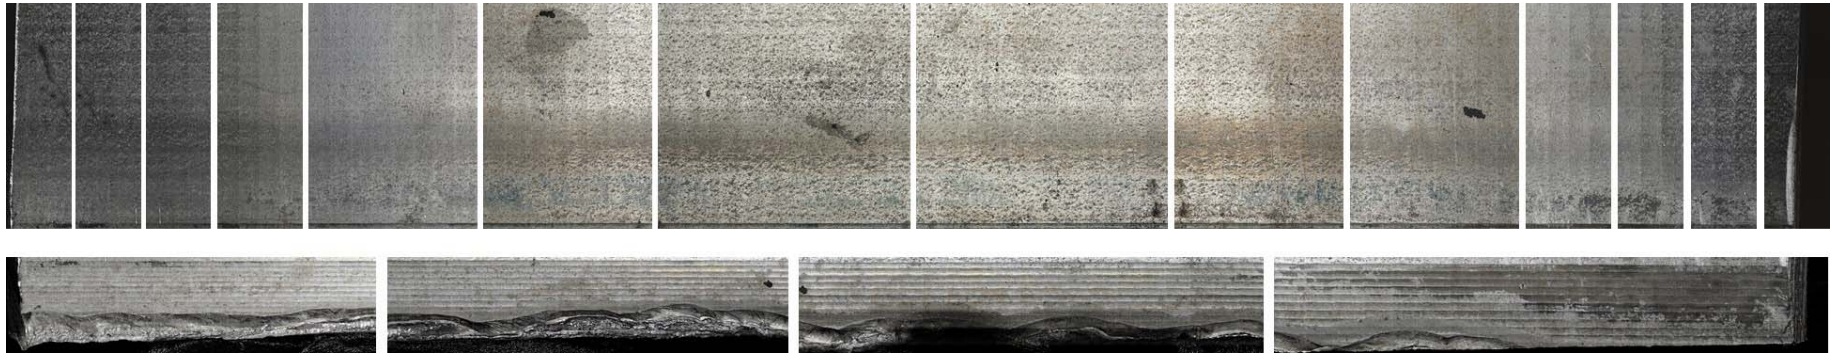
Figure B.5 Side by side LCM assemblies of Zone 3 (top) and Zones 1 and 2 (bottom) of ICCWR for FY15 DE07 Section C1. Zone 1 corresponds to the weld beads, Zone 2 corresponds to the machining marks region (above weld beads), and Zone 3 is the region above the machining marks. Each image represents an assembly of 45 to 180 individual images. Some overlap exists between assemblies to ensure data collection of 100% of full circumference.

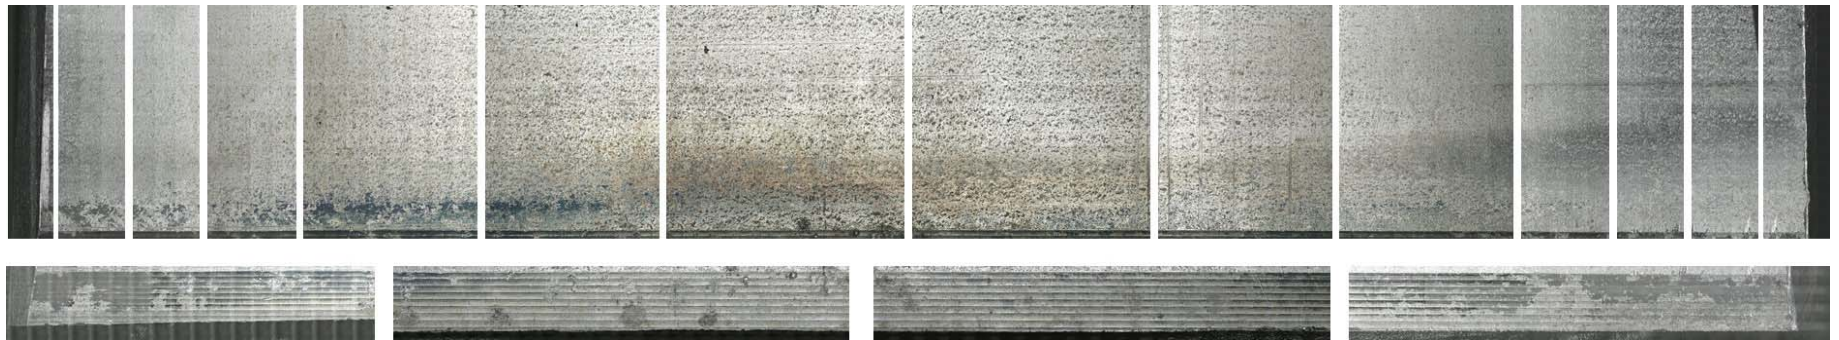
Figure B.6 Side by side LCM assemblies of Zone 3 (top) and Zones 1 and 2 (bottom) of ICCWR for FY15 DE07 Section C2. Zone 1 corresponds to the weld beads, Zone 2 corresponds to the machining marks region (above weld beads), and Zone 3 is the region above the machining marks. Each image represents an assembly of 30 to 165 individual images. Some overlap exists between assemblies to ensure data collection of 100% of full circumference.

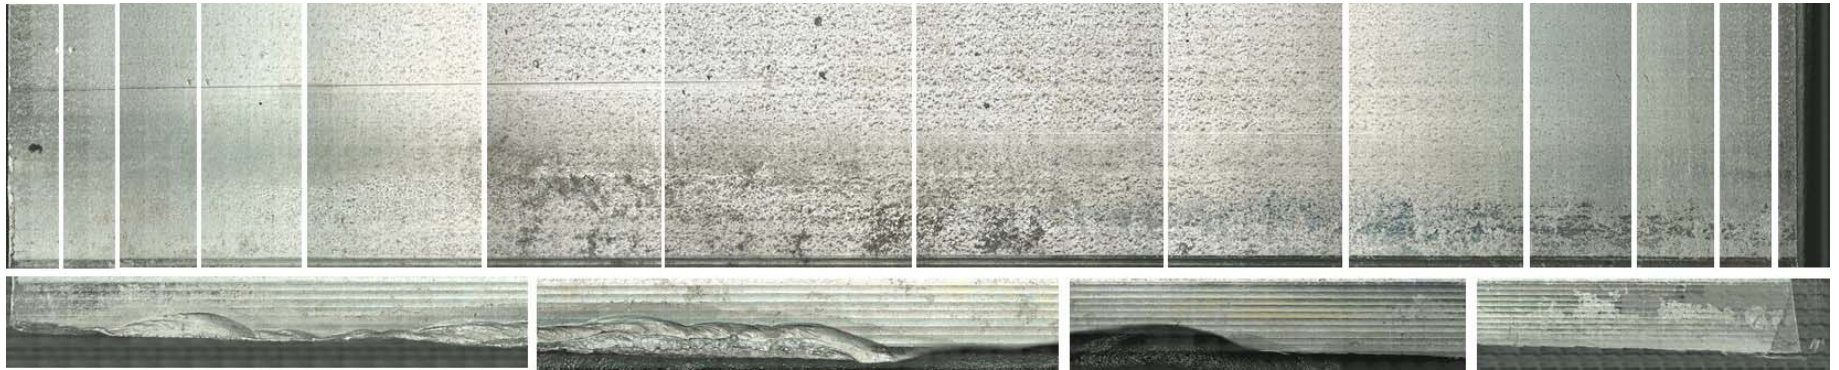
Figure B.7 Side by side LCM assemblies of Zone 3 (top) and Zones 1 and 2 (bottom) of ICCWR for FY15 DE07 Section D1. Zone 1 corresponds to the weld beads, Zone 2 corresponds to the machining marks region (above weld beads), and Zone 3 is the region above the machining marks. Each image represents an assembly of 30 to 150 individual images. Some overlap exists between assemblies to ensure data collection of 100% of full circumference.

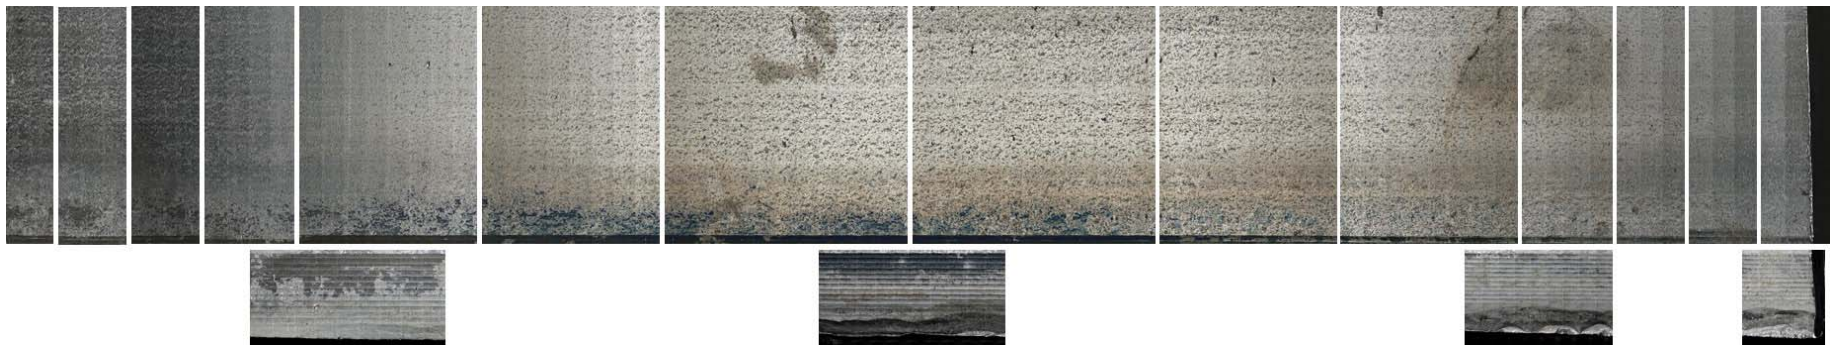
Figure B.8 Side by side LCM assemblies of Zone 3 (top) and Zones 1 and 2 (bottom) of ICCWR for FY15 DE07 Section D2. Zone 1 corresponds to the weld beads, Zone 2 corresponds to the machining marks region (above weld beads), and Zone 3 is the region above the machining marks. Each image represents an assembly of 30 to 165 individual images. Some overlap exists between assemblies to ensure data collection of 100% of full circumference.
