July 25, 2019

From: M. J. Martínez-Rodríguez, 773

FY19 Status of the Full Circumference Examination of the Inner Container Closure Weld Region for Selected 3013 DE Containers

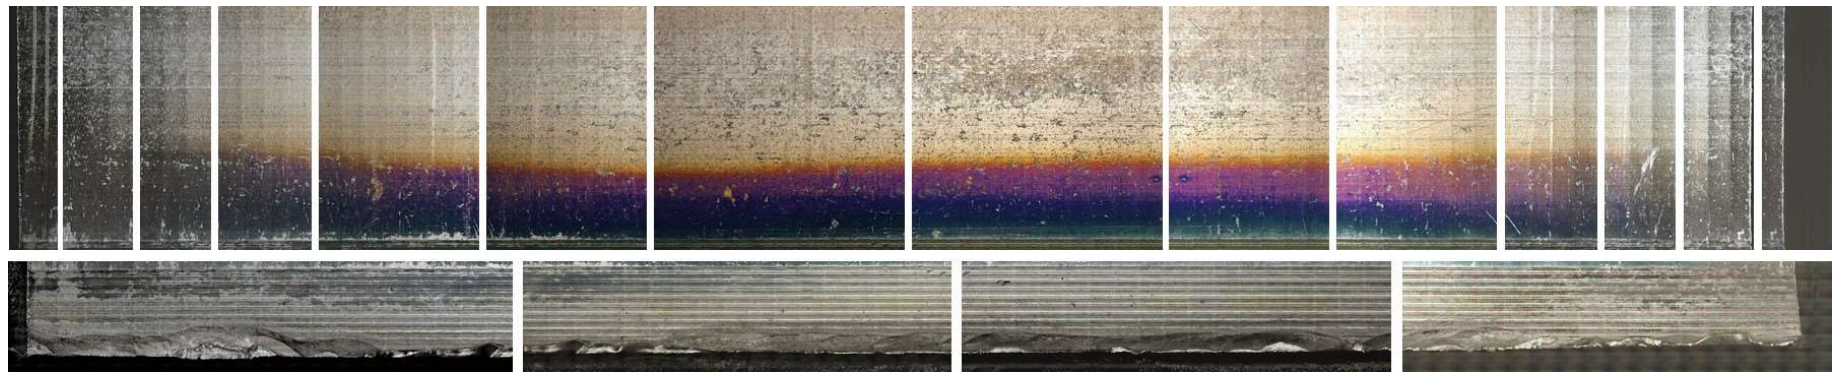
The data collected for FY16 DE05 shows general and localized corrosion on the surface. The major suspect corrosion events were observed on Section C2, which show two crack-like features. These two major features, Draco and Denebola, are indicated in Figure 5. Both features are located at the boundary of Zone 2 and Zone 3 as shown in Figure 6, While Denebola appears to be a large crack-like feature, Draco is a small feature that seems to be composed of several interconnected pits. Further examination will be required to determine if a crack has been developed. The length that can be observed from the optical image for Denebola is approximately 130 μm with its widest opening of about 10 μm , as shown in Figure 7(a). The height scan data is shown in Figure 7(b) with the horizontal linear profile (A-B) in Figure 7(c) and the vertical profile (C-D) in Figure 7(d) crossing Denebola around the region where it is deepest. Both profiles show the depth of Denebola at the center as 20 μm . However, gas analysis and statistical evaluation of the gas compositions and pressures via GEST analyses suggest that leakage between the OI and IC volumes was unlikely [8]. Section C2 of FY16 DE05 will be examined by serial metallography at SRNL for characterization of the cross-sections by SEM.

Figure A.6. Side by side LCM assemblies of Zone 3 (top) and Zones 1 and 2 (bottom) of ICCWR for FY16 DE05 Section C2. Zone 1 corresponds to the weld beads, Zone 2 corresponds to the machining marks region (above weld beads), and Zone 3 is the region above the machining marks. Each image represents an assembly of individual images. Some overlap exists between assemblies to ensure data collection of 100% of full circumference.

Additional characterization will be performed on the locations where the crack-like features were found. Sections C1 and C2 of FY15 DE07 were sent to LANL for characterization by XRT. Section C2 of FY16 DE05 will be examined by serial metallography at SRNL for characterization of the cross-sections by SEM. LANL and the University of South Carolina (USC) are working on methods for the analysis of the individual LCM images.

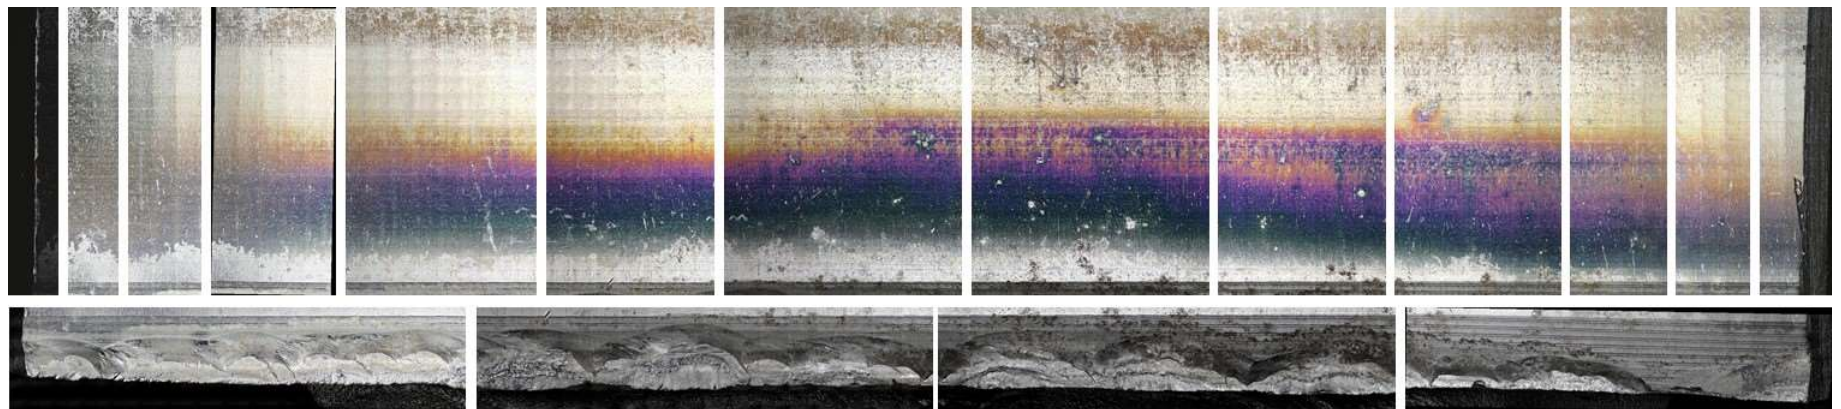
The data collected for FY15 DE08 shows general and localized corrosion on the surface. Although no major suspect corrosion events were observed by LCM on this DE, the ICCWR is characterized by significant number of agglomerated pits as shown in Figure 8. Unlike, FY15 DE07 and FY16 DE05, agglomerated pits were found at a larger extent on Zones 2 and 3. Figure 9 shows the panoramic assembly of Section B1 before cleaning where it can be observe corrosion products along the weld. After the sample was cleaned for LCM analysis it can be observe the pitting agglomeration close to the weld on Zone 2. Although not a corrosion event, FY15 DE08 is also characterized, at a larger extent than the other two ICCWRs, by dent and scratches on the surface as it can be seen in Figure 8(b).

Figure B.4 Side by side LCM assemblies of Zone 3 (top) and Zones 1 and 2 (bottom) of ICCWR for FY15 DE08 Section B1. Zone 1 corresponds to the weld beads, Zone 2 corresponds to the machining marks region (above weld beads), and Zone 3 is the region above the machining marks. Each image represents an assembly of individual images. Some overlap exists between assemblies to ensure data collection of 100% of full circumference.
