September 29, 2020

FY20 Status of the Characterization of DEs from the Full Circumference Examination of the Inner Container Closure Weld Region

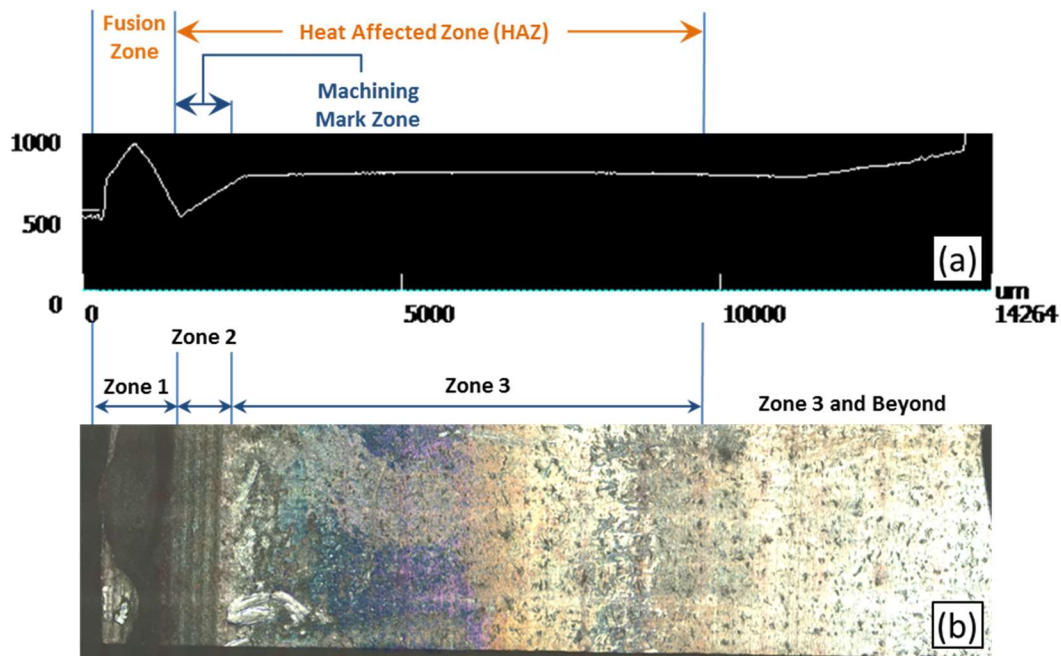
As part of the ICCWR examination protocol, a Keyence 3D laser confocal microscope (LCM) model VK-X110 is used to perform close visual examination of the surface at the ICCWR and surface profile measurements for pit depths or other corrosion features on the surface. Figure 1 shows the general topography of the ICCWR. In the weld fusion zone, the weld beads on the surface resemble valleys and mountains. In the heat affected zone (HAZ) the surface is mostly flat with a beveled region where the machining marks are located. The fusion zone is considered Zone 1, the region with machining marks is considered Zone 2 and the flat portion of the HAZ is considered Zone 3.

Figure 1. General topography of an ICCWR sidewall sample. Image of FY11 HHMC-90° sidewall showing (a) side view of surface profile and (b) top view optical image of surface [1, 5].

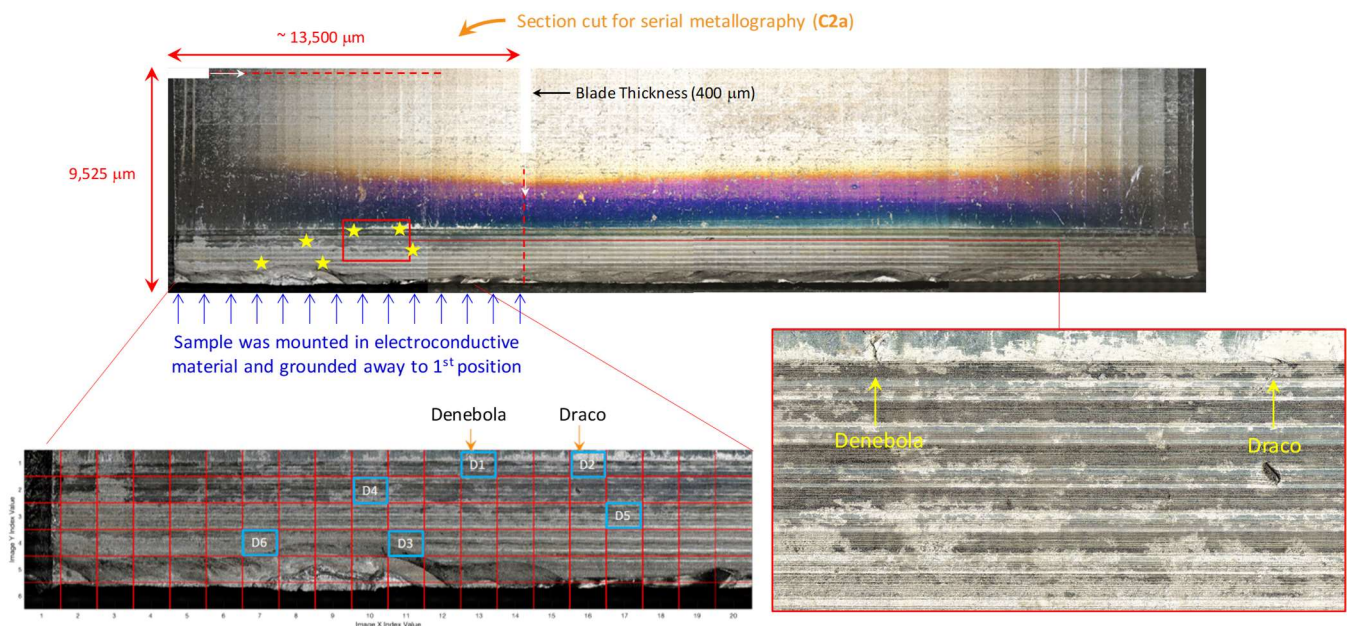
FY16 DE05 Section C2 was cut into a smaller sample, labeled as Subsection C2a, using a Buehler IsoMet Low Speed precision cutting saw in preparation for the cross-section examination. Figure 13 shows the section of the sample cut, which includes the suspect cracks or corrosion features D1 through D6. Subsection C2a was mounted using Technovit[®] 5000, an electroconductive polymer based on modified

Figure 13. LCM optical image of the ICCWR of FY16 DE05 Section C2 showing subsection C2a with locations, marked with yellow stars, of suspect cracks or corrosion features. Grid over a portion of Zone 2 show the locations labeled as D1 through D6, where D1 corresponds to Denebola and D2 corresponds to Draco.

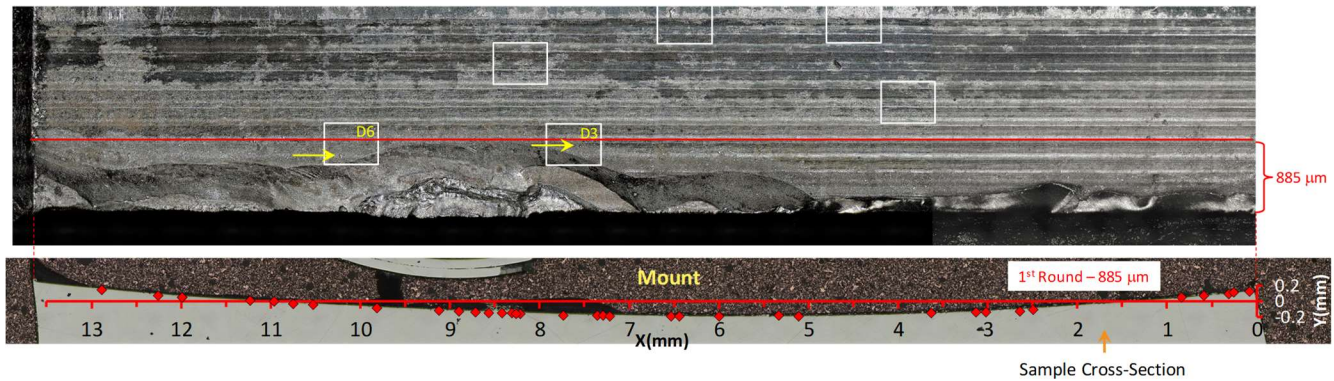
methyl methacrylate, which contain dendritic copper particles. After mounting and curing, the specimen was successively ground with finer and finer abrasive media to the first position (885 μm from weld edge), as shown in Figure 14. SEM images were obtained from this 1st round along the cross-section at several locations, as shown in Figure 15 through Figure 17. Although the best effort was made to stop at corrosion features D3 and D6, the corrosion feature D6 was missed due to the difficulty to stop at a very precise location. However, the main purpose of the cross-section examination is to be able to verify the larger corrosion features D1 and D2 (Denebola and Draco, respectively). Corrosion features D3 through D6 are being analyzed as best as possible while the sample is ground to the target position (D1 and D2). SEM images from the 1st round analysis show pits of different sizes (up to 16 μm) and depths (up to 10 μm). The sample has been ground to the next position and the 2nd round analysis is in progress.

Figure 14. The 1st round on the serial metallography process for the ICCWR of FY16 DE05 Section C2a. LCM optical image of the surface (top) and LCM optical image of the mounted cross-section (bottom) ground and polished 885 μm, from the bottom edge, corresponding to the red line located on top LCM image. X-axis on cross-section image show positions, marked with red diamonds, where SEM images were obtained.

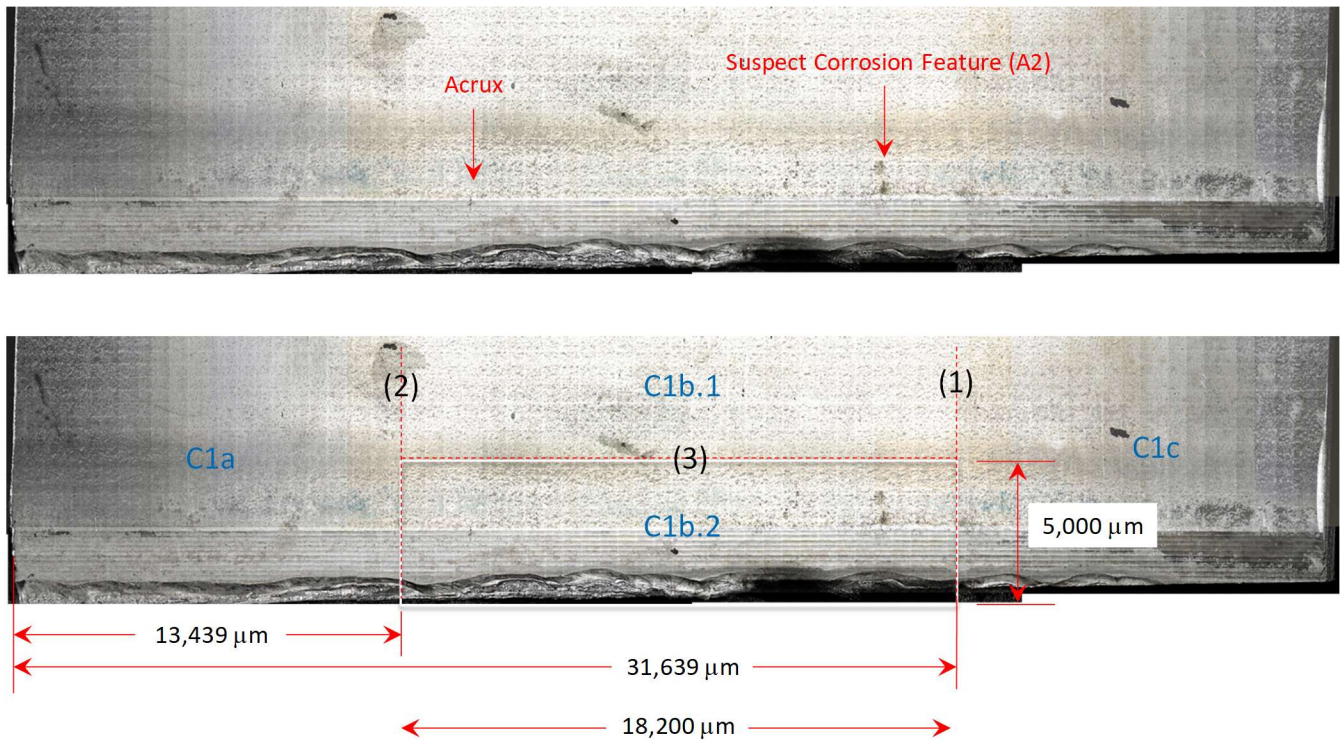
FY15 DE07 Sections C1 and C2 were received at SRNL. Planned cut locations for each sample are shown in Figure 19 and Figure 20, respectively. The samples were cut using a Buehler IsoMet Low Speed precision cutting saw. To make sure that corrosion features in the samples are not affected by the cut, extra distance was used to position the cutting blade. The final dimensions of the cut samples are shown in Figure 21 and Figure 22 for subsections C1b.2 and C2b.2, respectively. Both samples show that the original corrosion features are still present and unaffected by the cutting. The cut samples were returned to LANL for further examination with the XRT.

Figure 19. Planned cut locations for FY15 DE07 Section C1.

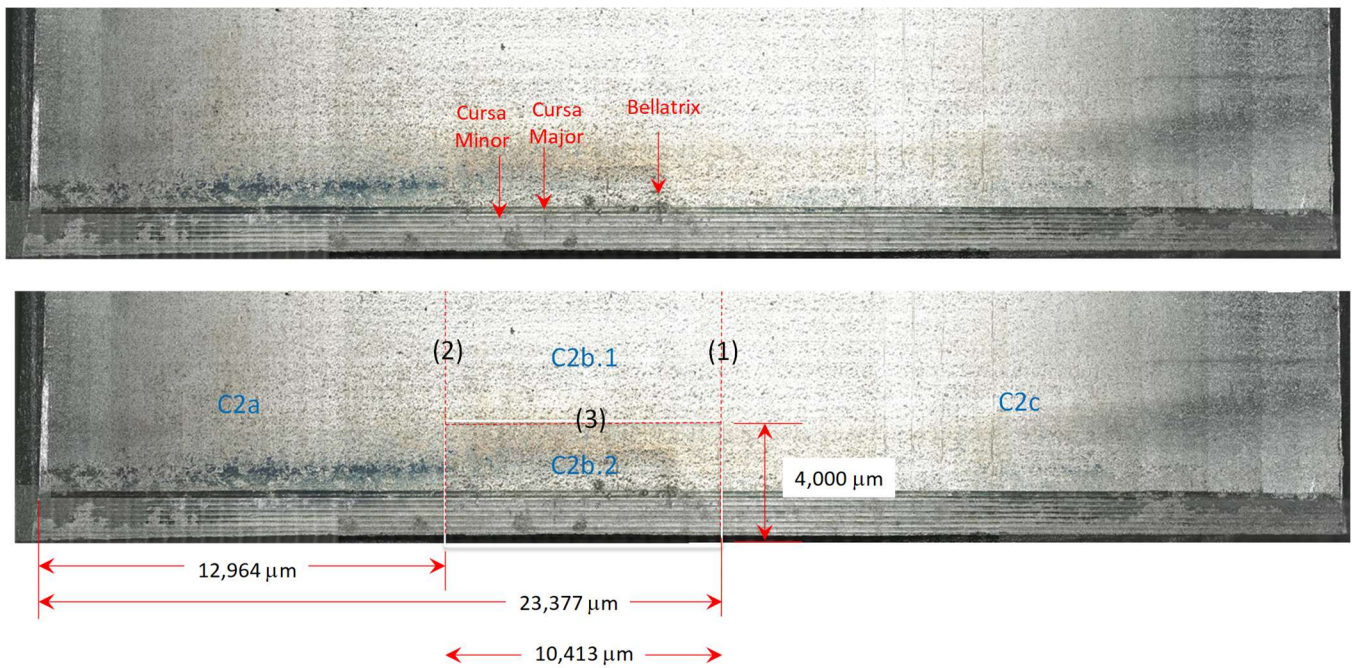
Figure 20. Planned cut locations for FY15 DE07 Section C2.

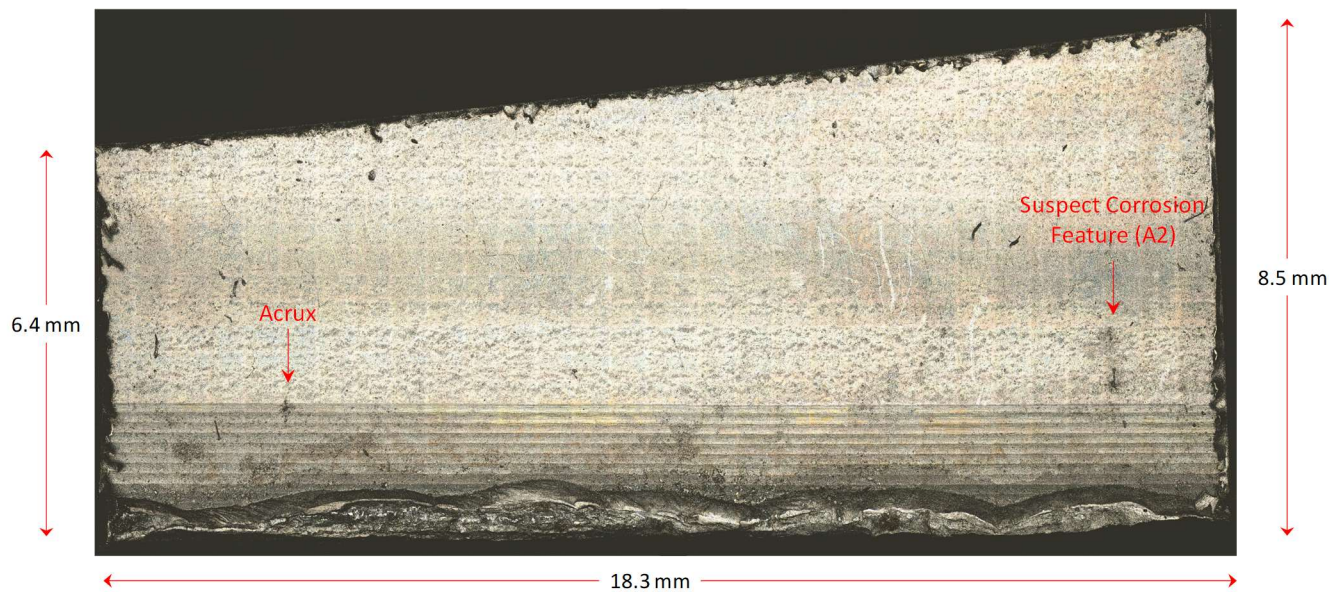
Figure 21. FY15 DE07 Section C1b.2 obtained from cutting main Section C1.

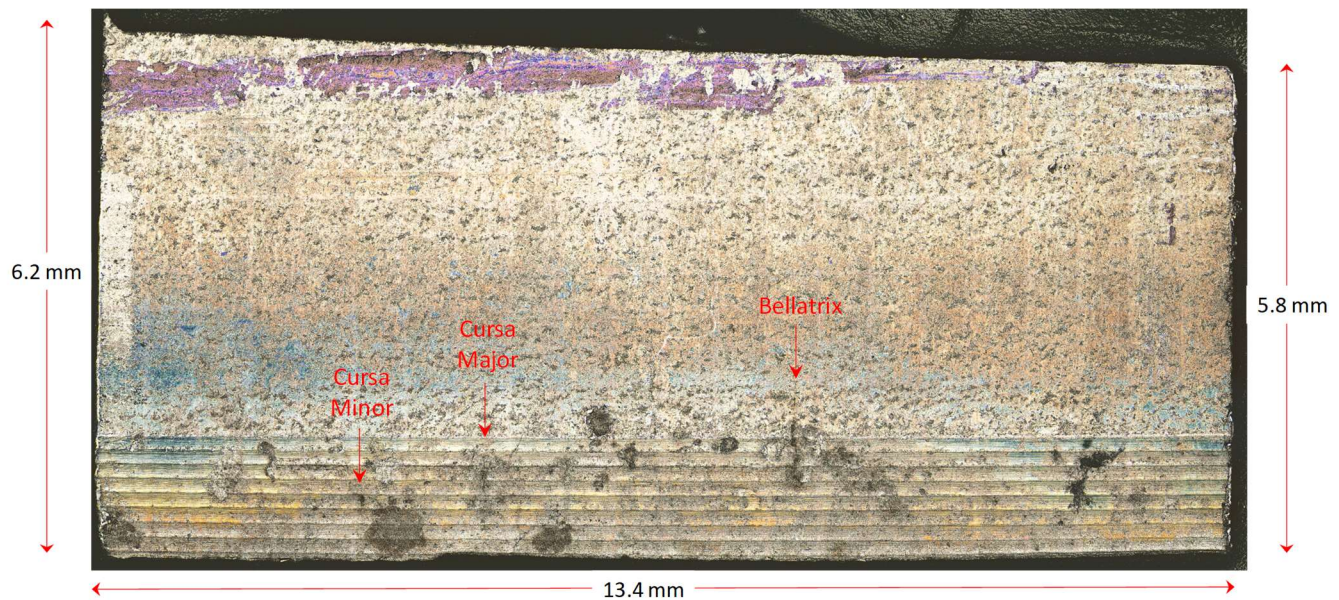
Figure 22. FY15 DE07 Section C2b.2 obtained from cutting main Section C2.
