EXAMINATION OF FIBERBOARD FROM SHIPPING PACKAGE 9975-01819

W. L. Daugherty

Savannah River National Laboratory
Materials Science & Technology

Document No. SRNL-STI-2009-00240 **Rev. No.** 0

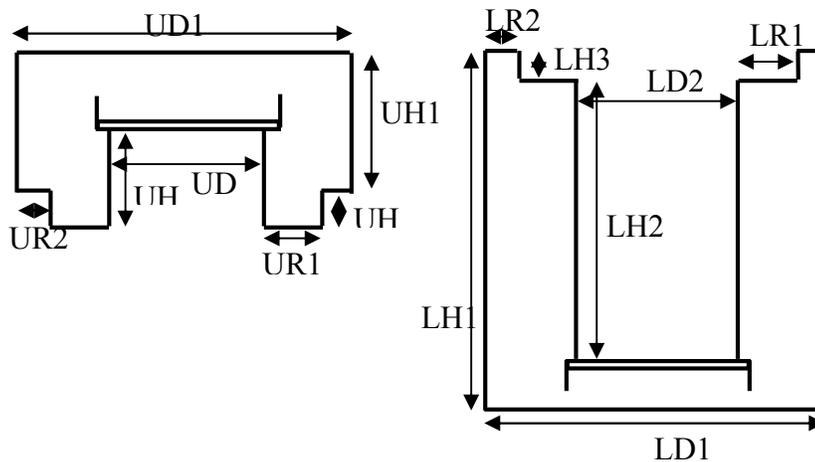
Table 2. Summary of fiberboard moisture content on 3/10/09. Data for the upper assembly are on the sketch. Data for the lower assembly are in the table.
