## **SRNL Phase II Shelf Life Studies – Series 1 - Room Temperature and High Relative Humidity**

J. I. Mickalonis  
J. M. Duffey

September 2012

Savannah River National Laboratory  
Savannah River Nuclear Solutions, LLC  
Aiken, SC 29808

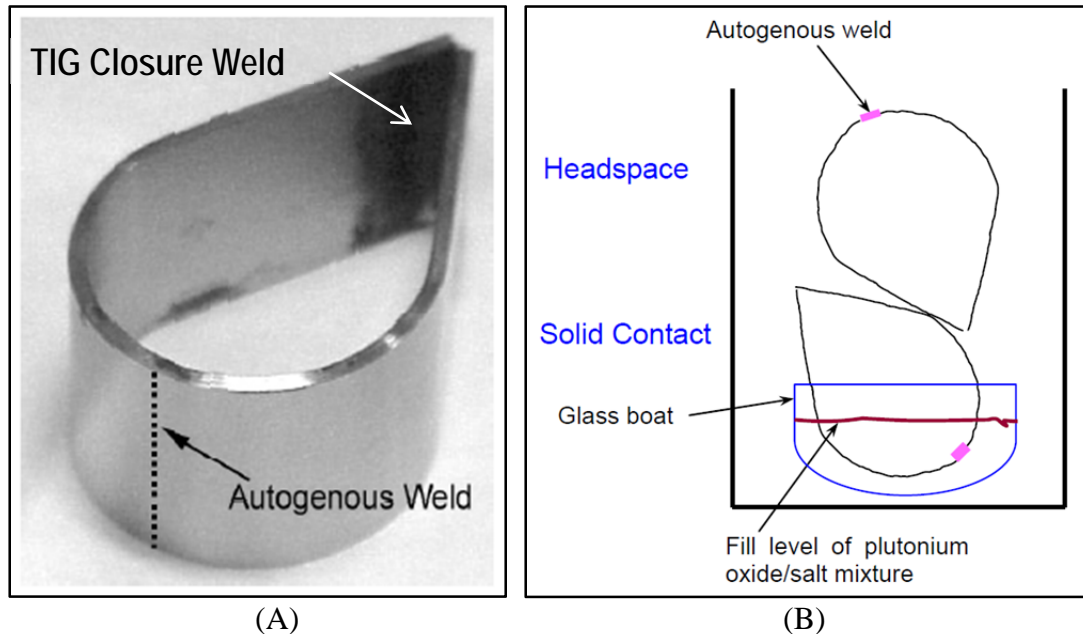
teardrop specimens had a transverse autogenous weld at the center of curvature in the rounded section to provide a similar weld microstructure as is present in the inner 3013 container closure weld area. When put into test, one coupon was positioned in the oxide/salt mixture and another teardrop was only in the vapor or headspace as shown in Figure 3-1 (B).

Figure 3-1 (A) Teardrop coupon for stress corrosion cracking testing with the autogenous weld centerline indicated by the dotted line and a TIG closure weld and (B) Arrangement of oxide/salt-contact and vapor-exposed teardrop coupons in test vessel [10]

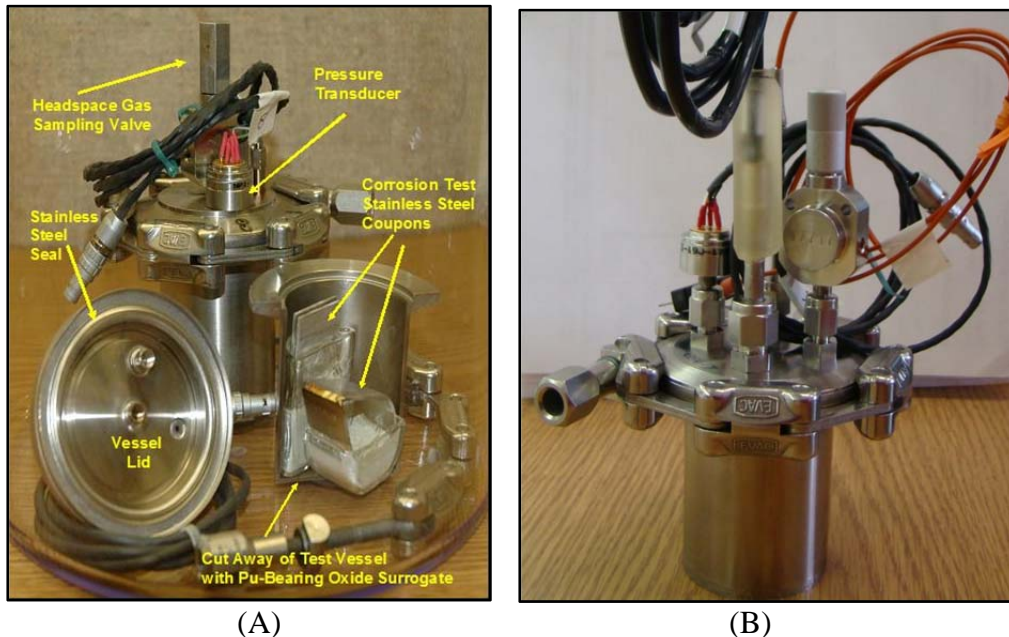
The pressure sensors were supplied by General Electric (Billerica, MA) and were modified by welding a 0.125-in. adapter. The humidity probes and thermocouples were supplied by EdgeTech (Marlborough, MA) and Omega (Stamford, CN), respectively. The dish to hold the oxide/salt mixture was made of borosilicate glass. The vessel components were helium leak tested for leak tightness [13]. The vessel bodies without the humidity probe passed the leak test and showed a rate of helium leakage of  $10^{-9}$  std cc/s at a pressure of 1 atm. However, placement of the humidity probes generally increased the leakage and caused the leak rates to vary between  $10^{-3}$  to  $10^{-9}$  std cc/s.

Several attempts were made to seal the probes with epoxy but these attempts were of limited success.

Figure 3-2 Comparison of small-scale corrosion test vessels: (A) Phase I testing using pressure monitoring and gas sampling capability and (B) Phase II testing using pressure sensor, humidity probe, thermocouple, and gas sampling capability

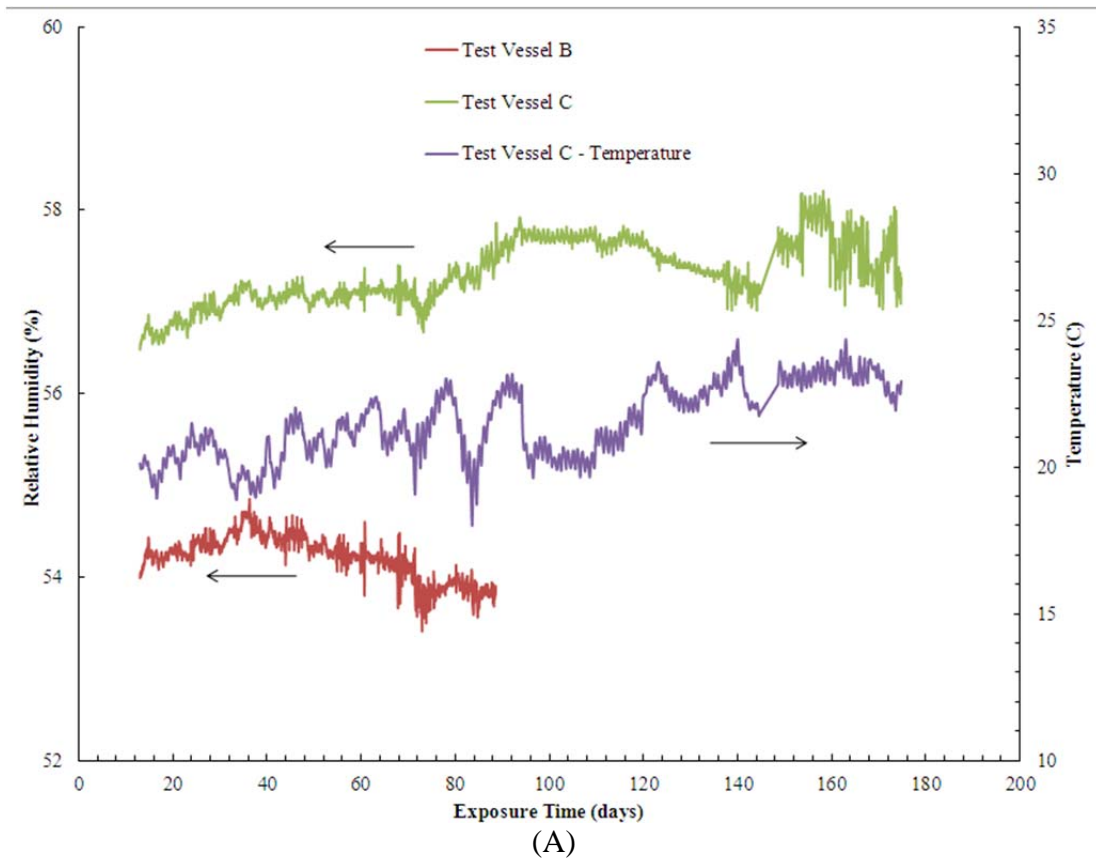
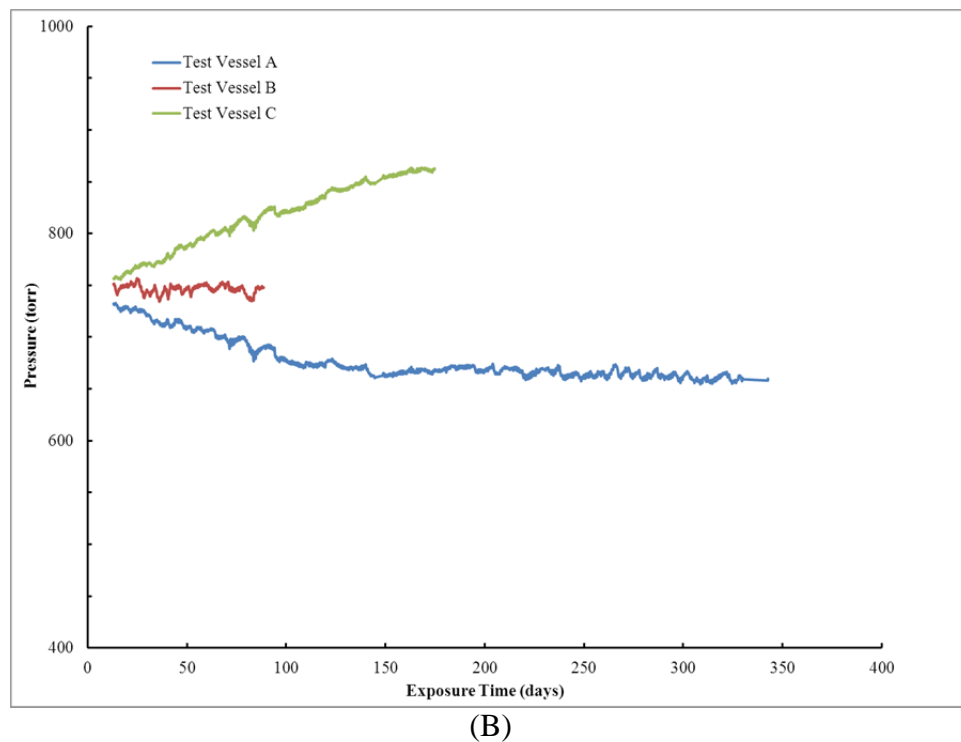
The RH, temperature and pressure trends of the three test vessels are shown in Figure 4-1. The RH probe in Vessel A did not generate a signal from the start of the test and troubleshooting was unsuccessful. The other vessels had fairly constant RH with Vessel B ranging between 53.5 to 54.7% and Vessel C in the range of 56.5 to 58%. The temperature varied from approximately 19 to 24 °C, increasing slightly over the six-month period. This increase reflected a seasonal temperature change.

Figure 4-1 Trends in exposure conditions for Series 1 test: (A) relative humidity and temperature and (B) pressure

The pressure trends for the test vessels differed as can be seen in Figure 4-1 (B). Vessel B remained at atmospheric pressure from the start of testing. This vessel did not appear to seal properly during closing. Since a leak was suspected, this vessel was opened first after 85 days. Vessel C showed an increasing pressure trend similar to many of the test vessels from Phase I testing. The peak pressure of approximately 860 Torr (114 kPa) occurred right before the vessel was opened at 175 days. Vessel A had a decreasing pressure until about 150 days when the pressure readings leveled at approximately 660 Torr (88 kPa).

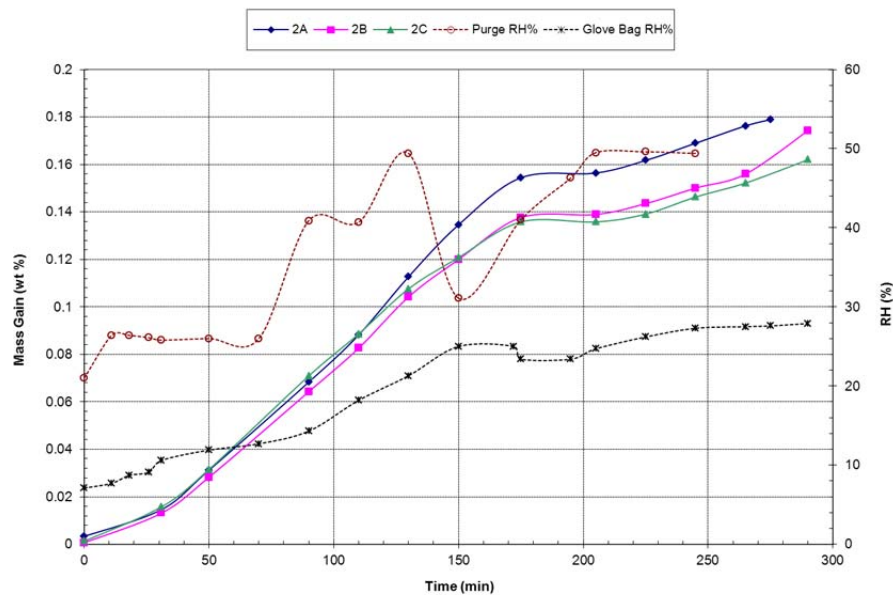
The Series 2 testing was initiated in August 2012. The moisture uptake is shown in Figure 6-1 and was approximately 0.18%. The target RH was approximately 22%, however, the initial RH of all three test containers was in the range of 35- 40%. The higher RH indicated that more water was present in the test vessels than planned. The uptake trend shows only the added moisture at the start of the test, but not moisture that may have been taken up by the oxide/salt mixture during storage after preparation but prior to the intentional addition of moisture. Although precautions were taken to keep the oxide/salt mixtures dry prior to moisture addition by the use of desiccants and double bagging, some additional moisture was likely taken up during this time.

Figure 6-1 Moisture uptake during loading of test vessels for Series 2 test

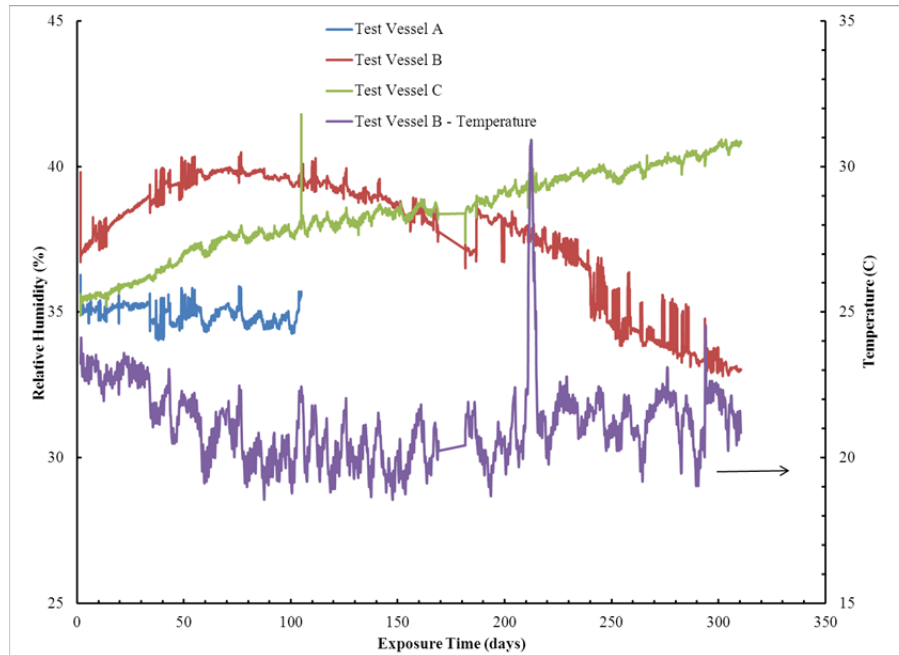
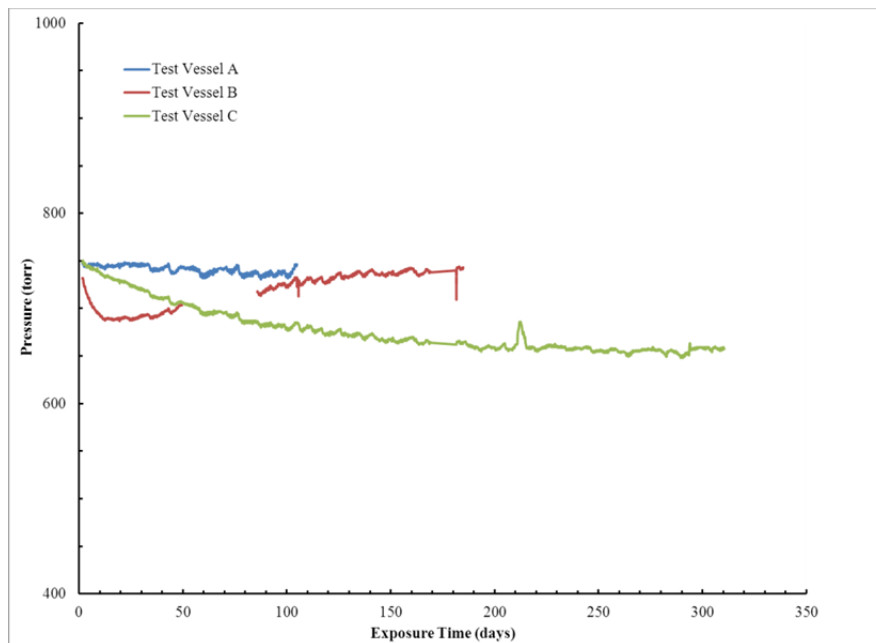
The RH, pressure and temperature trends over the test duration are shown in Figure 6-2. Vessel A was opened first after 105 days since the pressure remained at atmospheric pressure after closing, indicating a leak into the test vessel. However, the RH was fairly constant over this time interval at approximately 35%. Vessel B had a minimum around 25 days and a maximum occurring near 75 days in the pressure and RH trends, respectively. Problems with the pressure transducer led to gaps in the data. The pressure is holding at atmospheric pressure since the latest measurement at about 175 days agrees with current measurements at approximately 330 days (not shown in the figure). This change may be associated with a leak although current RH in the cell is below the

glovebox humidity. The pressure trends for the three vessels differ: Vessel A was at atmospheric pressure. Vessel C has showed a decreasing pressure trend, which may be starting to increase. The RH trend has been continuously increasing. This trend cannot yet be explained.

Figure 6-2 Trends in exposure conditions for Series 2 test vessels: (A) relative humidity and temperature, and (B) pressure
