# **Tank Inspection NDE Results for Fiscal Year 2014, Waste Tanks 26, 27, 28 and 33**

**James B. Elder III and Rodney W. Vande Kamp**

September 29, 2014

SRNL-STI-2014-00328

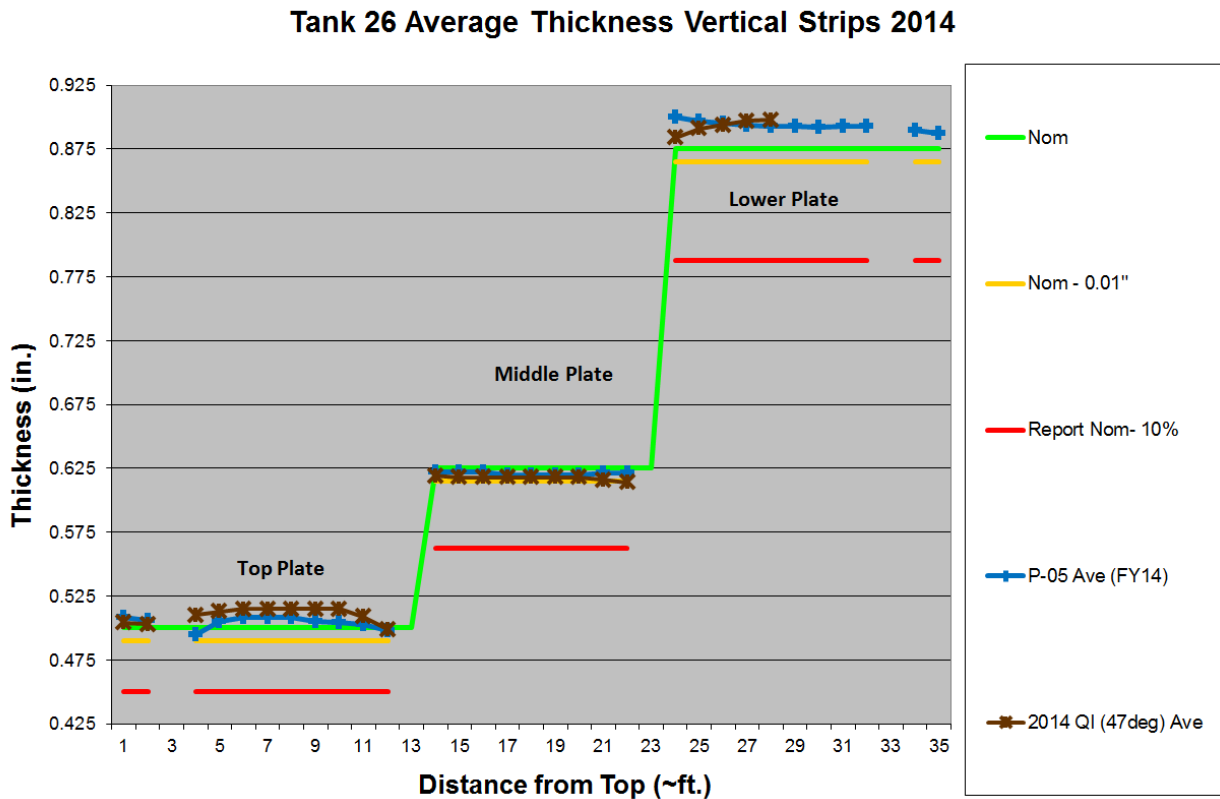
Figure 10: Tank 26 Average Thickness Data FY 2014

Figure 10 provides a thickness plot of the 2014 average thickness data while Table 2 provides average and minimum thickness values for all vertical strips collected on the primary wall of Tank 26 in 2014.

Tank 26		Nominal	Nom - 0.01"	Reportable (Nom -10%)	2014 QI (47deg) Ave	2014 QI (47deg) Min	P-05 Ave (FY14)	P-05 Min (FY14)	P-05 Ave (FY11)	P-05 Min (FY11)	P-05 Ave (FY04)
Top Knuckle	1	0.500	0.490	0.450	0.504	0.469	0.508	0.464	0.508	0.464	0.509
	2	0.500	0.490	0.450	0.503	0.472	0.506	0.467	0.508	0.473	0.509
Top Plate	1	0.500	0.490	0.450	0.510	0.486	0.495	0.455	0.495	0.456	0.497
	2	0.500	0.490	0.450	0.513	0.504	0.505	0.486	0.505	0.490	0.504
	3	0.500	0.490	0.450	0.515	0.496	0.508	0.496	0.508	0.489	0.506
	4	0.500	0.490	0.450	0.515	0.498	0.508	0.496	0.509	0.500	0.507
	5	0.500	0.490	0.450	0.515	0.509	0.508	0.486	0.508	0.489	0.507
	6	0.500	0.490	0.450	0.515	0.512	0.505	0.492	0.507	0.493	0.506
	7	0.500	0.490	0.450	0.515	0.496	0.504	0.490	0.505	0.489	0.505
	8	0.500	0.490	0.450	0.509	0.484	0.503	0.486	0.504	0.479	0.504
	9	0.500	0.490	0.450	0.499	0.482	0.498	0.484	0.499	0.479	0.501
Middle Plate	1	0.625	0.615	0.563	0.619	0.578	0.622	0.611	0.624	0.615	0.624

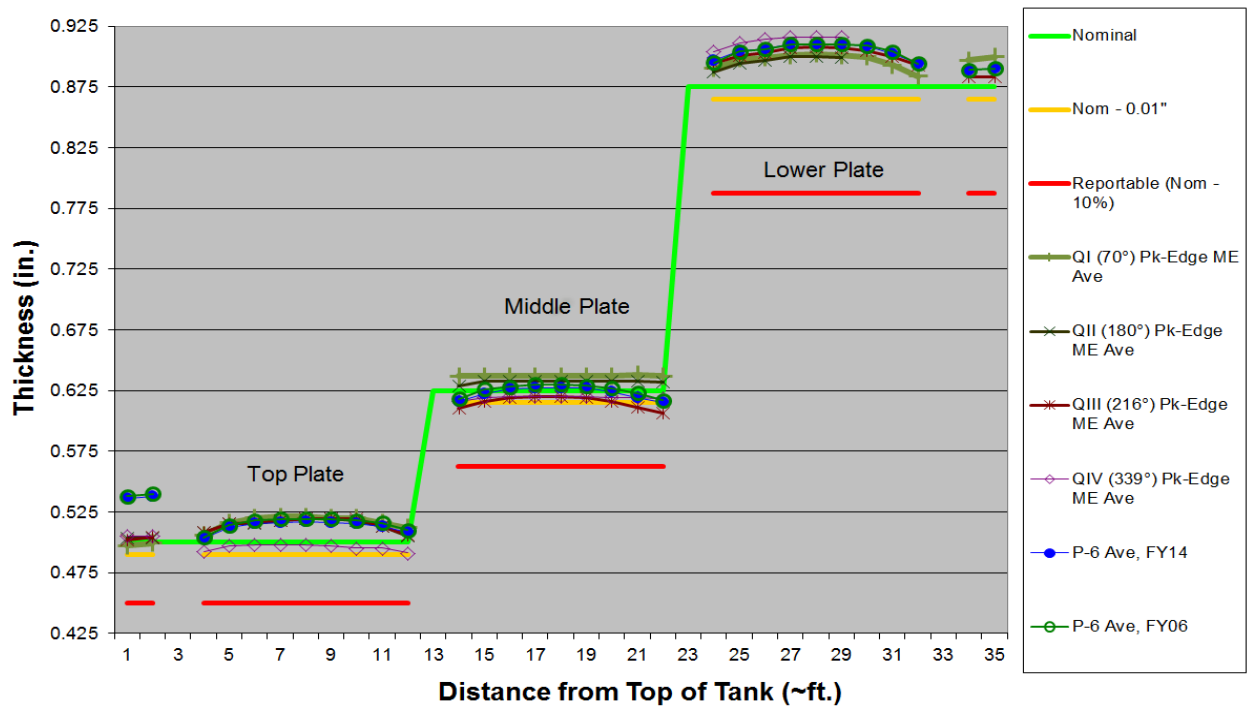
Figure 12: Tank 27 Average Thickness Data FY 2014

Figure 12 provides a thickness plot of the 2014 average thickness data while Table 3 provides average and minimum thickness values for all vertical strips collected on the primary wall of Tank 27 in 2014.

Tank 27		Nominal	Nom - 0.01"	Reportable (Nom -10%)	P-6 Ave, FY14	P-6 Min, FY14	QI (70°) Pk-Edge ME Ave	QI (70°) Pk-Edge ME Min	QII (180°) Pk-Edge ME Ave	QII (180°) Pk-Edge ME Min	QIII (216°) Pk-Edge ME Ave	QIII (216°) Pk-Edge ME Min	QIV (339°) Pk-Edge ME Ave	QIV (339°) Pk-Edge ME Min
Top Knuckle	1	0.500	0.490	0.450	0.536	0.512	0.497	0.469	0.503	0.472	0.502	0.482	0.505	0.484
	2	0.500	0.490	0.450	0.538	0.513	0.499	0.469	0.503	0.498	0.504	0.487	0.505	0.485
Top Plate	1	0.500	0.490	0.450	0.503	0.458	0.506	0.460	0.508	0.469	0.508	0.458	0.492	0.459
	2	0.500	0.490	0.450	0.512	0.486	0.516	0.464	0.515	0.485	0.515	0.496	0.497	0.467
	3	0.500	0.490	0.450	0.515	0.507	0.520	0.474	0.515	0.500	0.516	0.495	0.498	0.466
	4	0.500	0.490	0.450	0.516	0.504	0.521	0.496	0.518	0.500	0.518	0.496	0.498	0.471
	5	0.500	0.490	0.450	0.517	0.511	0.521	0.486	0.519	0.503	0.519	0.496	0.498	0.479
	6	0.500	0.490	0.450	0.516	0.506	0.520	0.502	0.519	0.505	0.519	0.484	0.497	0.480

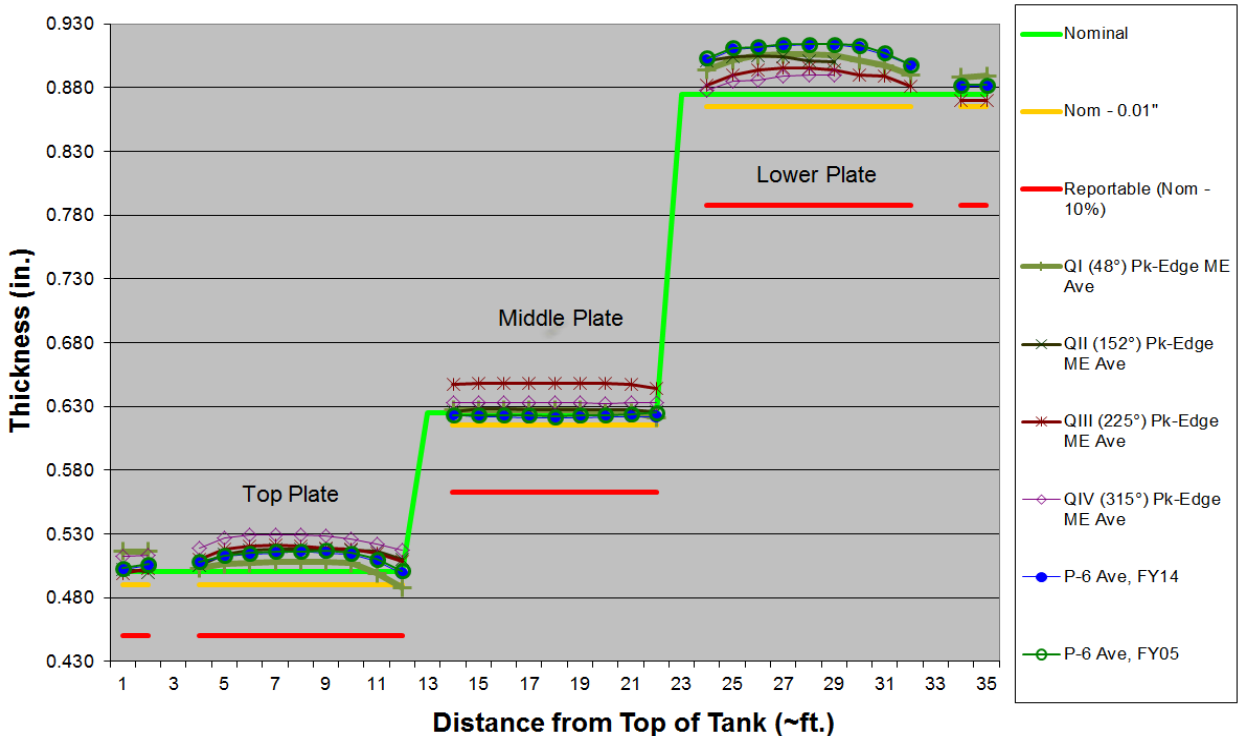
**Figure 14: Tank 28 Average Thickness Data FY 2014**  
**Tank 28 Average Thickness 2014 Vertical Strips**

Tank 28 had an area of localized thinning on the exterior wall of the secondary tank noted during the initial inspections in 2005. That area was inspected again in 2014 and found to be larger and slightly deeper. The deepest area of thinning in the secondary wall is less than 20% wall loss. The maximum length of thinning is less than 24 inches and does not impact structural or leak integrity per WSRC-TR-2002-00063.

Figure 14 provides a thickness plot of the 2014 average thickness data while Table 5 provides average and minimum thickness values for all vertical strips collected on the primary wall of Tank 28 in 2014.

Tank 28		Nominal	Nom - 0.01"	Reportable (Nom - 10%)	P-6 Ave, FY14	P-6 Min, FY14	QI (48°) Pk-Edge ME Ave	QI (48°) Pk-Edge ME Min	QII (152°) Pk-Edge ME Ave	QII (152°) Pk-Edge ME Min	QIII (225°) Pk-Edge ME Ave	QIII (225°) Pk-Edge ME Min	QIV (315°) Pk-Edge ME Ave	QIV (315°) Pk-Edge ME Min
Top Knuckle	1	0.500	0.490	0.450	0.502	0.488	0.516	0.505	0.502	0.469	0.499	0.471	0.512	0.483
	2	0.500	0.490	0.450	0.505	0.472	0.516	0.486	0.500	0.468	0.503	0.479	0.513	0.486
Top Plate	1	0.500	0.490	0.450	0.507	0.460	0.503	0.455	0.505	0.472	0.510	0.475	0.519	0.487
	2	0.500	0.490	0.450	0.512	0.495	0.506	0.493	0.514	0.500	0.518	0.503	0.527	0.507
	3	0.500	0.490	0.450	0.514	0.498	0.507	0.503	0.517	0.497	0.520	0.478	0.529	0.516
	4	0.500	0.490	0.450	0.515	0.494	0.508	0.492	0.518	0.500	0.521	0.504	0.529	0.516
	5	0.500	0.490	0.450	0.516	0.501	0.508	0.495	0.518	0.490	0.520	0.501	0.529	0.517
	6	0.500	0.490	0.450	0.515	0.509	0.508	0.504	0.518	0.493	0.519	0.496	0.528	0.513

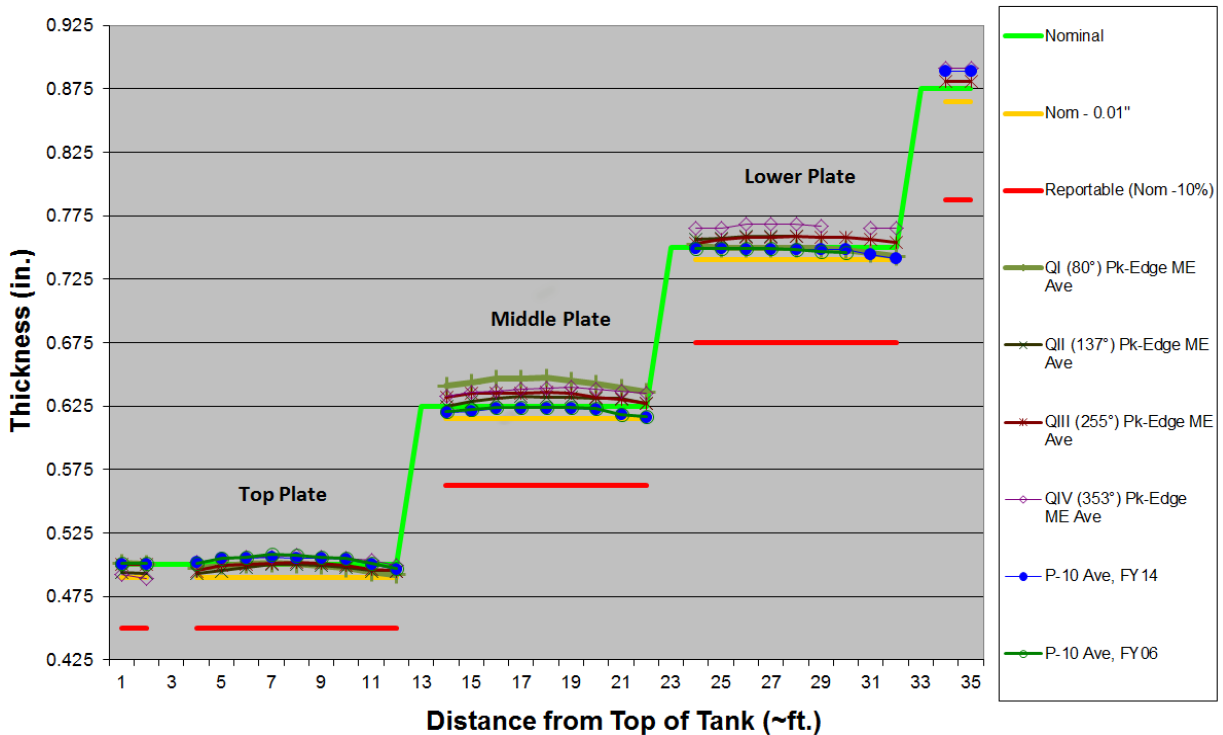
Figure 17: Tank 33 Average Thickness Data FY 2014  
Tank 33 Average Thickness 2014 Vertical Strips

Figure 17 provides a thickness plot of the 2014 average thickness data while Table 7 provides average and minimum thickness values for all vertical strips collected on the primary wall of Tank 33 in 2014.

Tank 33		Nominal	Nom - 0.01"	Reportable (Nom -10%)	P-10 Ave, FY14	P-10 Min, FY14	QI (80°) Pk-Edge ME Ave	QI (80°) Pk-Edge ME Min	QII (137°) Pk-Edge ME Ave	QII (137°) Pk-Edge ME Min	QIII (255°) Pk-Edge ME Ave	QIII (255°) Pk-Edge ME Min	QIV (353°) Pk-Edge ME Ave	QIV (353°) Pk-Edge ME Min
Top Knuckle	1	0.500	0.490	0.450	0.500	0.455	0.501	0.472	0.494	0.471	0.500	0.484	0.492	0.465
	2	0.500	0.490	0.450	0.500	0.474	0.500	0.448	0.493	0.468	0.500	0.478	0.489	0.457
Top Plate	1	0.500	0.490	0.450	0.502	0.479	0.497	0.453	0.493	0.455	0.495	0.467	0.502	0.484
	2	0.500	0.490	0.450	0.505	0.472	0.499	0.465	0.495	0.484	0.499	0.468	0.504	0.488
	3	0.500	0.490	0.450	0.505	0.489	0.500	0.464	0.498	0.485	0.500	0.471	0.506	0.487
	4	0.500	0.490	0.450	0.506	0.490	0.501	0.476	0.500	0.496	0.501	0.473	0.506	0.501
	5	0.500	0.490	0.450	0.505	0.490	0.500	0.469	0.500	0.496	0.502	0.472	0.507	0.490
	6	0.500	0.490	0.450	0.505	0.490	0.499	0.474	0.499	0.490	0.501	0.464	0.506	0.492
