DESTRUCTIVE EXAMINATION OF SHIPPING PACKAGE 9975-06100

W. L. Daugherty

Savannah River National Laboratory
Materials Science & Technology

Publication Date: November 2014

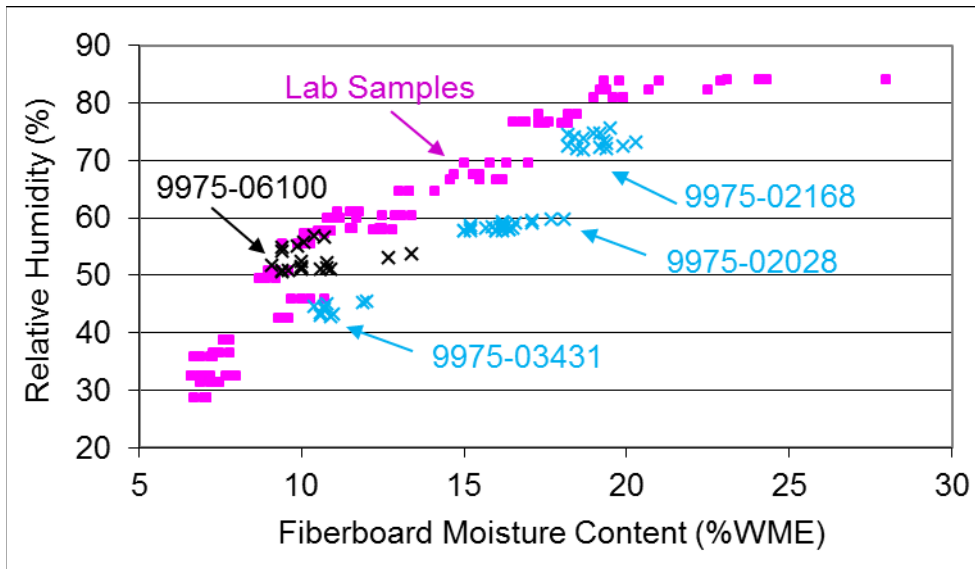
Consistent with recent efforts to correlate moisture content of fiberboard with humidity in the surrounding air, data were taken to correlate these two parameters. The fiberboard was placed back in the drum with a narrow channel cut down the side. A humidity probe was placed in this channel such that it could be raised and lowered with the drum closed. The edge of the drum lid was taped to seal around the gap created by the humidity probe cable. After humidity levels in the drum reached equilibrium, humidity readings were taken at several elevations along the fiberboard, and the fiberboard was then removed to measure the moisture content at those same locations. This process was repeated to demonstrate consistency in the results. These data are summarized in Figure 5, and compared to similar data from three previous DE packages and laboratory samples. All the prior data were generated with cane fiberboard, and show a similar trend, with the data for the 9975 packages offset slightly from that for laboratory samples. The current data from 9975-06100 are shifted slightly from the other 9975 DE packages, but are in good agreement with the cane fiberboard laboratory samples. Additional data will be needed from softwood fiberboard laboratory samples to identify whether there is a general offset in behavior between cane and softwood fiberboard.

Figure 5. Correlation between fiberboard moisture content and relative humidity of the adjacent air. Data from 9975-06100 are shown with comparable data from prior DE packages and laboratory samples. Measurements were taken along the fiberboard OD surface.

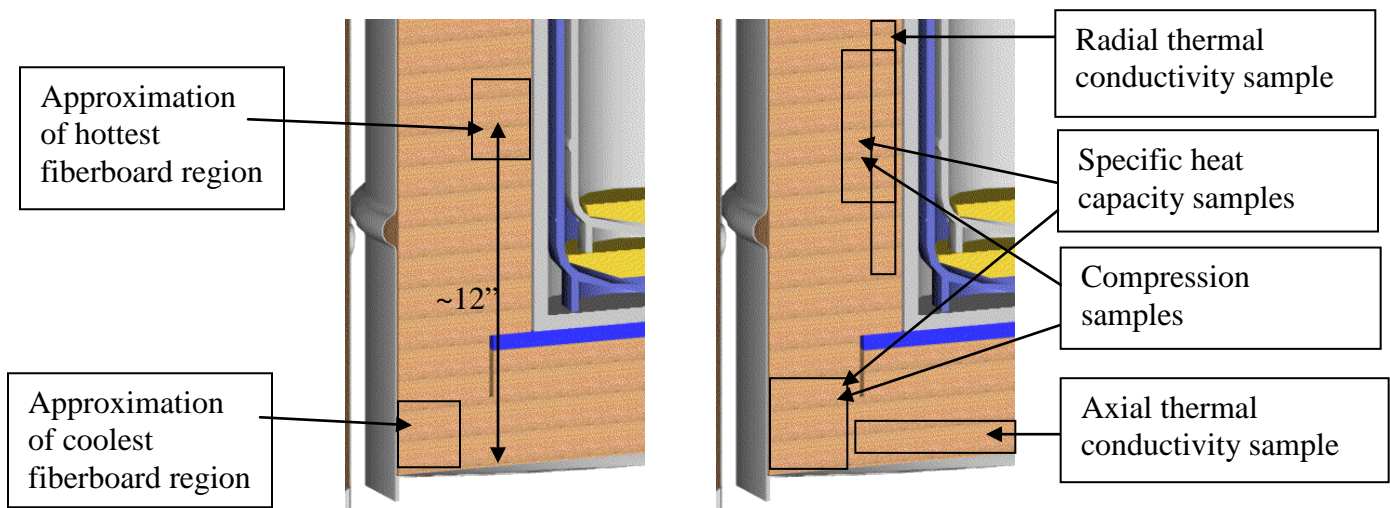
Samples of fiberboard were removed from the bottom fiberboard subassembly to measure compressive strength, specific heat capacity and thermal conductivity. The source location(s) of these samples is illustrated in Figures 6 and 7. The thermal conductivity sample from the bottom center of the subassembly is oriented for heat flow in the axial direction (perpendicular to the glue joints). The thermal conductivity sample from the side is oriented for heat flow in the radial direction (parallel to the glue joints). Testing on each sample was performed at a nominal (mean) temperature of approximately 25°C (77°F), with no environmental conditioning. Physical data on the fiberboard samples are recorded in Table 2.

Figure 6. Illustration of fiberboard regions of the bottom subassembly to be tested. Multiple samples (where used) were removed from the illustrated locations at different circumferential positions. Not to scale.

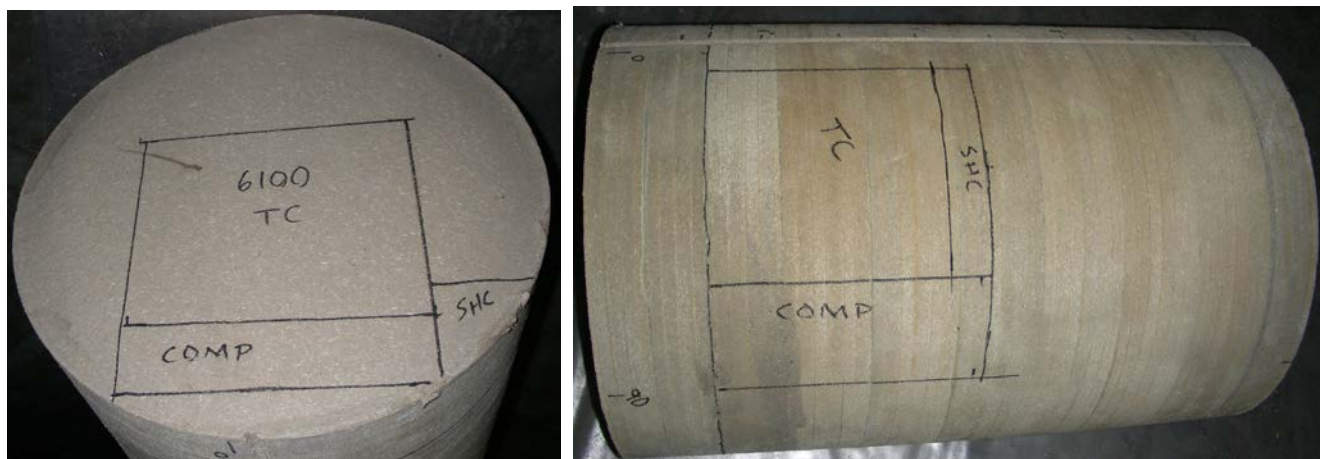
Figure 7. Lower fiberboard assembly marked for removal of test samples

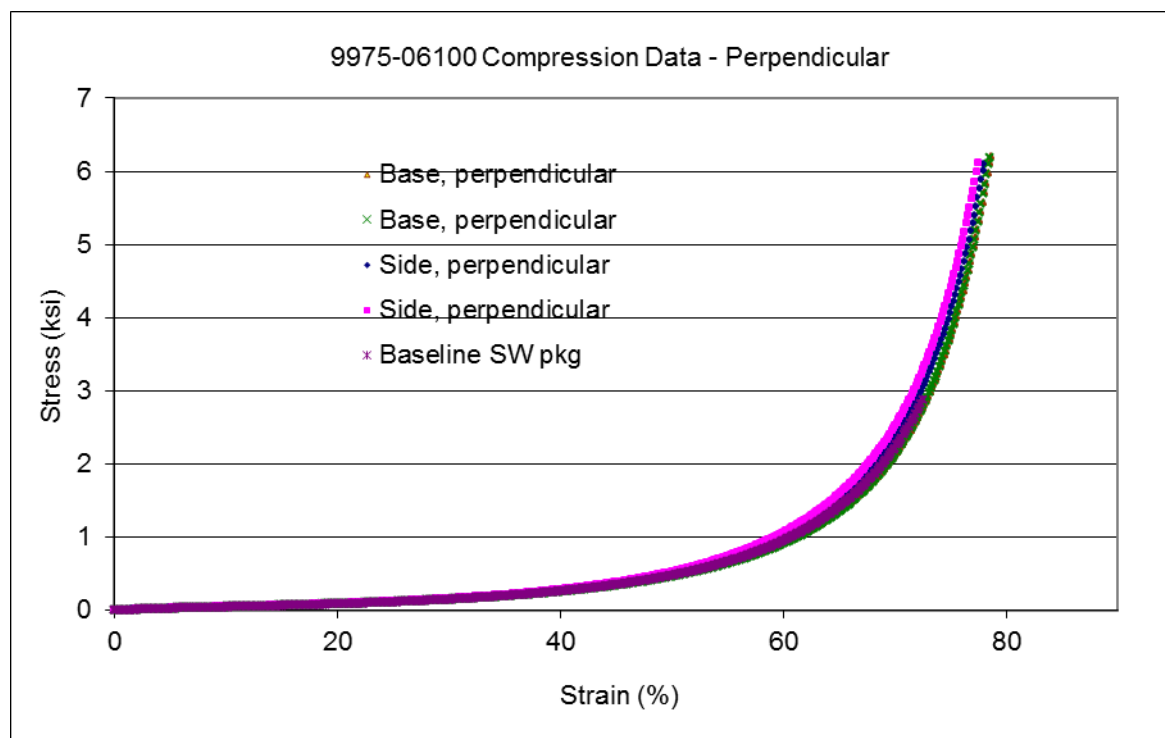
The compression test data are shown in Figures 8 and 9, along with baseline data for a different softwood fiberboard assembly. For both the perpendicular and parallel orientations, the

compression strength of the 9975-06100 samples is similar to the baseline samples. A series of photographs showing typical compression behavior under parallel loading is shown in Figure 10. The area under the stress-strain curve up to 40% strain is used as a relative indication of the energy absorption capacity of the fiberboard. This metric is shown in Figure 11 for each destructively examined package as a function of fiberboard moisture content. In general, the energy absorption capacity decreases as the moisture content increases. The results from 9975-06100 are circled in Figure 11. The Figure 11 data collectively show a trend consistent with undegraded softwood fiberboard and with other DE packages.

Figure 8. Fiberboard compression test data, compared with typical baseline data from an unaged softwood assembly, in the perpendicular orientation (i.e. load applied perpendicular to the fiberboard layers).

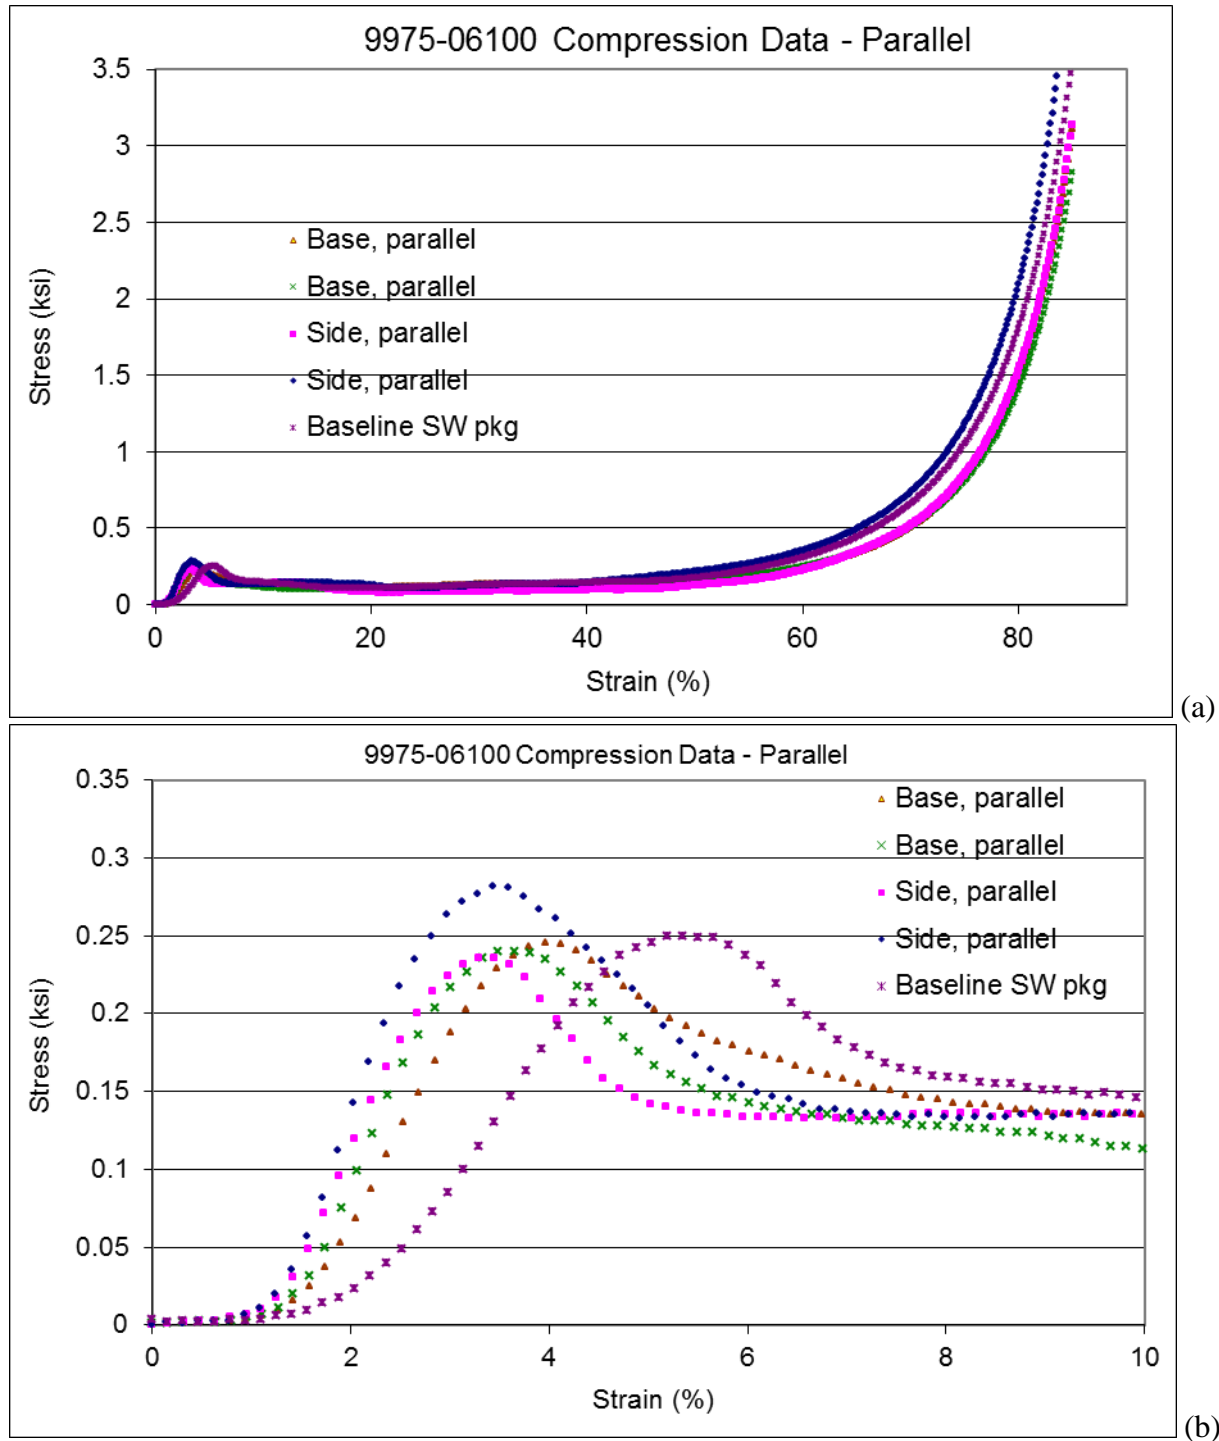
Figure 9. Fiberboard compression test data, compared with typical baseline data from an unaged softwood assembly, in the parallel orientation (i.e. load applied parallel to the fiberboard layers). The full curves are shown in (a), while the initial buckling region is expanded in (b).

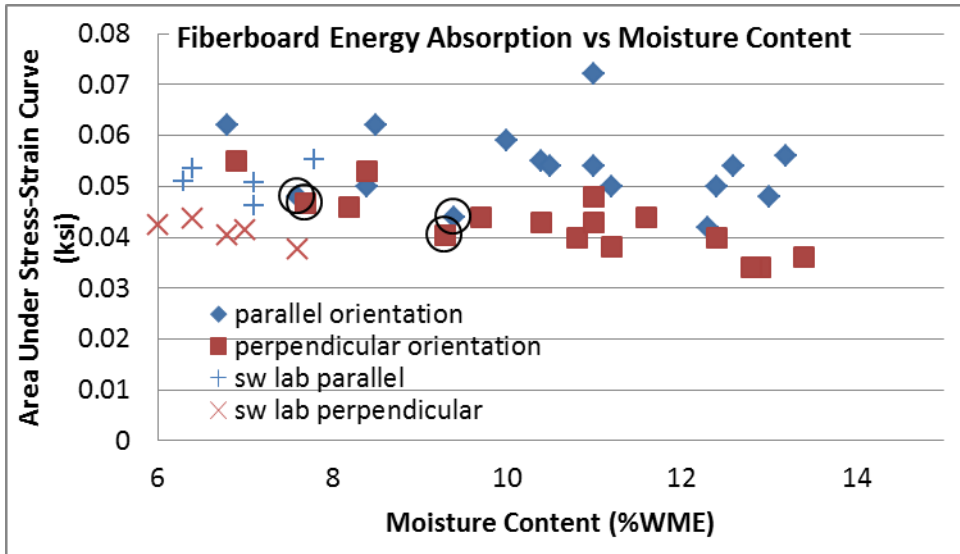
Figure 11. Fiberboard energy absorption, represented by the area under the stress-strain curve up to 40% strain, from tensile test samples from each destructively examined package (solid symbols). The results from 9975-06100 are circled. The open symbols (+, x) show baseline data from softwood fiberboard laboratory samples.

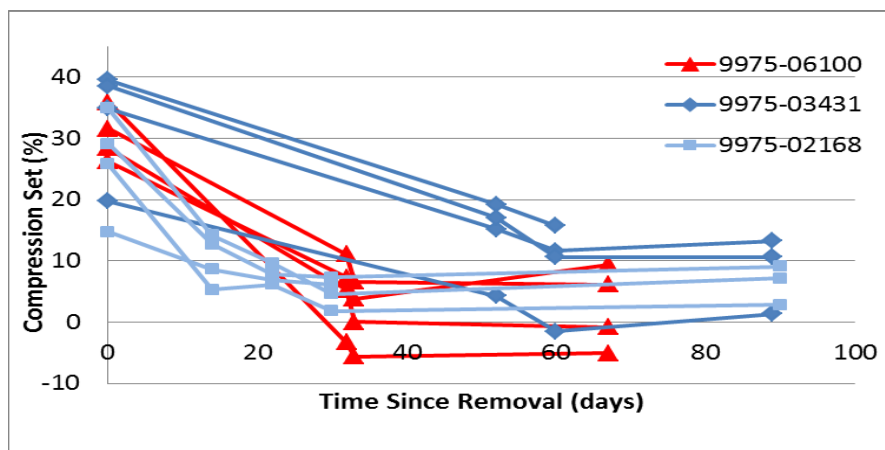
Compression set values are shown in Figure 13 as a function of time since removal of the O-rings, for the current package as well as for 9975-02168 and 9975-03431 for comparison. The compression set decreases with time, as the polymer continues to relax. Typically, the compression set has reached an equilibrium value after about 30 days or so. Compression set behavior is similar for each O-ring in these three packages. In the few cases where the compression set is negative, it is likely that the initial O-ring thickness was greater than the nominal 0.139 inch that was assumed.

Figure 13. O-ring relaxation as indicated by change in compression set following removal during field surveillance. Results are shown for each of the 4 O-rings from 9975-06100, compared to similar data from 9975-03431 and 9975-02168.

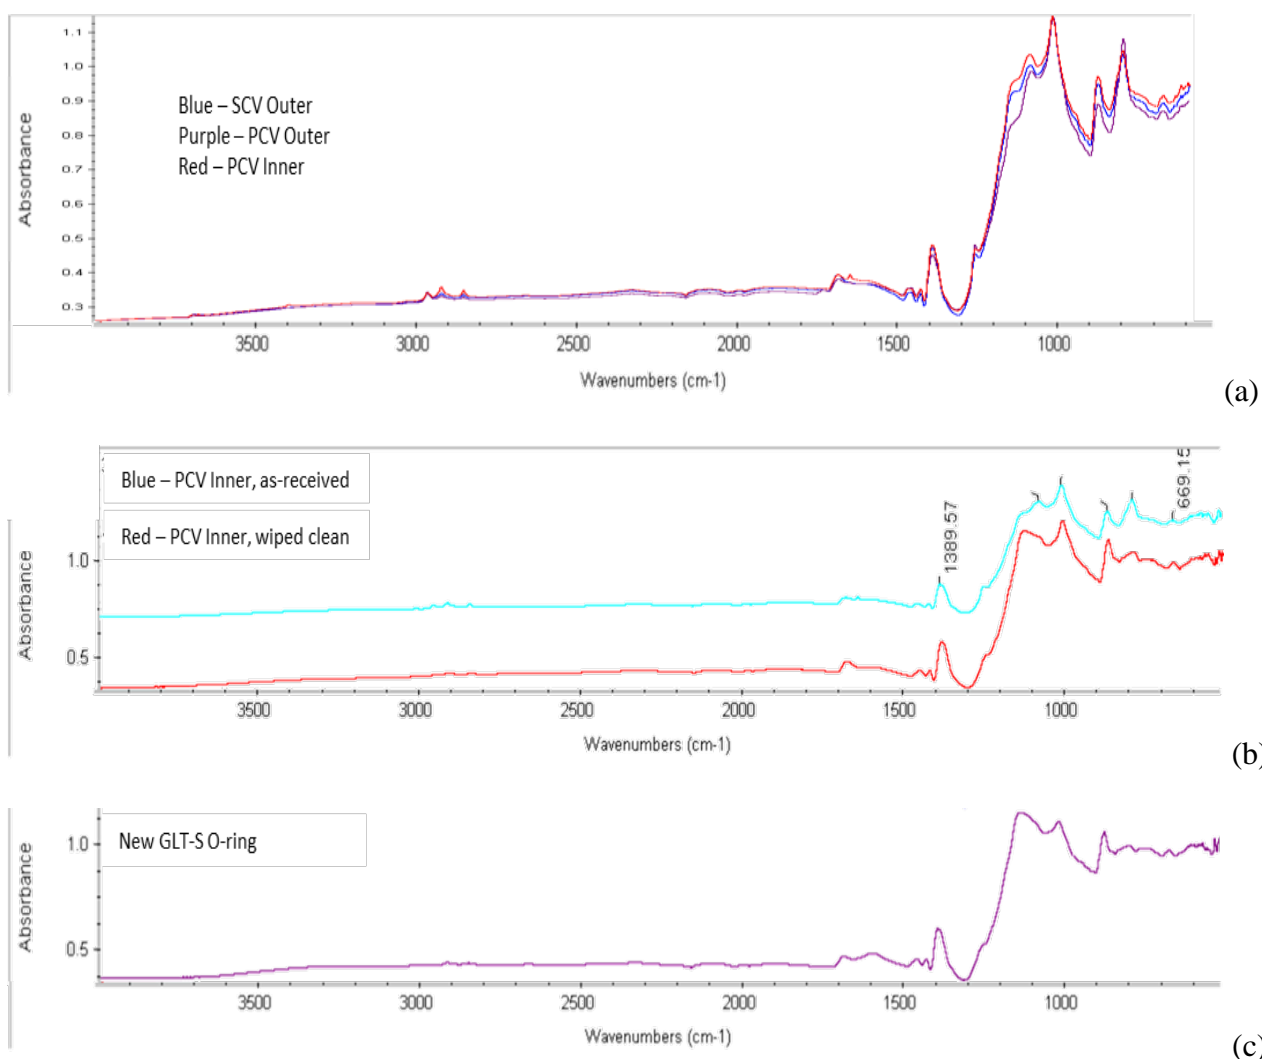
FT-IR spectroscopy generically identified the composition of each O-ring as consistent with a Viton[®] type fluoroelastomer (Figure 14). Each O-ring produced a similar FTIR spectrum in the as-received condition (i.e. with some grease residue). Figure 14 (b) compares the spectrum for the PCV inner O-ring before and after wiping off the grease, and shows some of the lower wavelength peaks reduced or eliminated. After wiping, the spectrum is very similar to that of a

new (unused and clean) Viton® GLT-S O-ring shown in Figure 14 (c), and is consistent with baseline data [17].

Figure 14. FT-IR spectra for the three tested Viton® GLT-S O-rings from 9975-06100, without cleaning (a). In (b), the PCV inner O-ring spectrum is repeated in the as-received condition, and compared to its spectrum after being wiped clean. A new (clean) GLT-S spectrum is shown in (c) for reference.

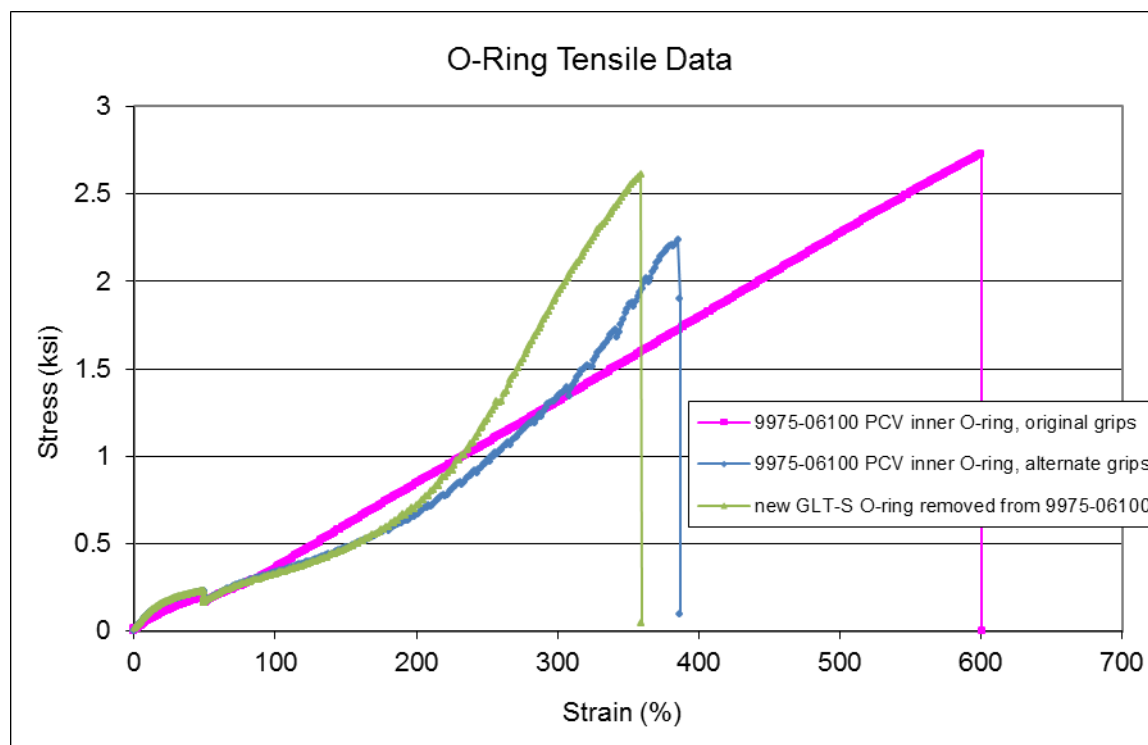
The PCV inner O-ring was tensile tested in accordance with ASTM D1414, using a cut (single strand) sample. The test was interrupted at 50% strain (Figure 17) to visually examine the O-ring for signs of cracking or other degradation. None were observed. The initial stress-strain curve for the PCV inner O-ring is shown in Figure 18. In this first test, the O-rings failed after reaching 600% strain, an unusually high value for any Viton® O-ring (GLT, GLT-S, etc), even compounds without reinforcing fillers. A re-test reached 650% elongation without breaking. Comparison tests performed on the PCV outer O-ring and a new O-ring that was re-installed on the PCV also produced higher elongation than expected (450, 530%). Each of these O-rings was tested using a yarn grip which would allow some stretch beyond the gage section. It is theorized that these GLT-S O-rings experienced significantly more stretch beyond the gage section than previous GLT O-rings. To more accurately measure the elongation, tests were performed with an alternate grip arrangement which does not allow such stretch. These alternate flat grips pose a greater risk of breaking within the grips (which would invalidate the test), but they provide a better measure of the elongation. With this arrangement, the PCV inner O-ring had an elongation of 385%, while the new O-ring had an elongation of 359%. Both of these values are similar to baseline data [17]. These comparison tests are also shown in Figure 18. For each of the O-rings tested, the tensile strength ranged from 2.2 to 2.9 ksi, which is comparable to baseline GLT-S data, but higher than prior GLT data.

Figure 18. Tensile data for PCV inner O-ring from 9975-06100 tested with the original yarn grip configuration, with comparison curves from the same PCV inner O-ring and a new O-ring (removed from 9975-06100 PCV), both tested with a flat grip configuration.
