**IMECE2015-53460**

**WEAR LOCATIONS IN STAINLESS STEEL PIPE FITTINGS FROM THE TURBULENT  
FLOW OF A LIQUID-SOLID SLURRY**

**Mark R. Duignan, Marissa M. Reigel, Kenneth J. Imrich,  
Michael L. Restivo and Mark D. Fowley**  
Savannah River Nuclear Solutions  
Savannah River National Laboratory  
Aiken, South Carolina, USA

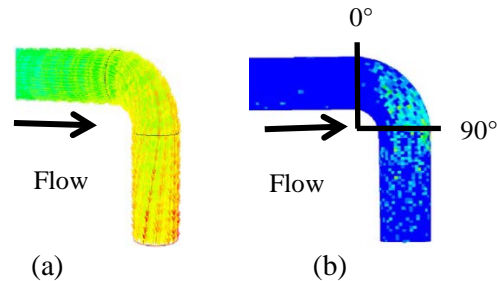
previously planned erosion test [42], see Fig. 1, indicating an angle of 90° in a 0.0762-m (3-inch) LR 90° elbow with a slurry velocity of 3.5 m/s.

Figure 1. CFD model of a water-sand flow through LR 90° elbow. (from [43]): (a) particle trajectories, (b) relative erosion rates.

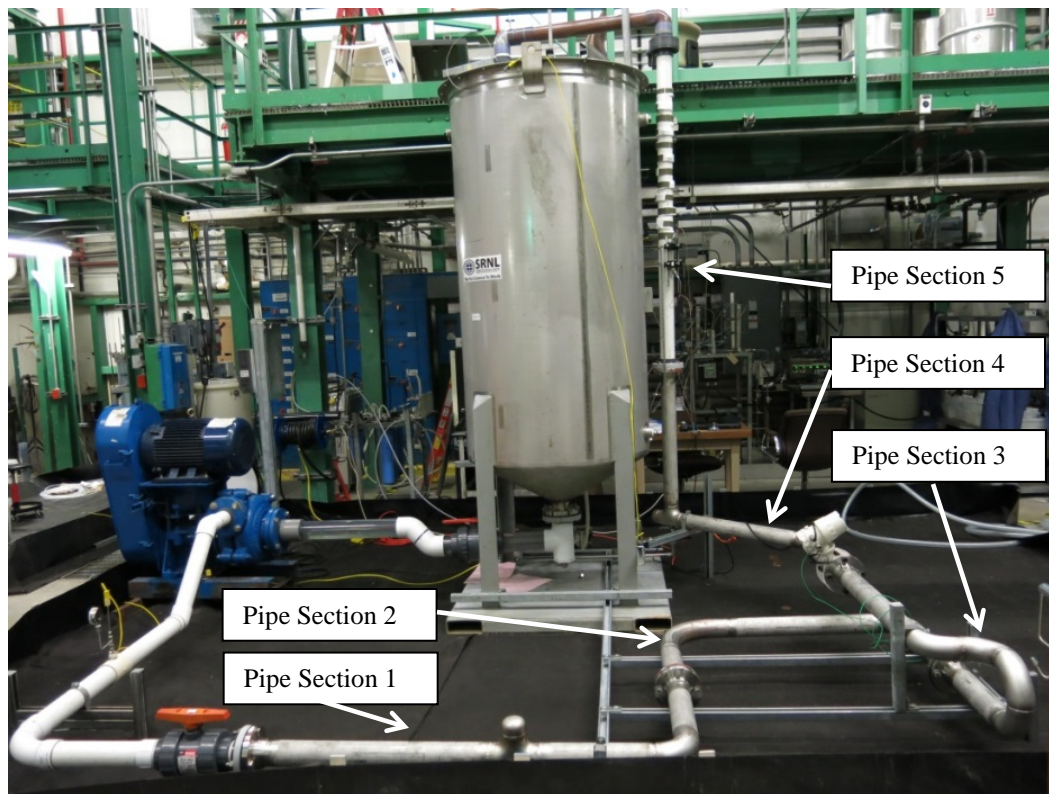
Figure 2. Overall sketch of paint loop

- Fully developed flow was not obtained even after 30D of vertically oriented straight pipe, which was evident from Section 4 to Section 5 pipes, Fig. 2. The higher wear seemed to be principally on one side of the pipe, but it slowly rotated as it straightened from a very traumatic flow change caused by the upstream tee fitting to the downstream LR 90° elbow at 34D.

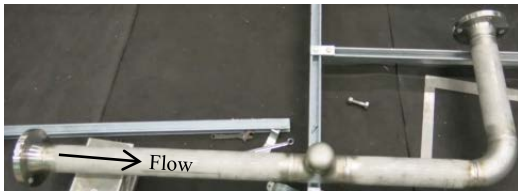
Section 1, seen in Fig. 3, begins immediately after the plastic pump discharge pipe. It starts with a 10D straight section that leads into a tee fitting with the branch blocked off with a cap. The D is the inside diameter of the pipe, which for a 0.0762-m (3-inch) Schedule 40 pipe is 0.07793 m. The tee is followed by a 5D straight section that leads into a Long Radius (LR) 90° elbow. Finally the elbow is followed by one half of a 10D straight section, which is split in the middle with an access flange.

Figure 3. Pipe Section 1: Contained tee, LR 90° elbow, and 10D & 5D straight pipe

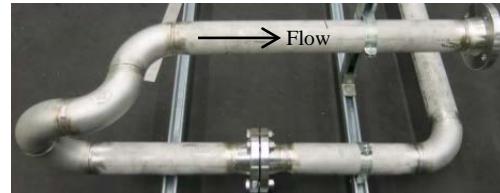
Section 3, seen in Fig. 5, begins with the second half of the 10D straight section at the end of the Section 2 pipe. The straight pipe is followed by a LR 90° elbow leading to three more LR 90° elbows that have 0D or straight pipe between each section. While such a combination of pipe bends is not expected to be purposely installed in a black cell, its existence is possible per the allowable technical specification to construct pipe; therefore, these close-joined bends were included to evaluate the effect of erosion in such situations. This section ends with a 10D straight pipe leading into Section 4.

Figure 5. Pipe Section 3: Contained four 0D LR 90° elbows, and 10 & 5D straight pipe

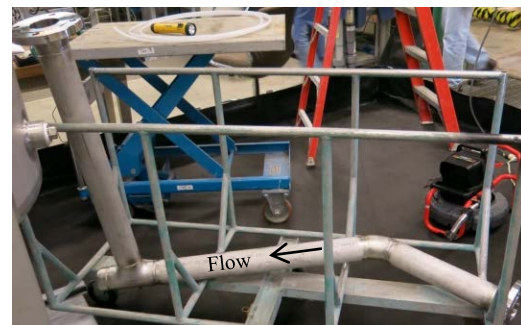
Section 4, seen in Fig. 6, begins with a 5D straight section, which when combined with the last pipe section results in a total of 15D of straight pipe. That straight section ends at a LR 45° elbow and is followed by a straight section of 10D. Here the pipe ends in a tee fitting with the straight section of the tee terminating with a pipe cap. However, the flow continues through the branch section of the tee into another 10D straight section, which directs the flow vertically upwards.

Figure 6. Pipe Section 4: Contained LR 45° elbow, LR 90° elbow, tee with branch flow, and 10D & 5D straight pipe

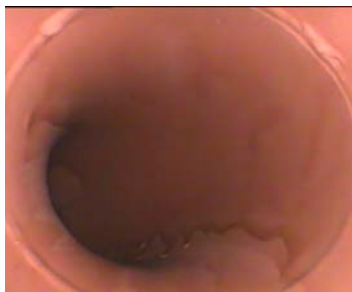
Figure 8. Painted elbow – uneven coat
