# DEVELOPMENT OF LASER ENGINEERED NET SHAPE (LENS) ADDITIVE MANUFACTURING FOR REPAIR

**PVP2015-46001**

## **DEVELOPMENT OF LASER ENGINEERED NET SHAPE (LENS) ADDITIVE MANUFACTURING FOR REPAIR**

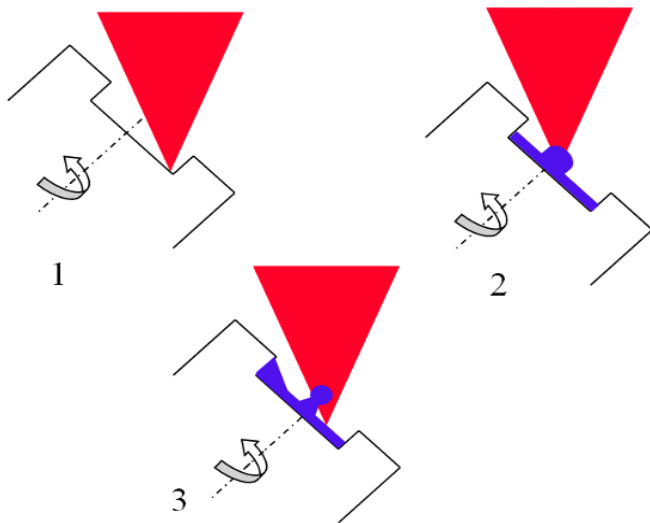
A second type of defect is represented by milling an oversized bore for a flat bottomed hole in a reclamation test base. The reclamation base is used to simulate a hydrogen storage vessel that is fabricated with a nominal 6 mm side bonded solid state resistance forge weld. This type of defect represents a hole that could be bored eccentrically or simply bored too large or too deep. A sketch of the part and LENS repair fill orientation is shown in Figure 3. The center diameter for the repair parts were increased by 0, 0.38, 0.76, and 1.14 mm and were filled using the parameters listed in Table 1. Note that the process parameters evolved as knowledge was gained for these specific repairs. For instance, the rotational speed was increased as material was deposited at the center of the reclamation base and a protrusion was observed, also the powder feed was decreased to avoid the build-up at the center

**Figure 3. LENS build-up orientation to minimize formation of a central build-up on the repaired parts. The rotational speed was increased to minimize the effect.**

which ultimately interfered with the material deposition. After LENS repair, the excess material was machined to provide a nominal 6 mm bore diameter with a 2 mm depth. The parts were cleaned and a standard diameter fill stem was welded in place. The welding conditions used for the LENS repaired bases were consistent with the production process parameters, 5.56 kN axial force, 11,400 Amperes, and 25 AC cycles (60 Hz nominal). These samples were burst tested in the as-fabricated and hydrogen charged condition.

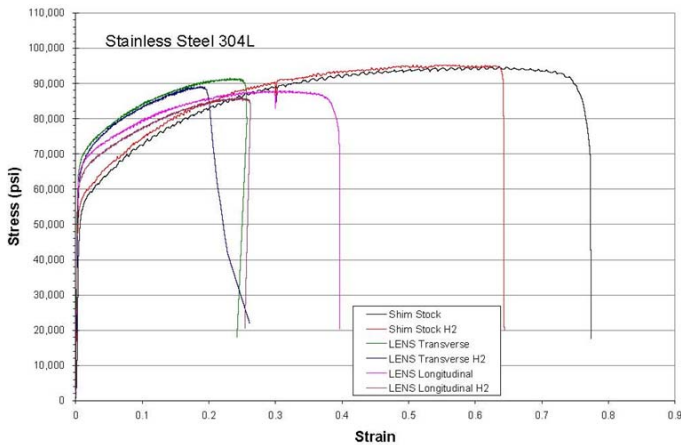
The tensile test results for the bulk LENS material are shown in Figure 9. The tensile results indicate a slight increase in yield strength of the LENS material compared to the baseline shim stock. There is significant reduction in elongation for the LENS material. A better comparison for the as deposited LENS material might be a comparison to cast compositions of 304L stainless steel, i.e., CF-3 which still has approximately 50 – 60% elongation in the as solution annealed condition (18). The tensile properties after hydrogen charging indicate a slight reduction in elongation. This decrease is consistent with materials that are only slightly affected by hydrogen charging (19).

**Figure 9.** Tensile Test results for SS shim stock and bulk LENS material as-fabricated and hydrogen charged conditions.

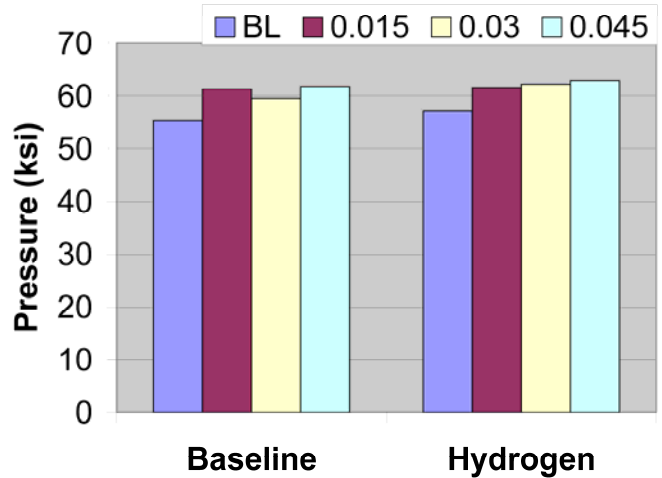
The repaired reclamation test bases were hydrogen charged as indicated previously. The samples were hydro-burst tested. All of the samples failed in the stem wall, as is expected for the geometry. The wall is about 0.76 mm thick, compared to the welds which are a minimum of 1.1 mm long. If one assumes that thin wall pressure vessel equations are valid for the hoop ( $\sigma = pr/t$ ) and axial stresses ( $\sigma = pr/2t$ ), then the tube wall will fail at a pressure of about half that required for the foot, assuming the same properties for both. The burst results are shown in Figure 10. Due to the sample and weld geometry this is not a very discriminating test to determine the relative merit of the repair, however, it is one acceptance criteria.

**Figure 10.** Burst test results for baseline and hydrogen charged reclamation test stems. No measurable effect was observed.

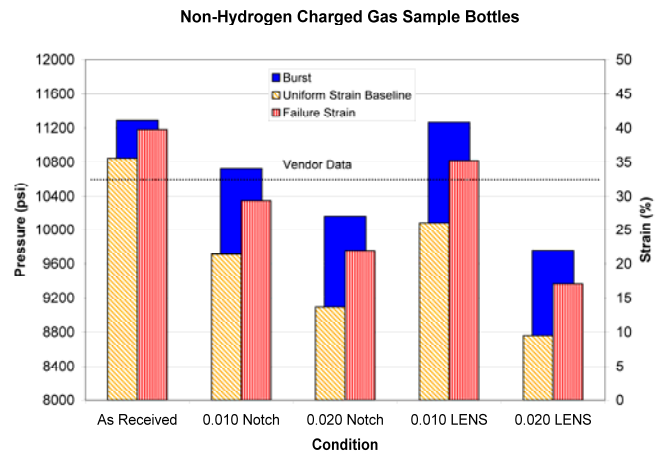
**Figure 11.** Burst test results and metrics for gas sample bottles in the as-received, as-notched, and LENS repaired conditions.

bottles that had been LENS repaired. The burst pressure, uniform ductility and failure strain were determined for these conditions. The uniform strain is estimated based on the maximum diameter measure post-test while the failure strain is estimated based on the measured maximum bulge at the failure. The uniform strain is likely a better measure of the ductility. The summary data for the baseline conditions are shown in Figure 11. These data show that the presence of the notch reduces the burst pressure and ductility. The 0.25 mm LENS

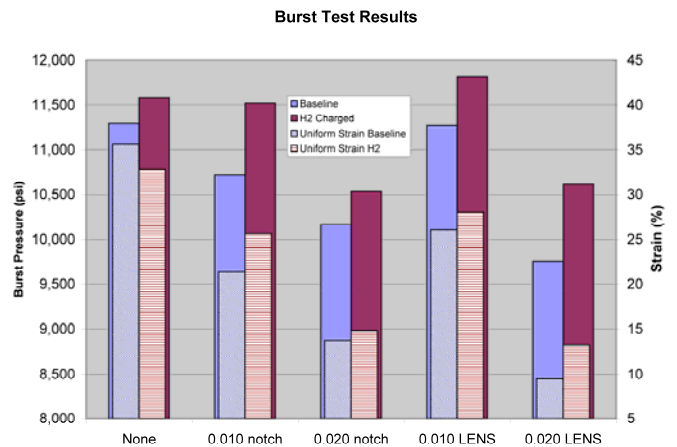
**Figure 12.** Burst test results comparing the effects of hydrogen on baseline and repaired gas sample bottles.

The gas bottles that were notched, and notched then LENS repaired and hydrogen charged were also burst tested. The hydrogen charged samples exhibit interesting results. The baseline data shown in Figure 11 is repeated in Figure 12 along with the hydrogen sample data. The hydrogen charged samples show some strengthening due to hydrogen charging. This

phenomenon has been seen in previous tensile test work (19). The hydrogen data plotted in Figure 12 is the average of the two points for the conditions charged and tested. As was the case for the baseline samples, the presence of notches reduced the burst pressure for hydrogen charged samples, although the fractional reduction in burst pressure was less for the hydrogen charged samples than the baseline. The burst ductility is lower for the hydrogen charged samples with notches.

The appearance of the burst tested gas sample bottles exhibited the expected failure with the bottle tearing axially, in addition all of the samples with notches failed in the notch. There was one exception for the LENS repaired samples with one of the 0.25 mm LENS repaired samples failing in the vessel body away from the repair, indicating that the repair was excellent and that it had no adverse impact on strength. Photographs of selected burst tested vessels for both baseline and hydrogen charged conditions are shown in Figure 13. The change in sample diameter growth, i.e., direct indication of strain, appears lower as the extent of the defect increases, this feature is apparent in Figure 12 as well.
