DESTRUCTIVE EXAMINATION OF SHIPPING PACKAGE 9975- 02019

SRNL-STI-2016-00324, Revision 0

Keywords: *K-Area
Surveillance
9975 Shipping Package*

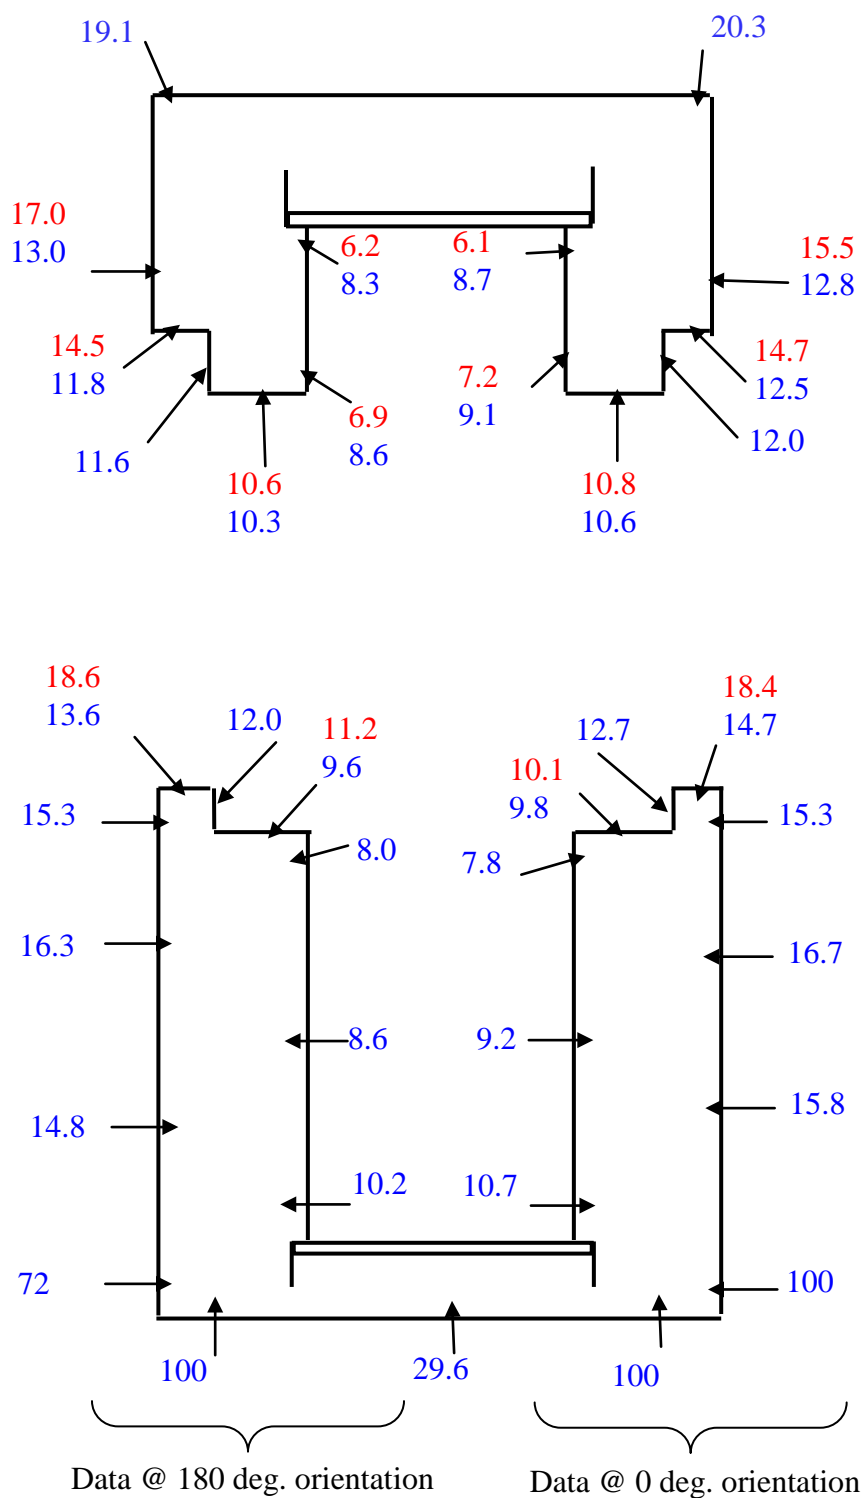
A GE Protimeter Surveymaster moisture probe was used to measure the moisture content of the top and bottom fiberboard subassemblies. This probe identifies the wood moisture equivalent (WME), or the weight % of moisture that would produce the same electrical conductivity in wood. Moisture content data from each examination are presented in Figure 4.

Figure 4. Fiberboard moisture content data. The values in red were measured during field surveillance. The values in blue were measured 15 days later, except for the top of the upper fiberboard subassembly which was measured 21 days later. All values are % wood moisture equivalent.

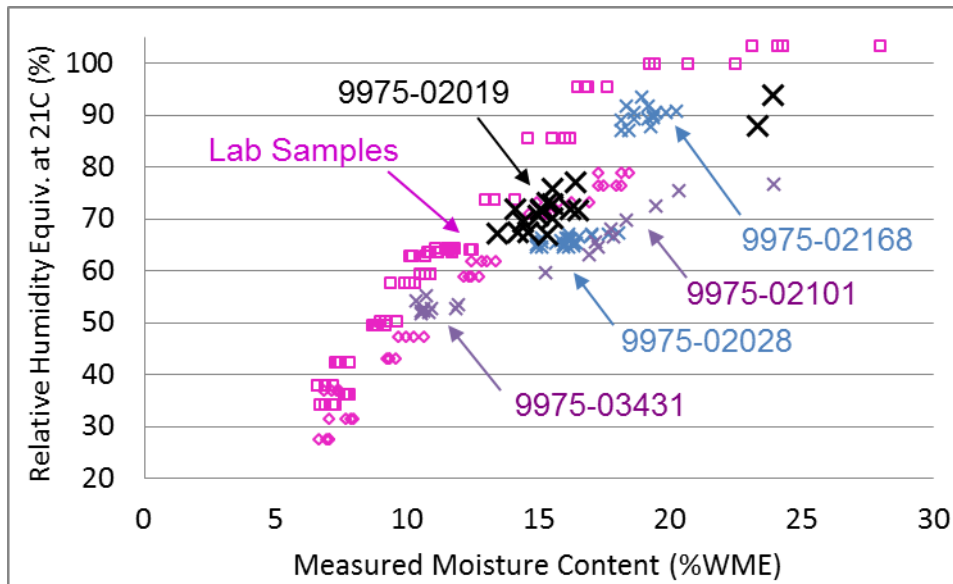
Consistent with recent efforts to correlate moisture content of fiberboard with humidity in the surrounding air, data were taken to correlate these two parameters. The fiberboard was placed back in the drum with a narrow channel cut down the side. A humidity probe was placed in this channel such that it could be raised and lowered with the drum closed. A plastic bag was taped over the top of the drum and sealed around the humidity probe cable. After allowing time for the humidity levels in the drum to approach equilibrium, humidity readings were taken at several elevations along the fiberboard, and the fiberboard was then removed to measure the moisture content at those same locations. The humidity data were then converted to the equivalent relative humidity corresponding to a constant temperature of 21 °C, since relative humidity is temperature dependent. These data are summarized in Figure 5, and compared to similar data from several previous DE packages and laboratory samples with cane fiberboard. The data from 9975-02019 show reasonable agreement with the other data.

Figure 5. Correlation between fiberboard moisture content and relative humidity of the adjacent air. Data from 9975-02019 are shown with comparable data from prior cane fiberboard DE packages and laboratory samples. Measurements were taken along the fiberboard OD surface. Since relative humidity is temperature dependent, all the data in this graph have been converted to a consistent equivalent relative humidity at 21 °C.

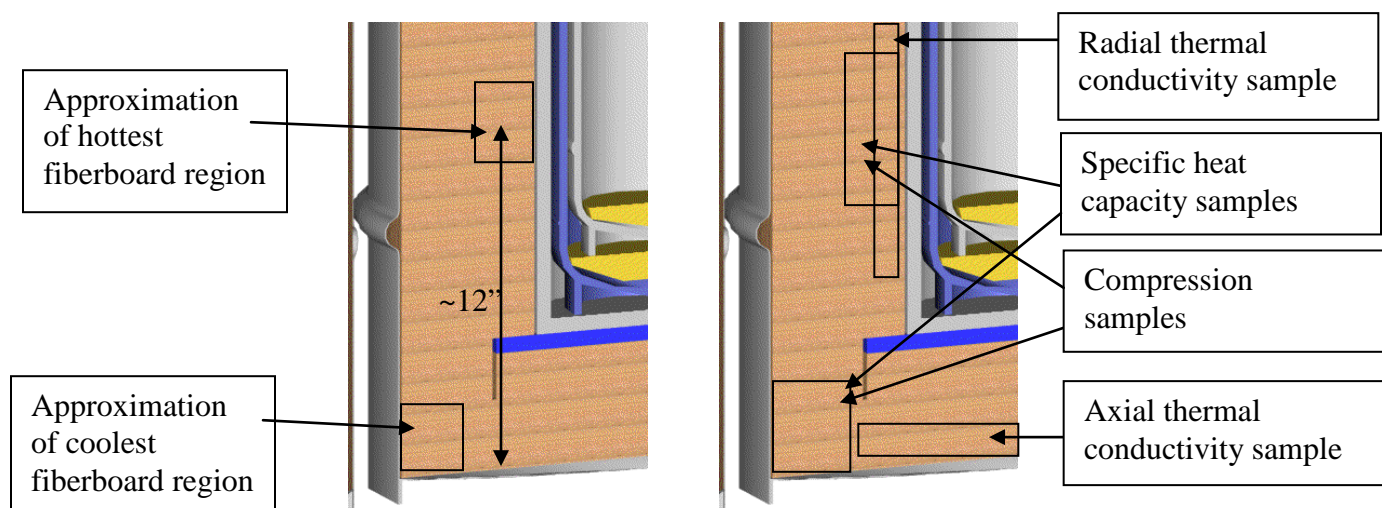
Samples of fiberboard were removed from the bottom fiberboard subassembly to measure compressive strength, specific heat capacity and thermal conductivity. The source locations of these samples are illustrated in Figure 6. The thermal conductivity sample from the bottom center of the subassembly is oriented for heat flow in the axial direction (perpendicular to the glue joints). The thermal conductivity sample from the side is oriented for heat flow in the radial direction (parallel to the glue joints). Testing on each sample was performed at a nominal (mean) temperature of approximately 25°C (77°F), with no environmental conditioning. Physical data from the fiberboard samples are recorded in Table 2.

Figure 6. Illustration of fiberboard regions of the lower subassembly to be tested. Multiple samples (where used) were removed from the illustrated locations at different circumferential positions. Not to scale.

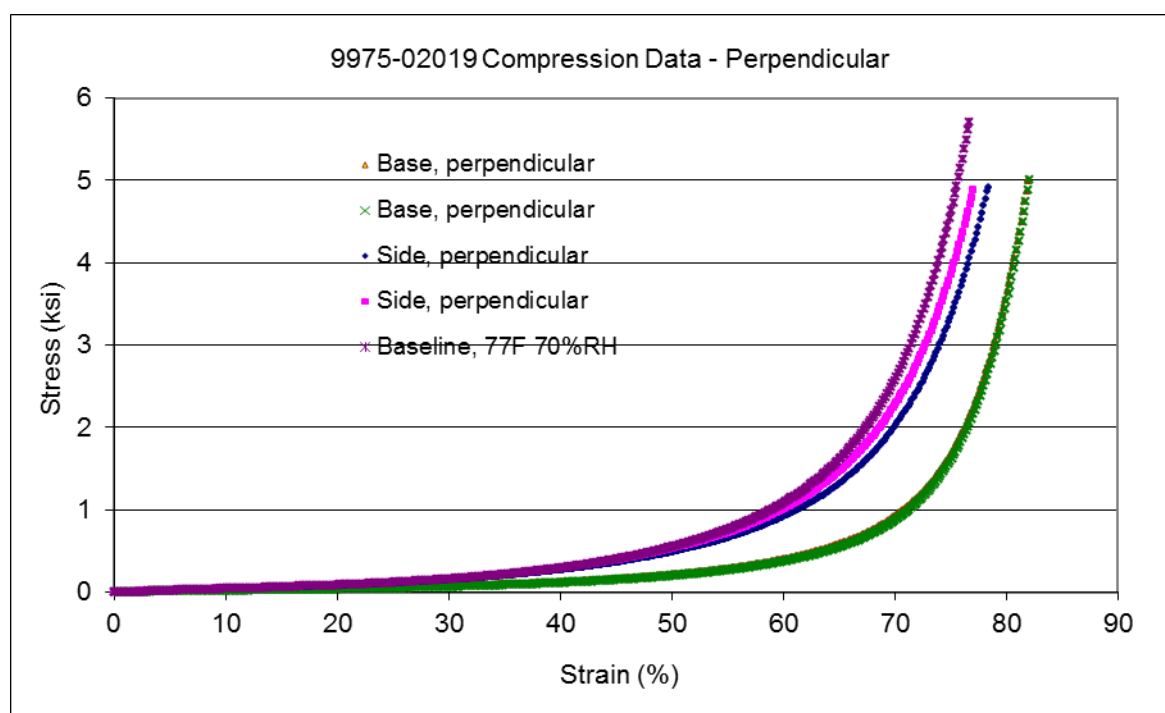
The compression test data are shown in Figures 7 and 8, along with baseline data for a different fiberboard assembly. A series of photographs showing typical compression behavior under parallel loading is shown in Figure 9. The area under the stress-strain curve up to 40% strain is used as a relative indication of the energy absorption capacity of the fiberboard. This metric is shown in Figure 10 for all destructively examined packages as a function of fiberboard moisture content. In general, the energy absorption capacity decreases as the moisture content increases. The results from 9975-02019 are circled in Figure 10. These data show a trend consistent with the other DE packages.

Figure 7. Fiberboard compression test data, compared with typical baseline data from an unaged assembly, in the perpendicular orientation (i.e. load applied perpendicular to the fiberboard layers).

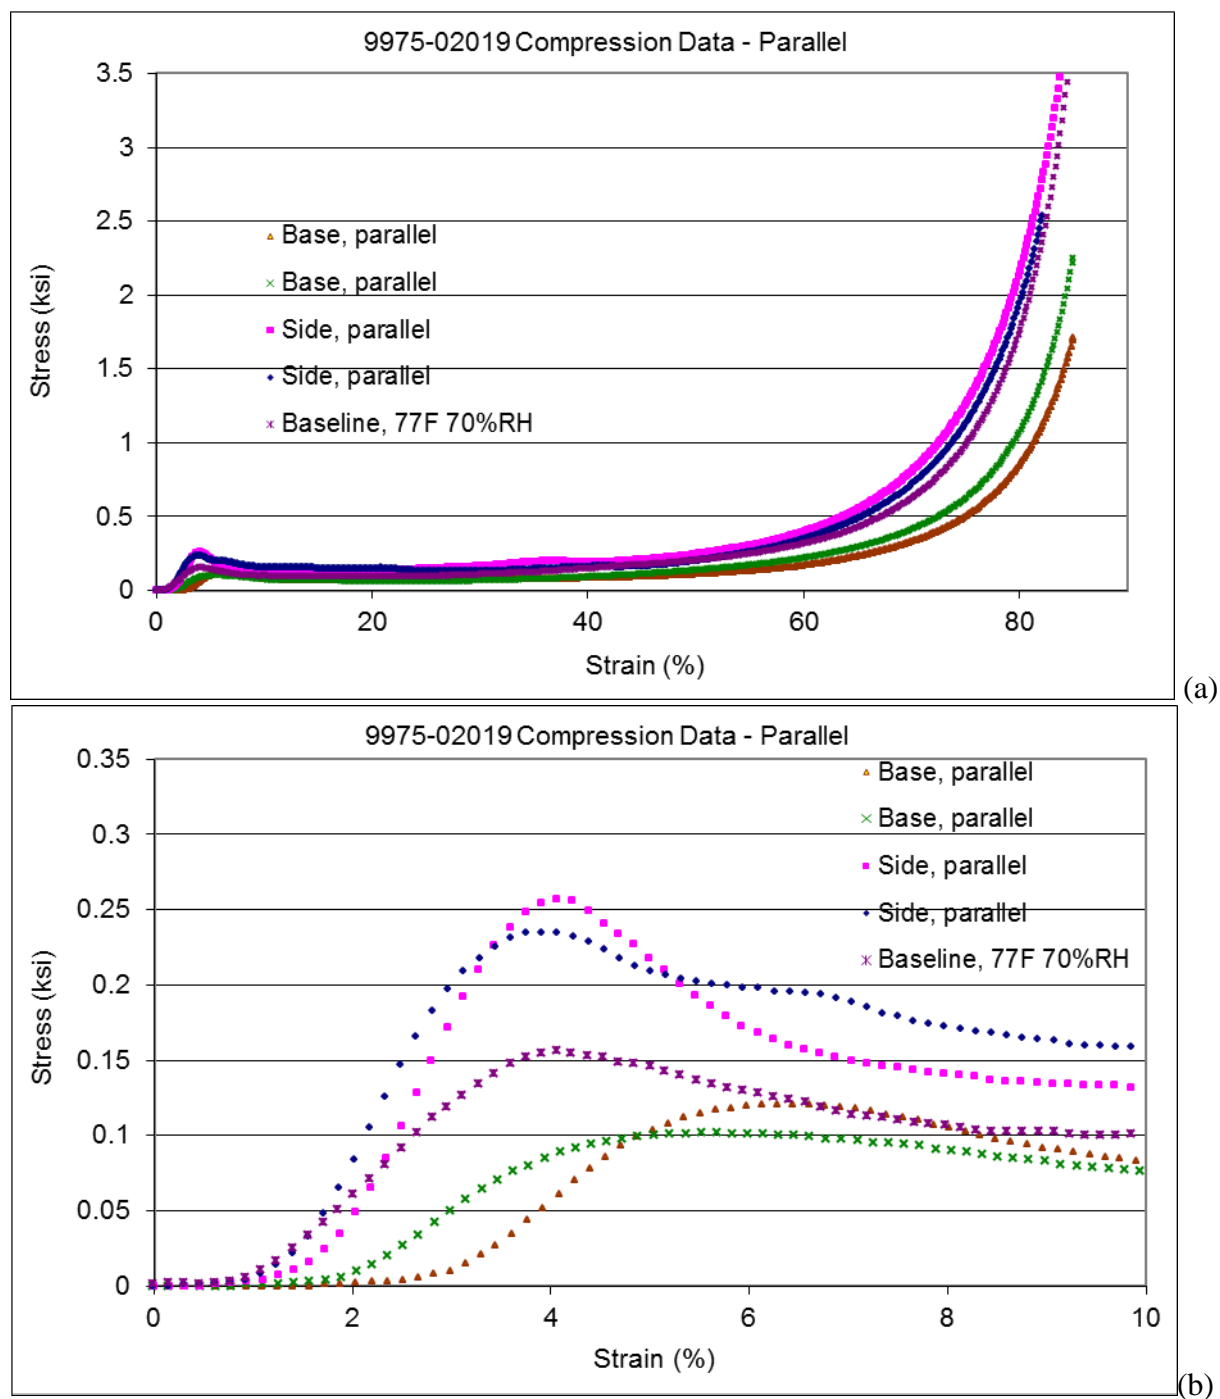
Figure 8. Fiberboard compression test data, compared with typical baseline data from an unaged assembly, in the parallel orientation (i.e. load applied parallel to the fiberboard layers). The full curves are shown in (a), while the initial buckling region is expanded in (b).

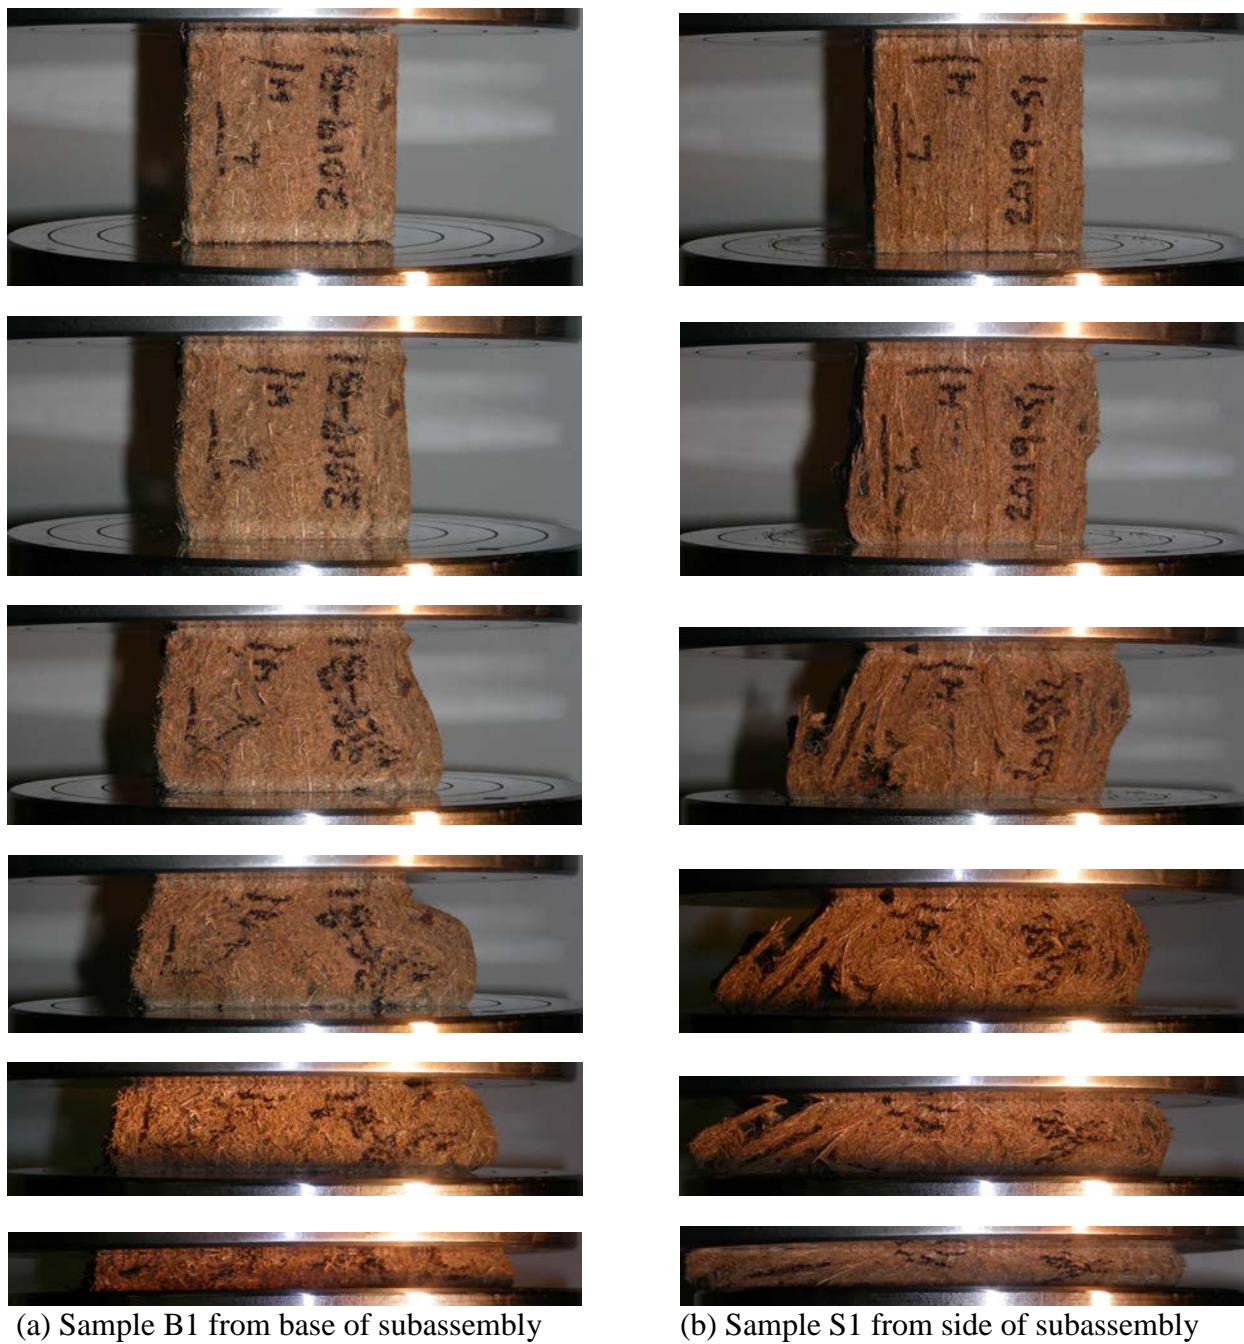
Figure 9. Photographs of fiberboard samples during compression testing, parallel orientation

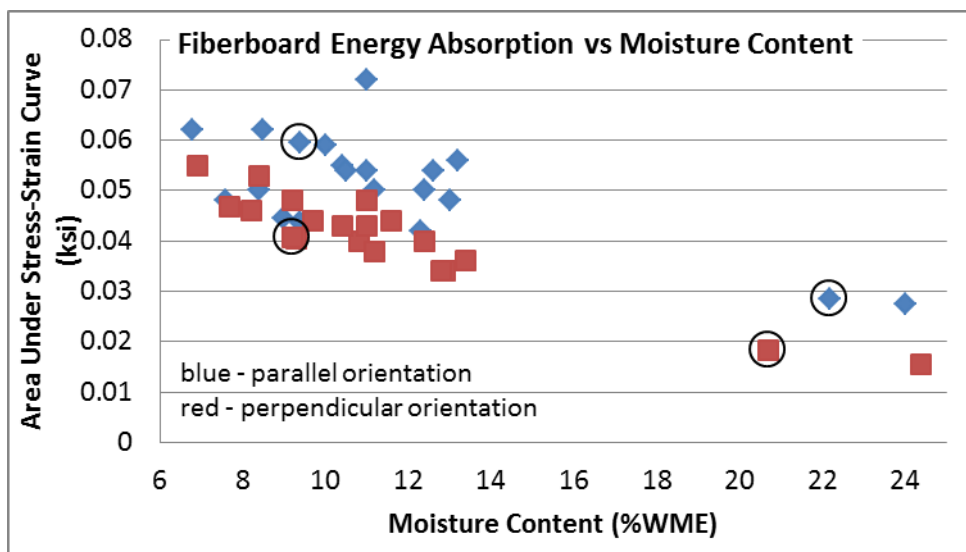
Figure 10. Fiberboard energy absorption, represented by the area under the stress-strain curve up to 40% strain, from tensile test samples from all destructively examined packages. The results from 9975-02019 are circled.

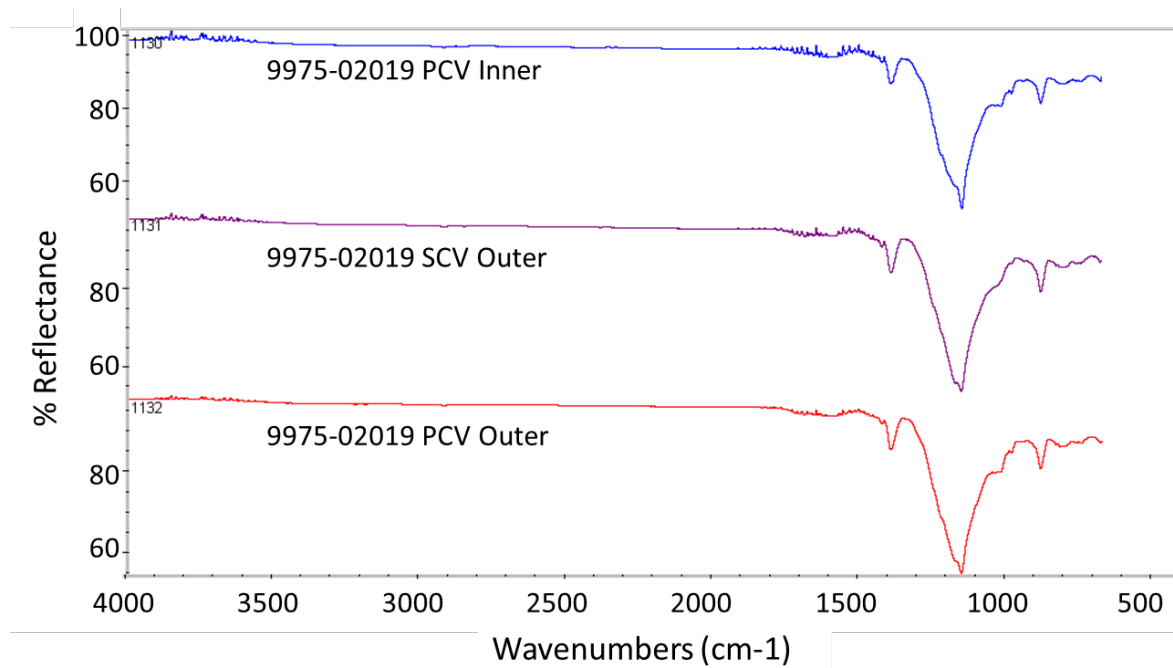
FT-IR spectroscopy generically identified the composition of each O-ring as consistent with a Viton® type fluoroelastomer (Figure 12). Each O-ring produced a similar FTIR spectrum consistent with that from previous characterization of Viton® GLT O-rings, and with a library image of a Viton® FTIR spectrum.

Figure 12. FT-IR spectra for the three tested Viton® GLT O-rings from 9975-02019. PCV outer – red, PCV inner – blue, SCV outer – purple.

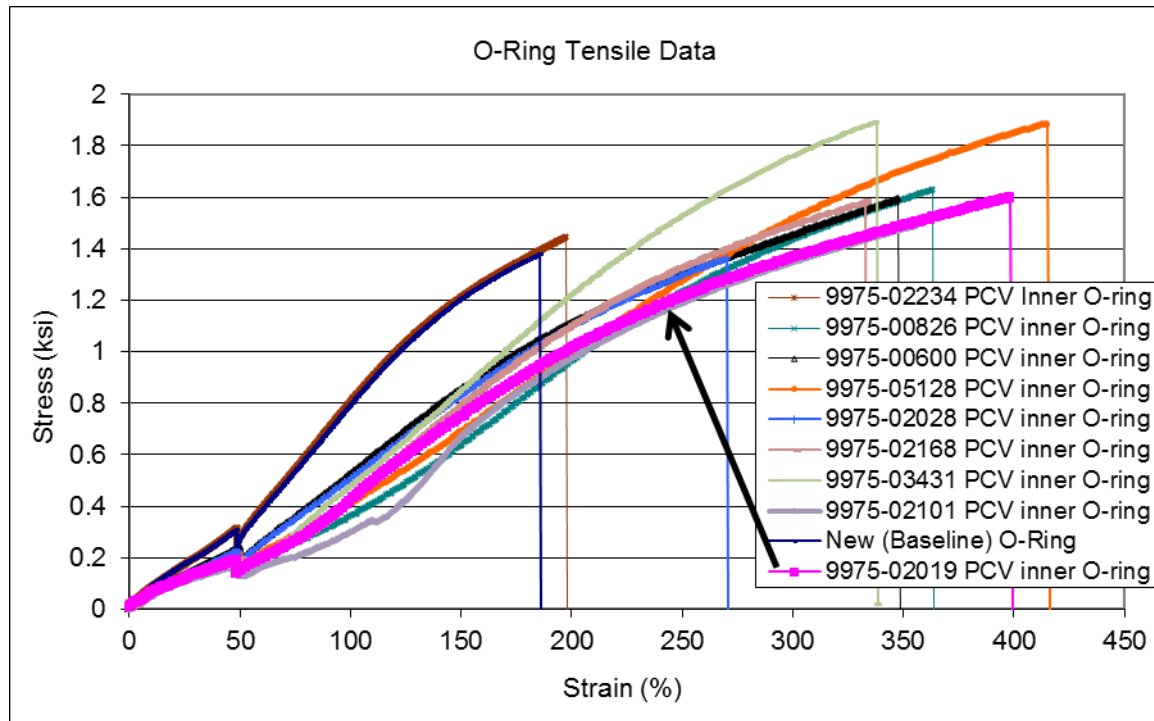
The PCV inner O-ring was tensile tested in accordance with ASTM D1414, using a cut (single strand) sample. The test was interrupted at 50% strain (Figure 15) to visually examine the O-ring for signs of cracking or other degradation. None were observed. The initial stress-strain curve for the PCV inner O-ring is shown in Figure 16, along with results of other tests with Viton GLT O-rings. In this first test, the O-ring failed after reaching 398% elongation. A re-test was performed with a different grip arrangement, and reached 157% elongation (Figure 17). The first test uses a yarn grip which would allow some stretch beyond the gage section, especially if the O-ring had any residual grease. To more accurately measure the elongation, the second test was performed with an alternate grip arrangement which does not allow such stretch. Since these alternate flat grips pose a greater risk of breaking within the grips (which would invalidate the test), the portion of O-ring within the grips was wrapped with tape for cushioning.

Figure 16. Tensile data for PCV inner O-ring from 9975-02019, with comparison curves from other DE packages with Viton GLT O-rings. All of these tests were conducted with the original yarn grip configuration

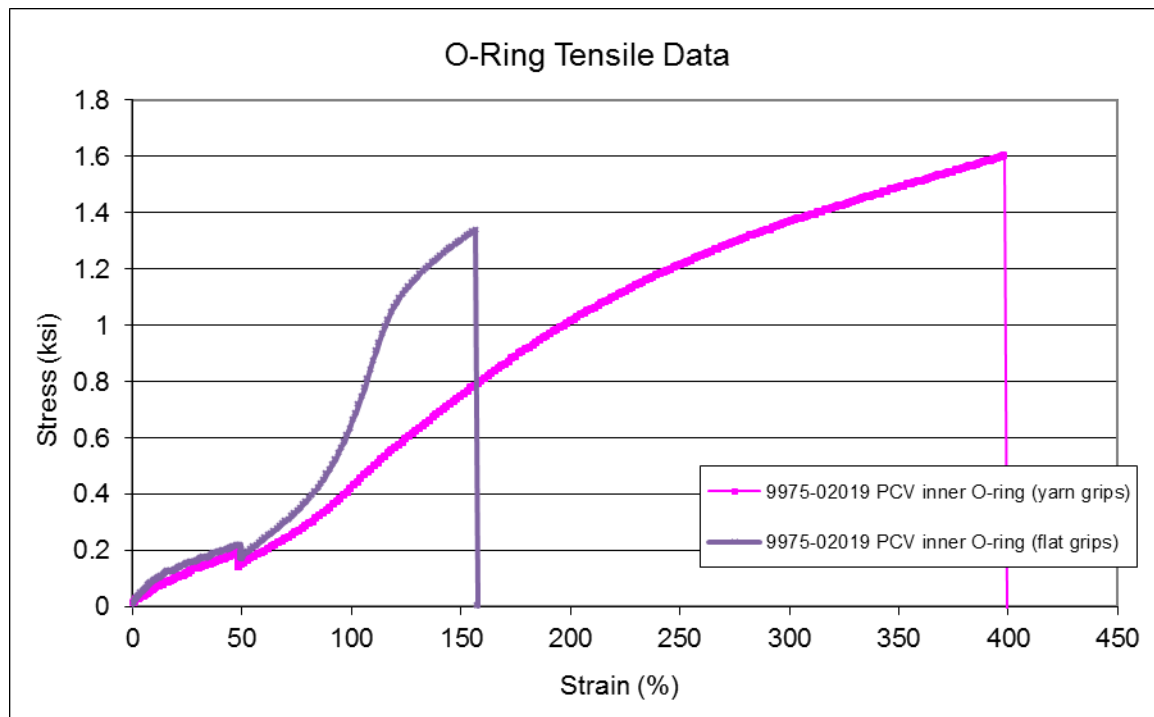
Figure 17. Tensile data for PCV inner O-ring from 9975-02019 comparing effect of yarn grips and flat grips.
