**Savannah River
National Laboratory™**

Analysis of an MCU HEPA Filter

January 2017

SRNL-STI-2016-00729, Revision 0

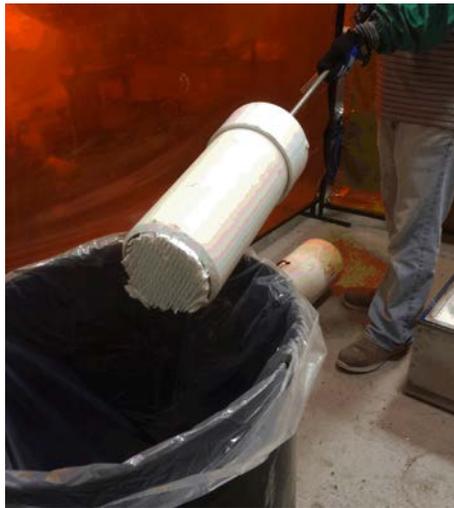
Figure 1. Coring Tool Used to Sample the HEPA Filter

SRR Maintenance personnel used a custom built tool (Figure 1) to core a 6" diameter center portion cylinder of the filter element (~12" long) and this sample was delivered to SRNL. SRR noted the direction of air flow on the filter sample and the shipping container.

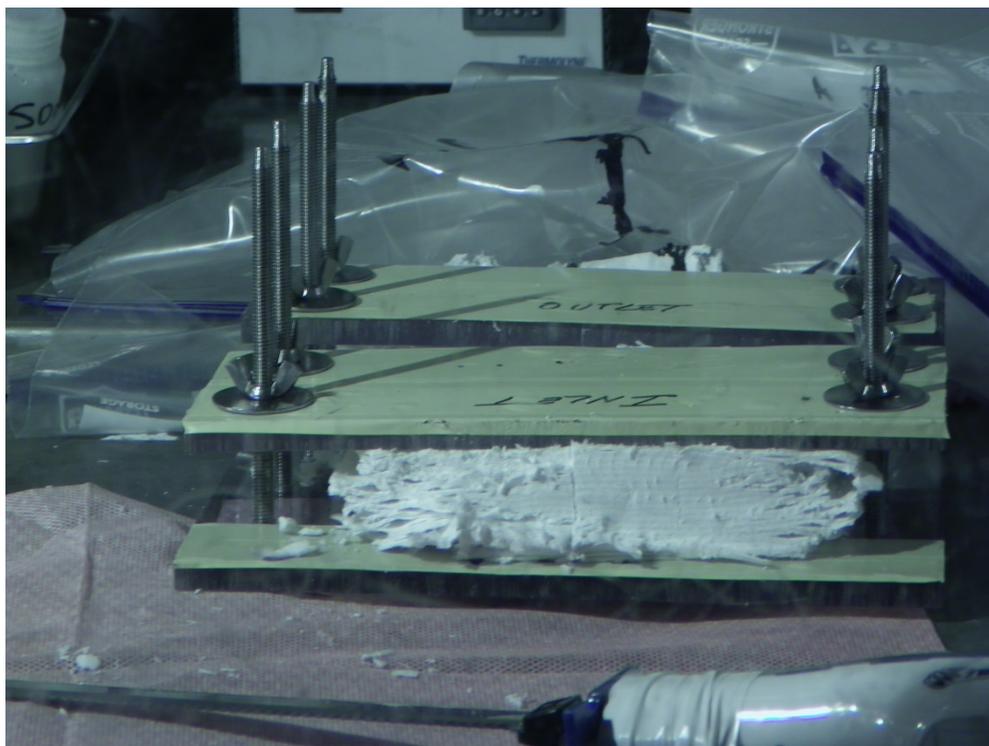
Figure 2. Cutting Frame for HEPA Filter

SRNL devised a tool by which sections could be cut from the HEPA sample. Using a Plexiglas frame, the filter media was compressed into a roughly flat sheet, with three sections exposed for cutting. See Figure 2.

The orientation of the filter was noted (Inlet, Center, and Outlet). Using a small reciprocating saw, the cells technicians were able to cut 1” wide sections from the Inlet, Center and Outlet sides. With the material under compression, the cuts were fairly clean, and easily made. The long, 1” wide sections were then cut in half, leaving six sets of samples, Inlet-A, Inlet-B, Center-A, Center-B, Outlet-A, and Outlet-B.

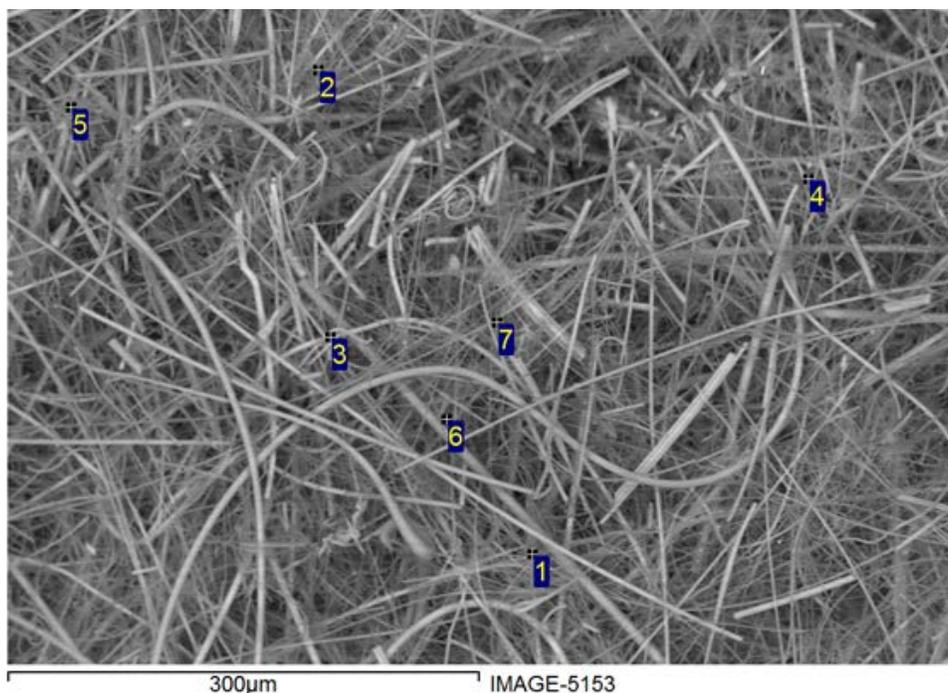
Figure 12. Example of CSEM Sample

In this example, the scale is approximately 100 µm per inch; the analyst located 7 spots of possible interest. Each post is then subjected to an electron beam which generates a spectrum of elemental signals. The spectrum is semi-quantitative and as such the areas of the peaks may, but do not necessarily correspond to analyte concentrations.

Figure 13 is an example spectrum of a clean, unused sample. This spectrum shows the expected silicon and oxygen (from the glass matrix) as well as zinc, barium and a few other peaks (the prevalence of the zinc and barium suggest some sort of coating as part of the substrate). Figure 14 is a spectrum from point #1 in Figure 12. While it shows the expected background peaks from the blank, it also shows a strong signal from iron, likely indicating some sort of particle of steel or rust from the system.

Other than the background signals and spots which we attribute to steel or rust, there is very little to be seen in any of the SEM results that would be expected of salt solution. Figure 14 is a representative sample. Any amount of salt solution (feed or decontaminated) should dry out in the fibers of the filter to leave inorganic deposits such as aluminates, aluminosilicates, or carbonates.
