Visual Inspection of Defense Waste Processing Facility Melter 2 Interior after End of Service

April 2018

SRNL-STI-2017-00428, Revision 0

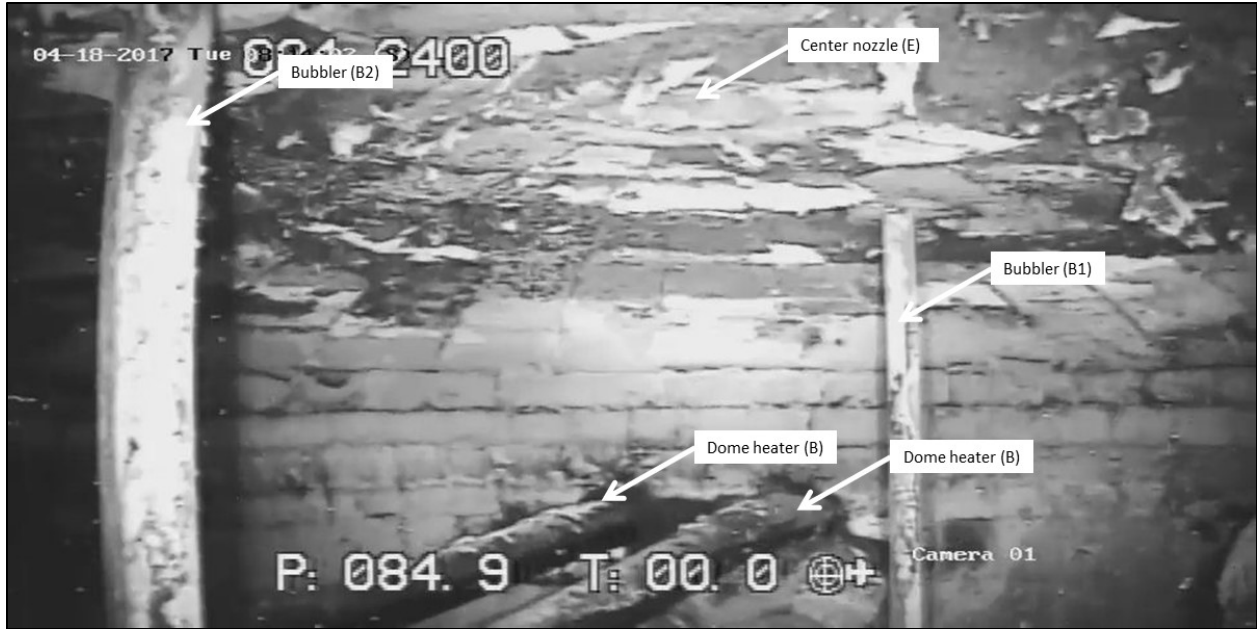
The visual inspection of the interior of DWPF Melter 2 started by inserting the camera system through the primary off-gas nozzle (Nozzle A). Overviews of the vapor space refractory and components are shown in Figure 5-1 and Figure 5-2. The melter feed tube was removed for reuse prior to cooling of the glass pool. The bubbler tubes and vapor space thermowell remained. The vapor space refractory appeared to be in good condition after nearly 14 years of melter operation. Deposition of material on the refractory surfaces was visible and significant, which precluded direct observation of most of the refractory. Some of this accumulated material appeared to have spalled off during cooling. Figure 5-3 shows an area of the Korundal XD refractory that appears to have been exposed after deposits spalled away from its surface. A closer view of this area, near to the C2 bubbler and level dip tube, is shown in Figure 5-4.

Figure 5-1. Overview of Melter 2 vapor space refractory and components

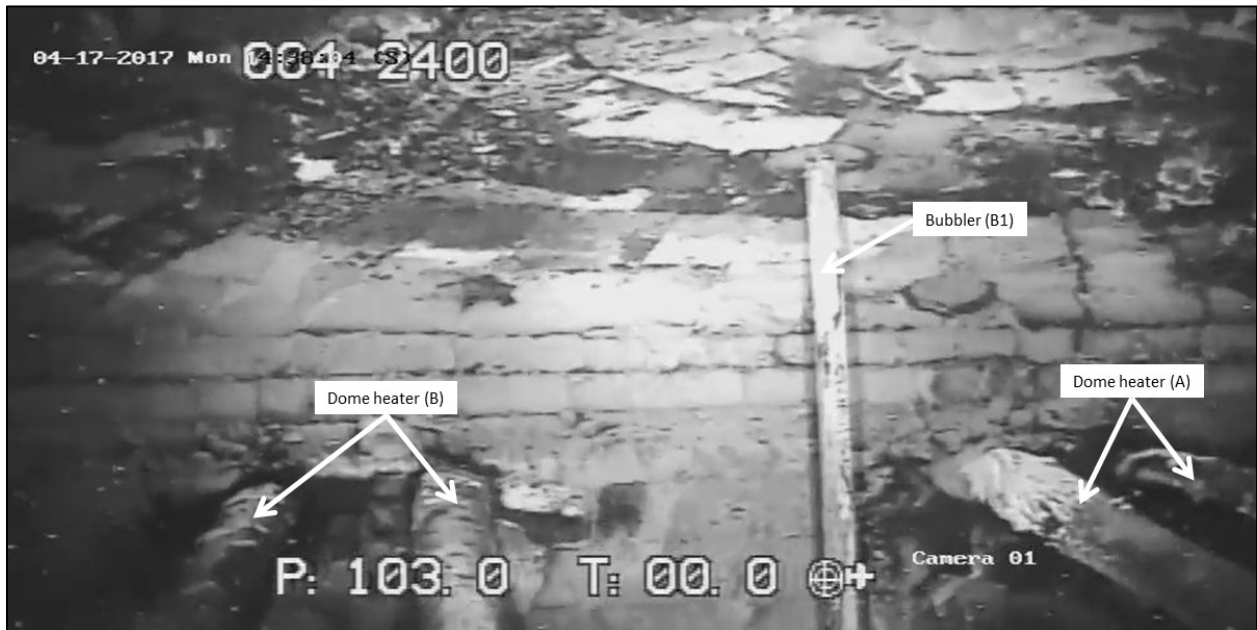
Figure 5-2. Melter 2 vapor space refractory and dome heaters

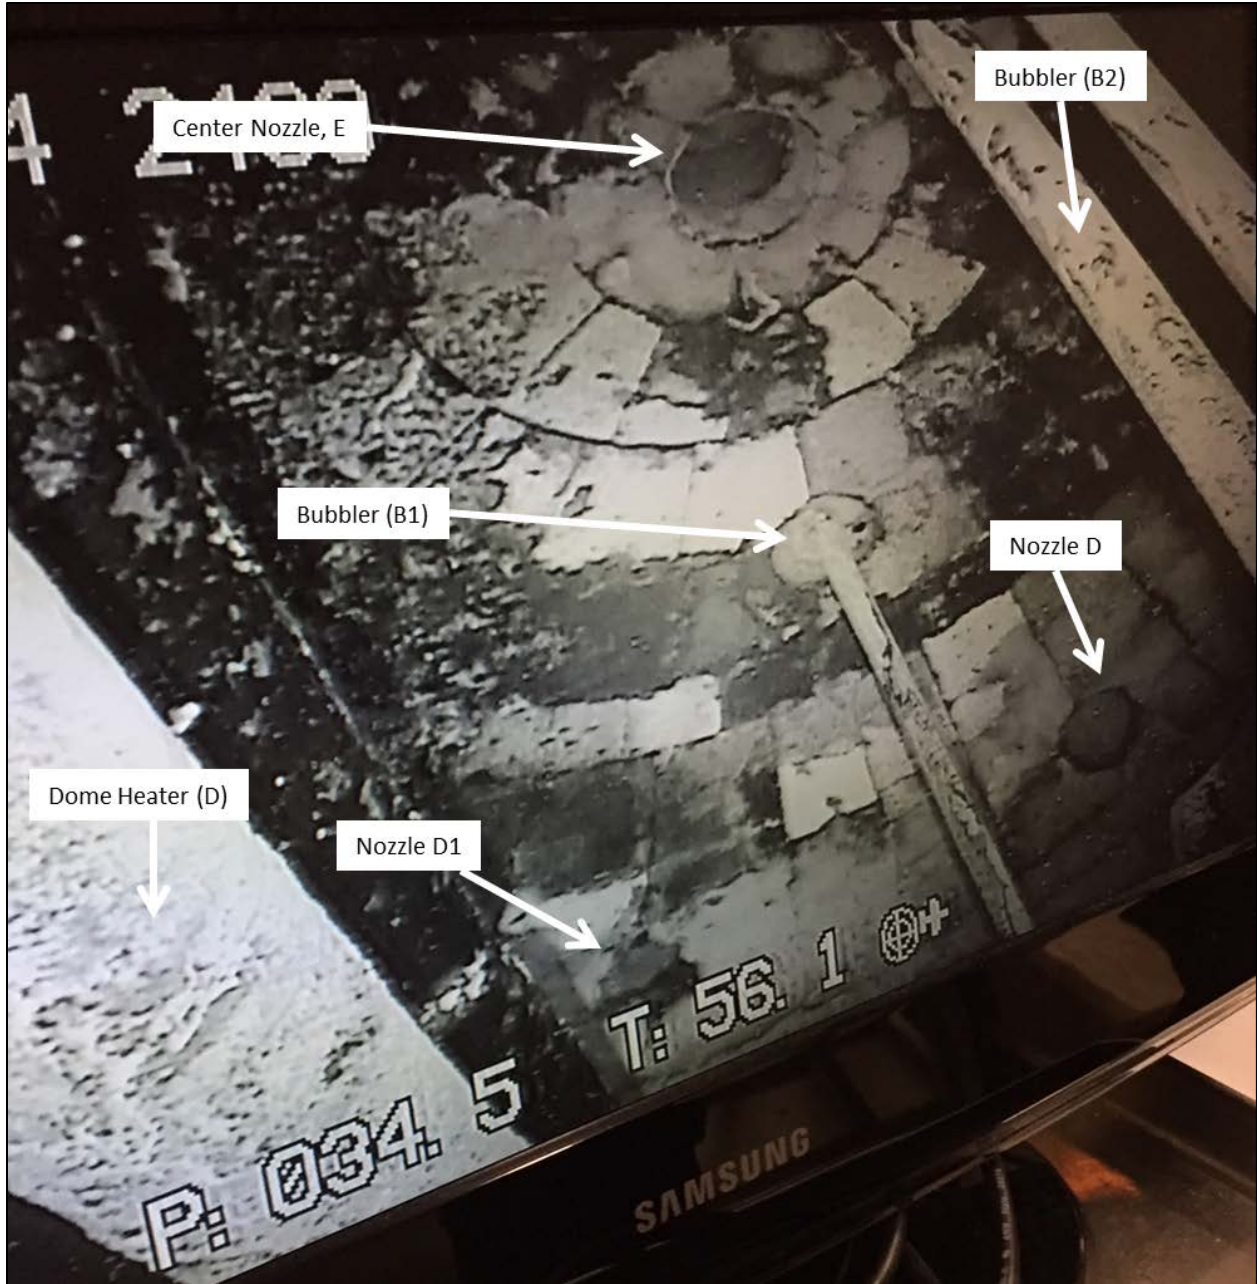
Figure 5-5 provides a view of the melter top head from below, captured by lowering the camera onto the solidified glass pool. Figure 5-6 provides a closer view of the vapor space refractory. The hole visible at the top, left of center in this image is a borescope nozzle (Nozzle D). In general, the vapor space refractory exhibited a level of wear expected after of 14 years of continuous operation. No missing pieces of refractory were observed. Joints between refractory blocks appeared to remain tight.

Figure 5-5. Underside of Melter 2 top head showing vapor space refractory and nozzle penetrations

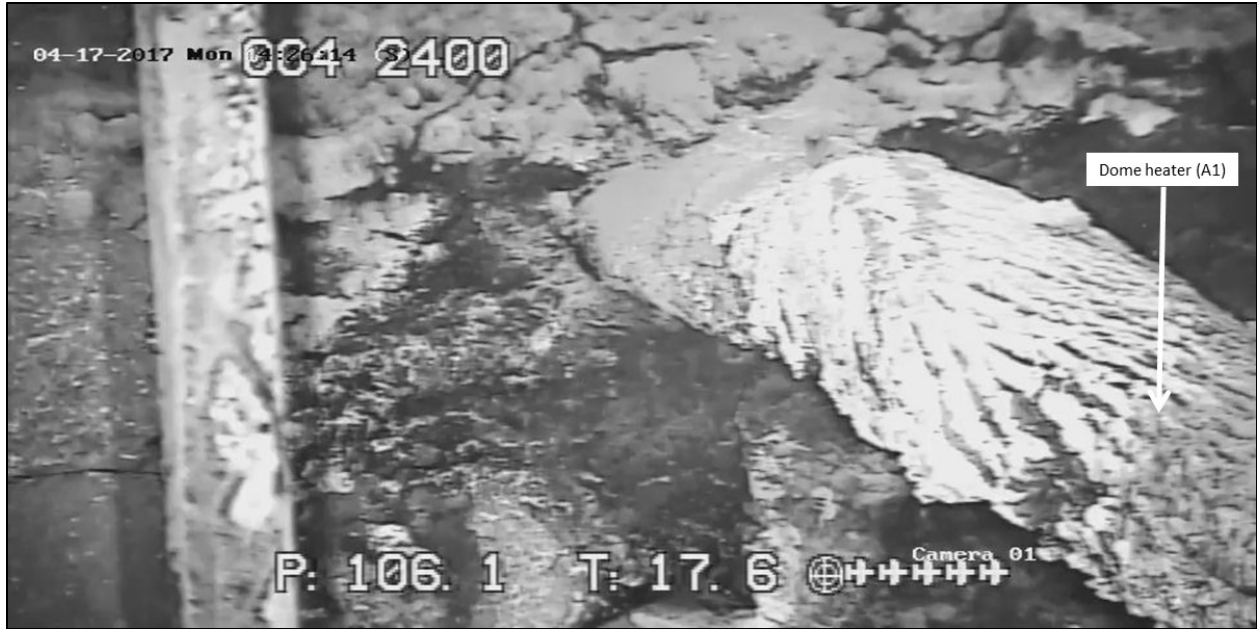
Figure 5-10 is an image of the dome heaters (A and C) on the east side of the melter and their penetration through the refractory on the northeast side. Deposits and degradation of the refractory are visible around the penetrations. A closer view of one of the dome heaters at this location is shown in Figure 5-11. The accumulated material on the top of the dome heater (A1) at this location is likely due to the air purge from the borescope nozzle (Nozzle D) above. An alternate view of this location (captured when the camera was inserted through the backup off-gas nozzle, Nozzle T) is shown in Figure 5-12. A closer view of the lower pair of dome heaters (A) is shown in Figure 5-13 at the northeast refractory wall penetration. Again, both degradation of the refractory and accumulation of material are visible at the dome heater penetrations. The inspection of Melter 1 after shutdown identified similar deposits, especially below the off gas film cooler nozzles.²

Deposition or accumulation of material may cause multiple issues for operation of the dome heaters. Deposits may serve as insulators causing a hot spot, which can result in distortion of the heater. Deposits can also reduce the amount of heat that is transferred into the vapor space.

Degradation of the refractory at the dome heater penetrations may allow chloride and sulfate salts to condense in areas where the surface temperature is reduced to the 500-600 °C range. This may leave these areas prone to rapid attack by breakaway corrosion or sulfidation. Closer inspections of these regions was not possible with the available camera. Overall, operation of the dome heaters does not appear to have been significantly hindered by the deposition and refractory degradation.

Figure 5-11. Dome heater penetrations, upper pair (A), northeast side of melter

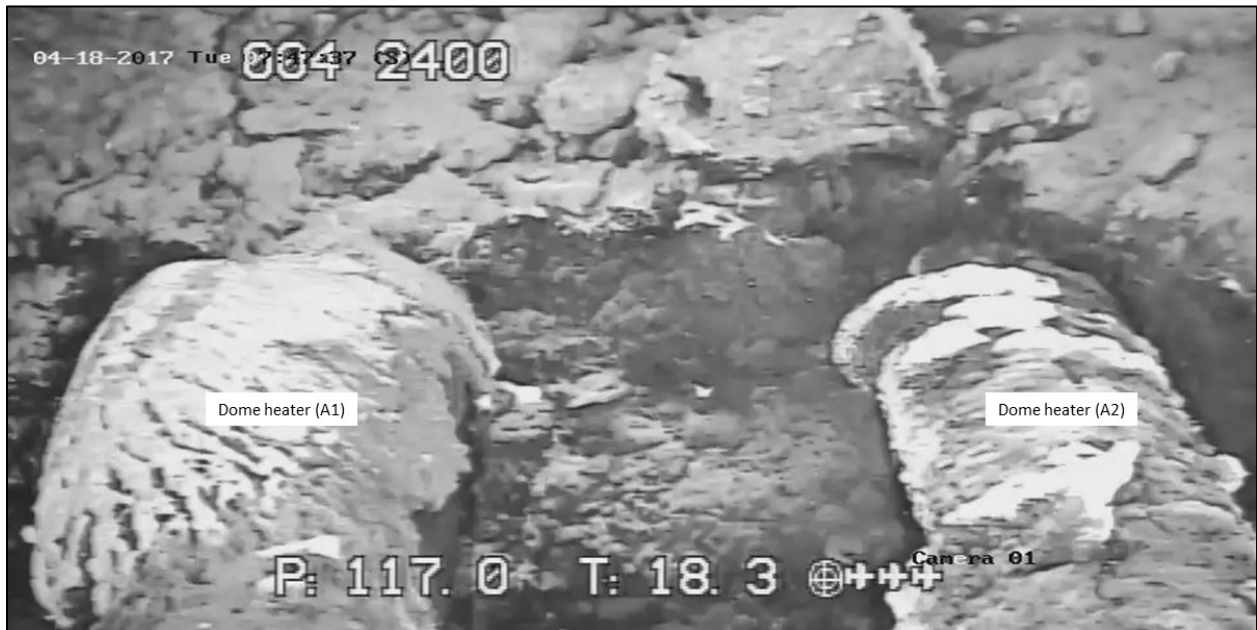
Figure 5-12. Dome heater penetrations, upper pair (A), northeast side of melter, alternate view

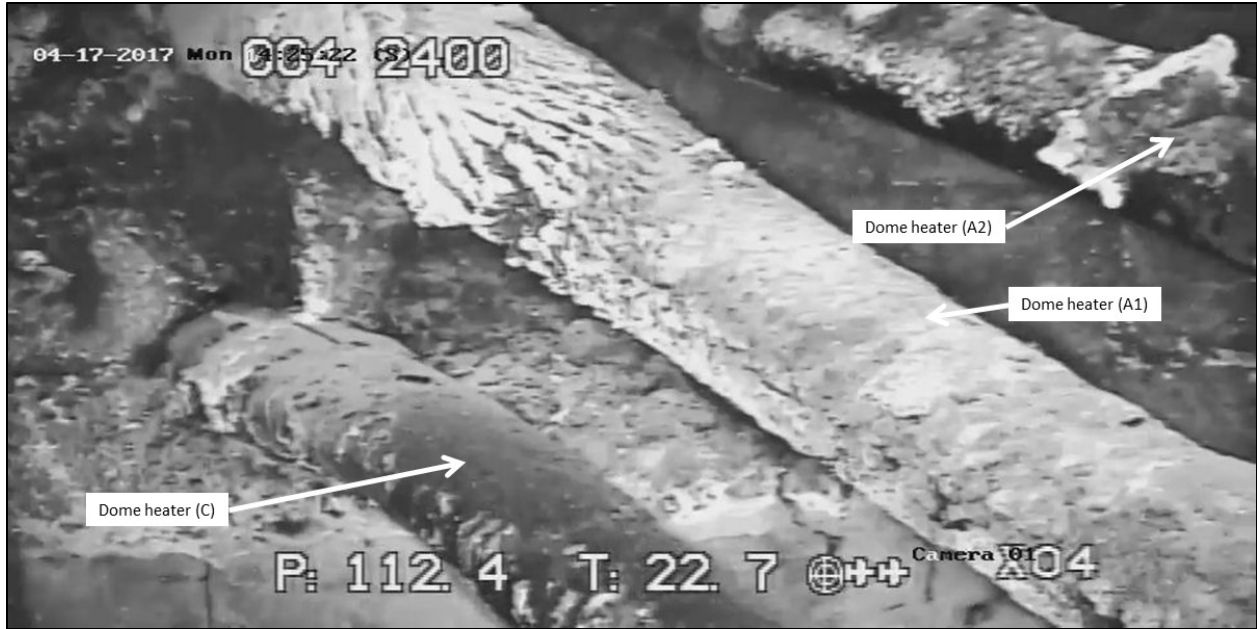
Figure 5-13. Dome heater penetrations, lower pair, northeast side of melter

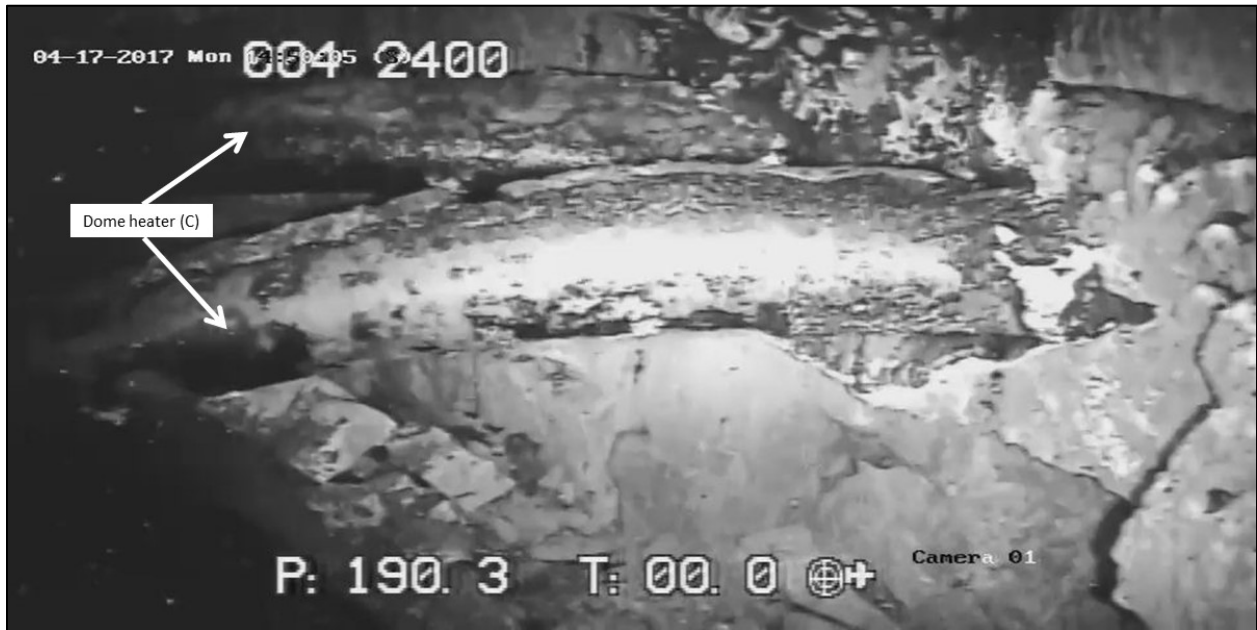
Figure 5-14 provides a view of deposits and degradation of the refractory around the dome heater penetrations at the southeast side of the melter. The additional deposition seen on the upper pair of dome heaters is likely due to quenching from the purge air entering through the backup off gas film cooler (Nozzle T) above this location. Material condensed in the film cooler may also spall off and accumulate in this area. A closer view of the penetration of the lower pair of dome heaters at this location is provided in Figure 5-15. An alternate view of the deposits on top of the dome heaters at this location is shown in Figure 5-16, where the camera was inserted through the backup off gas nozzle (Nozzle T).

Figure 5-15. Detail of dome heater penetrations, lower pair, southeast side of melter

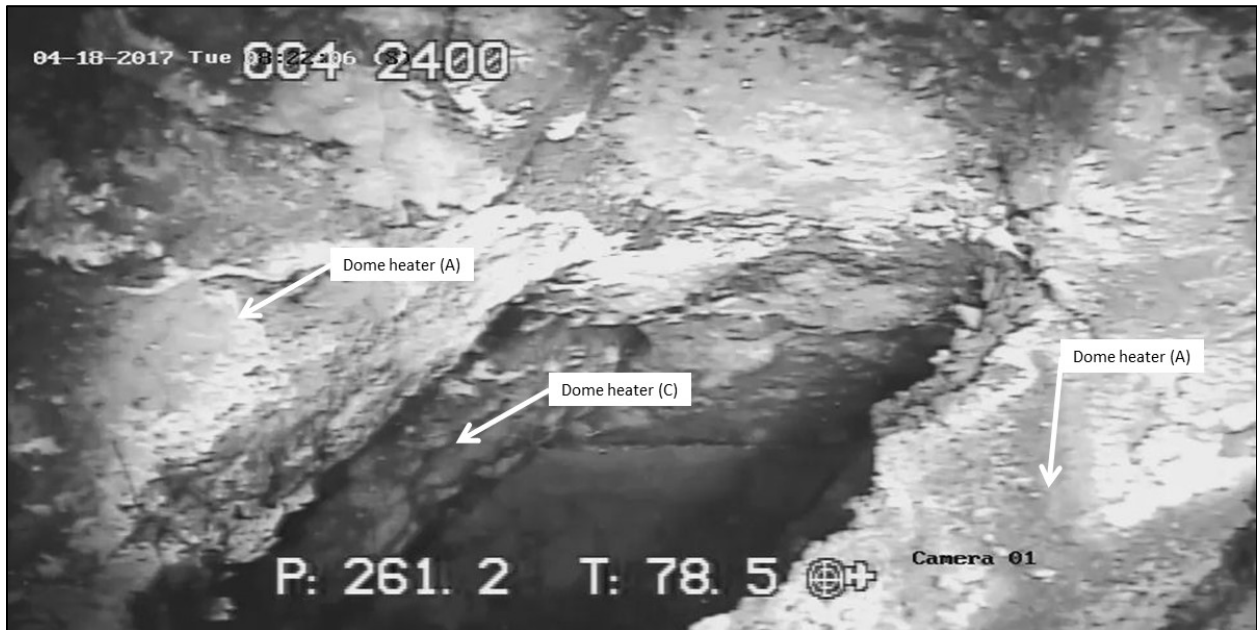
Figure 5-16. Dome heater penetrations, southeast side of melter, view from above

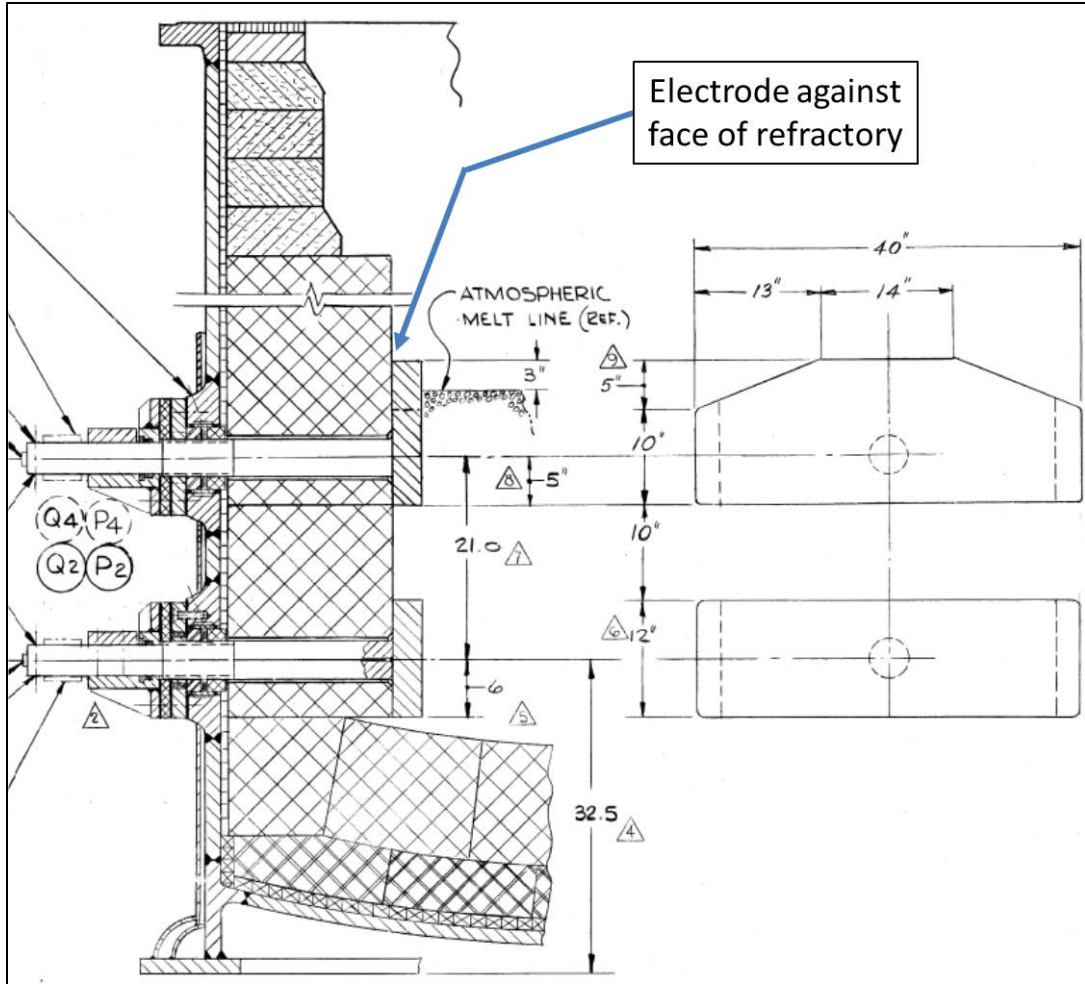
off of the refractory wall during cooling of the melter, as they would otherwise have been expected to fall into the melt pool. As shown in the drawing in Figure 5-24, the back of the electrode was originally up against the refractory wall. From Figure 5-22 and Figure 5-23, it appears that the refractory has worn or spalled away, leaving a gap between the electrode and the refractory wall that may be filled with glass. The width of the gap appears to be approximately equal to the thickness of the electrode (3 inches). The missing K-3 at this location is an un-retained “shelf” of K-3 formed as a result of producing the flat refractory surface for mounting of the electrodes (Figure 5-25). Similar significant material spalling or loss was not observed elsewhere around the circumference of the melter. Figure 5-26 shows the L1 electrode as viewed from above, via inserting the camera down through the backup off gas nozzle (T). The refractory pieces are again visible.

**Figure 5-24. Original electrode and glass contact refractory configuration
(adapted from drawing W728051)**

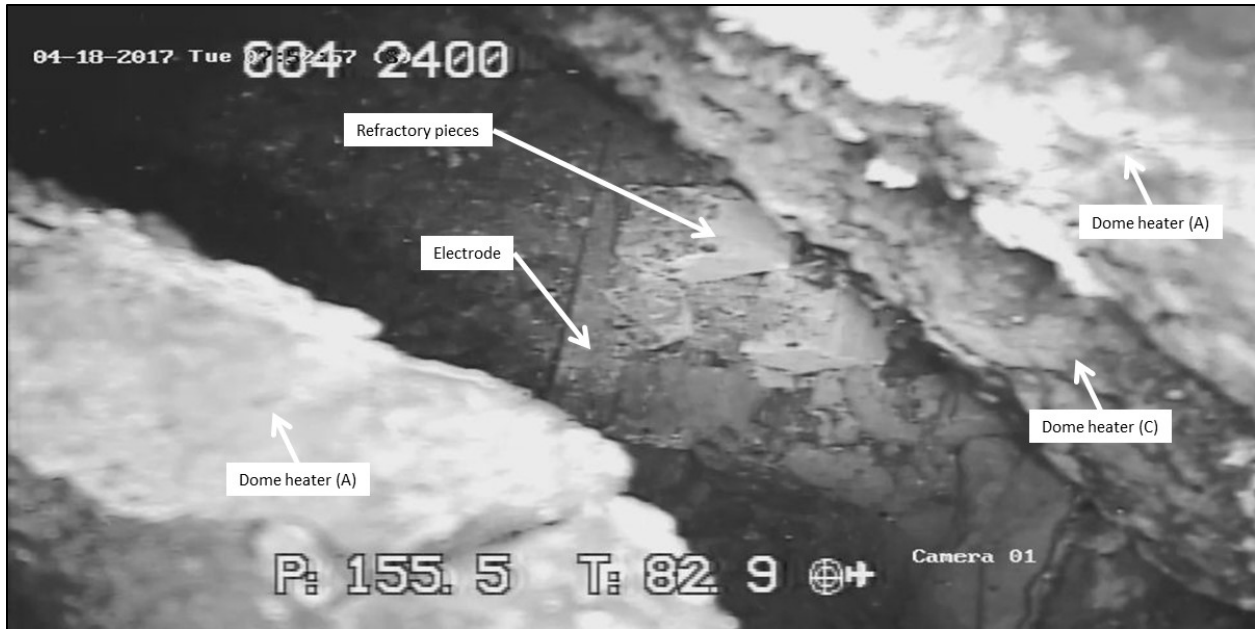
Figure 5-26. Upper electrode, southeast side of melter, viewed from above

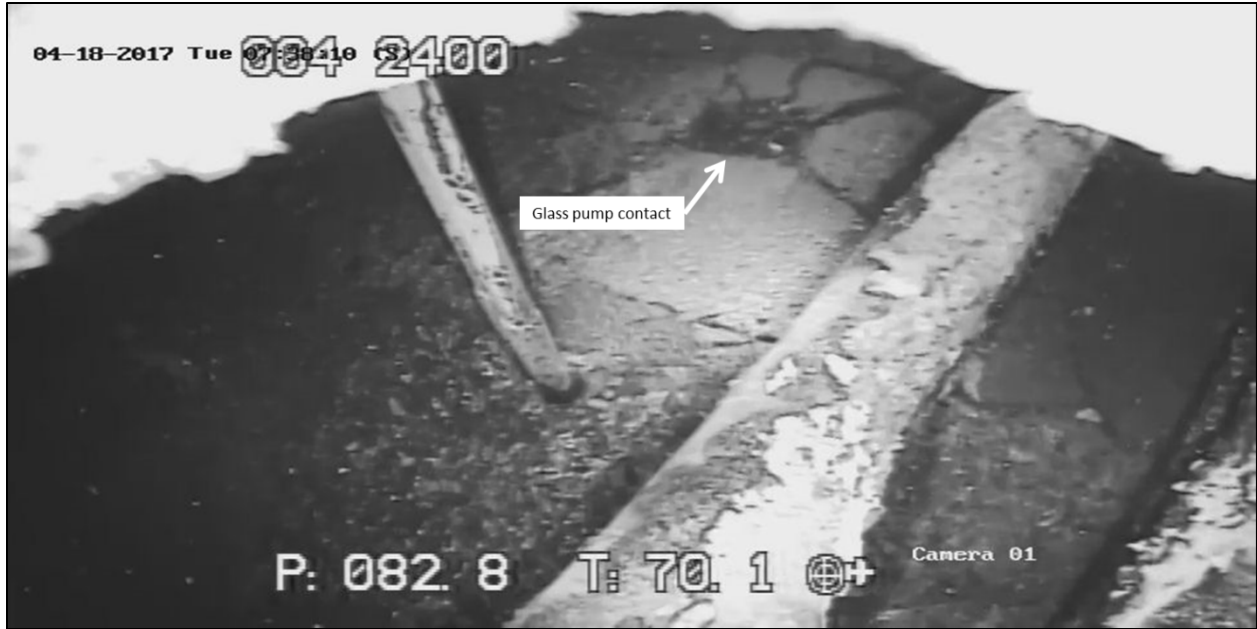
A previously used glass pump was retrieved with the crane and inserted through the center nozzle (Nozzle E) in an attempt to determine whether the mound was solid or whether it was the top of a large void (bubble), and to allow for further observations. Figure 5-38 and Figure 5-39 show the appearance of the mound after contacting it with the glass pump.

Figure 5-38. View of mound of material after contacting with glass pump through center nozzle

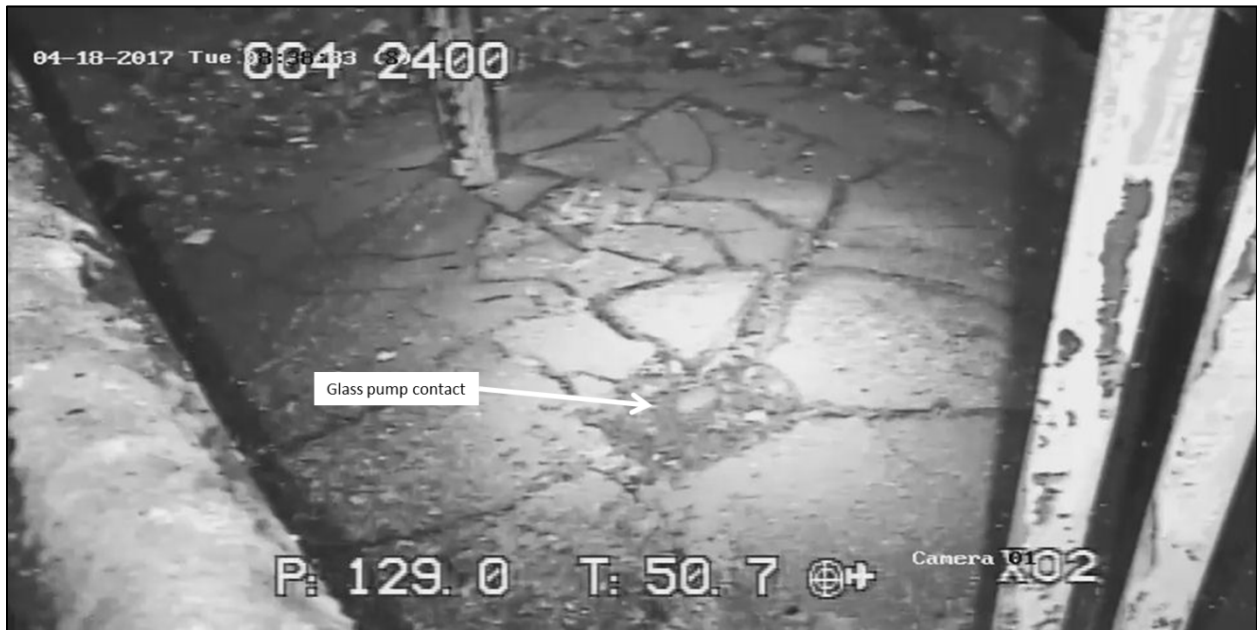
Figure 5-39. Alternate view of mound of material after contacting with glass pump

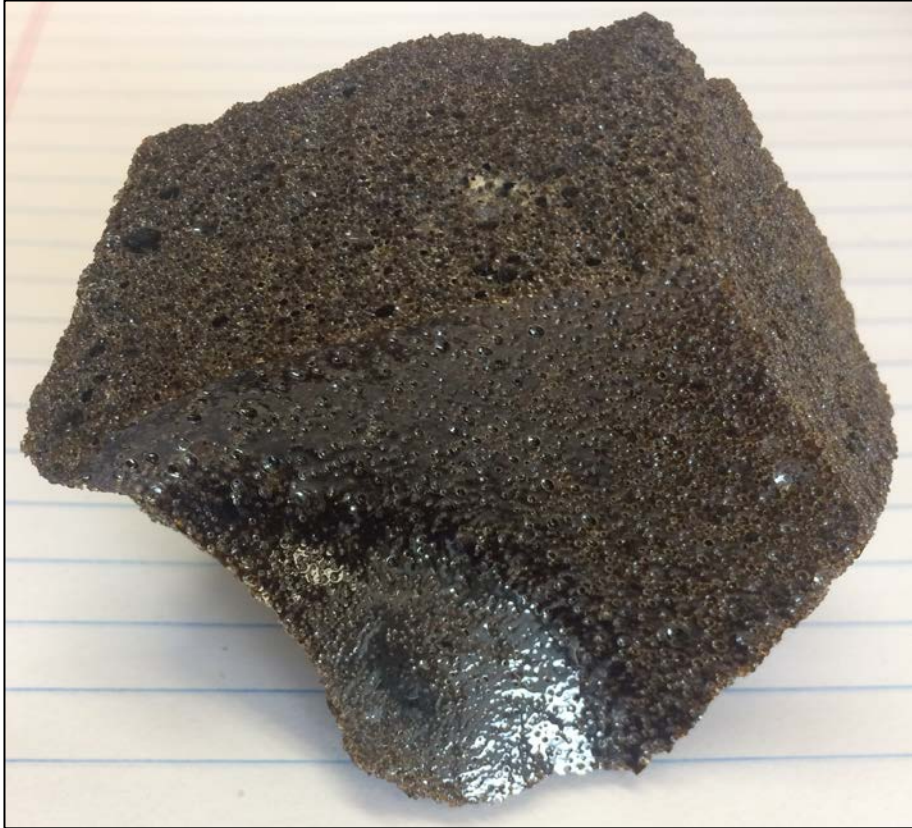
Images of the first sampler are shown in Figure 6-3 and Figure 6-4. All of the material collected appeared to be black, shiny, porous glass. Similar foamy glass was generated in the past during stirred melter testing via rapid gas evolution in the glass pool, an example of which is shown in Figure 6-5.

Figure 6-5. Example of foamy glass generated via rapid gas evolution in the glass pool during stirred melter testing
