# Evaluating All-Metal Valves for Use in a Tritium Environment

September 2017

SRNL-STI-2017-00516, Revision 0

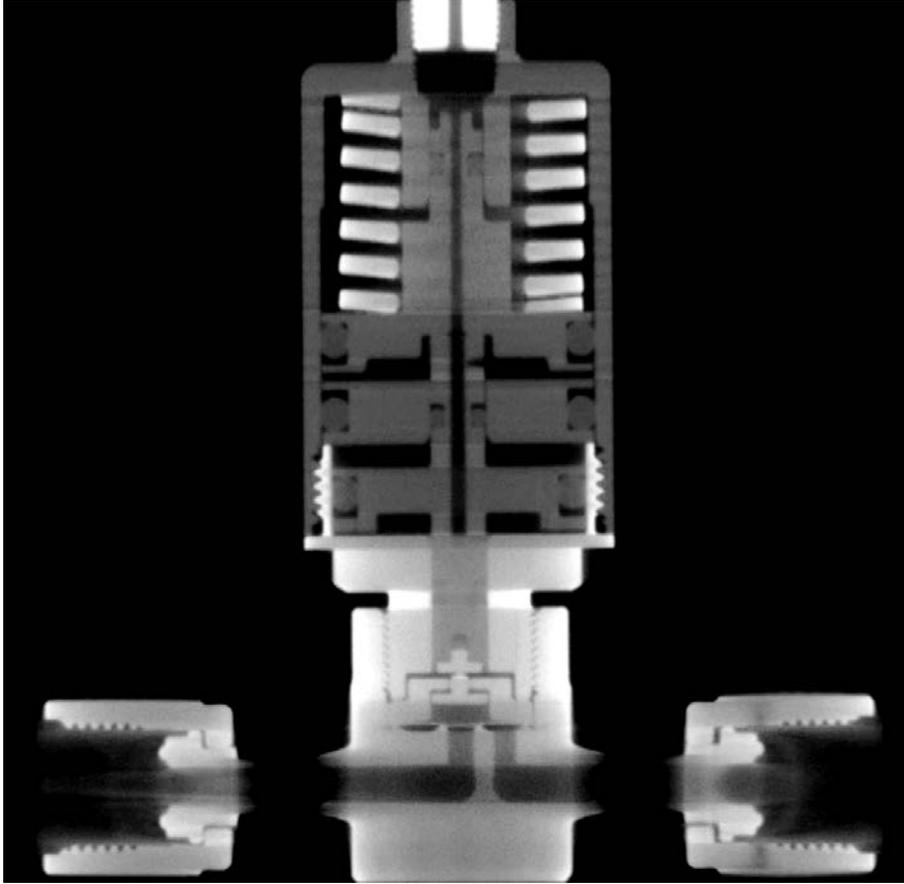
**Figure 2-4. Digital Radiographed Valve**

Valve structure was imaged optically, with X-rays (Figure 2-4), and with a Scanning Electron Microscope (SEM).

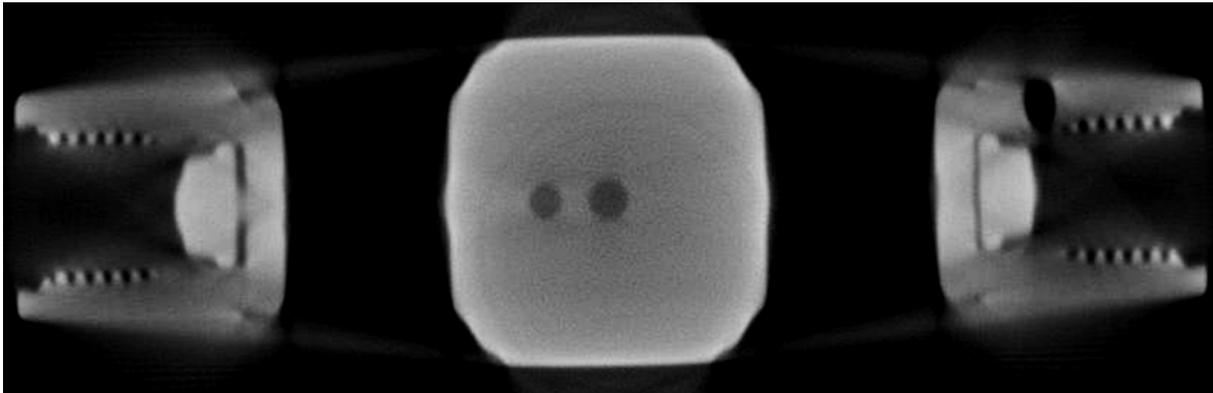
**Figure 3-4. Digital Radiograph Top-Down Image Showing Asymmetric Valve**

Figure 3-4, is another Ham-Let valve radiograph. The valve inlet is in the center of the of the valve body, the outlet is offset.

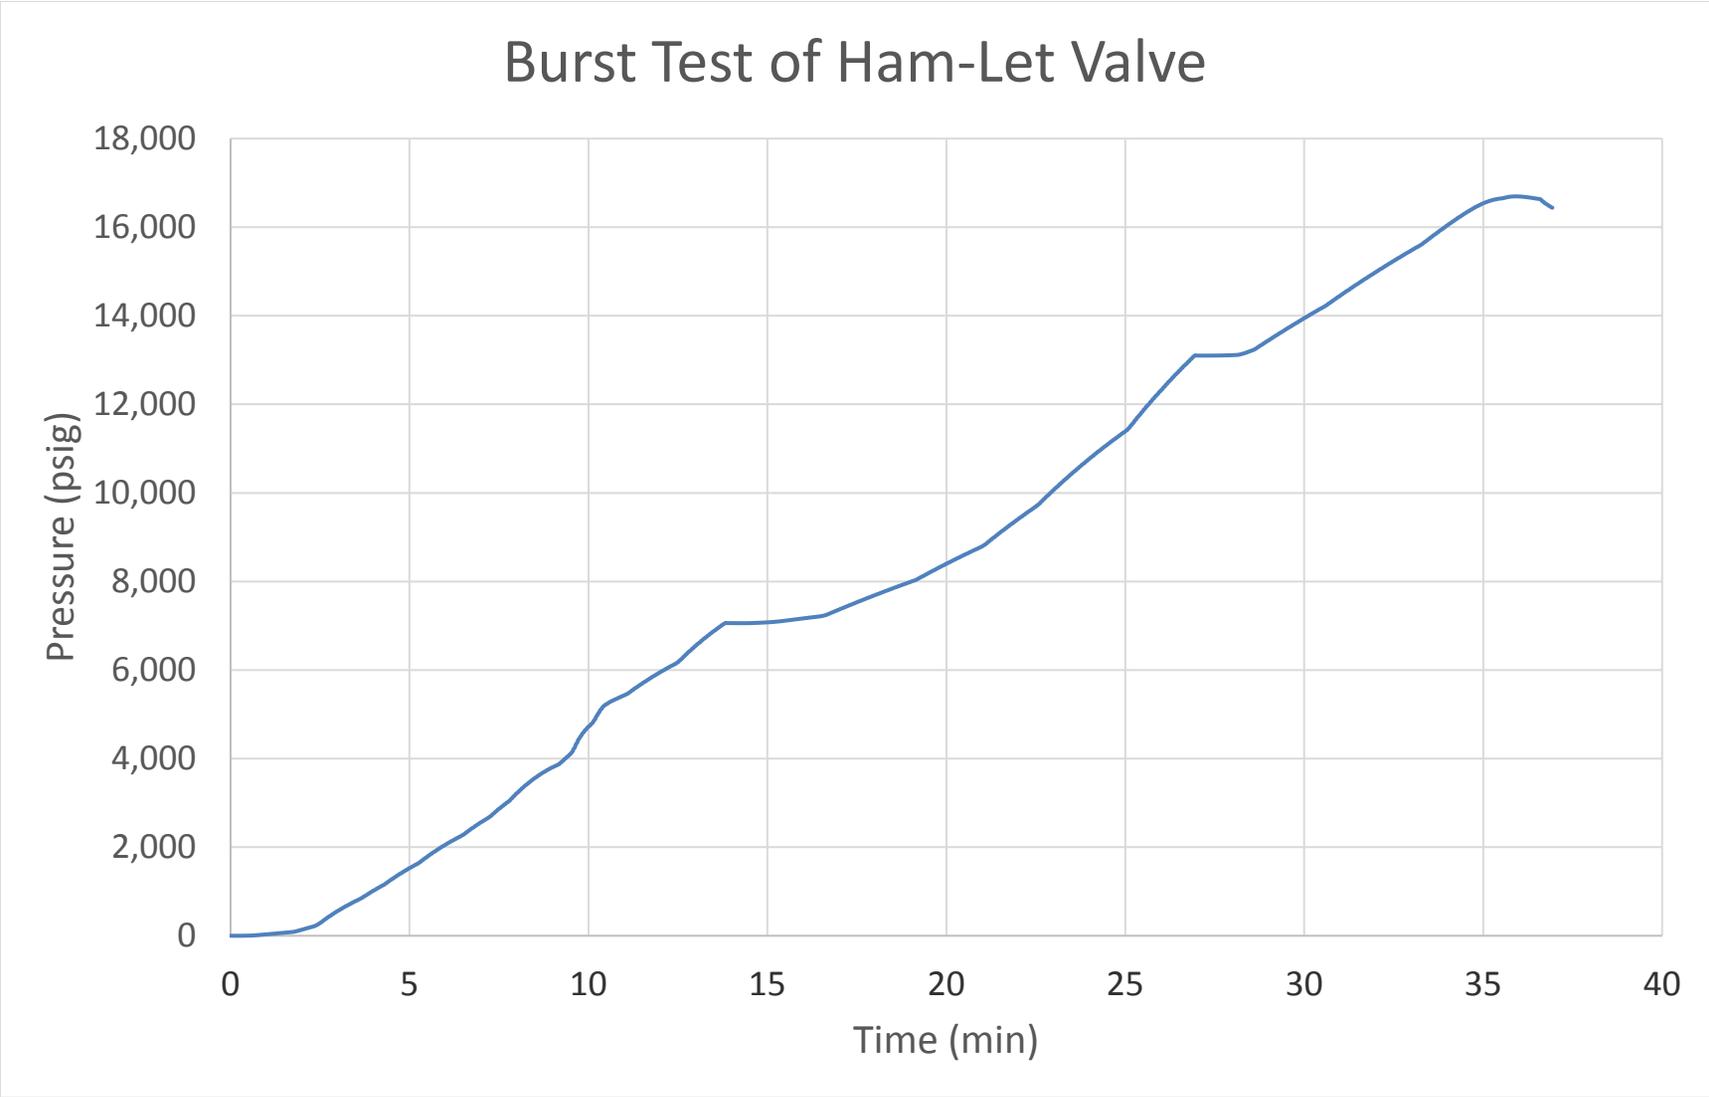
**Figure 3-5. Graph of Burst Test of Ham-Let Valve**

Valve V04 was selected for burst testing. Both the inlet and the outlet sides of the valve were pressurized with nitrogen until the valve failed near 16,695 psig. The test is depicted graphically in Figure 3-5.

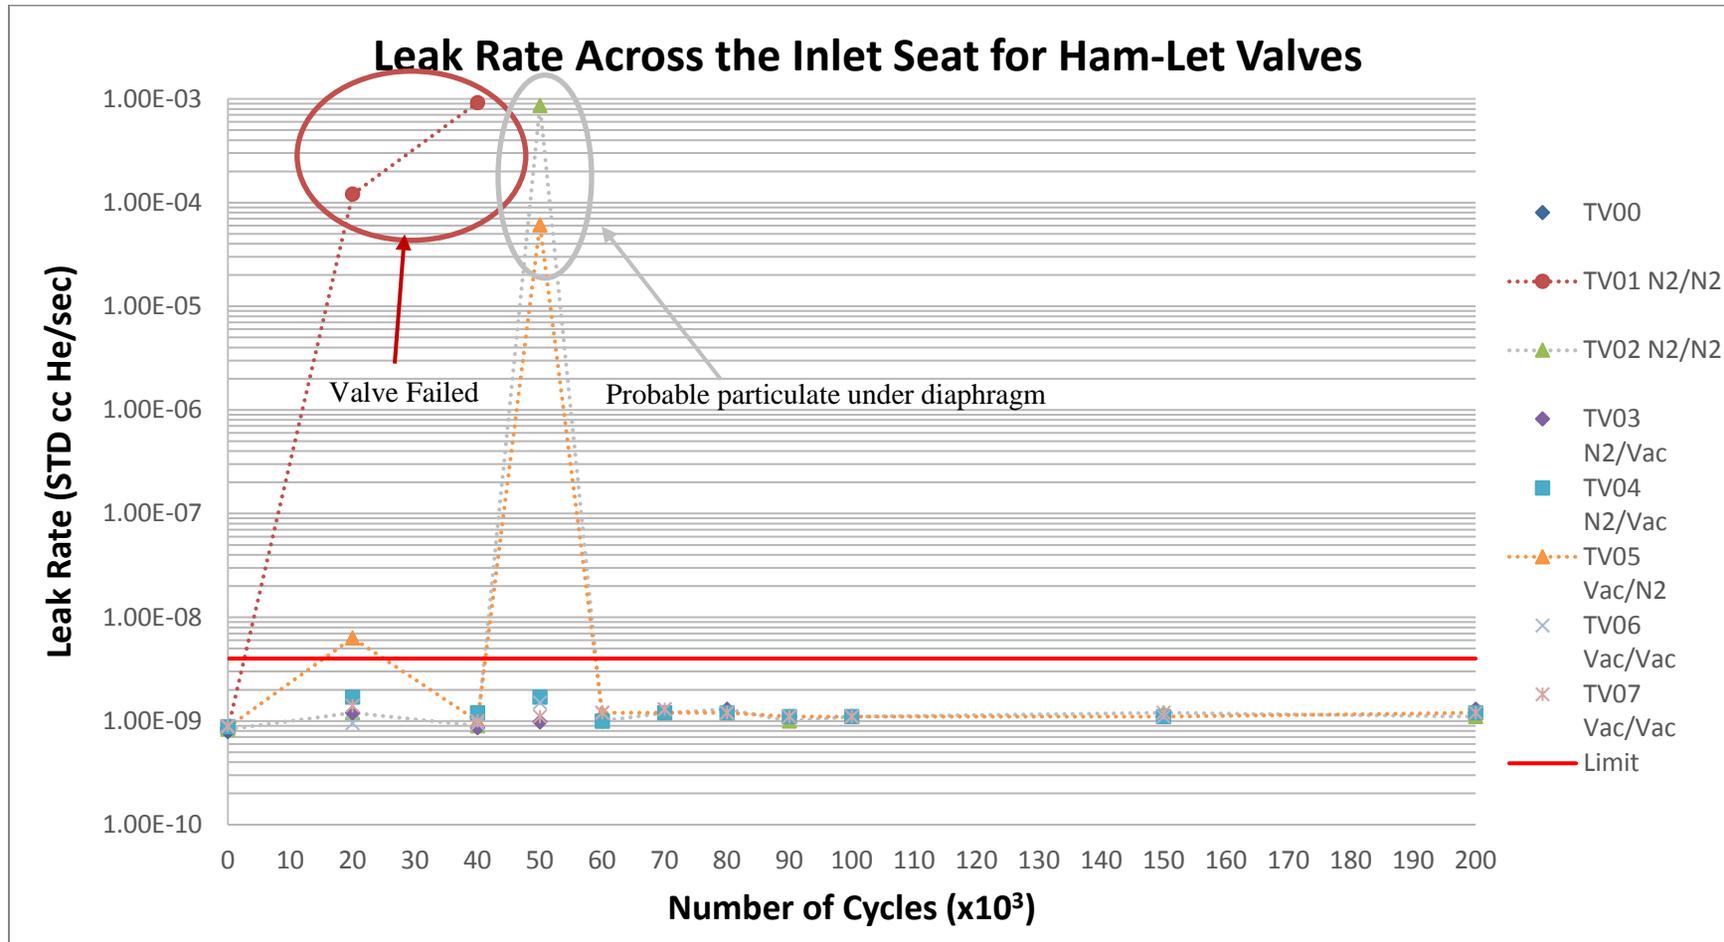
Figure 3-10. Graph of Leak Rates across the Inlet Seat of Ham-Let Valves

Leak rate test results are given in Table 3-3, valves that did not meet the required leak rate are highlighted in red. During testing, the LabVIEW program malfunctioned and data for 10,000 cycles and 30,000 cycles were not retrievable. TV01 passed the initial inlet seat leak test, 0 cycles, but failed at 20,000 cycles, Figure 3-10. After 50,000 cycles, two additional valves, TV02 and TV05, failed the inlet seat leak test. All of the failed valves were tested with nitrogen pressure on the outlet side. It is unknown whether this contributed to the valve failure. After TV02 and TV05 failed, Swagelok 0.003  $\mu\text{m}$  filters, part number SS-SCF3-VR4-P-30, were installed in the nitrogen inlet line and at the outlet of isolation valves IV15 and IV18 and testing continued. TV01 testing continued without improvement. Both TV02 and TV05 passed leak testing after 60,000 cycles, suggesting the earlier leaks were a result of particulate contamination. It is unknown whether failure of TV01 was due to particulate contamination or valve failure.

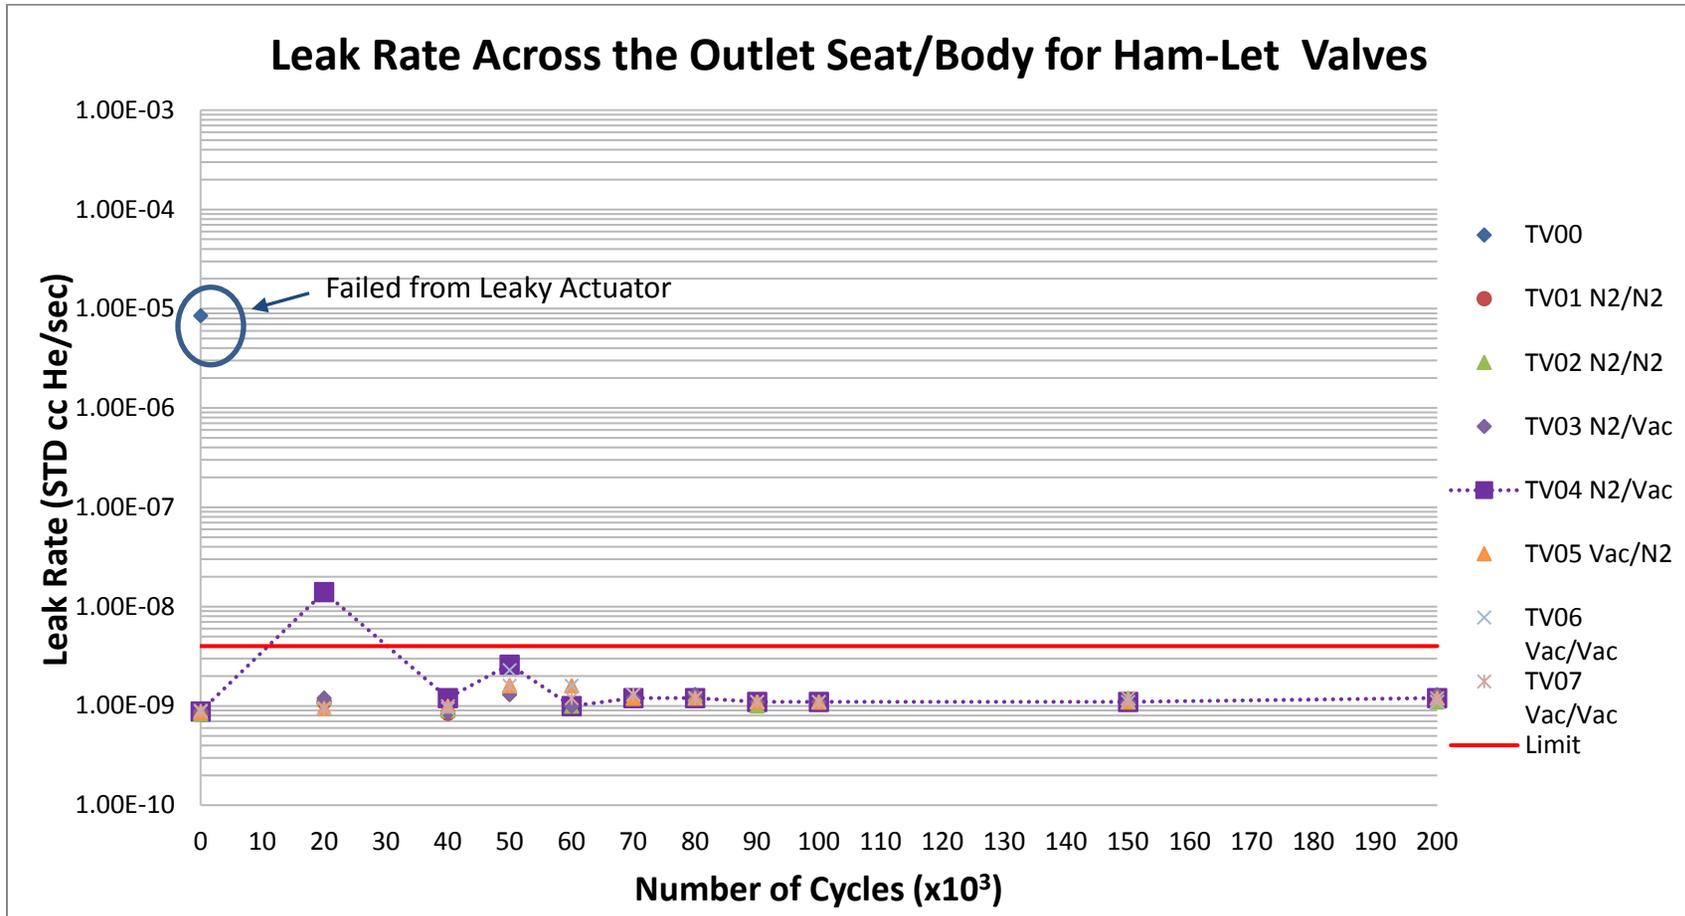
Figure 3-11. Graph of Leak Rates across the Outlet Seat or Body of Ham-Let Valve

One valve that was planned on being cycled failed the initial body test, TV00, this valve was never cycled as it was determined to have a leak in the actuator. Only one other valve had a leak from the body leak test, TV04 at 20,000 cycles, this was because this normally closed valve would not stay open for the duration on the test. The valve was still functioning and could be cycled, but it could not be body leak tested. Because of this, the High Pressure Lab determined that it would be best to only conduct outlet seat leak tests. For further cycling, all of the test valves have passed the outlet seat leak tests up to 200,000 cycles.

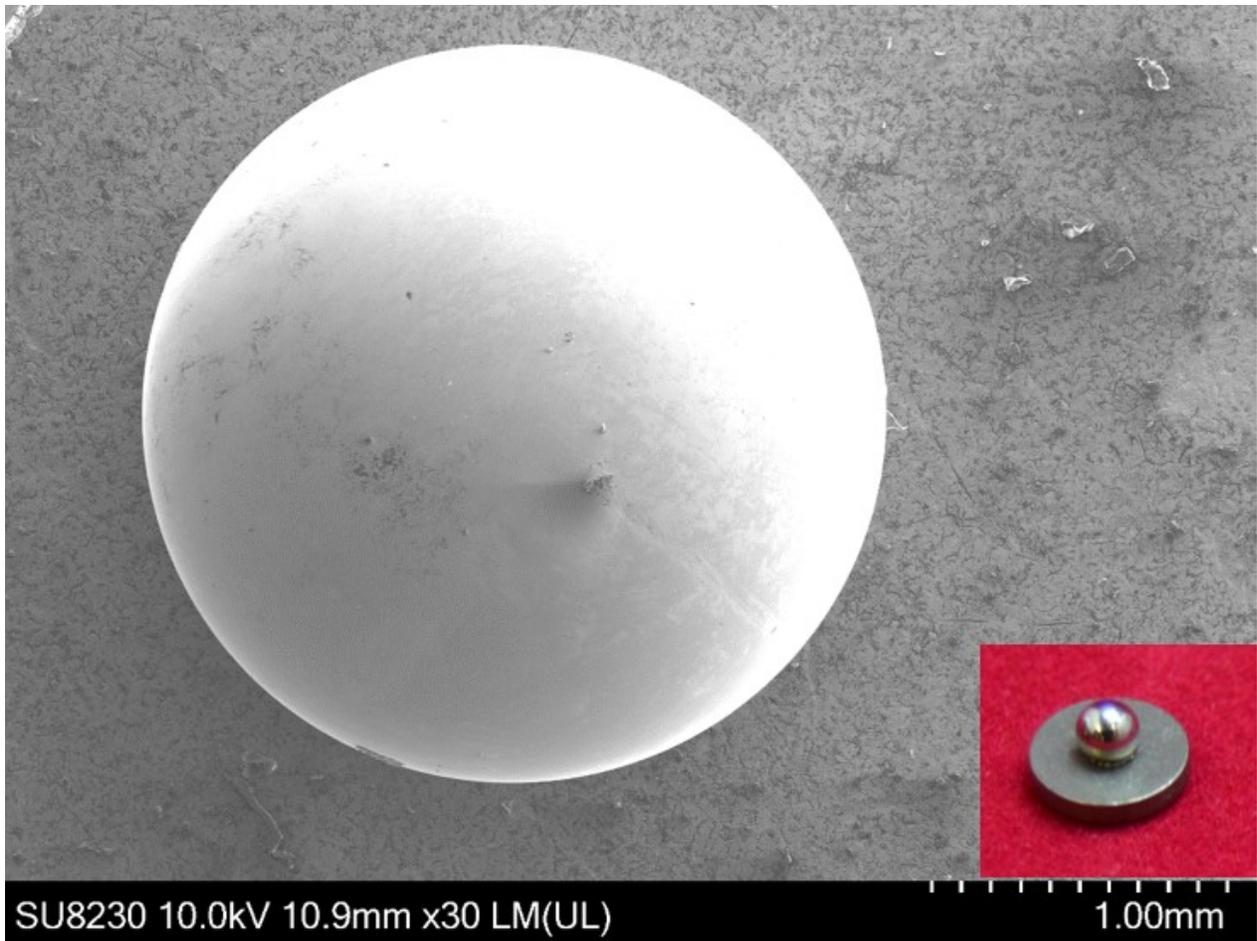
Figure 3-16. SEM image of Top Actuator Button Set with photograph inset

Each sample was then analyzed separately in the SEM. The Top Actuator Button Set (on the left in Figure 3-15) was easy to image and it did not have any evidence of off-gassing. The surface of the Top Actuator Set appears metallic from imaging, Figure 3-16. The surface is easy to image and features are distinguishable. By using Energy-dispersive X-ray spectroscopy (EDS), a chemical fingerprint was obtained, Figure 3-17. This chemical footprint shows large amount iron and chromium.

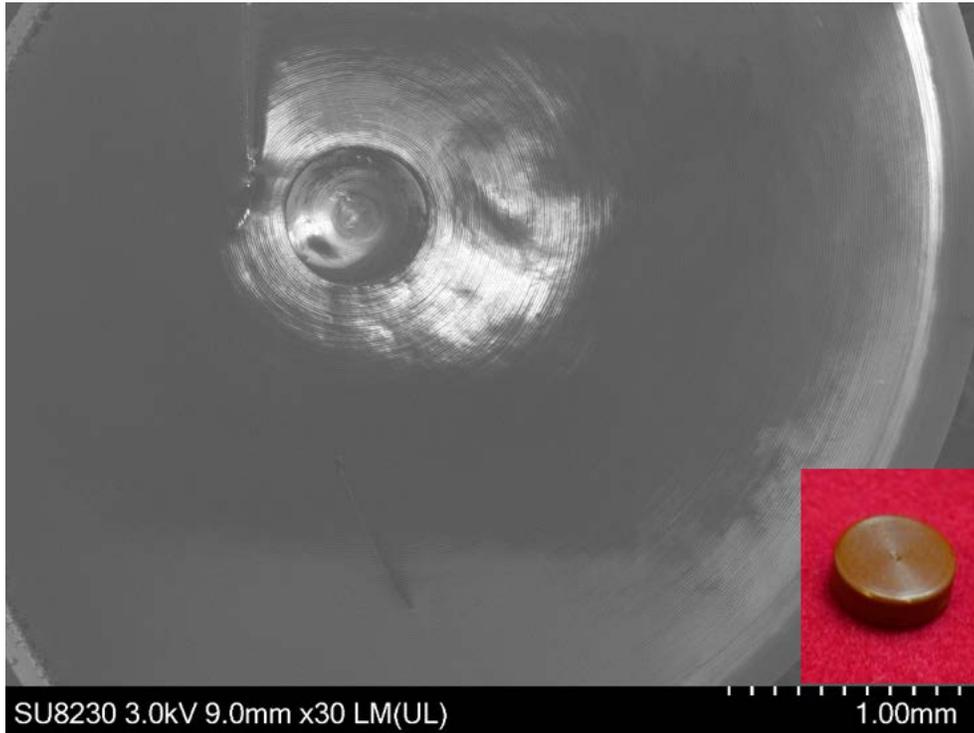
Figure 3-18. SEM image of Bottom Actuator Button Set with photograph inset

The Bottom Actuator Button Set was then analyzed in the SEM, Figure 3-18. Elemental analysis performed with EDS, Figure 3-19, detected only carbon and oxygen.

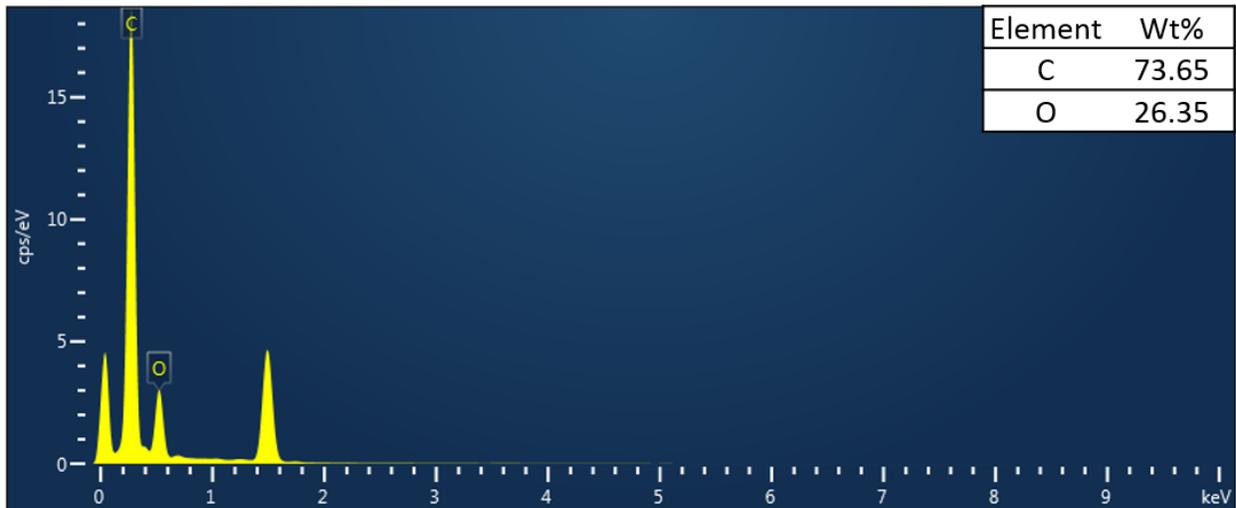
Figure 3-19. EDS Spectra of Bottom Actuator Button Set with Table of elemental compositions

From the SEM with EDS and ATR-FTIR, the Actuator Button Set is comprised of two materials, contradicting the specifications in the Ham-Let catalog. The top button is a metal, suspected to be 304L Stainless Steel, and the bottom button is a polymer, belonging to the polyimide family.

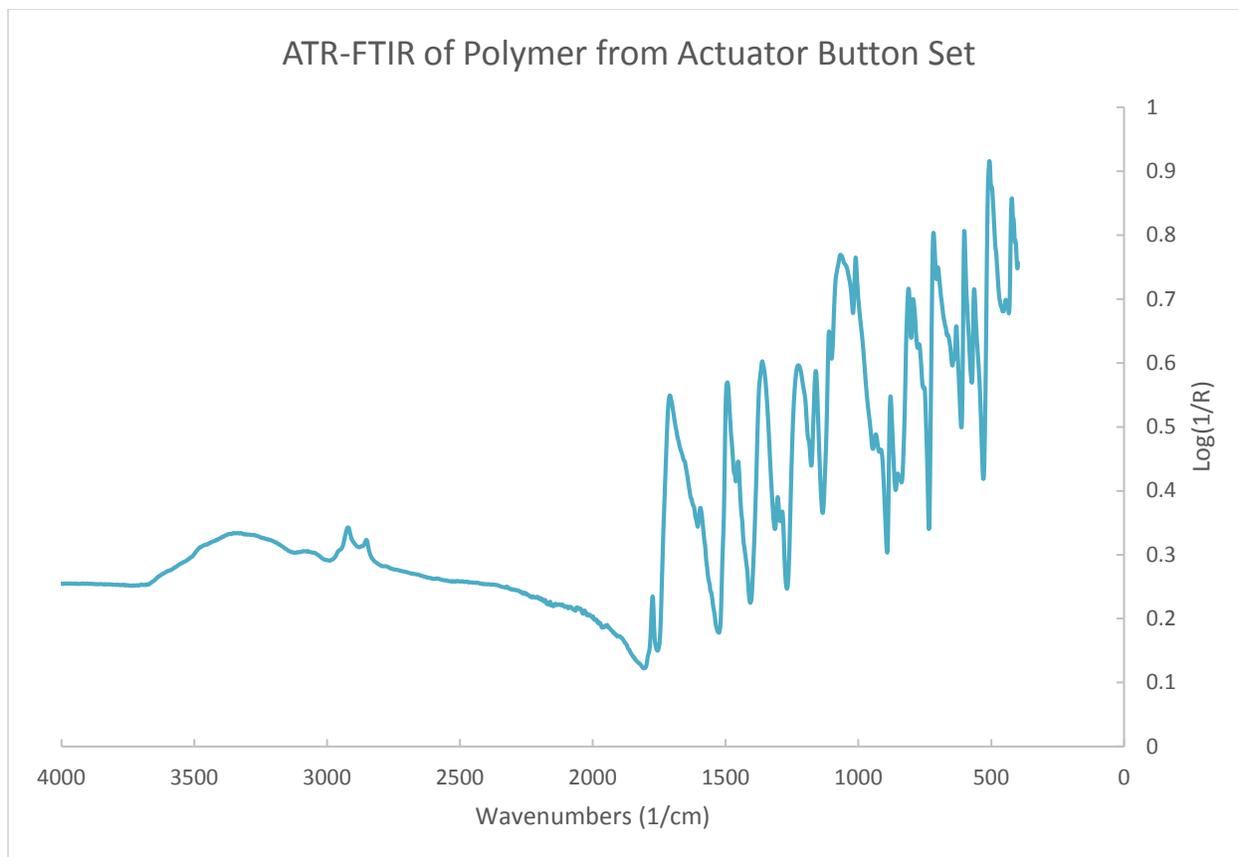
**Figure 3-20. ATR-FTIR spectra of Bottom Actuator Button Set**

The bottom actuator button set was then analyzed with an ATR-FTIR. The resulting spectra (Figure 3-20) was matched with that of a known polymer in a chemical database.

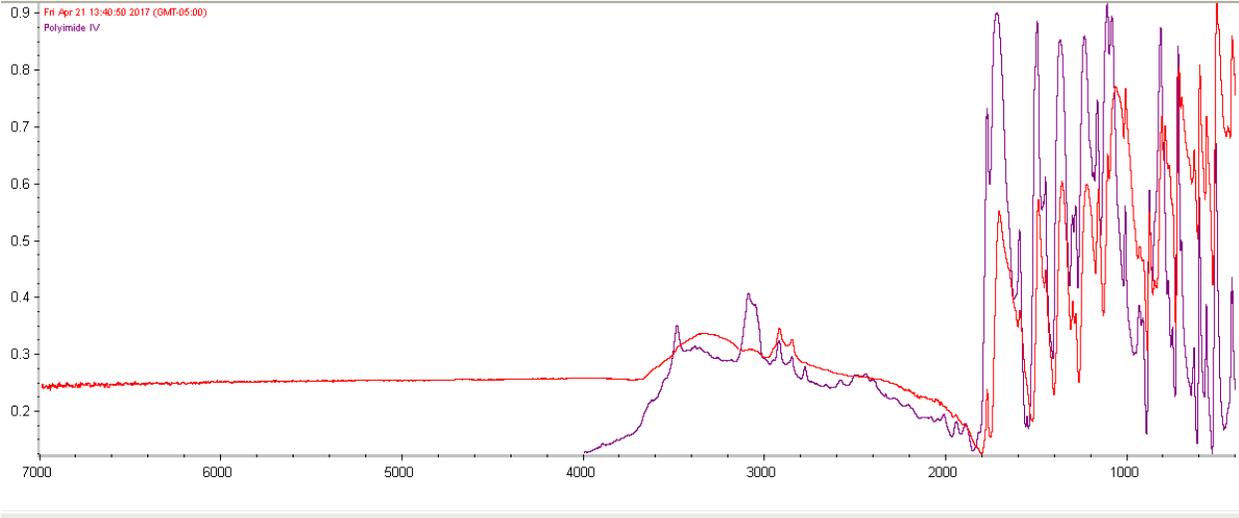
**Figure 3-21. Comparison of Bottom Actuator Button Set (red) to Polyimide IV (purple)**

Comparisons of the spectra obtained from the Bottom Actuator Button Set to Polyimide IV is given in Table 3-4 and Figure 3-21.

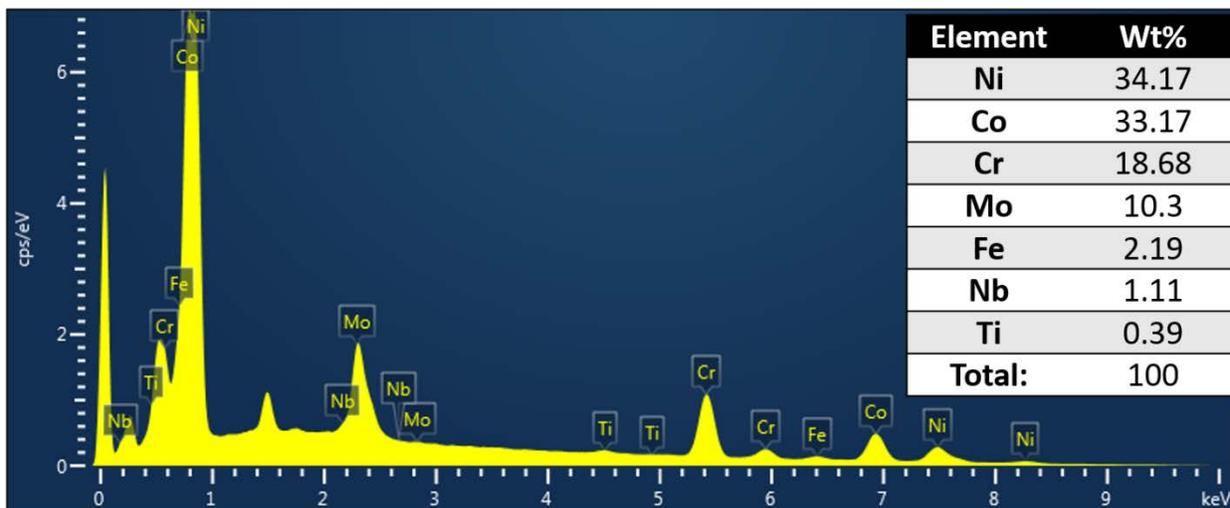
**Figure 3-23. EDS Spectra of Diaphragm 1 with inset of atomic weight percent for this location**

The EDS spectra reveal that two different cobalt-chromium-nickel alloys were used. The wetted diaphragm was SPRON510 and the non-wetted diaphragms were Elgiloy.

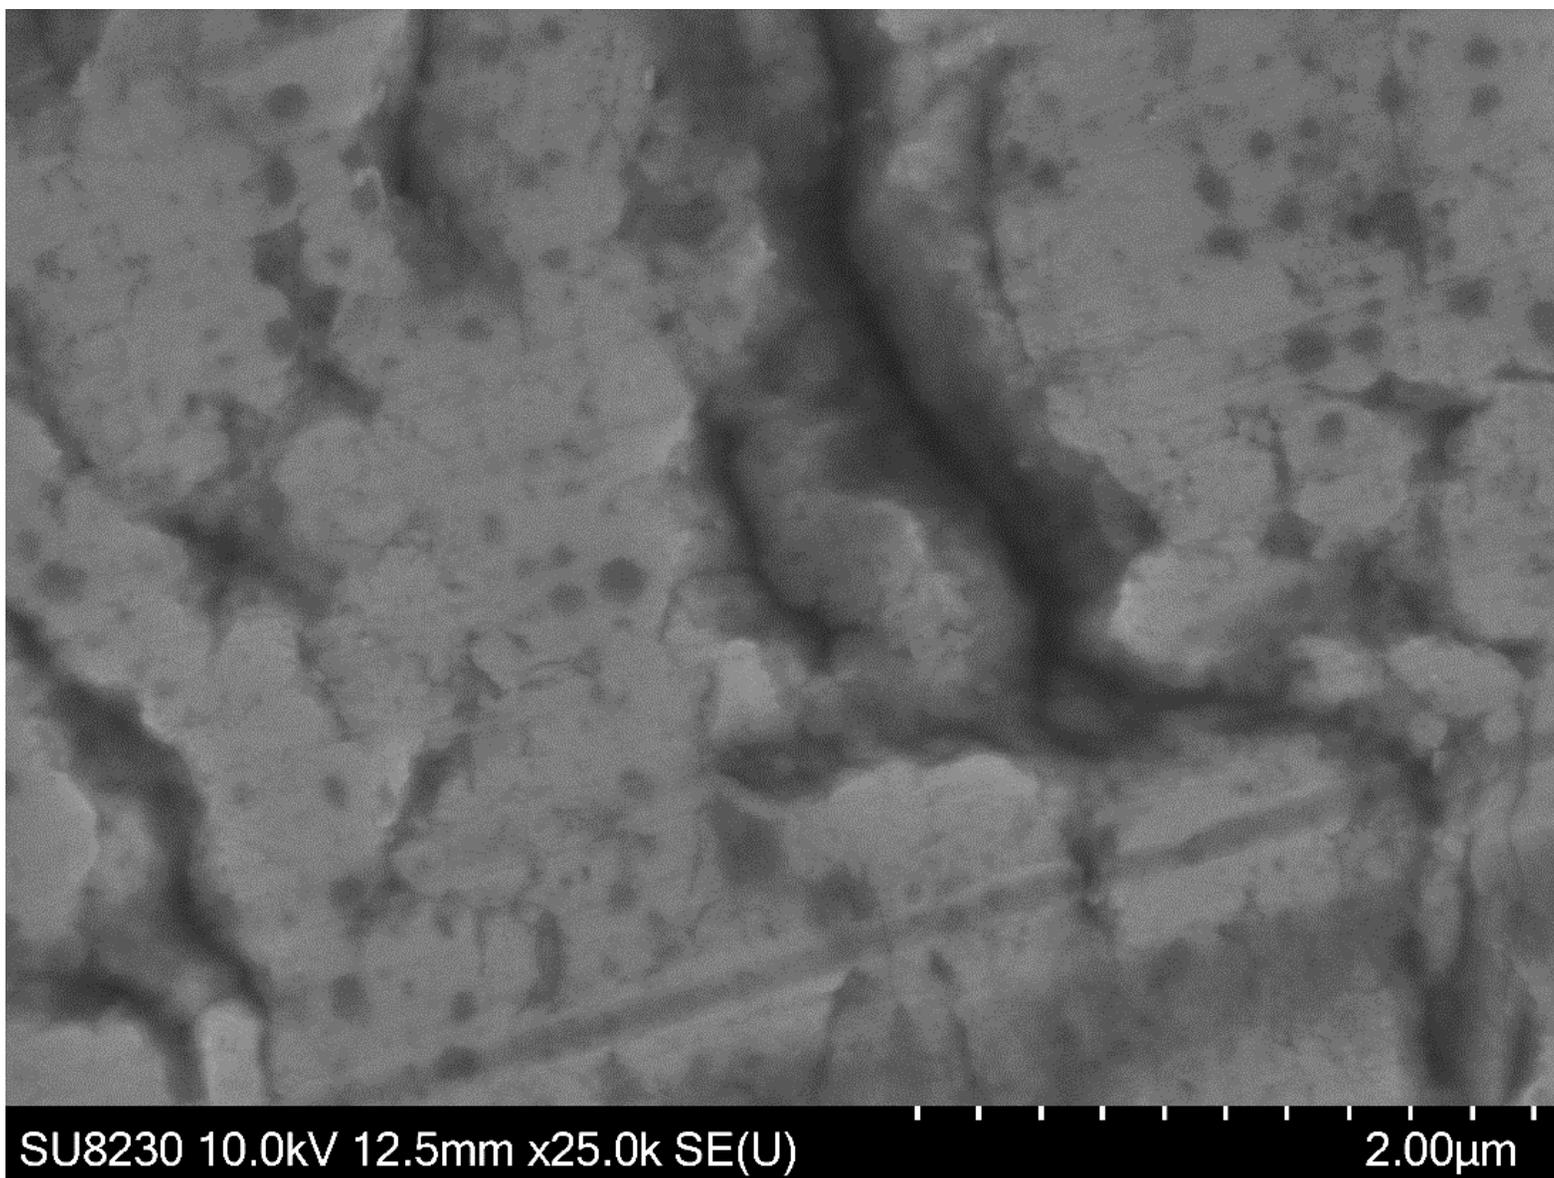
Figure 3-25. High Resolution SEM Image of Diaphragm

SEM images were also obtained to analyze the surface of the diaphragm. As shown in Figure 3-24, the surface appears somewhat rough with cracks all over. A higher resolution image of the diaphragm is given in Figure 3-25. A cross sectional image of the diaphragm that was cut by EDM was also viewed in the SEM, Figure 3-26.
