DESTRUCTIVE EXAMINATION OF SHIPPING PACKAGE 9975- 02644

W. L. Daugherty

October 2017

SRNL-STI-2017-00666, Revision 0

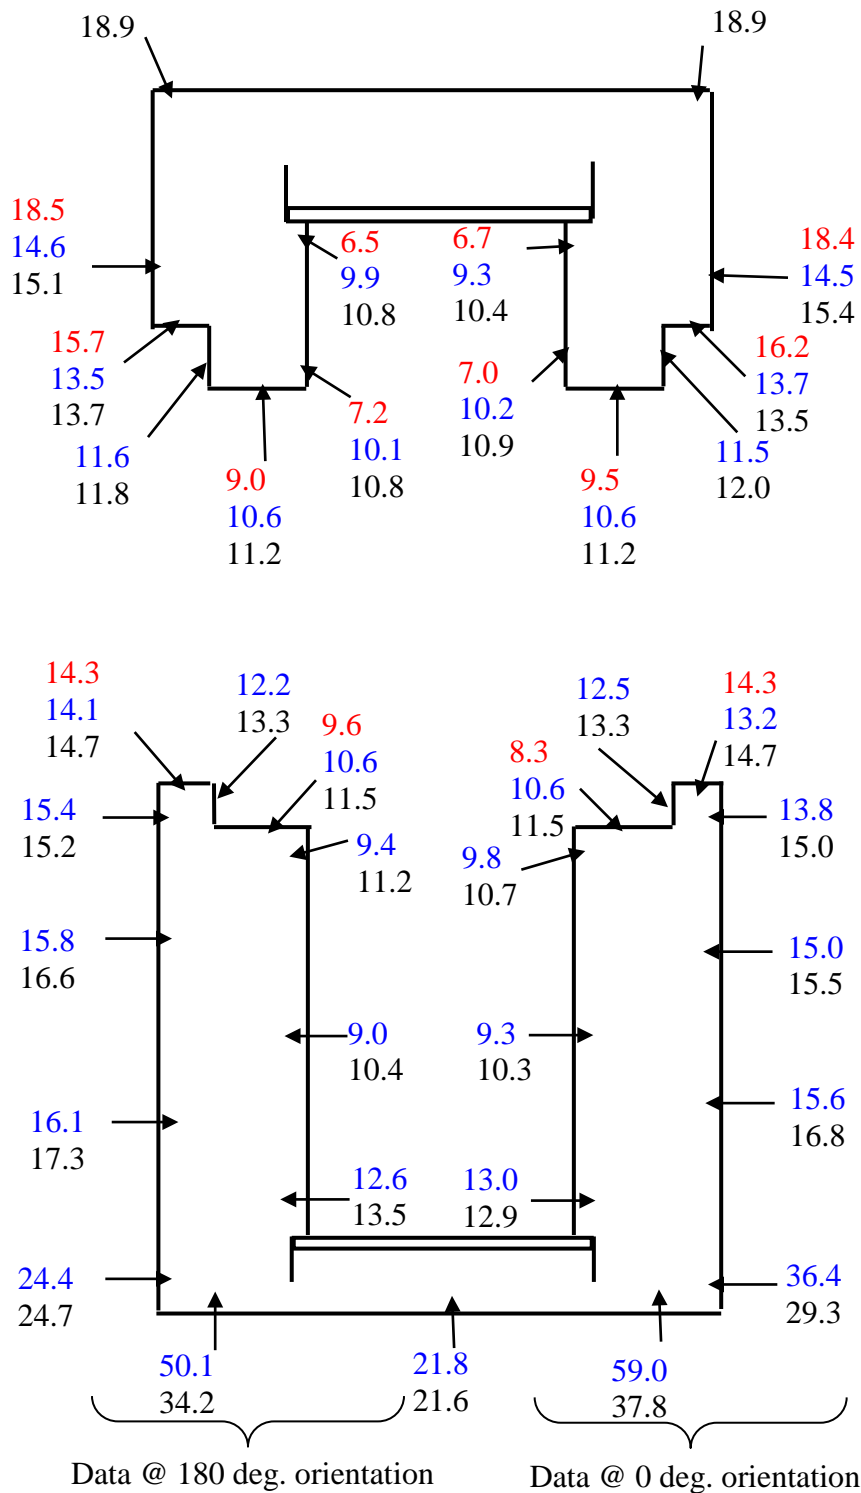
A GE Protimeter Surveymaster moisture probe was used to measure the moisture content of the upper and lower fiberboard subassemblies. This probe identifies the wood moisture equivalent (WME), or the weight % of moisture that would produce the same electrical conductivity in wood. Moisture content data from each examination are presented in Figure 8.

Figure 8. Fiberboard moisture content data. The **values in red** were measured during field surveillance. The **values in blue** were measured 27 days later. The **values in black** were measured 40 days after field surveillance. All values are % wood moisture equivalent.

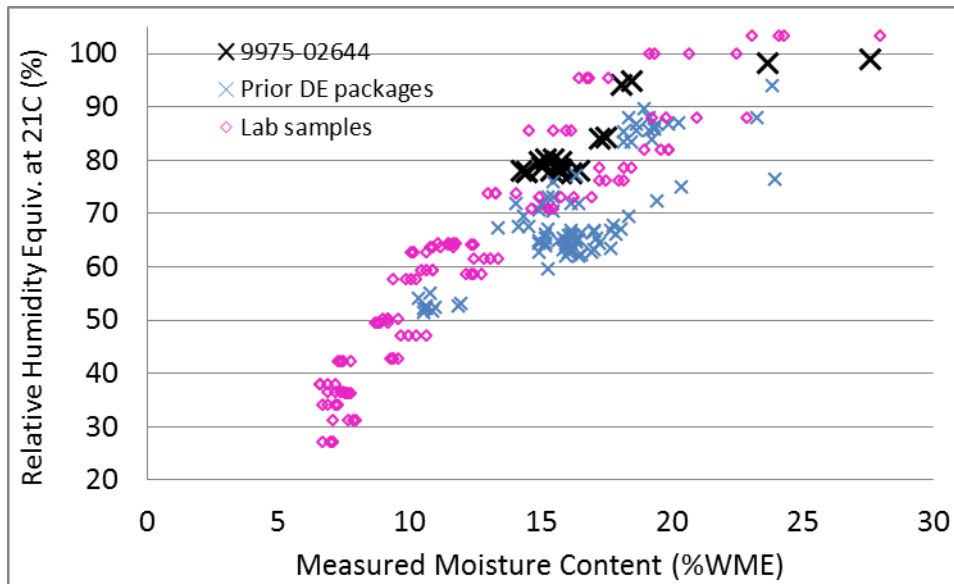
Consistent with recent efforts to correlate moisture content of fiberboard with humidity in the surrounding air, these two parameters were measured. The fiberboard was placed back in the drum with a narrow channel cut down the side. A humidity probe was placed in this channel such that it could be raised and lowered. A plastic bag was taped over the top of the drum and sealed around the humidity probe cable. After allowing time for the humidity levels in the drum to approach equilibrium, humidity readings were taken at periodic elevations along the fiberboard, and the fiberboard was then removed to measure the moisture content at those same locations. The humidity data were then converted to the equivalent relative humidity corresponding to a constant temperature of 21 °C, since relative humidity is temperature dependent. These data are summarized in Figure 9, and compared to similar data from several previous DE packages and cane fiberboard laboratory samples. The data from 9975-02644 show reasonable agreement with the other data.

Figure 9. Correlation between fiberboard moisture content and relative humidity of the adjacent air. Data from 9975-02644 are shown with comparable data from prior cane fiberboard DE packages and laboratory samples. Measurements were taken along the fiberboard OD surface. Since relative humidity is temperature dependent, all the data in this graph have been converted to a consistent equivalent relative humidity at 21 °C (70 °F).

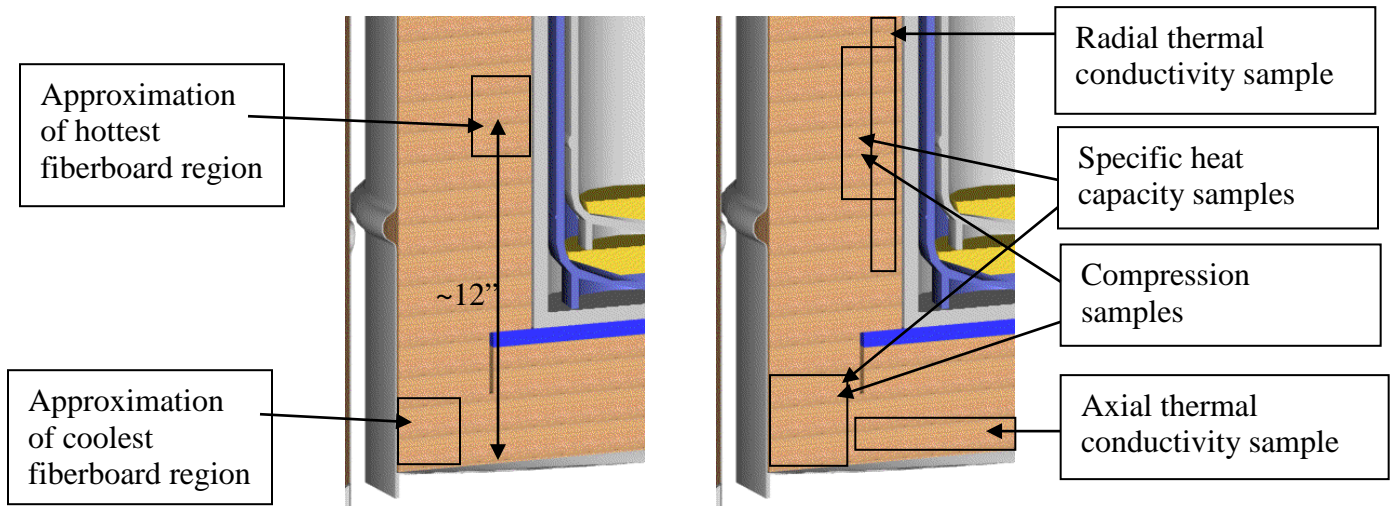
Samples of fiberboard were removed from the lower fiberboard subassembly to measure compressive strength (including energy absorption capacity), specific heat capacity and thermal conductivity. Figure 10 illustrates the locations from which these samples were removed. Physical data from the thermal conductivity and compression fiberboard samples are recorded in Table 2.

Figure 10. Illustration of fiberboard regions of the lower subassembly to be tested. Multiple samples (where used) were removed from the illustrated locations at different circumferential positions. Not to scale.

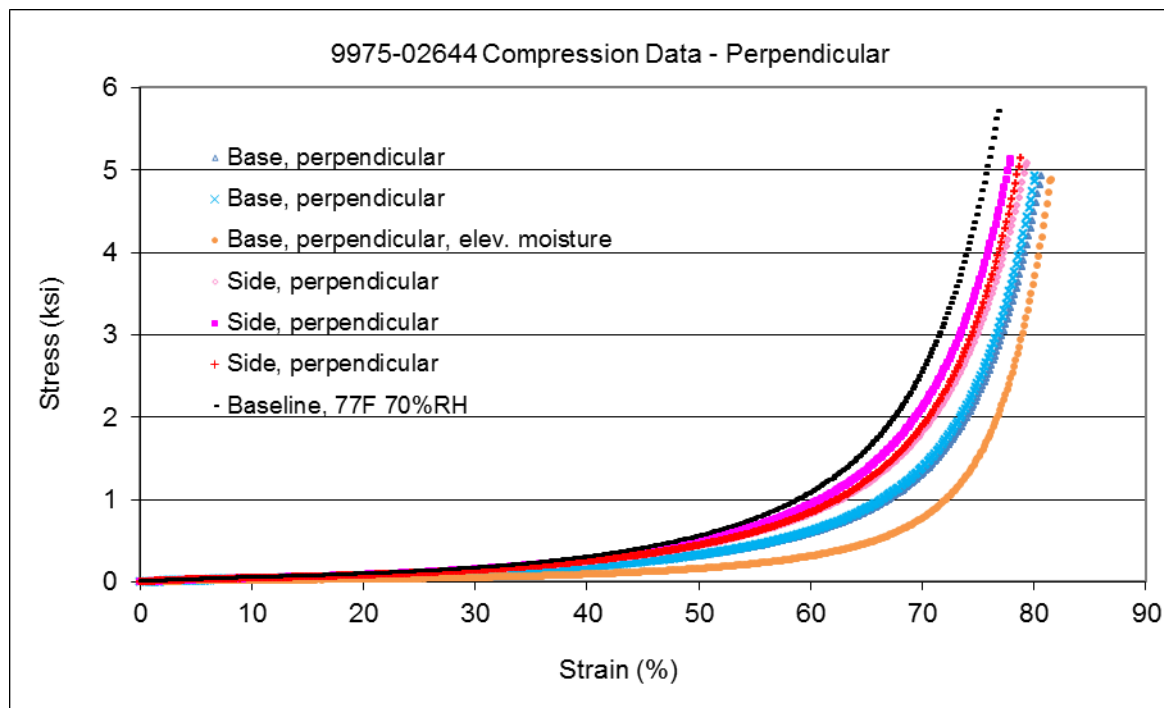
The compression test data are shown in Figures 11 and 12, along with baseline data for a different fiberboard assembly. A series of photographs showing typical compression behavior under parallel loading is shown in Figure 13. The area under the stress-strain curve up to 40% strain is used as a relative indication of the energy absorption capacity of the fiberboard. The buckling strength provides an additional comparison metric for samples tested in the parallel orientation.

Figure 11. Fiberboard compression test data, compared with typical baseline data from an unaged assembly, in the perpendicular orientation (i.e. load applied perpendicular to the fiberboard layers).

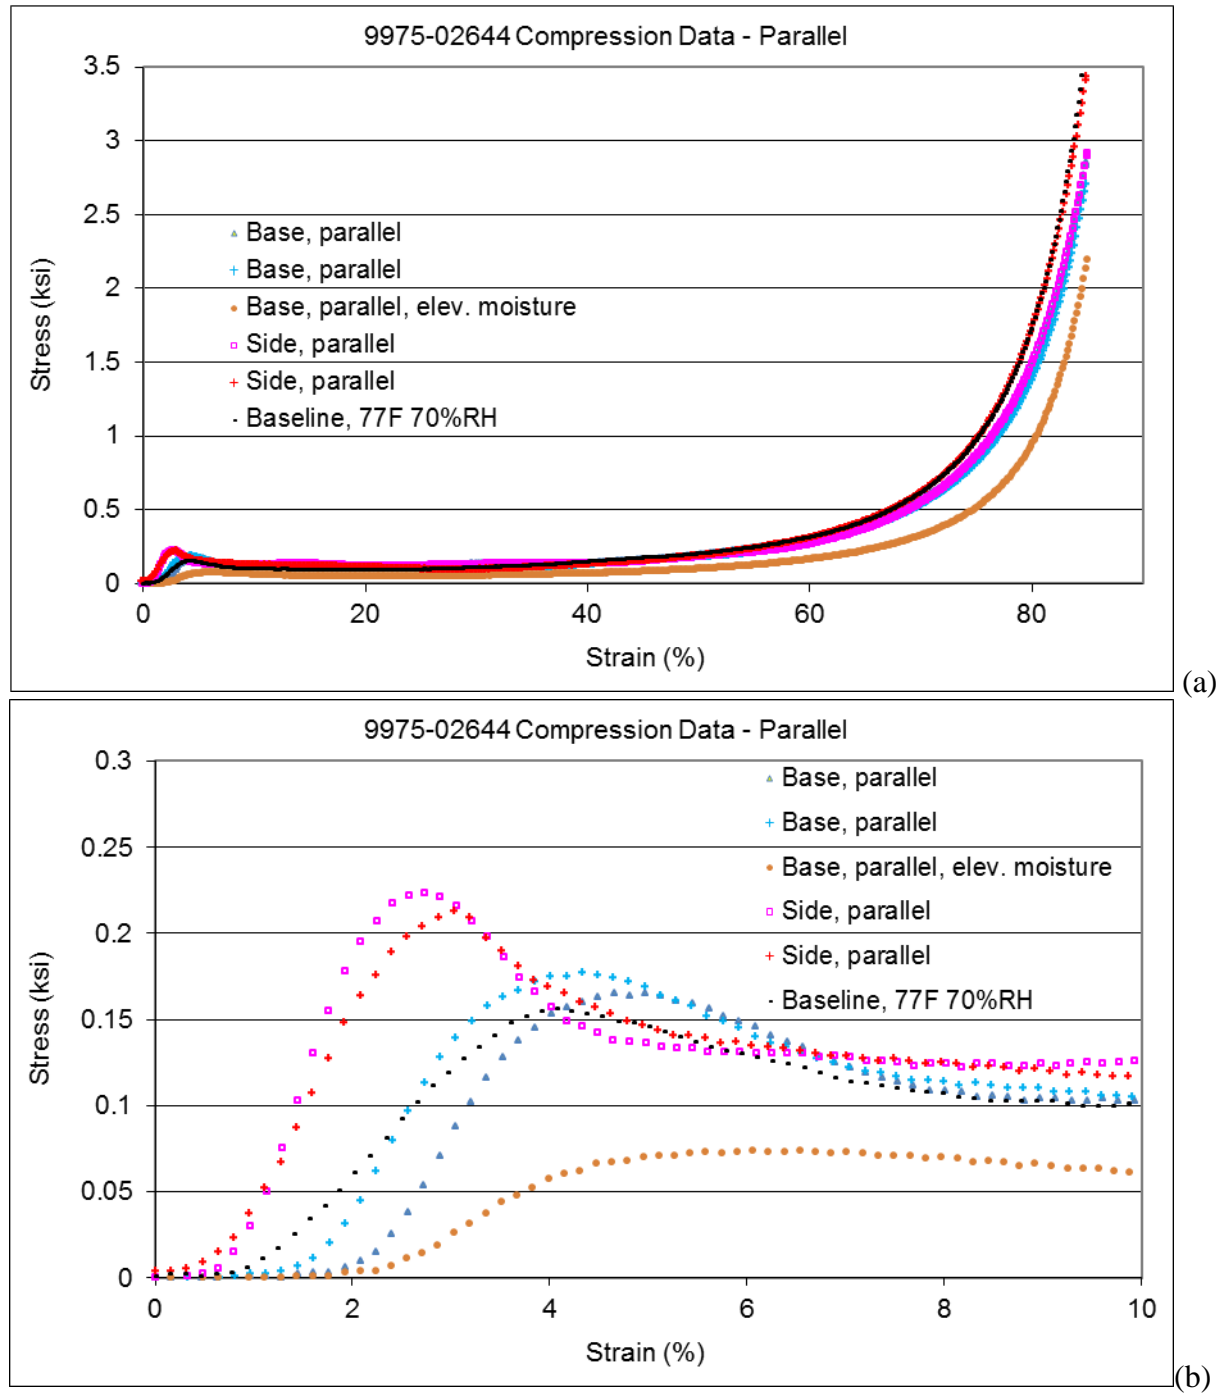
Figure 12. Fiberboard compression test data, compared with typical baseline data from an unaged assembly, in the parallel orientation (i.e. load applied parallel to the fiberboard layers). The full curves are shown in (a), while the initial buckling region is expanded in (b).

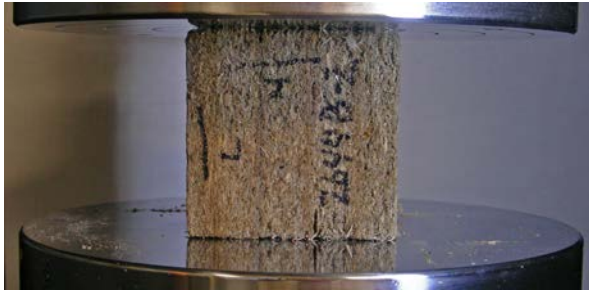
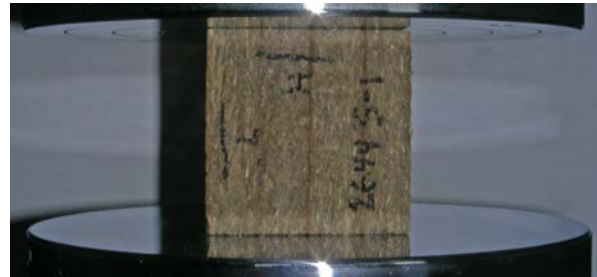
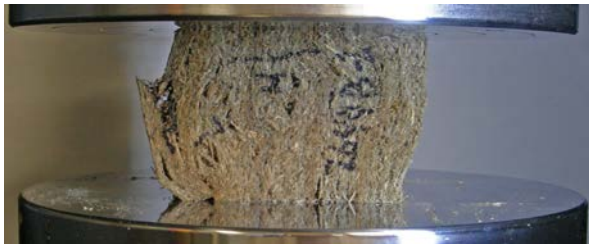
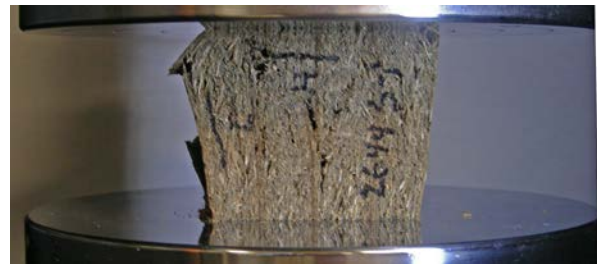
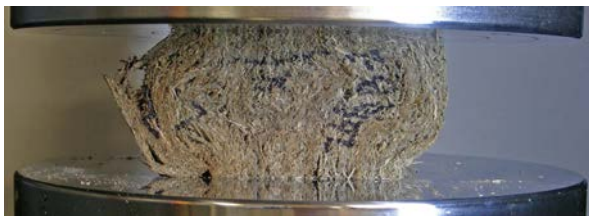
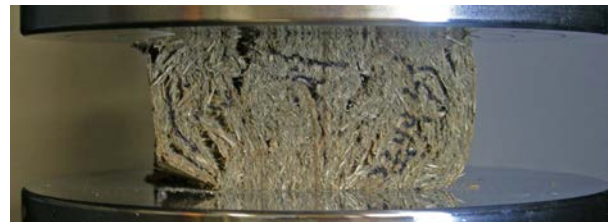
(a) Sample B2 from base of subassembly

(b) Sample S1 from side of subassembly

Figure 13. Photographs of fiberboard samples during compression testing, parallel orientation

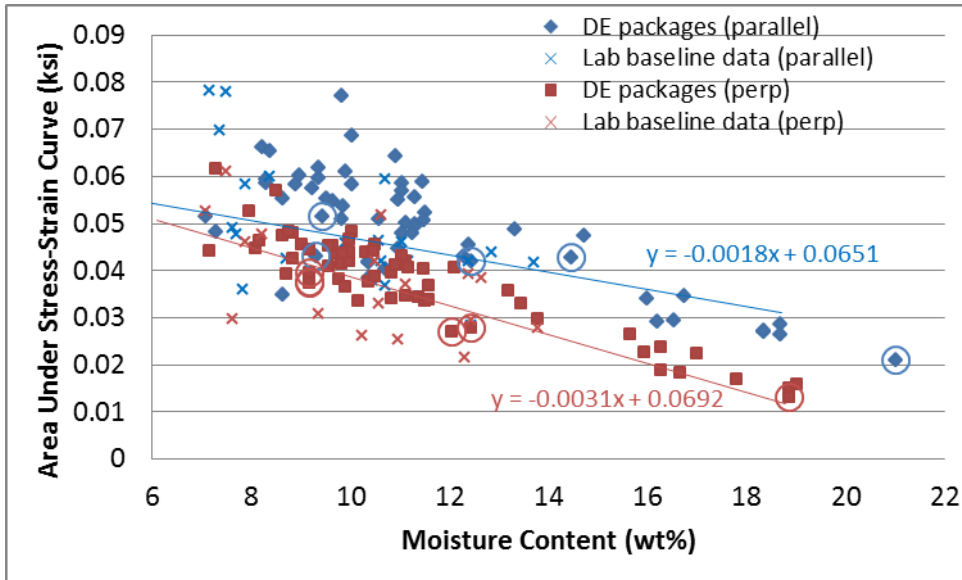
Figures 14 and 15 compare compression test metrics from all the DE packages, plotted as a function of fiberboard moisture content. In these comparative figures, the 9975-02644 data are circled for identification. Energy absorption (Figure 14) tends to decrease with increasing moisture content. Figure 14 includes data from several DE packages that have not been previously reported. These samples were recently tested after conditioning in a humid environment to provide more comparative data at relatively high moisture content. The samples from 9975-02644 consistently fall near the bottom of the range for all DE packages. Comparable trends are seen for the buckling strength (obtained from compression samples tested in the parallel orientation) in Figure 15.

Figure 14. Fiberboard energy absorption, represented by the area under the stress-strain curve up to 40% strain, from compression test samples from all destructively examined packages, compared to baseline data from laboratory samples used to develop fiberboard degradation models. The trendlines represent the laboratory sample data. The results from 9975-02644 are circled.

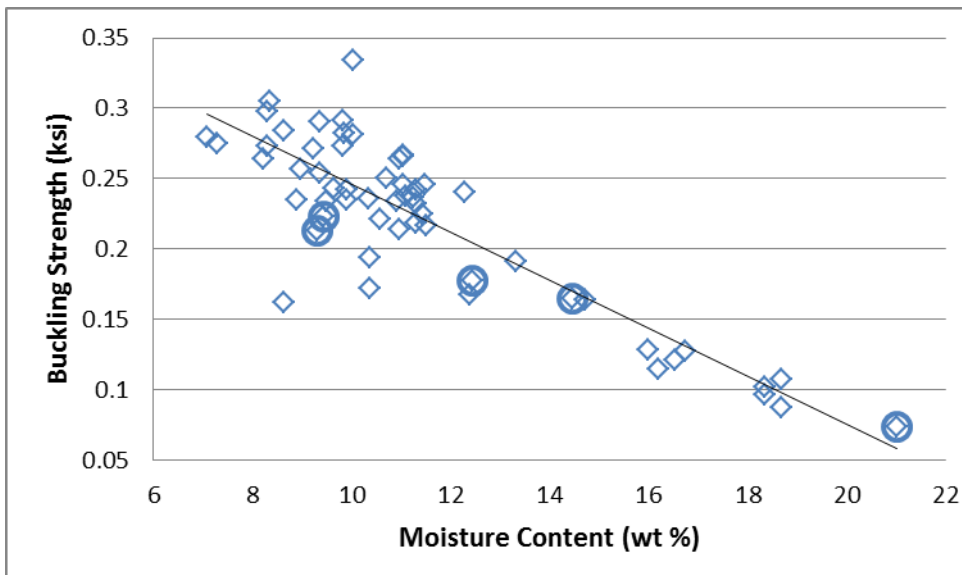
Figure 15. Fiberboard buckling strength for parallel orientation compression test samples from all destructively examined packages. The results from 9975-02644 are circled.

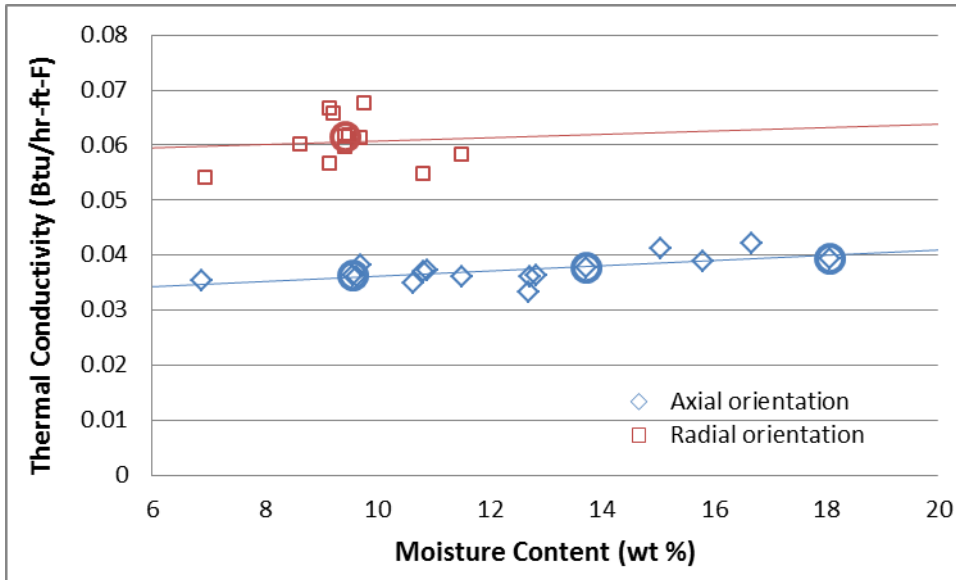
- The radial thermal conductivity sample (which was also removed from the inner sidewall region) gave results very comparable to the average behavior of other DE packages (Figure 16). The degradation rate for thermal conductivity in a low humidity 128 °F environment is predicted to be 0.034 %/year [10], so no discernible degradation would be expected for this parameter.

Figure 16. Fiberboard thermal conductivity from all destructively examined packages. The results from 9975-02644 are circled.

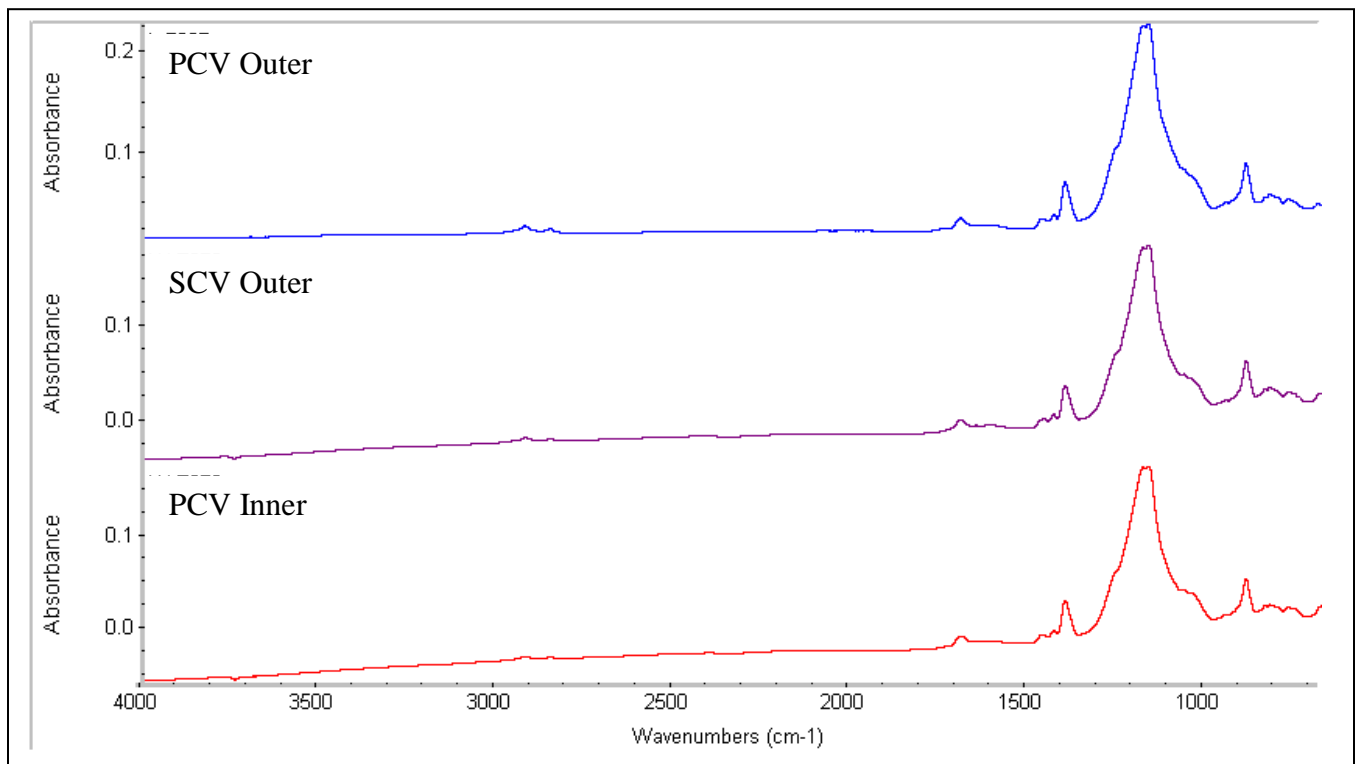
Figure 19. FT-IR spectra for the three tested Viton® GLT O-rings from 9975-02644.

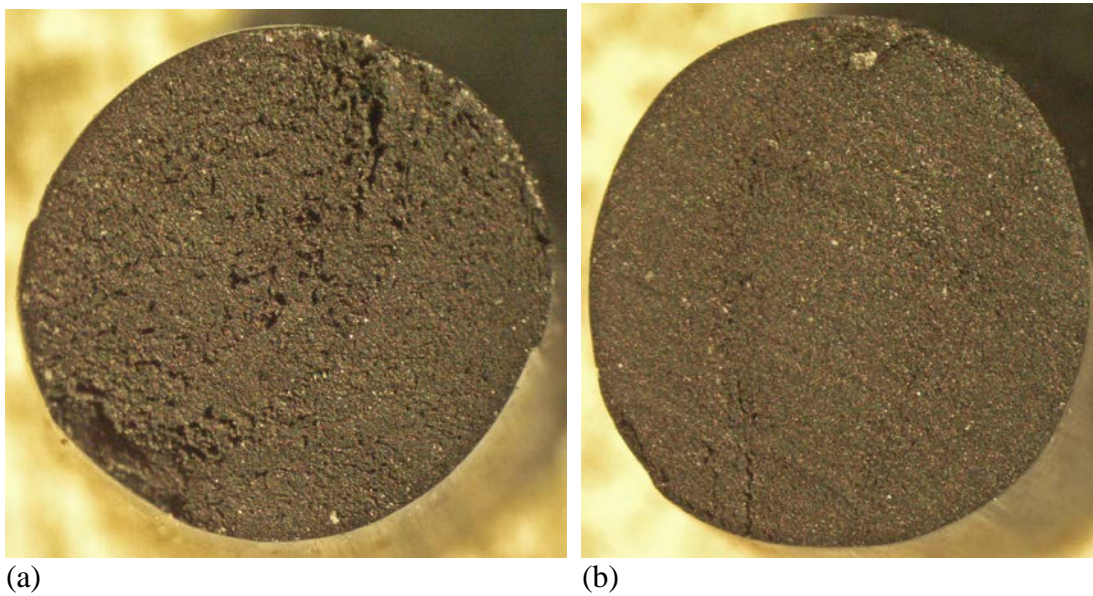
Figure 20. Optical cross section of the (a) PCV outer and (b) SCV outer O-rings. Photos taken by 723-A Met Lab.

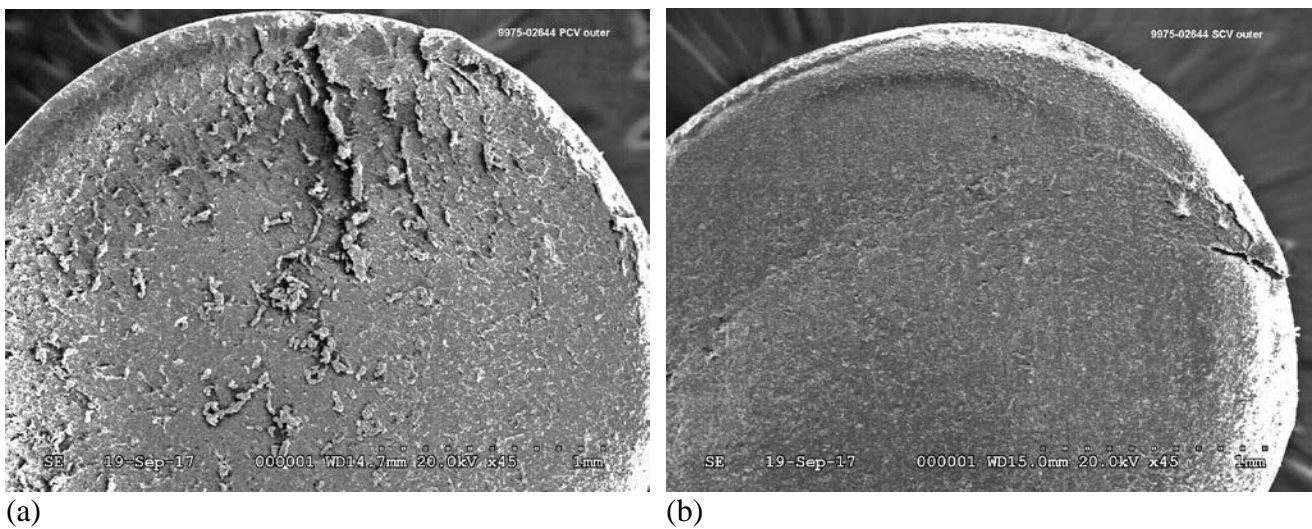
Figure 21. SEM cross section of the (a) PCV outer and (b) SCV outer O-rings. Photos taken by 723-A Met Lab.

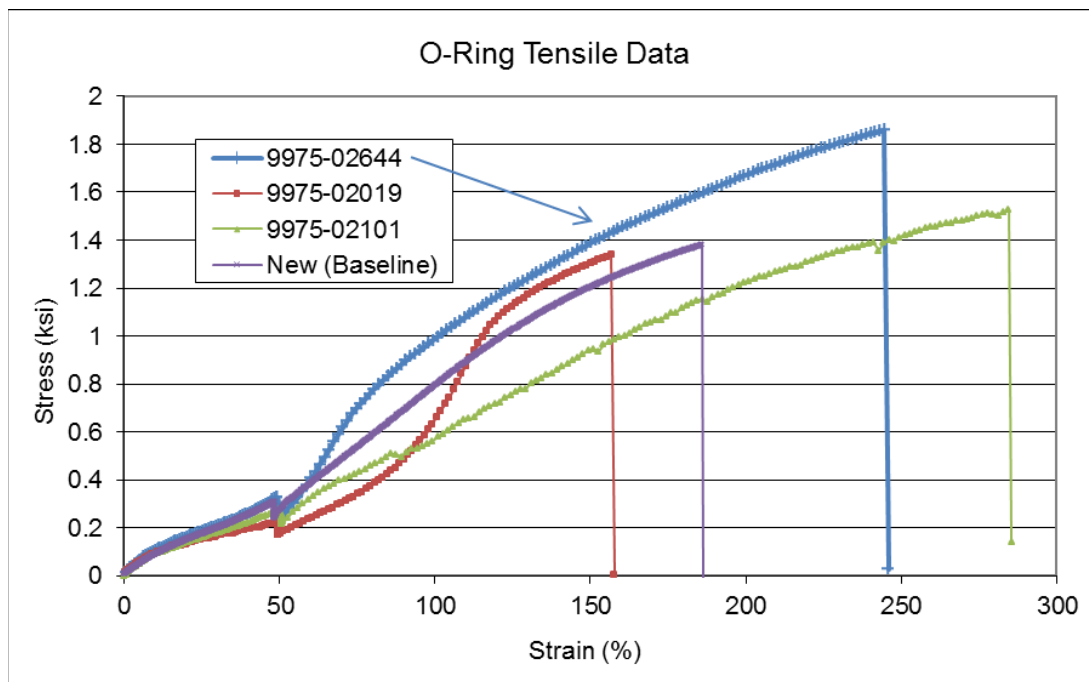
Figure 23. Tensile data for PCV inner O-ring from 9975-02644, with comparison curves from other DE packages with Viton GLT O-rings. Each of these tests was conducted with the flat grip configuration.
