Characterization of Oxyhydroxides on a Dry-Stored Fuel Plate From L-Basin

October 2018

SRNL-STI-2018-00428, Revision 0

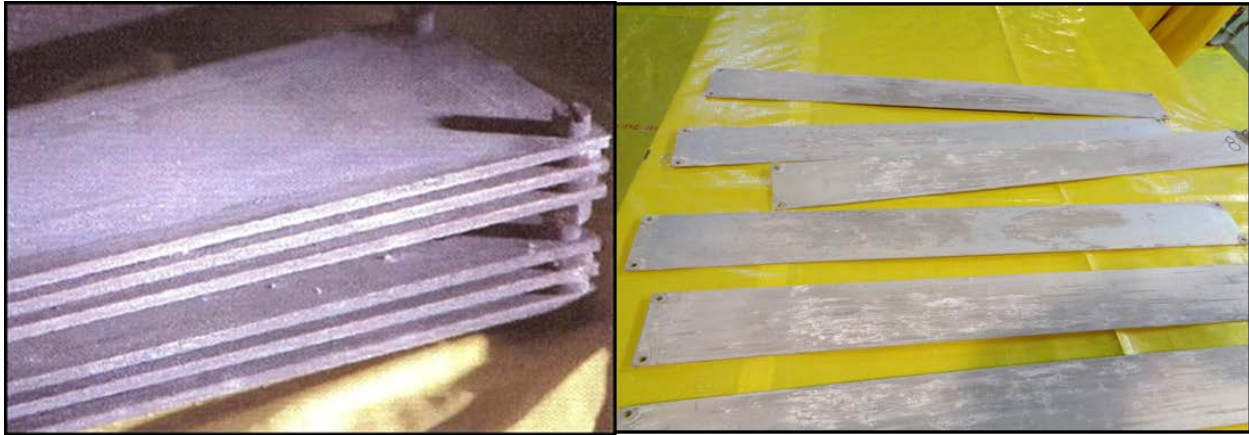
Figure 1 Plate fuel bundle (left) and debundled plates (right) from Uruguay RU-1 Pool Reactor.

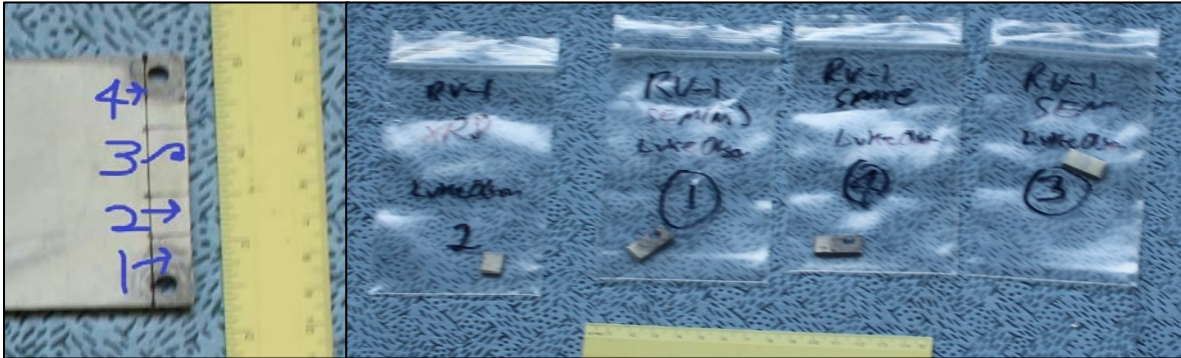
A single, dry-stored RU-1 fuel plate was shipped to SRNL for analysis and testing (Figure 2). Four cladding samples were cut from the end of plate using mechanical shears such that internal LEU fuel meat was not exposed (Figure 3). One sample was retained as a spare in storage; one was analyzed with X-ray diffraction (XRD) and then later used for plan-view imaging using contained scanning electron microscopy (SEM), and the other two samples were mounted and prepared for cross-sectional imaging using field emission SEM (FESEM) (Figure 4). Of the two samples prepared for FESEM, one had its oxide surface nickel-plated prior to mounting while the other was mounted without the addition of nickel-plating.

Figure 3 (Left) Location of samples on fuel plate; (right) samples used in characterization: XRD and plan-view SEM, nickel-plating + FESEM, spare, FESEM.

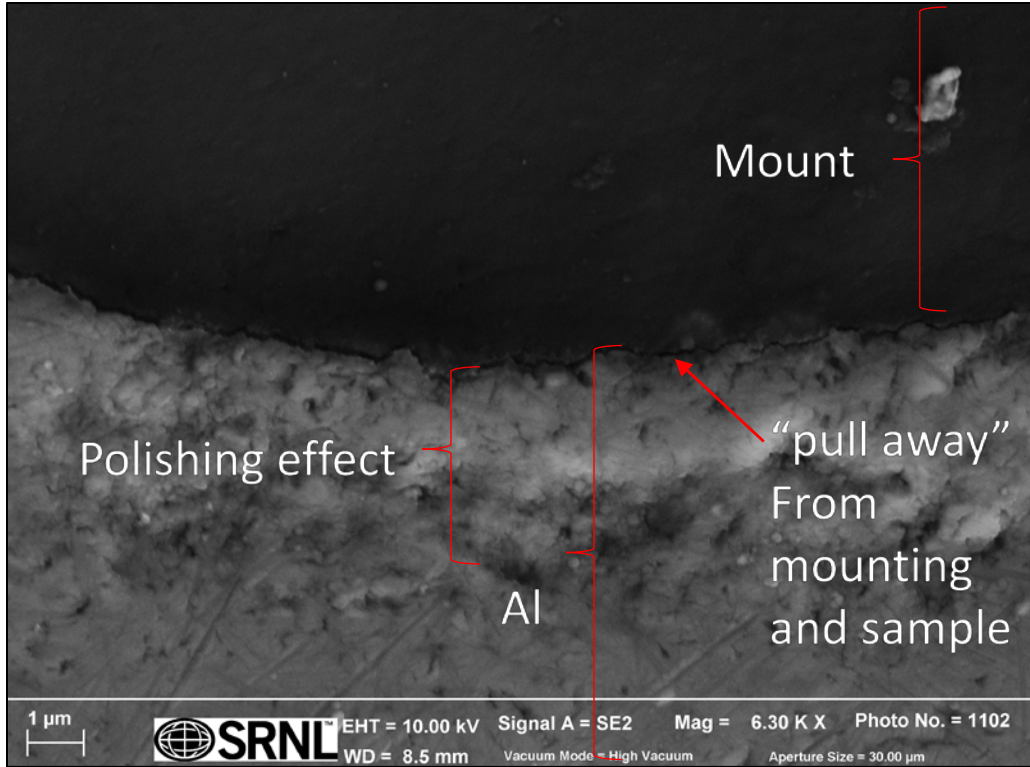
Sample 3 (Figure 3) was mounted in EpoFix without the application of a nickel plating to the oxide surface. A gap was observed to be present between the sample and the mounting material along the entire edge of the sample, Figure 8 and Figure 9. It is believed that the EpoFix mount medium likely pulled away from the oxide surface during curing to produce this gap.

Figure 8 Sample 3 SEM image for topological information (6.3kX magnification).
