Tank Inspection NDE Results for Fiscal Year 2019, Waste Tanks 25, 26, 33, 34, 41 & 50

James B. Elder III and Rodney W. Vande Kamp

October 28, 2019

SRNL-STI-2019-00519

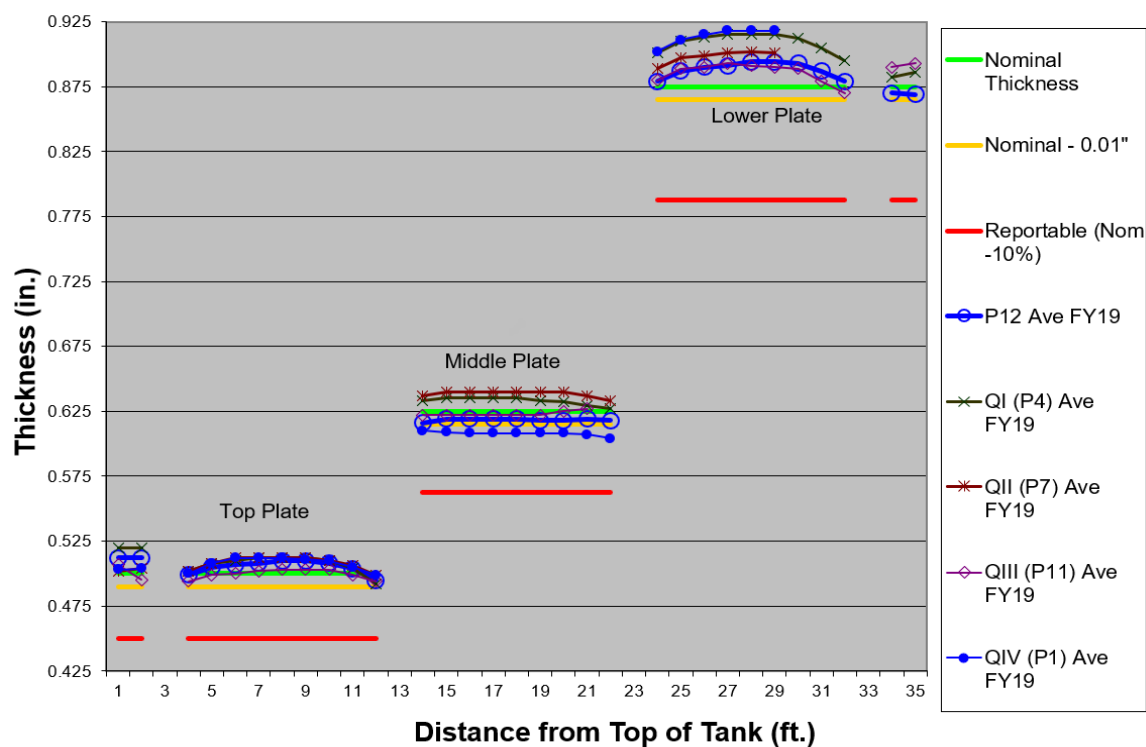
Figure 11: Tank 25 Average Thickness Data FY 2019
Tank 25 Average Thickness All Risers FY2019

Figure 11 provides a plot of the FY 2019 average thickness data from all risers examined while Table 2 provides average thickness values for all vertical strips collected on the primary wall of Tank 25 in 2019. Minimum measured thickness values are shown in Table 3.

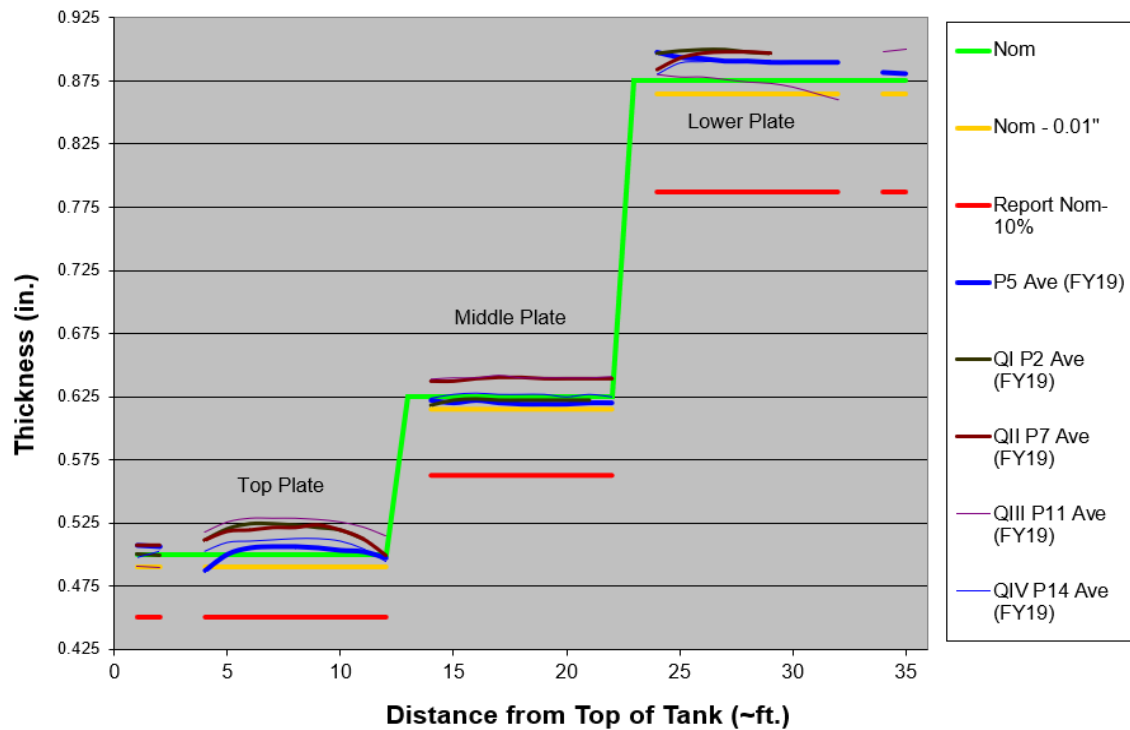
Figure 13: Tank 26 Average Thickness Data FY 2019
Tank 26 Average Thickness All 2019 Strips

Figure 13 provides a plot of the FY 2019 average thickness data from all risers examined while Table 5 provides average thickness values for all vertical strips collected on the primary wall of Tank 26 in 2019. Minimum measured thickness values are in Table 6.

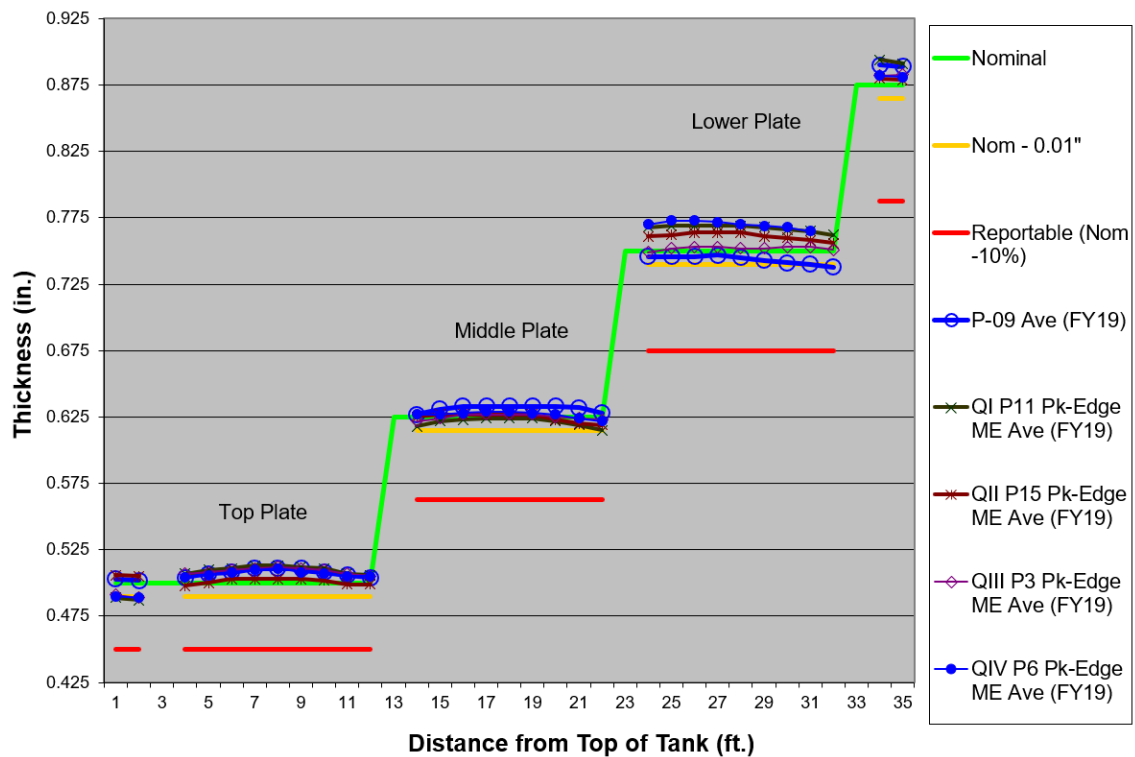
**Figure 17: Tank 34 Average Thickness Data FY 2019
Tank 34 Average Thickness 2019 Risers**

Four high speed randomized vertical strips were completed with no service induced reportable thinning or pitting. Figure 17 provides a plot of the FY 2019 average thickness data while Table 11 provides average thickness values for all vertical strips collected on the primary wall of Tank 34 in 2019. Minimum measured thickness values are in Table 12.

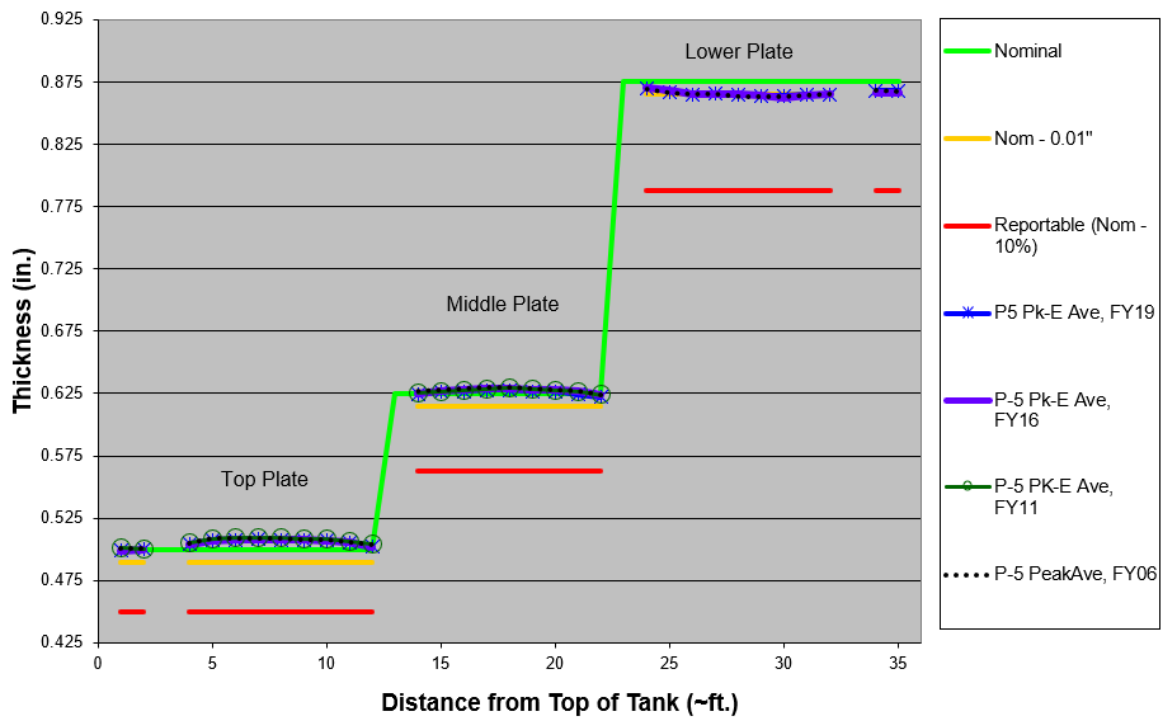
Figure 19: Tank 41 Average Thickness Data FY 2019

Figure 19 provides a plot of the average thickness data from all risers examined in FY 2019. Table 14 provides average thickness values for all vertical strips collected on the primary wall of Tank 41 in 2019. Minimum measured thickness values are in Table 15.
