# **Augmented Monitoring and Condition Assessment Program (AMCAP) Material Test Reactor (MTR) Fuel Inspection Program Report**

August 2020

SRNL-STI-2020-00152, Revision 0

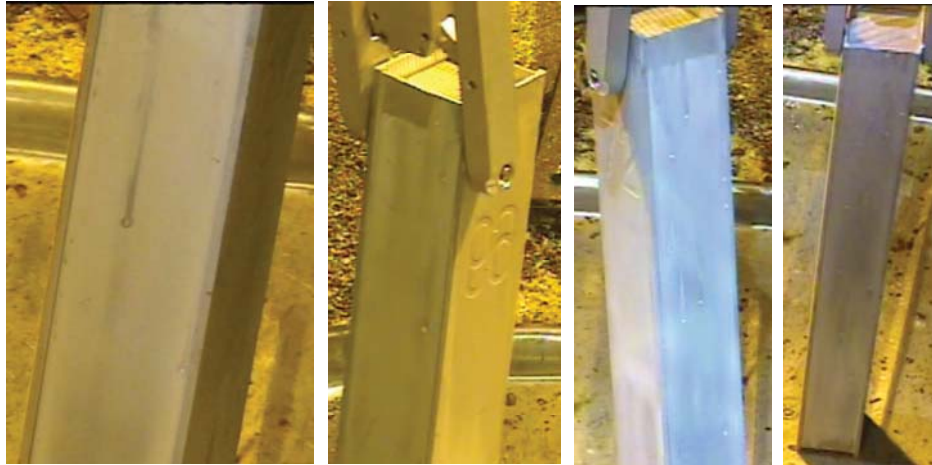
All five of the debundled standard Galileo fuel assemblies had anomalies present over the fuel meat regions of exterior fuel plates. The prevalent features were sparsely populated raised nodules and/or pits with darker discoloration trailing phenomena or no trailing. Whitish patchy discoloration was also prevalent on these fuel meat areas of the exterior fuel plates.

**Figure 4-21 Exterior fuel plates of the 2nd Galileo bundle of fuel during the debundling process (various debundled assemblies)**

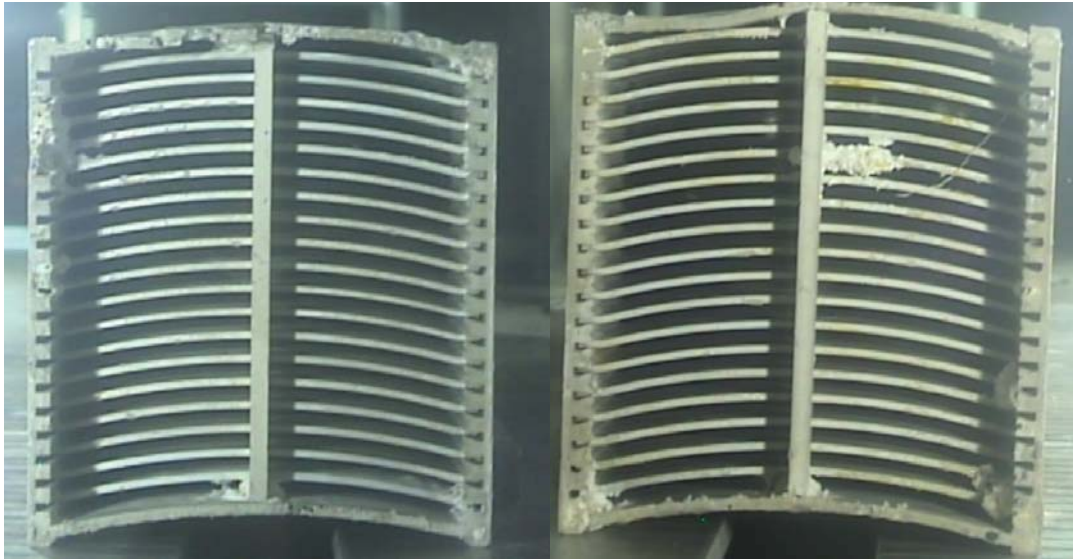
The side plates of the inspection assembly had numerous scratches, markings and some isolated pits present. Pitting was also observed at some areas of crevice attack that was pronounced and extensive.

The outer dummy fuel plates had some severe pitting near, but slightly below, the crevice region. The outer dummy fuel plates had some brown discoloration patches with no evidence of pitting. A few isolated holes in the outer dummy fuel plate center areas were noted with no discoloration around these pitted holes.

*Figure 4-25 Top and Bottom views of the Inspection Assembly 3-9-IX*

ENEA ISPRA Reactor fuel assembly 3-9-IX is also recommended for reinspection. Extensive crevice corrosion and corrosion of the side plates was observed, in addition to end-grain corrosion observed on the ends of the assembly. Because of these extensive, identifiable corrosion features, this assembly is a valuable candidate for reinspection to determine if the good water quality conditions of L-Basin are effectively mitigating additional corrosion attack in areas where accelerated attack has occurred. In addition, a higher burnup assembly is recommended within the same bundle. Assembly 3-51-VI is selected for inspection during future inspection campaigns. This assembly has a 60% burnup compared to 3-9-IX with a burnup of only 30%. A comparison of the recommended inspections could elucidate the impact, or lack thereof, of burnup on the extent or type of corrosion.

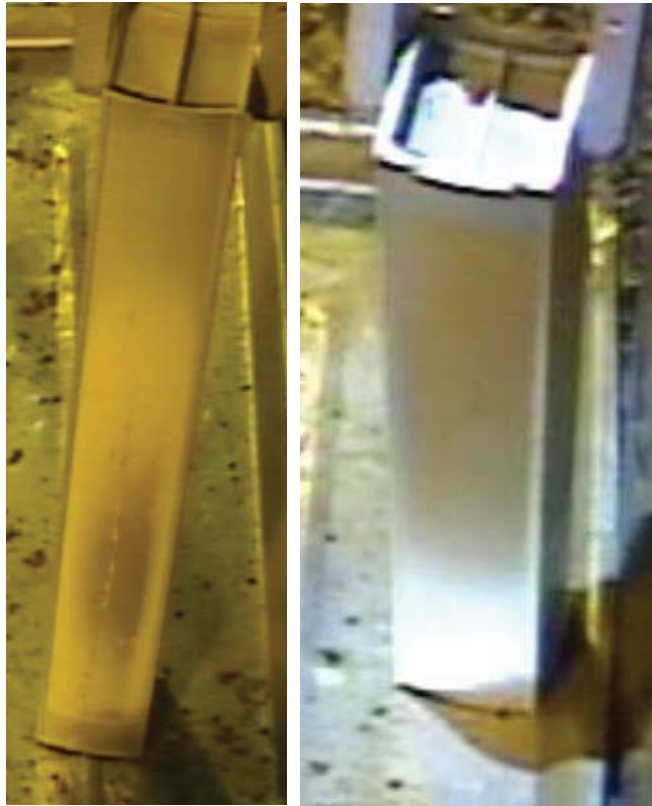
Assemblies F976 and F1130 showed some dark patches of discoloration over part of one side of the exterior fuel plate over the fuel meat regions.

**Figure 4-30 Assembly F976 (left) and Assembly F1130 (right)**

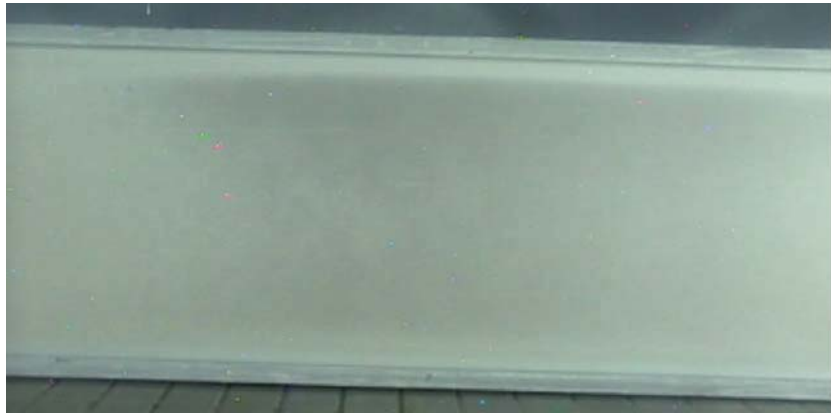
**Figure 4-32 Clean face but somewhat tarnished of an exterior fuel plate of Inspection Assembly F950**

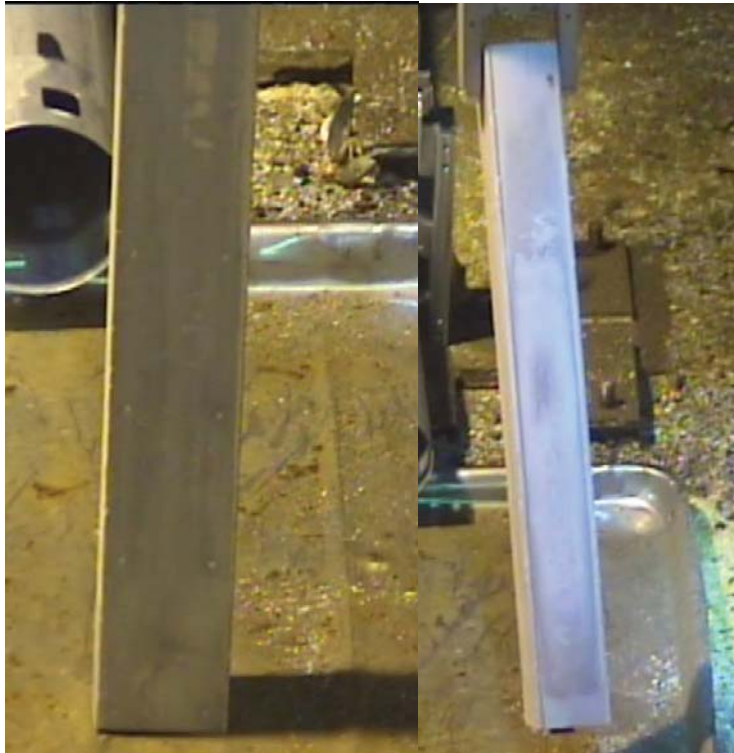
**Figure A1-1 Inspection Assembly S-113 (Control Assembly)**

The first fuel assembly inspected was an aluminum-clad Argentine RA-3 box type control assembly with very low burnup. The control assembly had cropped ends, no bail present, and easily seen, from either assembly end, two pairs of stainless steel control plate guide inserts running through the assembly body. The assembly had edge corrosion on side plates, crevice corrosion at the interface of the side plates and exterior fuel plates, a cluster of raised nodules and singular patches of pits over the fuel meat region of fuel plates, some evidence of partial discolorations on the edges of fuel meat regions, and minor incidence of pit discolorations. One of the debundled assemblies within the inspection bundle had a darker discoloration over the complete face of an exterior fuel plate, within the fuel meat region.

For the RA-3 fuel, two of the four assemblies are recommended to be reinspected in 5 years. This includes S-113, the first RA-3 inspection assembly, which was a control assembly with stainless steel components that could serve as galvanic couples and the final RA-3 assembly, 236, which was a standard assembly with significantly higher burnup, stainless steel components, and corrosion features unique to the RA-3 assemblies inspected. All RA-3 assemblies showed similar corrosion features in the same places for edge corrosion, crevice corrosion, fuel meat corrosion both pits and nodules and end-grain corrosion on the ends of the assemblies. Additionally, there was a standard assembly, 138, within the first inspection assembly bundle, that had complete dark discolorations over one face of the fuel meat region of an exterior fuel plate that is also recommended for inspection. Three RA-3 assemblies are recommended for future fuel inspections.

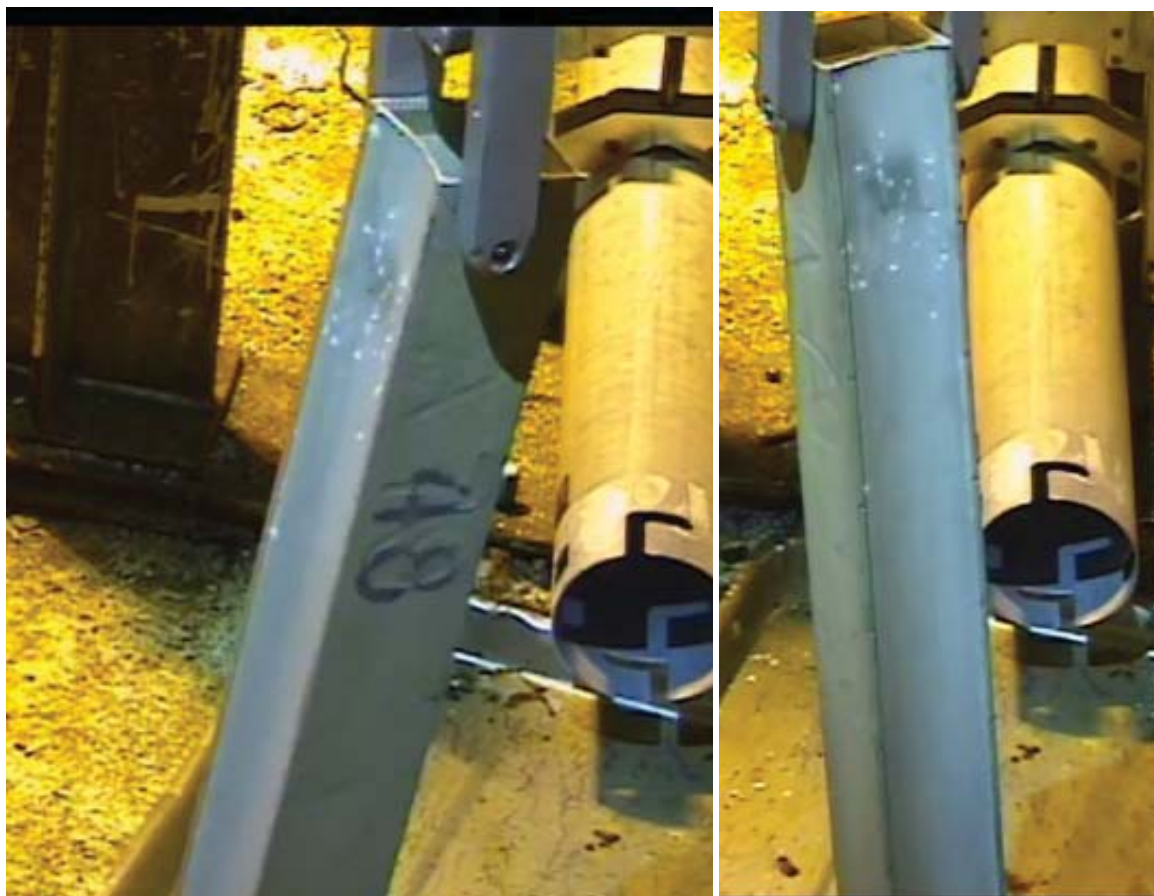
*Figure A1-4 Inspection Assembly IEA 79*

A Brazilian Instituto de Energia Atomica (IEA-R1) reactor fuel was examined in the second inspection. Like RA-3 fuel, the IEA-R1 fuel had moderate to advanced corrosion attack including severe side plate edge corrosion; moderate crevice corrosion; exterior fuel plate, fuel meat region pitting including raised nodule colonies and pronounced pitting that included decladding and discolorations in some of those pits.

The IEA-R1 reactor assembly IEA-79 is also recommended for reinspection. This assembly contained pits in the fuel meat region that appeared to indicate decladding and fuel failures, in addition to a number of other corrosion phenomena, which in many cases were some of the most severe of the ten assemblies inspected. As IEA-79 was a relatively low burnup assembly, a high burnup assembly IEA-77 (in an adjacent stored fuel bundle, same rack) is also recommended for the next fuel inspection. This higher burnup fuel selection for inspection is contingent on the availability of previous facility inspection data that can be used for comparisons.

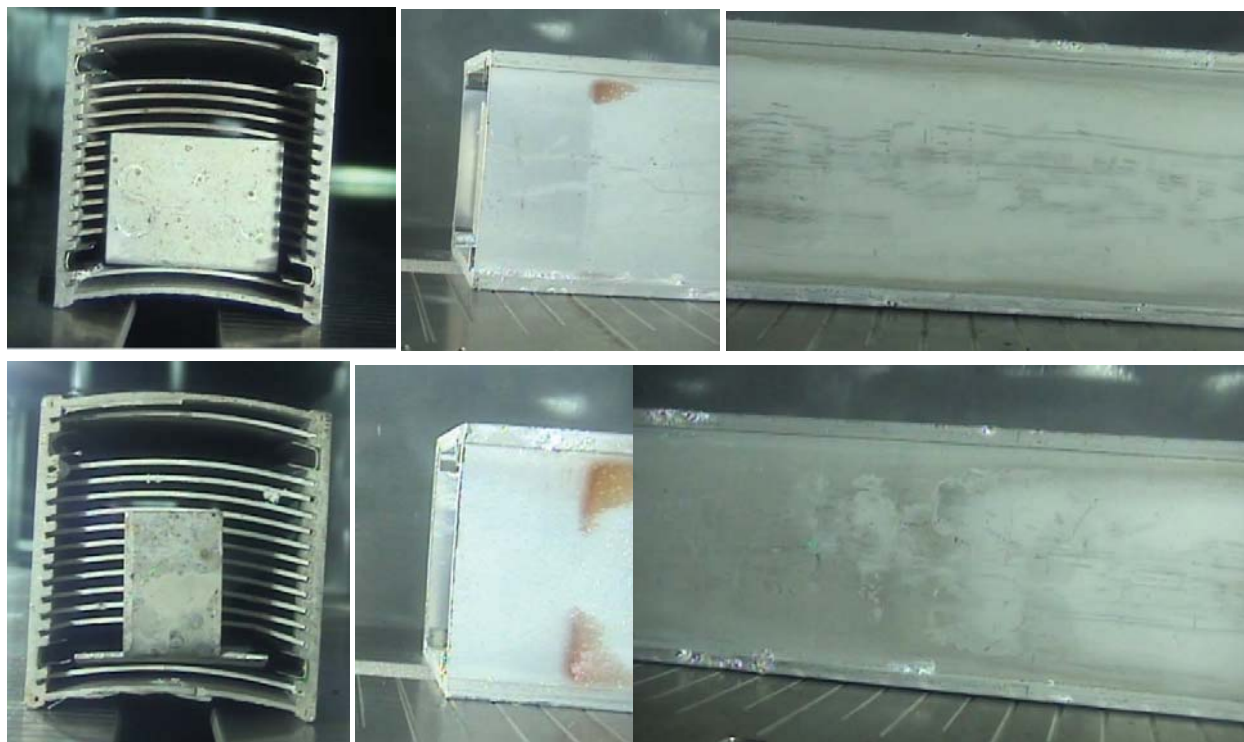
**Figure A2-2 First inspection assembly. Pictures of fuel ends (left) with concave and convex exterior fuel plates (right).**

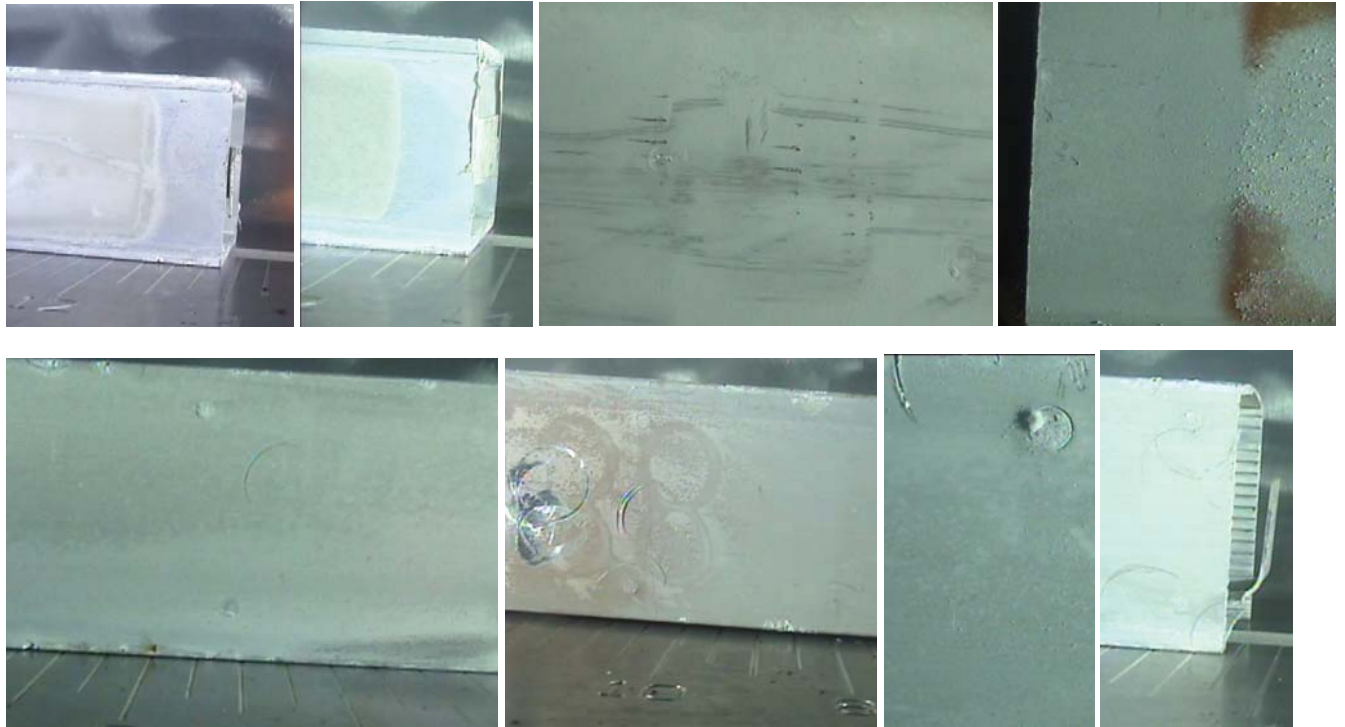
**Figure A2-3** Concave and convex exterior fuel plate ends (left) followed by exterior fuel plate details (right).

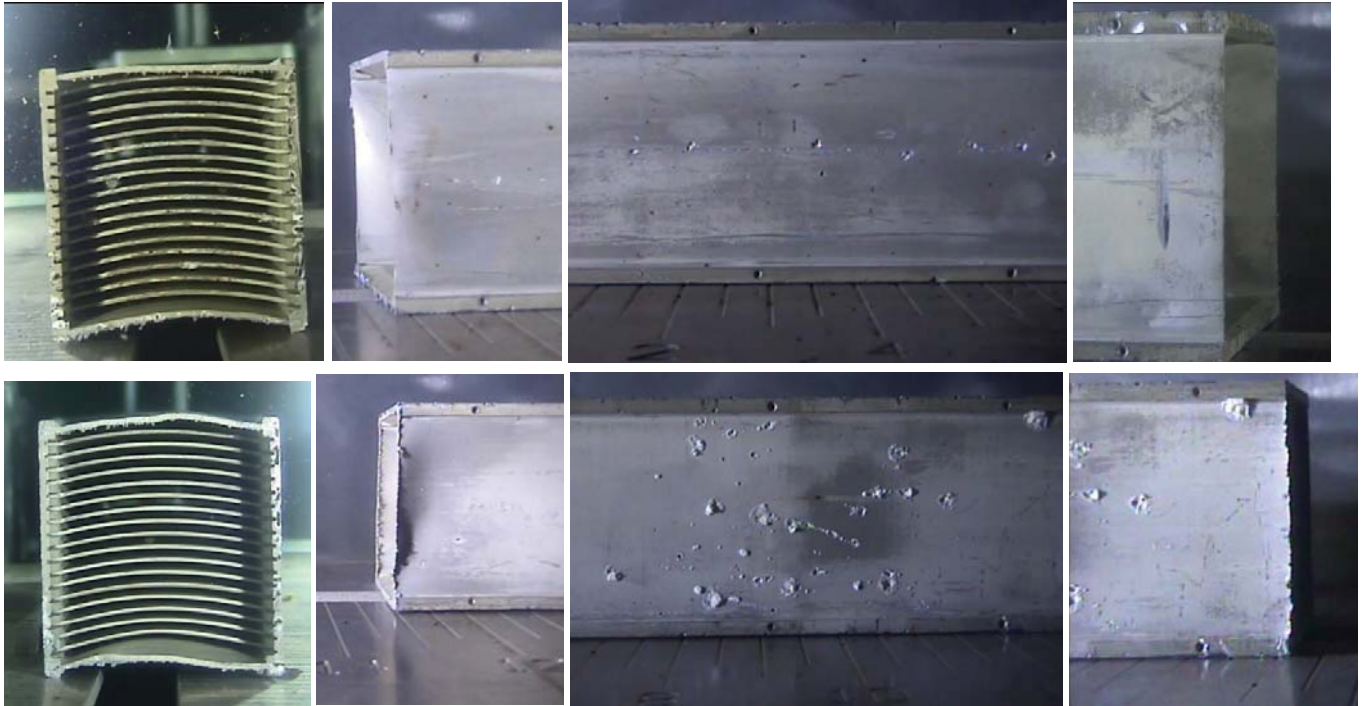
*Figure A2-4 Second inspection assembly. Pictures of fuel ends (left) with concave and convex exterior fuel plates (right).*

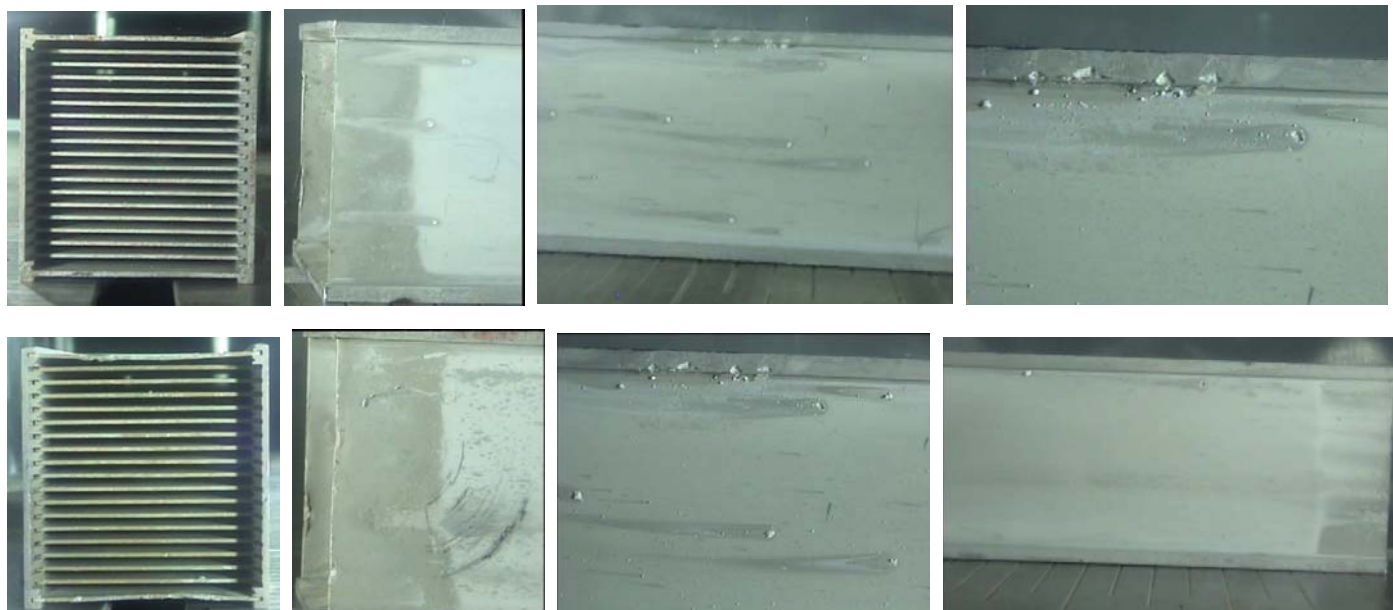
**Figure A2-10 Pictures of fuel ends (left) with exterior fuel plates (right)**

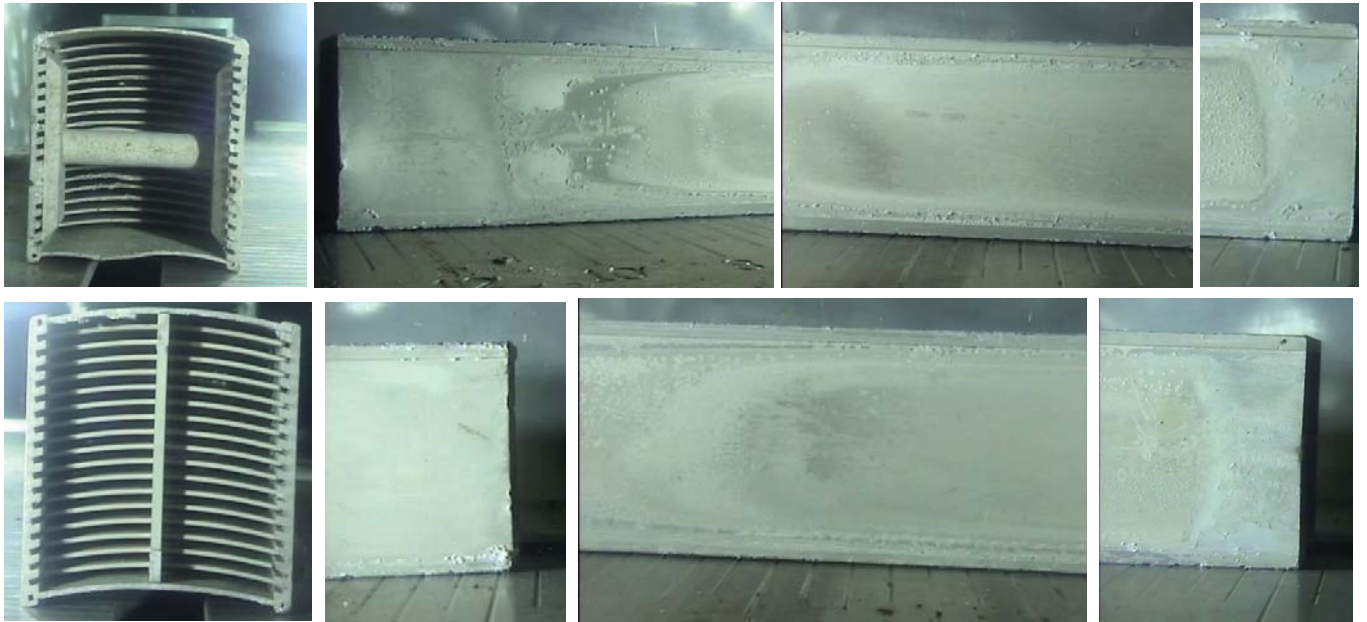
*Figure A2-13 Pictures of fuel ends (left) with concave and convex exterior fuel plates (right)*

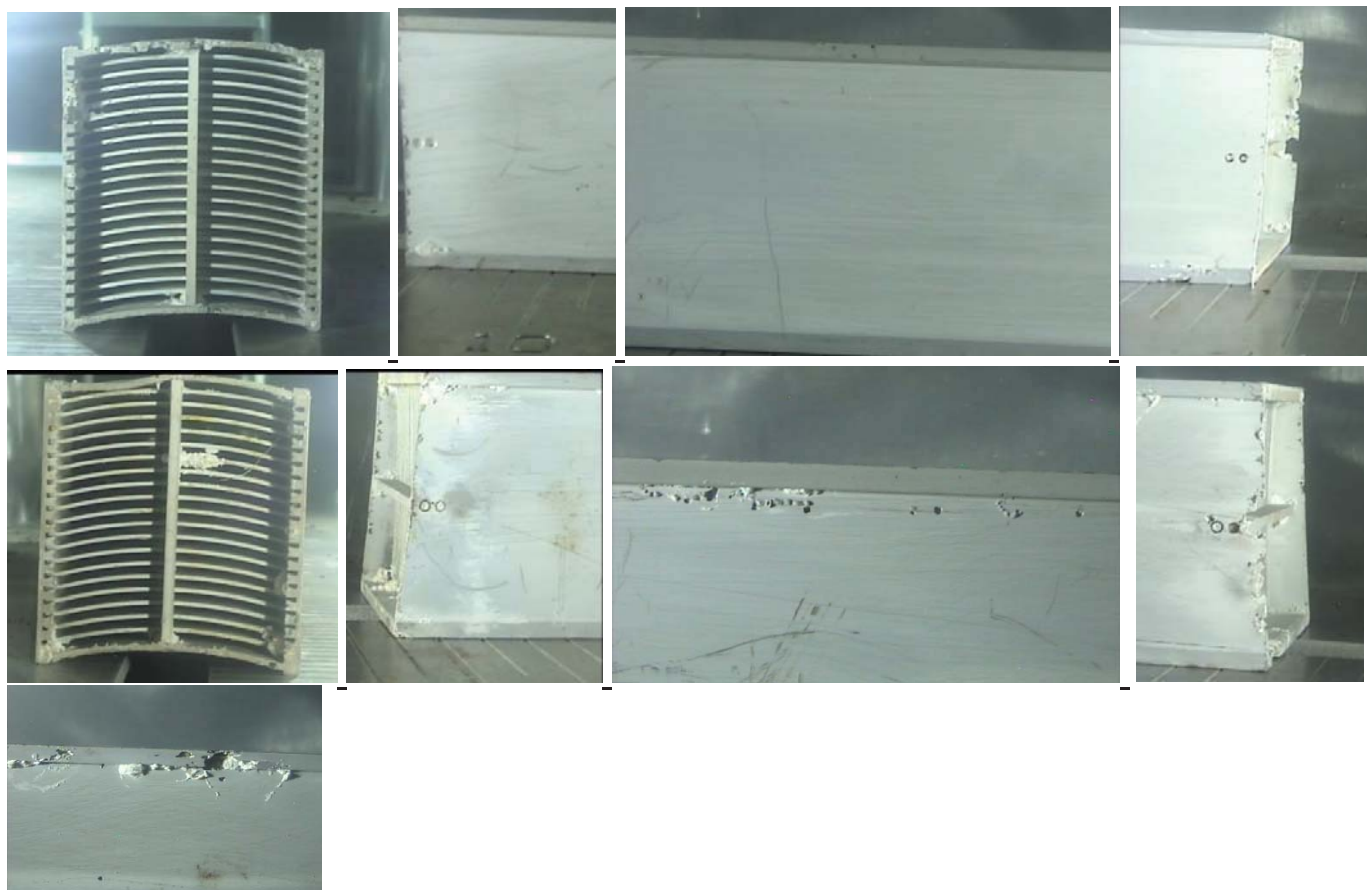
**Figure A2-15** Pictures of fuel ends (left) with concave and convex exterior fuel plates (right)

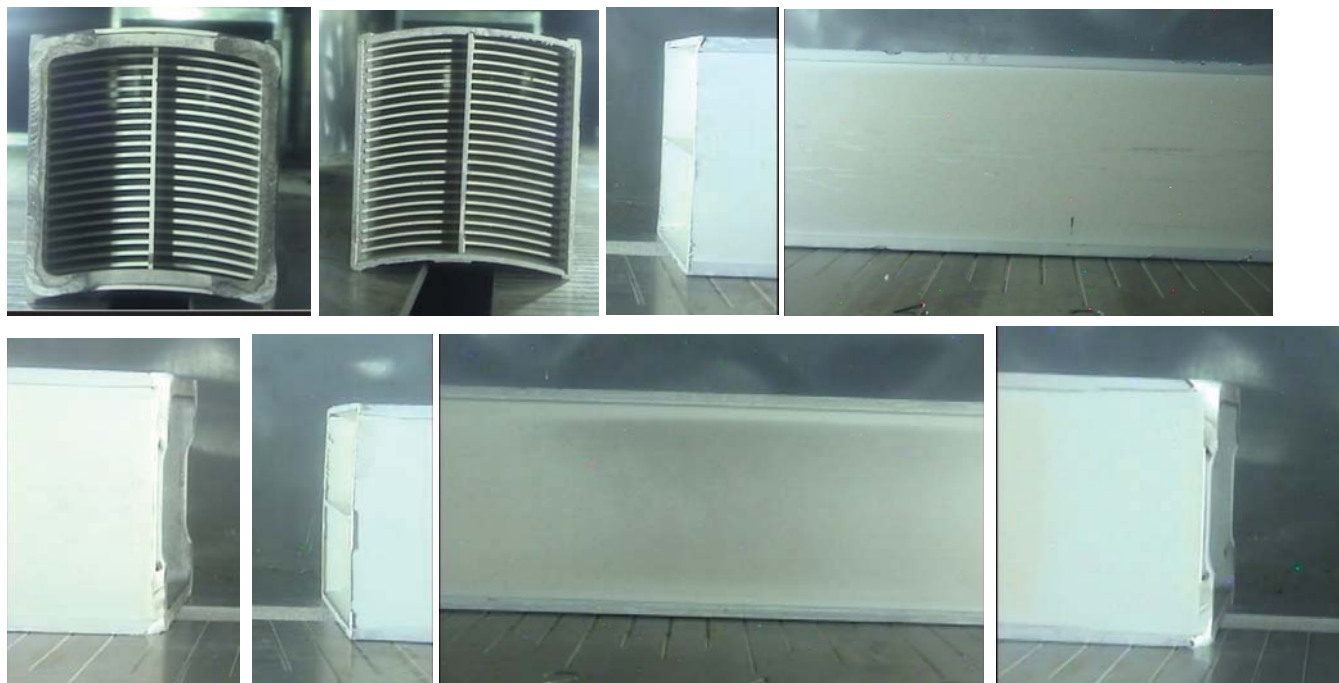
**Figure A2-17 Pictures of fuel ends followed by concave and convex exterior fuel plates**

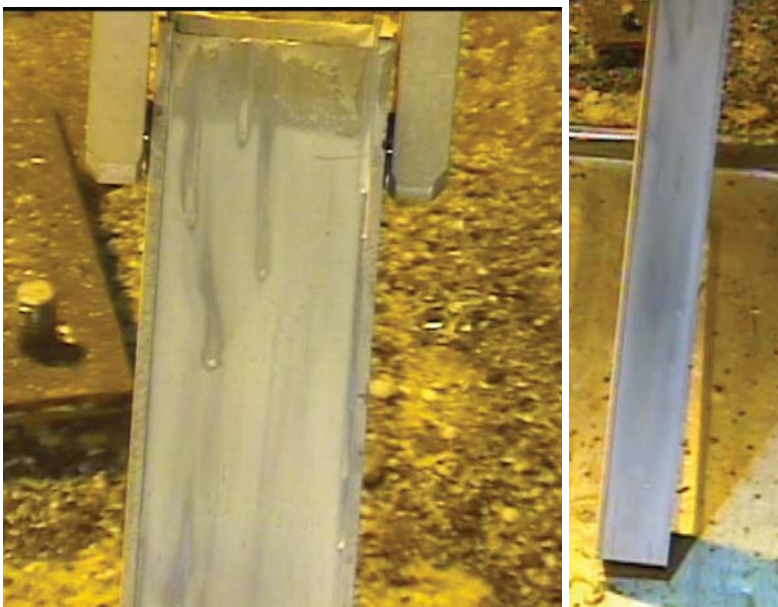
Figure A3-8 Assembly 71-GA72

Comments: There are numerous  
nodules with several  
> 1/8"

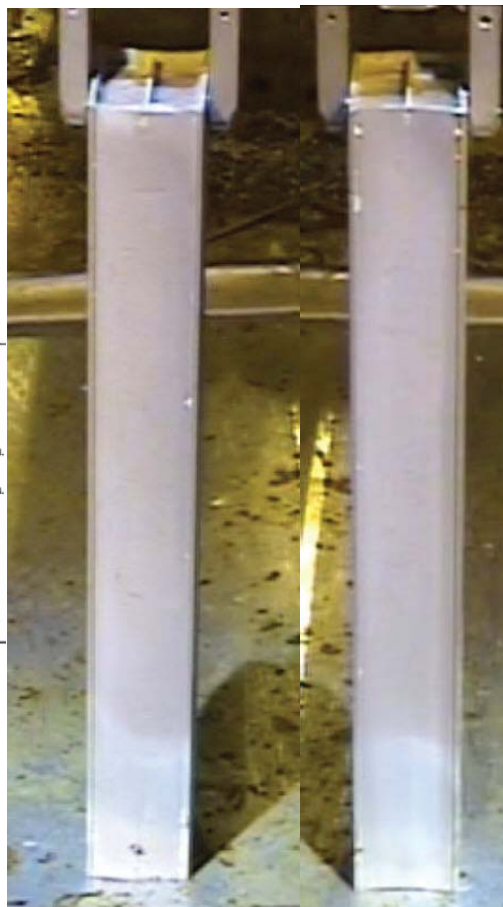
Figure A3-13 3-1-IX Assembly

Comments: Opp A-1  
handling scratches side 1  
crevice on both end  
views  
Outer plates contain no  
fuel.

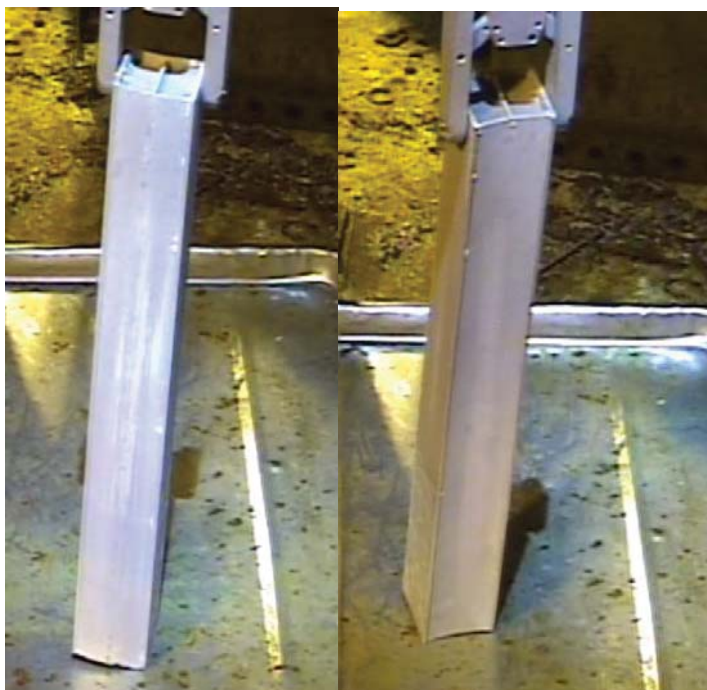
Figure A3-14 3-5-IX Assembly

Comments: App A-1  
check on both end views  
outer plates contain  
no fuel

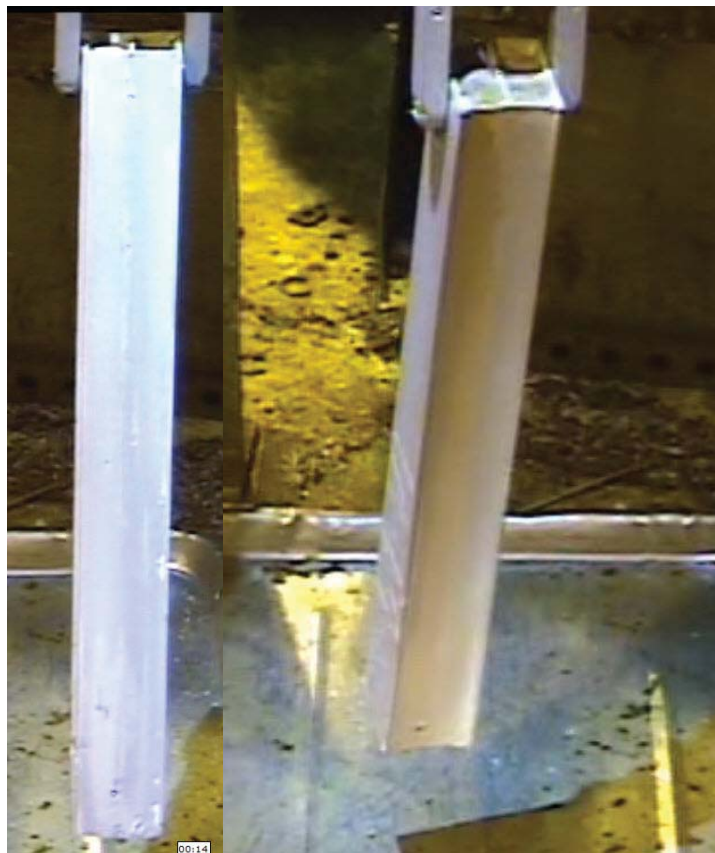
Figure A3-15 3-51-VI Assembly

Comments: App A-2  
corrosion on both end  
views, mechanical  
damage in various spots  
Outer plates contain no  
fuel

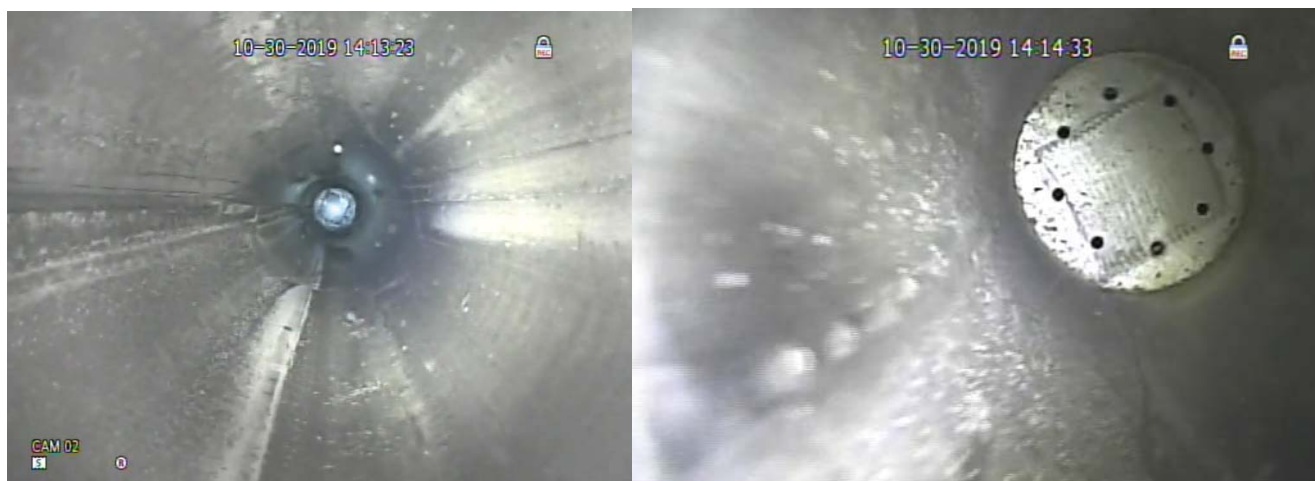
**Figure A5-8** Inside of vacated bundle L-RA3-0794 about half-way down inside (left) noting fuel assembly imprint (right)

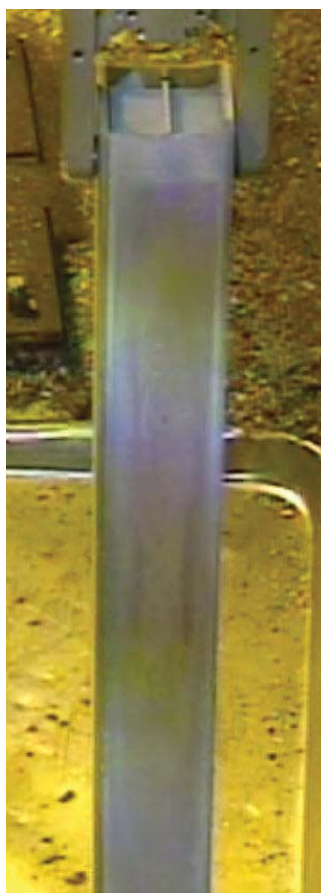
**Figure A5-9** Less than desirable shadowing effect due to underwater camera light and basin lighting which evolved this multi-color looking fuel plate phenomena on debundled assembly 257.

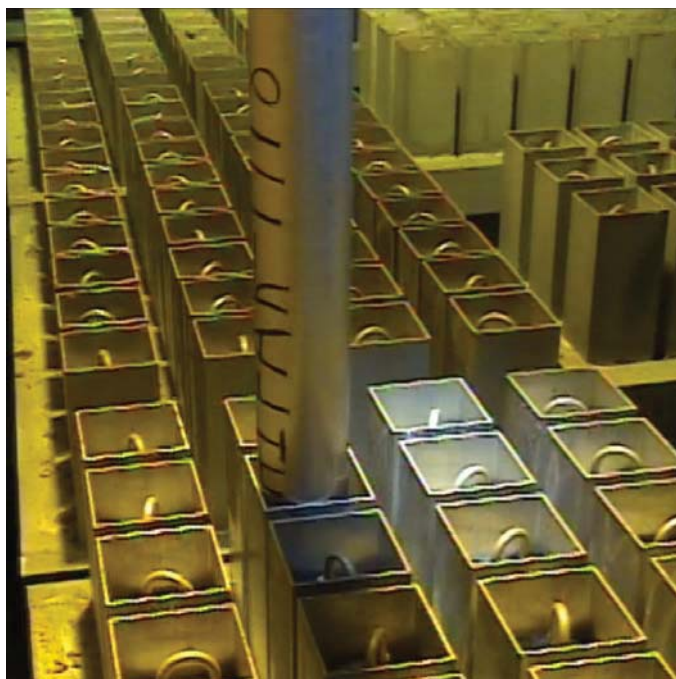
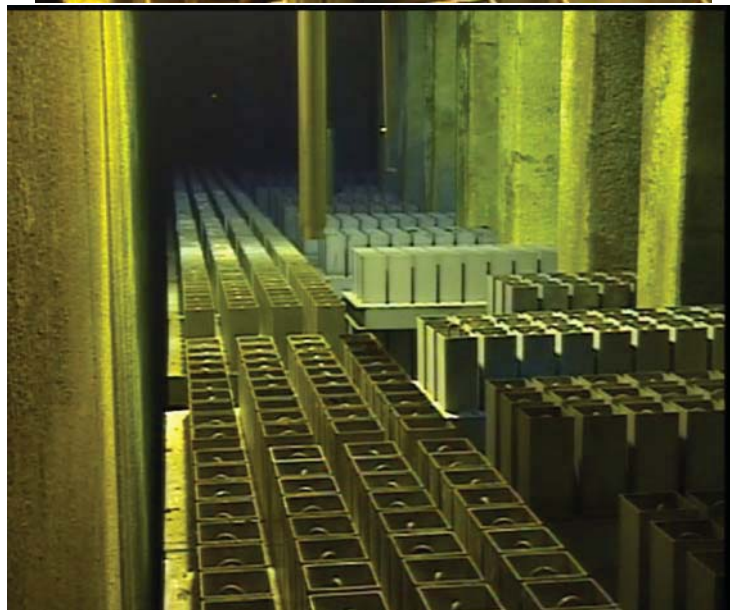
**Figure A5-12 (Top) HIFAR bundle coming out of rack (Bottom) Movement of Bundle L-HIFAR-1918 turning east in the 4 by 20 rack rows**

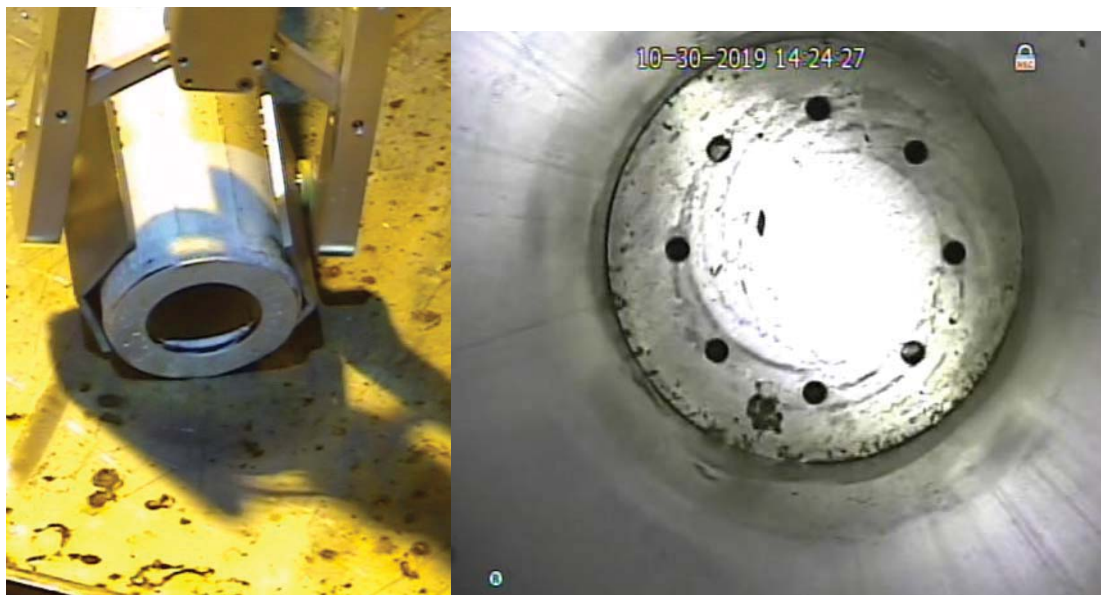
**Figure A5-13** Handling of 1st Debundled assembly. Bottom of the inside of vacated HIFAR Bundle 1553 using round parallel grippers L-HIFAR-1918 showing bottommost fuel imprint.

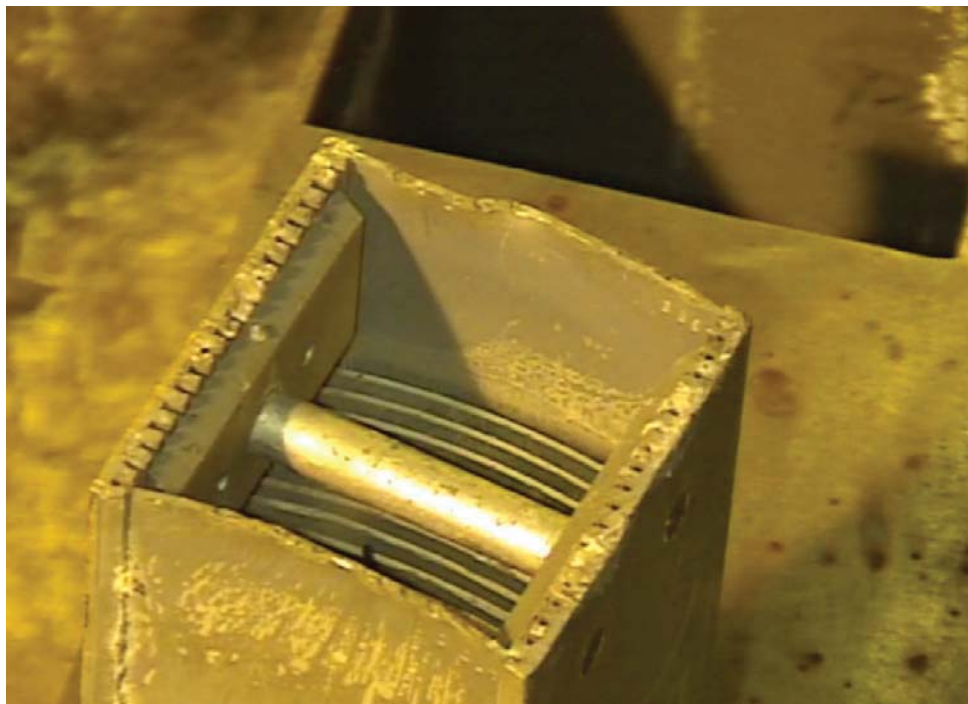
*Figure A5-15 1st assembly debundled CNEA 272 sitting in slug bucket.*

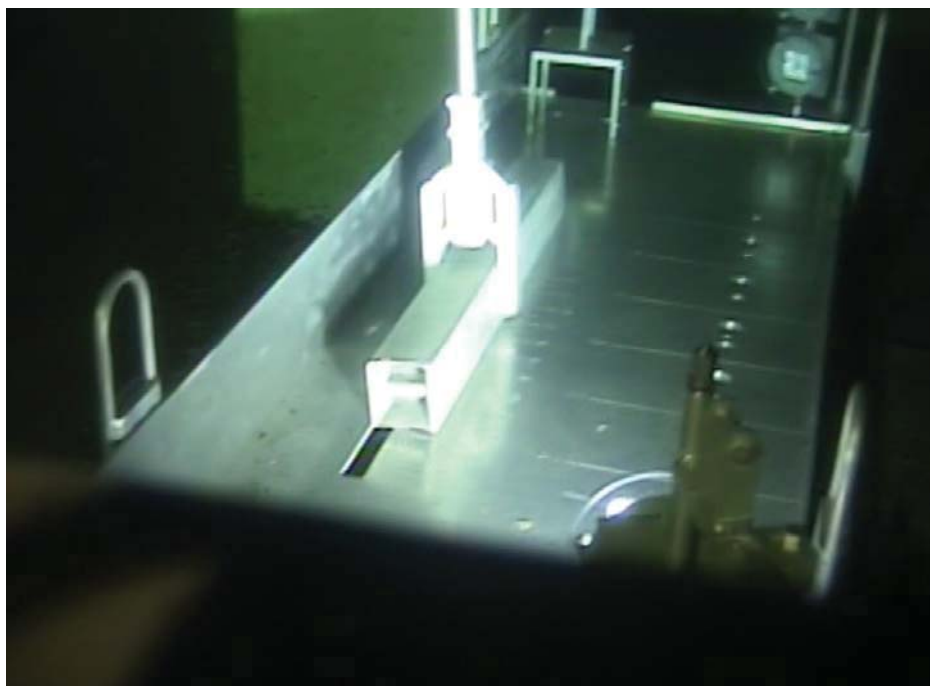
*Figure A5-16 Inspection assembly 236 Bird Eye View on Inspection Table.*

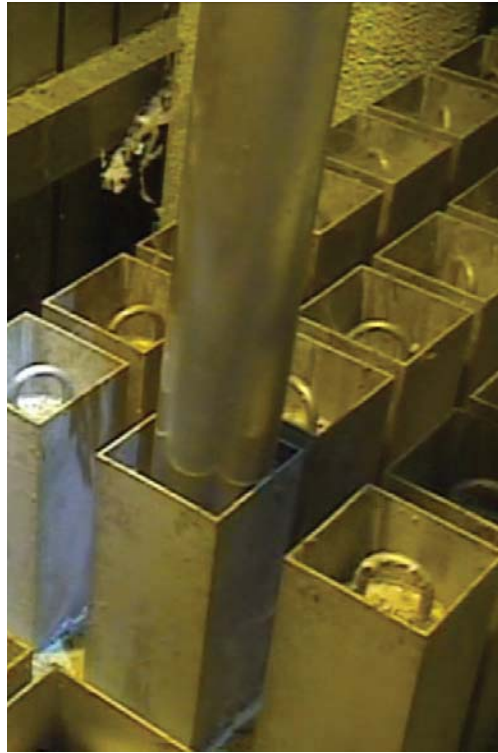
*Figure A5-19 Cobwebs on left side of bundle as inspection bundle L-HFR-1435 is pulled out of the rack.*

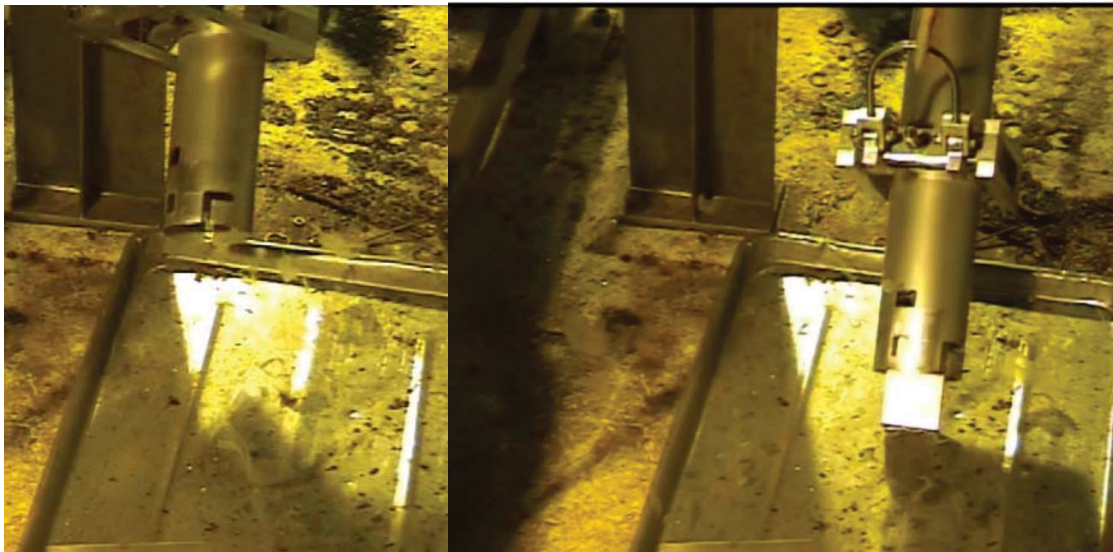
*Figure A5-20 Cobwebs exiting the bundle (Left) as the 1st Assembly is removed from the bundle with cobwebs (Right).*
